Attention:	Mr. John L. Ubbing, P.E.
	Bridge Engineer
Reference:	Structure Foundation Exploration – Final
	PIK-CR9-5.29
	Latham, Ohio
	CTL Project No. 19050131COL

STRUCTURE FOUNDATION EXPLORATION - FINAL

PIK-CR9-5.29 LATHAM, OHIO CTL PROJECT NO. 19050131COL

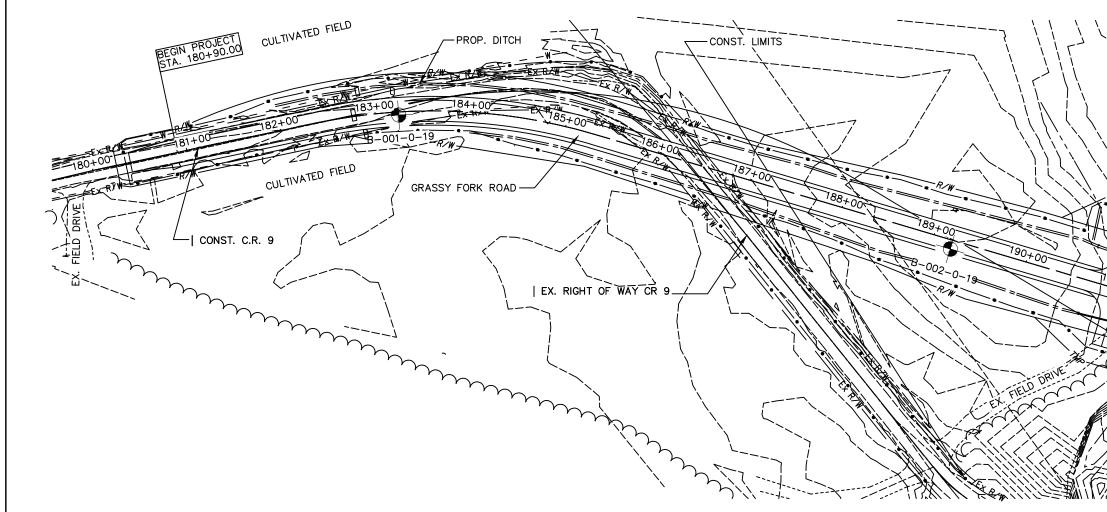
▶ PIK-CR 9-5.29	SOIL PROFILE

-			
640																
630					PI	ROPOSED	GRADE						EX	 STING GF 	 RADE 	
620			B-001-0-1 3' RT. ASPH.=0.17 BASE COURSE=	9 ,, 0.67'					/ EX.	C.R. 9			В-	-002-0-1 9'RT. PSOIL=0.6	9	
610			11 26 8 21 12 24						`_/\.			.1		12 22 12 20 14 23		
600			Neo WC											6 32 19 1 ++++ 43 3 /// 25 11	¥ W	
590													8/50/2 N	11 18 2" 26 60 WC		
580																
570																
560																
180+00	181+00	182+00	183+00	184+00	185+0	00	186+	00	187	+00	188·	+00	189	+00	190	+00

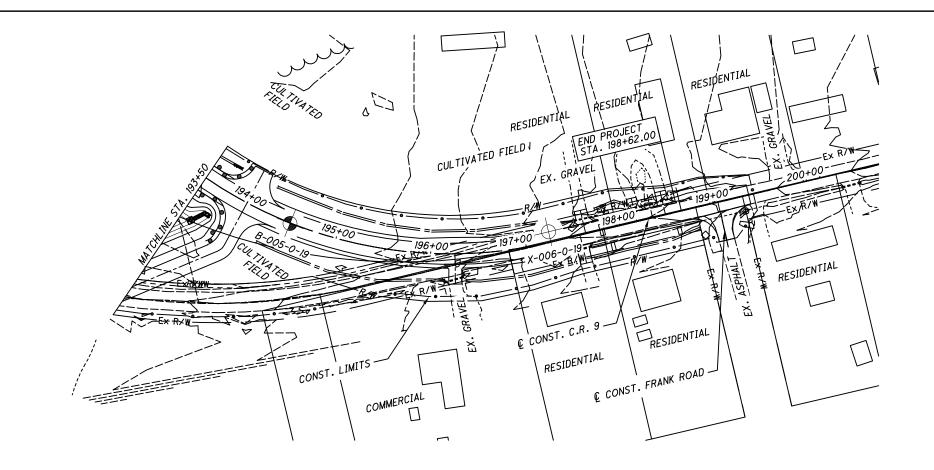
640															640
							E	XISTING (I GRADE						
			 PROPOSEL												
630			1 10/ 0322				/								630
		/				/									
620		B-005 1' R TOPSOIL	-0-19 7.												620
020		- TOPSOIL	=0.67′ —												020
		14	23												
610		12	23 25 -23 -▼ 34 31												610
		12	23-												
		10	31												
600		14 🖽	18 WC —												600
		N ₆₀	WC I												
590															590
580															580
570															570
560	10.4	00	105		100		107		100		100		200		560
	194+	-00	195-	FUU	196-	-00	197-	-00	198-	FUU	199-	-00	200	+00

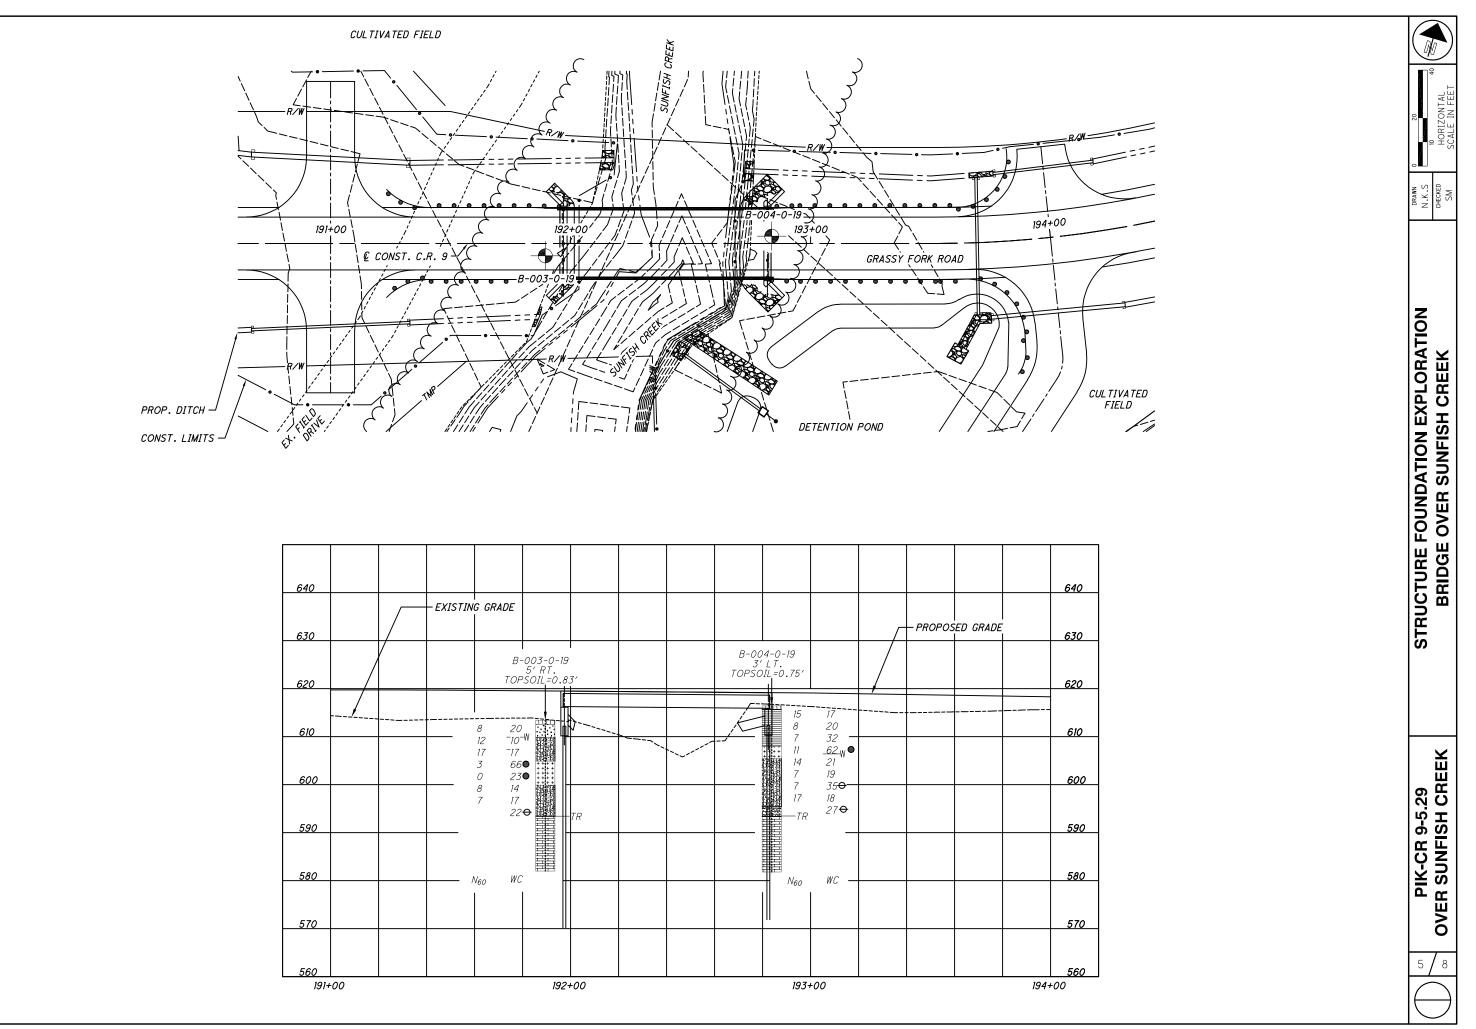
640													
630		- EXISTIN	G GRADE							 – PROPOS	ED GRADE	 	ľ
620	/		B- TOF	-003-0-19 5' RT. 2SOIL=0.8] 3′		B-00 3' TOPSC	94-0-19 1 L T . 91L=0.75'					
610		 	8 20 12 10		· · · · · · · · · · · · · · · · · · ·		K	15 8 7	17 20 32 —	 			
600			17 ⁻ 17 3 66 0 23			 		++++ 11 14 14	52 <u>62</u> ₩ 21 19 35 0				
590			7 17	13:11:14	TR			7 17 TR	18 27 0				
580		,	V ₆₀ WC	↔				N ₆₀	WC —				
570													
560													
191 -	+00			192-	+00			193-	+00			194-	+(

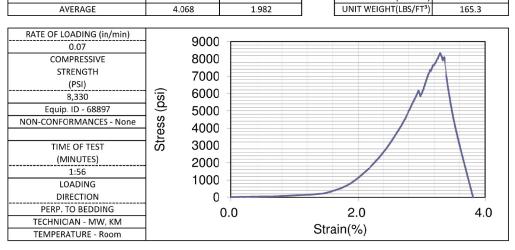
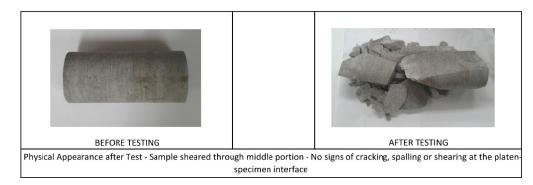
ROJECT NO:	19050131COL	U	NIAXIAL	COMPRESSIVE	STRE	NGTH OF	
ATE:	1/16/2020		INTACT	ROCK CORE -	ASTM	D 7012	
		-		Method C		ENGINEERIN	Gë
	BORING NUMBER	B-0	04-0-19	TOP DEPTH(FT)	28.3	BOTTOM DEPTH(FT)	28.7
	SAMPLE NUMBER		NQ-2	DISTRICT	9	PID NO.	
	COUNTY		Pike	ROUTE	CR 9	SECTION	5.29
				e, Lilley and Bisher F			
				Unweathered, Stro	ng, Dolo	omitic, Vuggy	
MOIS	STURE CONDITION	As Rec	eived				
MEAS	UREMENT	LENGT	H(INCHES)	DIAMETER(INCHES)		LENGTH/DIAMETER	2.1
	1		4.077	1.955		CORRECTION FACTOR	1
	2		4.075	1.967		AREA(IN ²)	3.1
	3	4	1.080	1.956		MASS (GRAMS)	535.4
A٧	/ERAGE	4	1.075	1.980		UNIT WEIGHT(LBS/FT ³)	162.6
	DADING (in/min)	-	12000	-	_

0.09 IPRESSIVE	-				Λ	
	RENGTH		10000				
	(PSI)						
	(1,267	<u>;;</u>	8000				
	ID - 68897	ğ					
	RMANCES - None	ŝ	6000				
		Stress (psi)					
TIM	E OF TEST	l t	4000				
(M	INUTES)

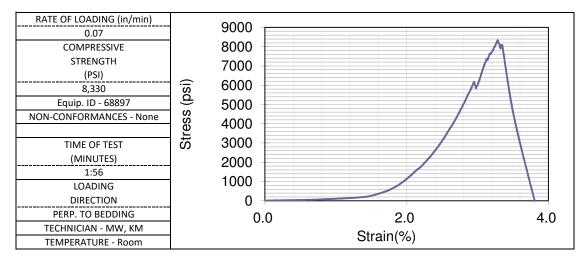
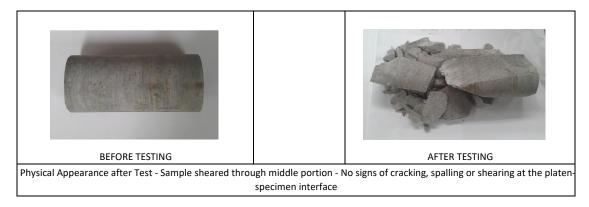
UNIAXIAL COMPRESSIVE STRENGTH OF INTACT ROCK CORE - ASTM D 7012

FORMATION	Peebles Dolomite, Lilley and Bisher Formations, Undivided
DESCRIPTION	Limestone, Gray, Unweathered, Strong, Vuggy, Dolomitic
MOISTURE CONDITION	As Received

MEASUREMENT	LENGTH(INCHES)	DIAMETER(INCHES)
1	4.077	1.955
2	4.075	1.967
3	4.080	1.956
AVERAGE	4.068	1.982

LENGTH/DIAMETER	2.1
CORRECTION FACTOR	1
AREA(IN ²)	3.1
MASS (GRAMS)	544.8
UNIT WEIGHT(LBS/FT ³)	165.3

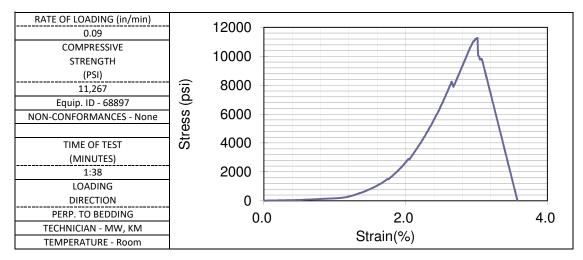
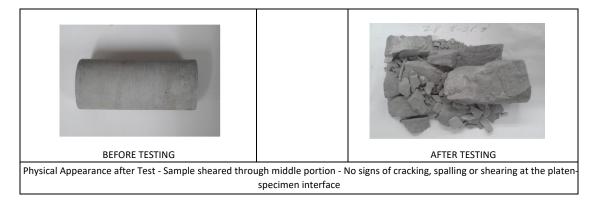
FORMATION	Peebles Dolomite, Lilley and Bisher Formations, Undivided
DESCRIPTION	Limestone, Gray, Unweathered, Strong, Dolomitic, Vuggy
MOISTURE CONDITION	As Received

MEASUREMENT	LENGTH(INCHES)	DIAMETER(INCHES)	1	LENGTH/DIAMETER	2
1	4.077	1.955		CORRECTION FACTOR	
2	4.075	1.967		AREA(IN ²)	3
3	4.080	1.956		MASS (GRAMS)	53
AVERAGE	4.075	1.980		UNIT WEIGHT(LBS/FT ³)	16
