Re: SUM-8-1.75 Bridge Replacement Study
PID 91710
Bridge Asbestos Inspections

Gannett Fleming completed an asbestos inspection for bridge SUM-8-1.99 over the Little Cuyahoga River in Akron, Summit County. As specified in the scope of work, the inspection included a review of available plan sheets, a visual inspection of the bridge, and collection of samples of suspected asbestos-containing material (ACM).

PHOTOGRAPHS

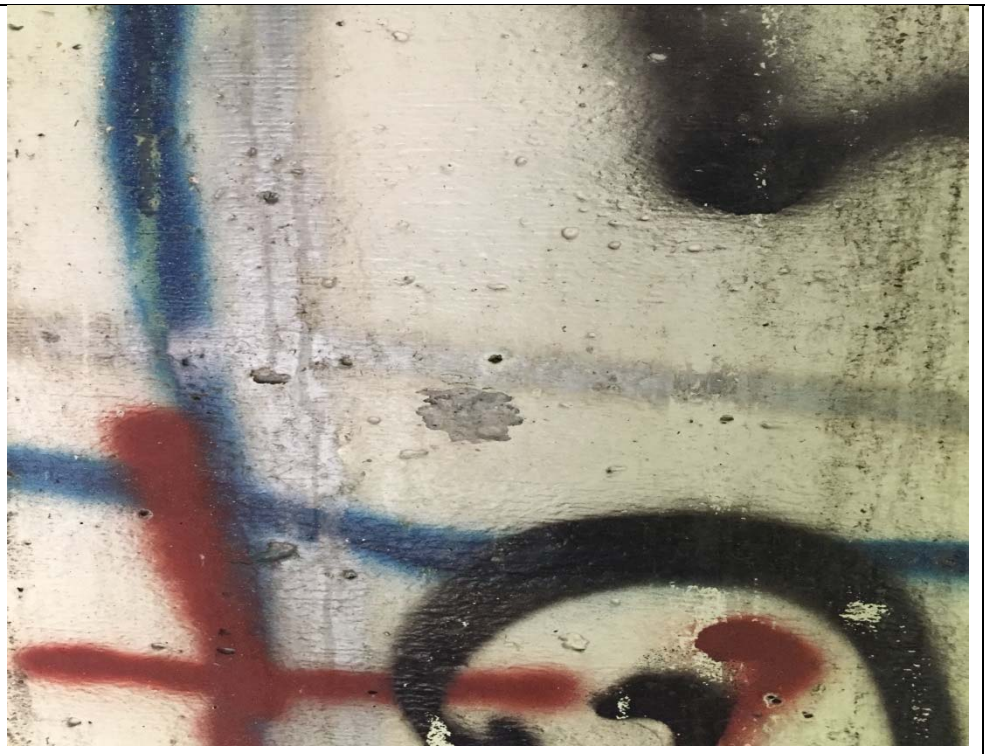
Photo No. 1	Date: 6/12/15	Direction: NA
-----------------------	-------------------------	-------------------------

Sample Layers	Asbestos Content
Multicolored Concrete	ND
Sample Composite Homogeneity: Poor

Concrete Abutment, North Side

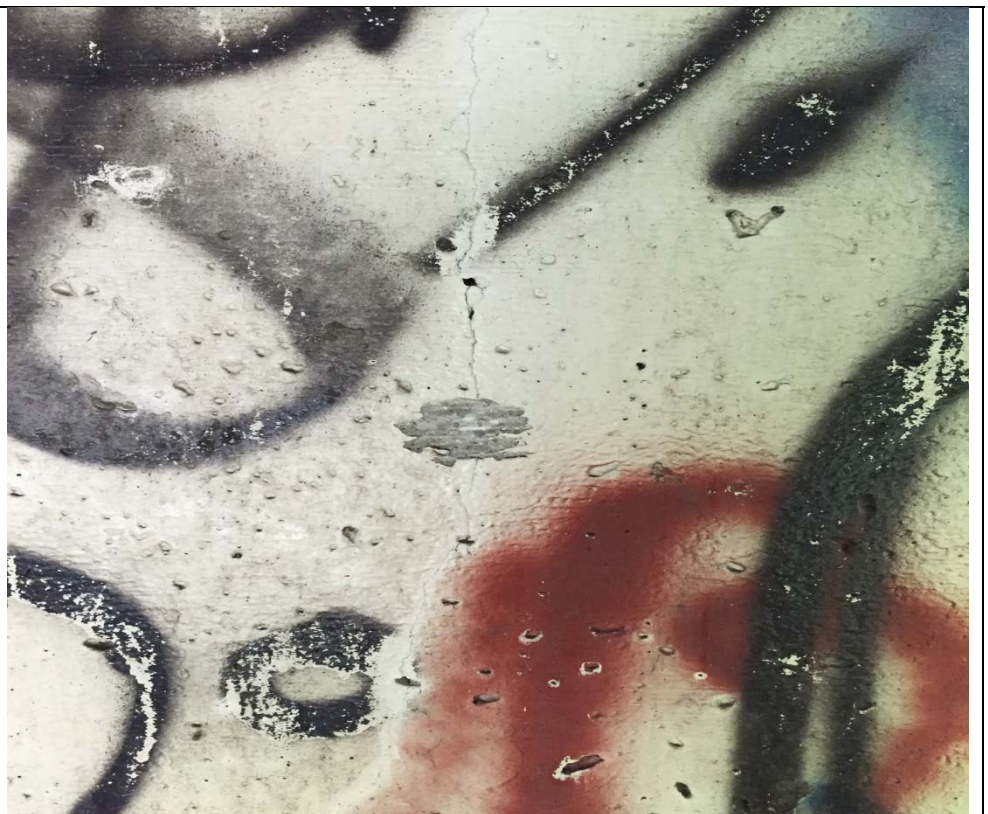
Photo No. 2	Date: 6/12/15	Direction: NA
-----------------------	-------------------------	-------------------------

Sample Layers	Asbestos Content
Multicolored Concrete	ND
Sample Composite Homogeneity: Poor

Concrete Abutment, North Side

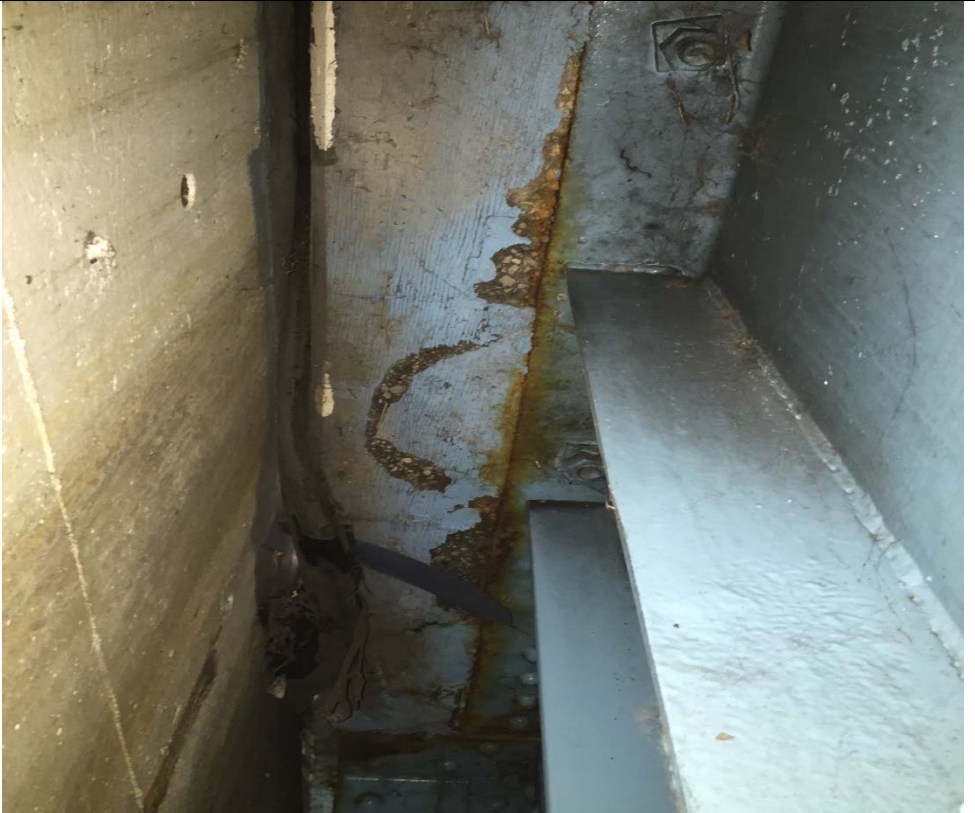
Photo No.	Date:	Direction:
5	6/12/15	NA
Description: Concrete Deck, eastern side

Sample Layers	Asbestos Content
Blue Paint /Gray Concrete	ND
Sample Composite Homogeneity: Moderate

Photo No.	Date:	Direction:
6	6/12/15	NA
Description: Concrete Deck, western side

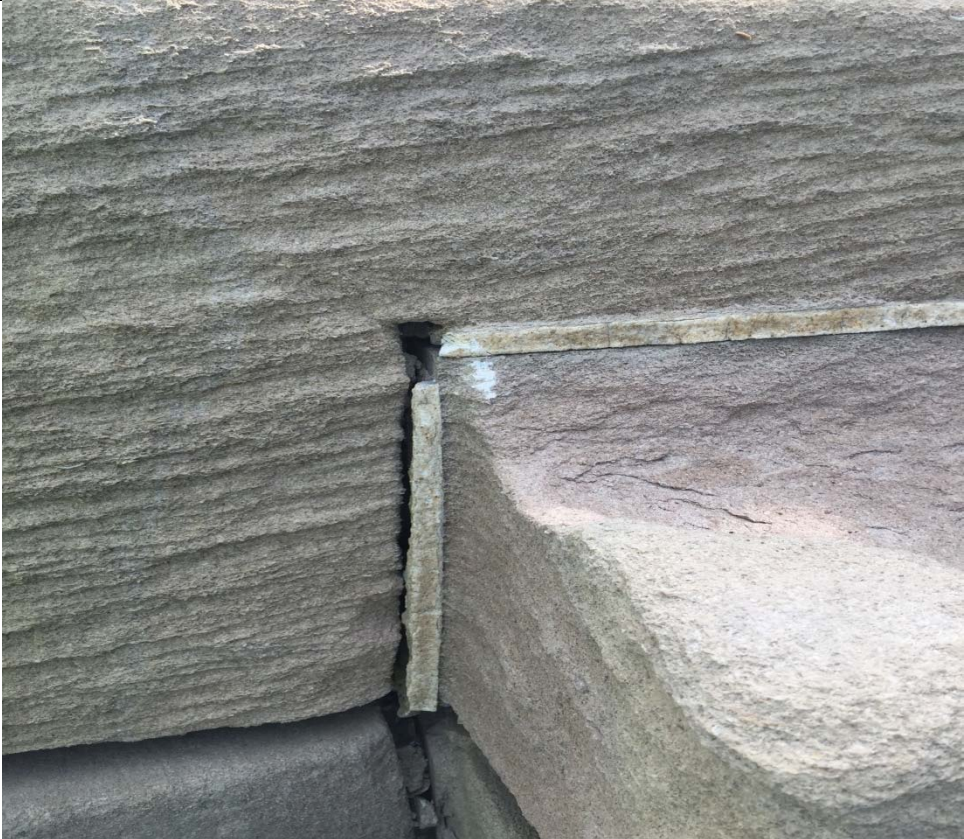
Photo No. 8	Date: 6/12/15	Direction: NA

Sample Layers	Asbestos Content
Multicolored Concrete	ND
Sample Composite Homogeneity: Moderate

Photo No. 7	Date: 6/12/15	Direction: NA	Not Available
Description: Pier Cap Mortar

Description: Pier Cap Mortar

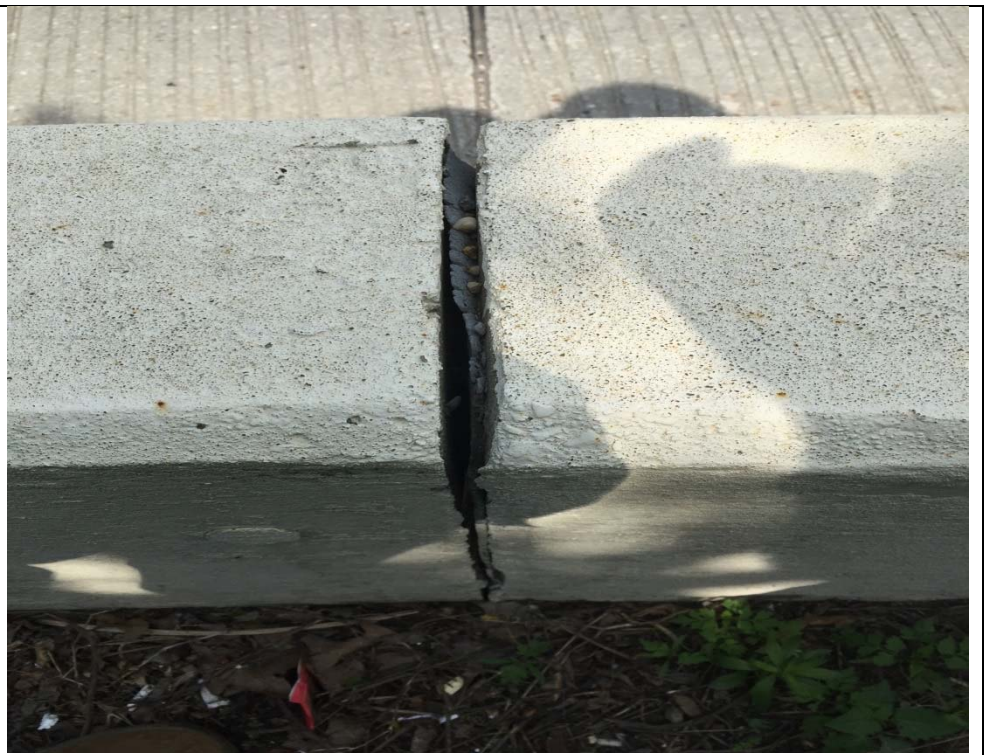
Photo No. 9	Date: 6/12/15	Direction: NA
-----------------------	-------------------------	-------------------------

Sample Layers	Asbestos Content
Gray Caulk	ND
Composite Non-Asbestos Content:	2% Cellulose
Sample Composite Homogeneity:	Moderate

Description:
Sidewalk Wall Caulk

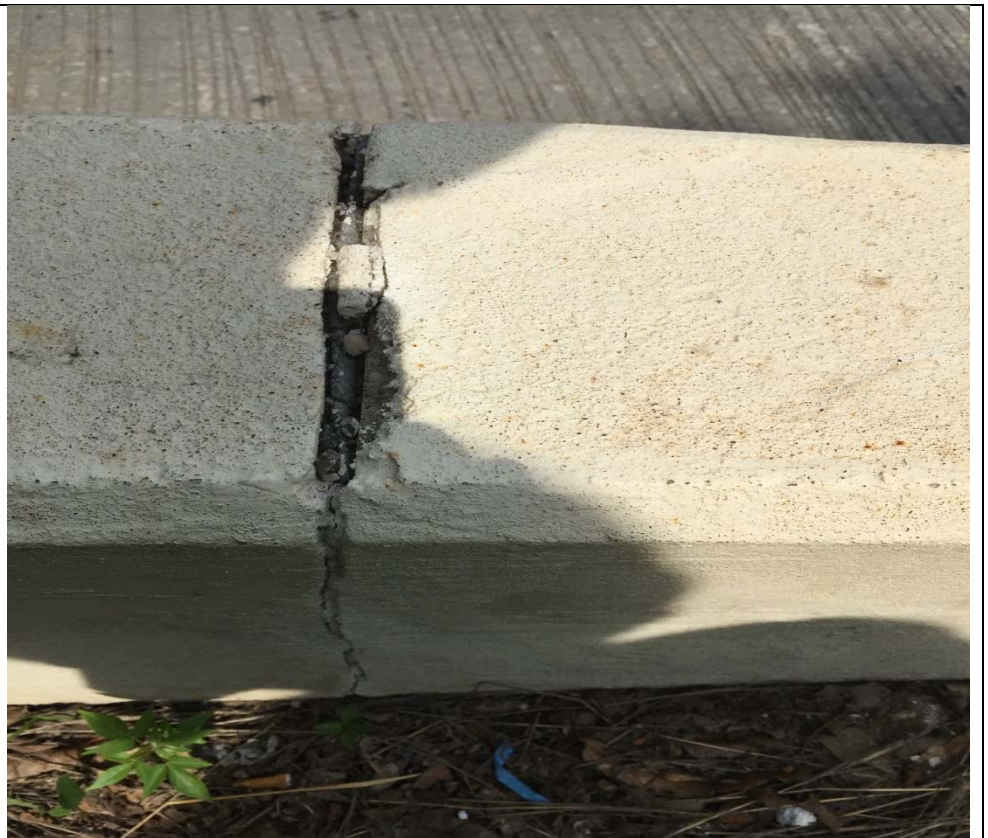
Photo No. 10	Date: 6/12/15	Direction: NA
------------------------	-------------------------	-------------------------

Sample Layers	Asbestos Content
Gray Caulk	ND
Composite Non-Asbestos Content:	2% Cellulose
Sample Composite Homogeneity:	Moderate

Description:
Sidewalk Wall Caulk

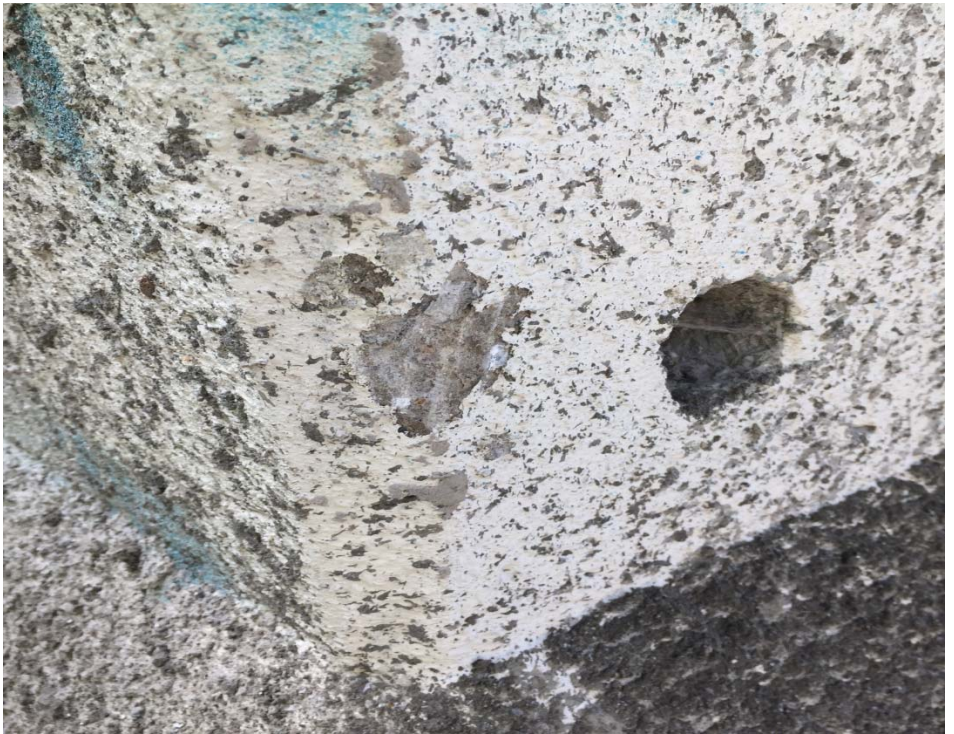
Photo No. 12	Date: 6/12/15	Direction: NA

Sample Layers	Asbestos Content
White Paint /Gray Concrete	ND
Sample Composite Homogeneity:	Moderate

Photo No. 11	Date: 6/12/15	Direction: NA	 
Description: Bridge Column

Description: Bridge Column
