**Regulated Materials Investigation for
PPN 122-16-21, -022, -028
(Contract Document)**

**Innerbelt Bridge
Construction Contract Group 1 (CCG1)**

FINDINGS OF A REGULATED MATERIALS INVESTIGATION

***The Gillota Fuels Buildings
308 Central Viaduct
Cleveland, Cuyahoga County, Ohio
[CUY-Innerbelt CCG1 Design/PID 77332]***

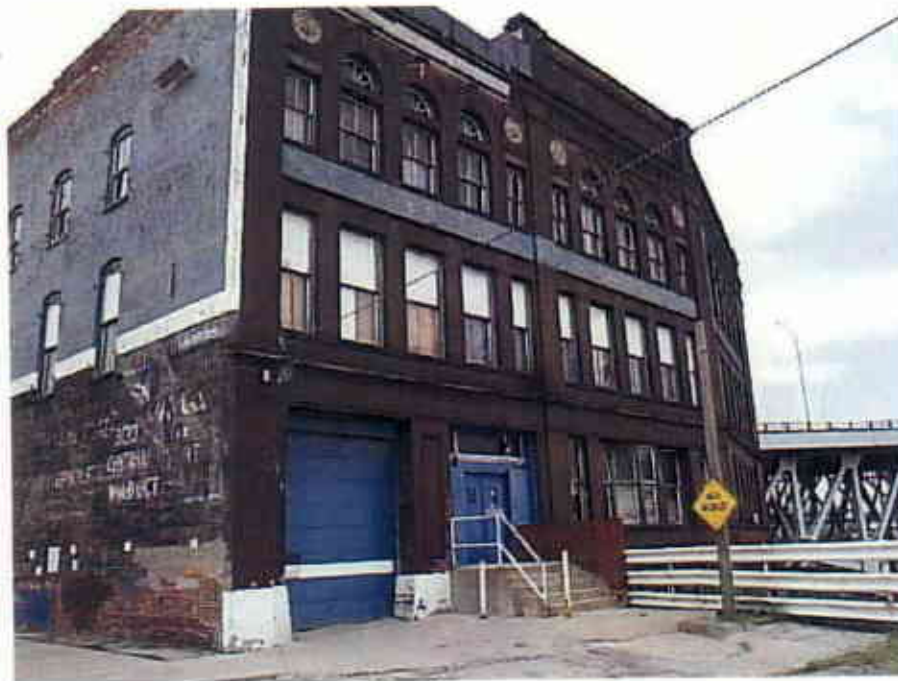
Photograph 02

View Looking Southeast at the West Side of the Gillota Fuels Main Building
308 Central Viaduct, Cleveland, Ohio (CCG1 Design PID 77332)

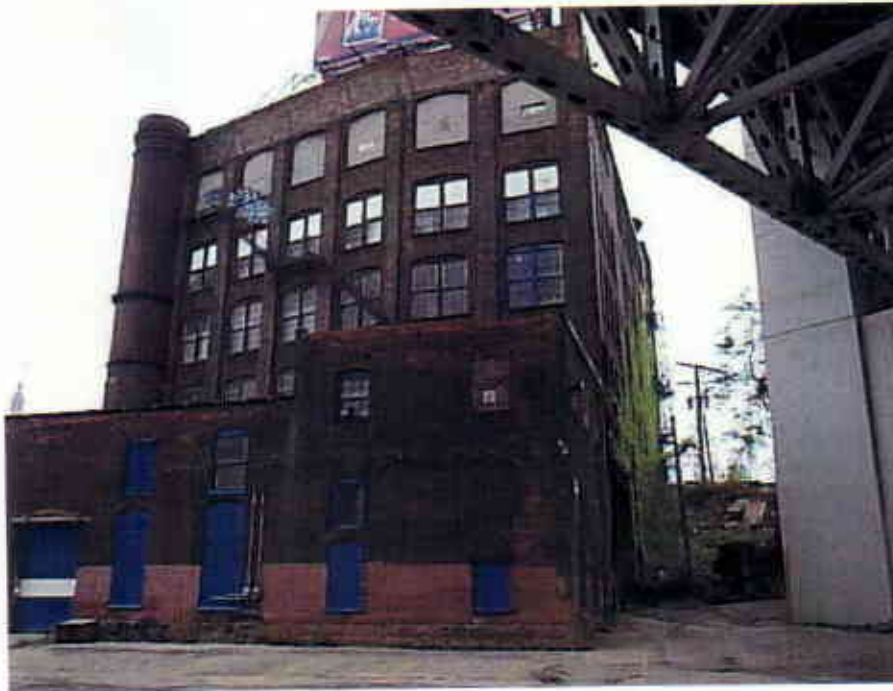
Photograph 03

View Looking North at the South Side of the Gillota Fuels Main Building
308 Central Viaduct, Cleveland, Ohio (CCG1 Design PID 77332)

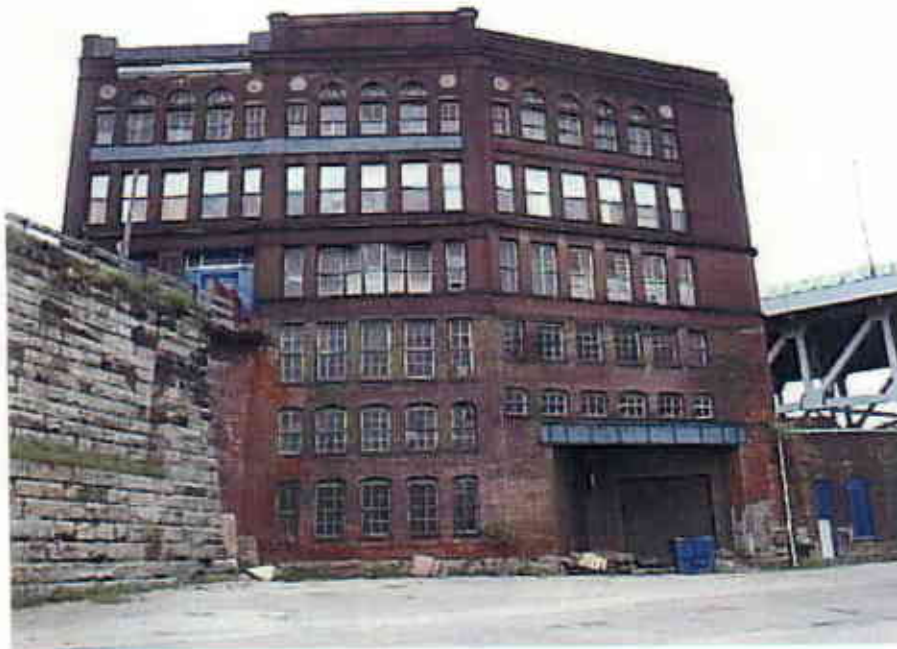
Photograph 04

View Looking East at the West Side of the Gillota Fuels Main Building
308 Central Viaduct, Cleveland, Ohio (CCG1 Design PID 77332)

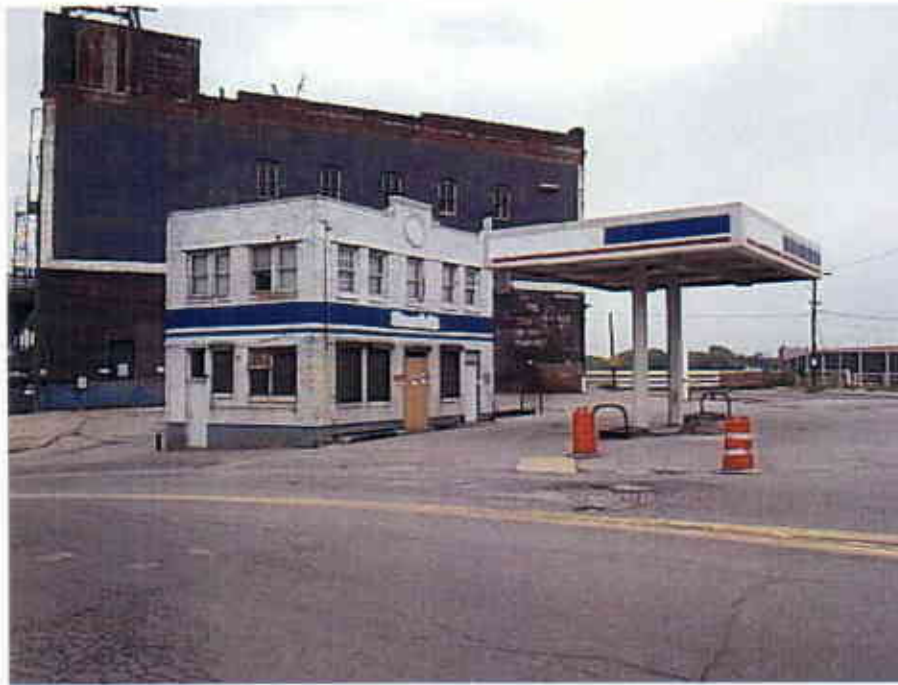
Photograph 05

View Looking South at the North Side of the Gillota Fuels Gas Station Building
308 Central Viaduct, Cleveland, Ohio (CCG1 Design PID 77332)

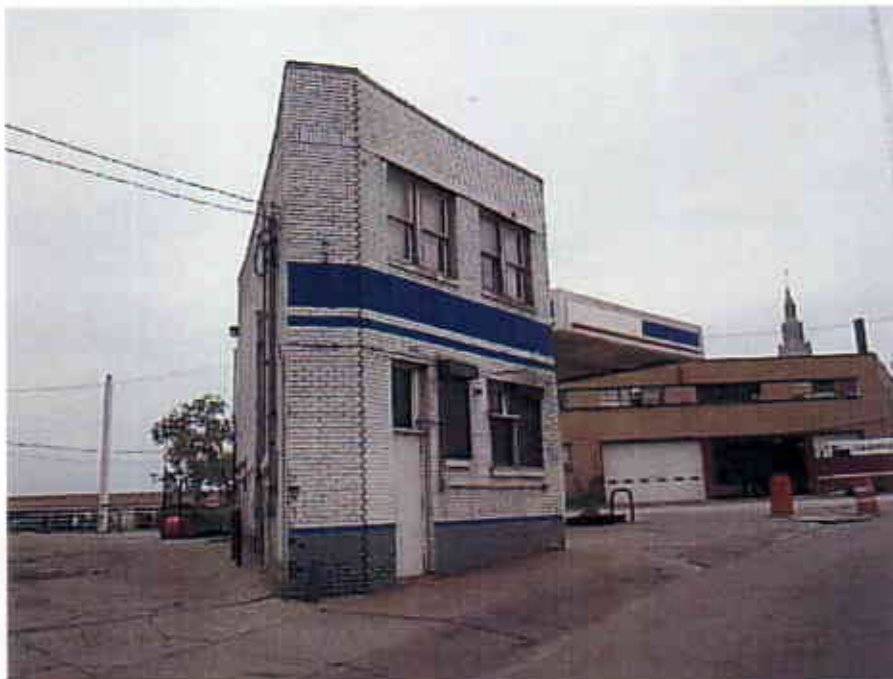
Photograph 06

View Looking West at the East Side of the Gillota Fuels Gas Station Building
308 Central Viaduct, Cleveland, Ohio (CCG1 Design PID 77332)

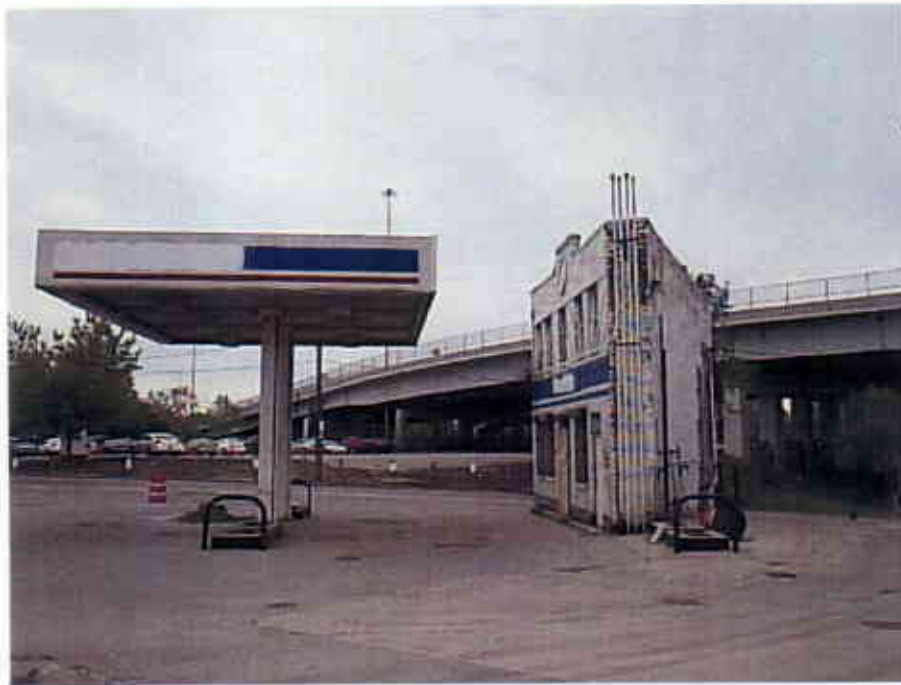
Photograph 07

View Looking Northeast at the South Side of the Gillota Fuels Gas Station Building
308 Central Viaduct, Cleveland, Ohio (CCG1 Design PID 77332)
