O.D.O.T. DISTRICT 2 SURVEY OFFICE (USE ONLY)

PERSONNEL _____ REFERENCE NO. 11 A SHEET 18 OF 26
 NOTES CANTERBURY DATE 08-18-1998 ROUTE SR 109
 H.C. ROUSOS WEATHER PRTLY CLDY COUNTY HENRY
 R.C. BARNHISEL TEMP. +80°F TOWNSHIP MARION
 _____ SECTION 3
 _____ T 3 N R 7 E

TYPE MONUMENT RR SPK IN WOOD HUB
~~ON SURFACE~~ - BELOW 2"
 LEFT - ~~PAV'T~~ - RIGHT 20.3'
10' TO LT EDGE PAVEMENT
 S.L.M. 565+27

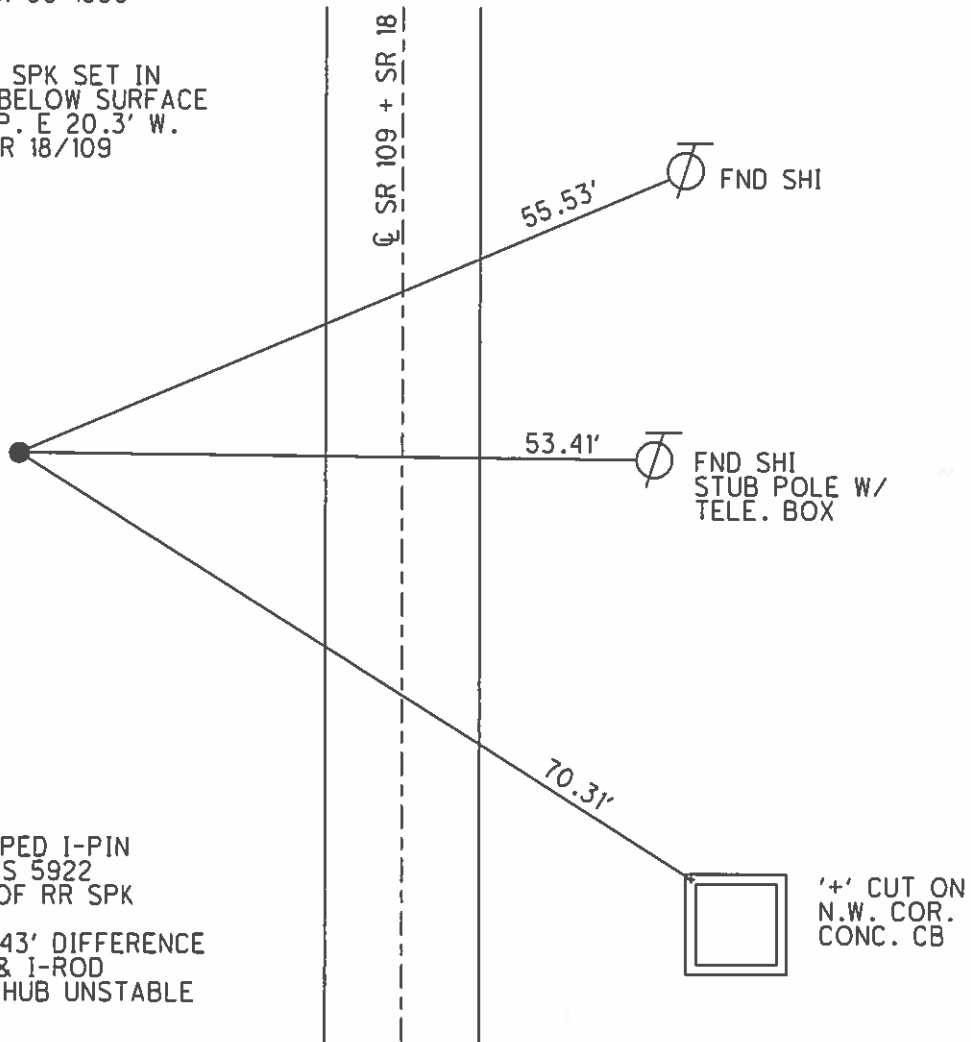
REC:
 FND SMALL RR SPK SET IN
 WOOD HUB 2" BELOW SURFACE
 10' W OF W E.P. E 20.3' W.
 OF C PVMT. SR 18/109

NOTE:
 ALSO FND CAPPED I-PIN
 STAMPED # RLS 5922
 3.5" TO N.E. OF RR SPK

THERE IS A 0.43' DIFFERENCE
 BETWEEN SPK & I-ROD
 SMALL SPK IN HUB UNSTABLE

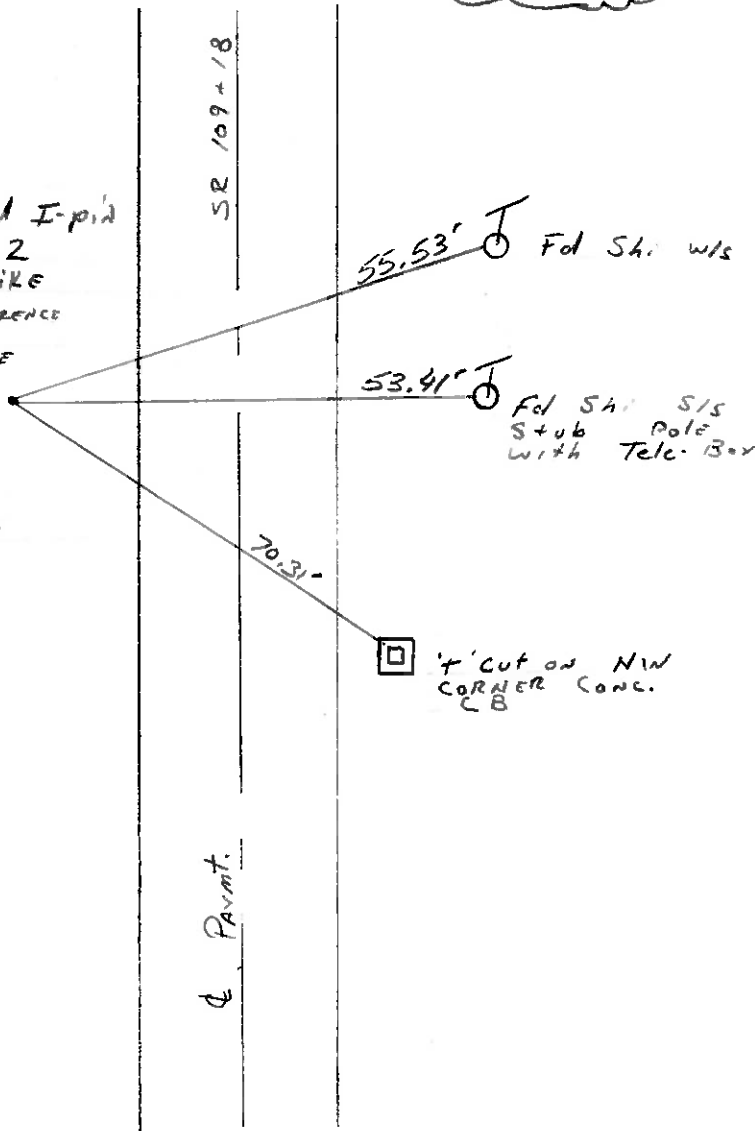
TYPE MONUMENT Sm. RR spike in wood hub
~~ON SURFACE~~ - BELOW 2" Below
 LEFT- & PAV'T. ~~RIGHT~~ 20, 3' W of &
10' ETO W EDGE PAVEMENT

Also Found capped I-pin
 STAMPED *RLS 5922
 3.5" to N.E. of RR spike

* THERE IS A 0.43' DIFFERENCE
 BETWEEN SPIKE & I-ROD
 - SMALL SPIKE IN HUB IS UNSTABLE

FIND, SMALL RR SPIKE SET IN
 WOOD HUB 2" BELOW SURFACE
 10' W. OF W. E.P. & 20, 3' W.
 OF & PAVT. SR 18/109

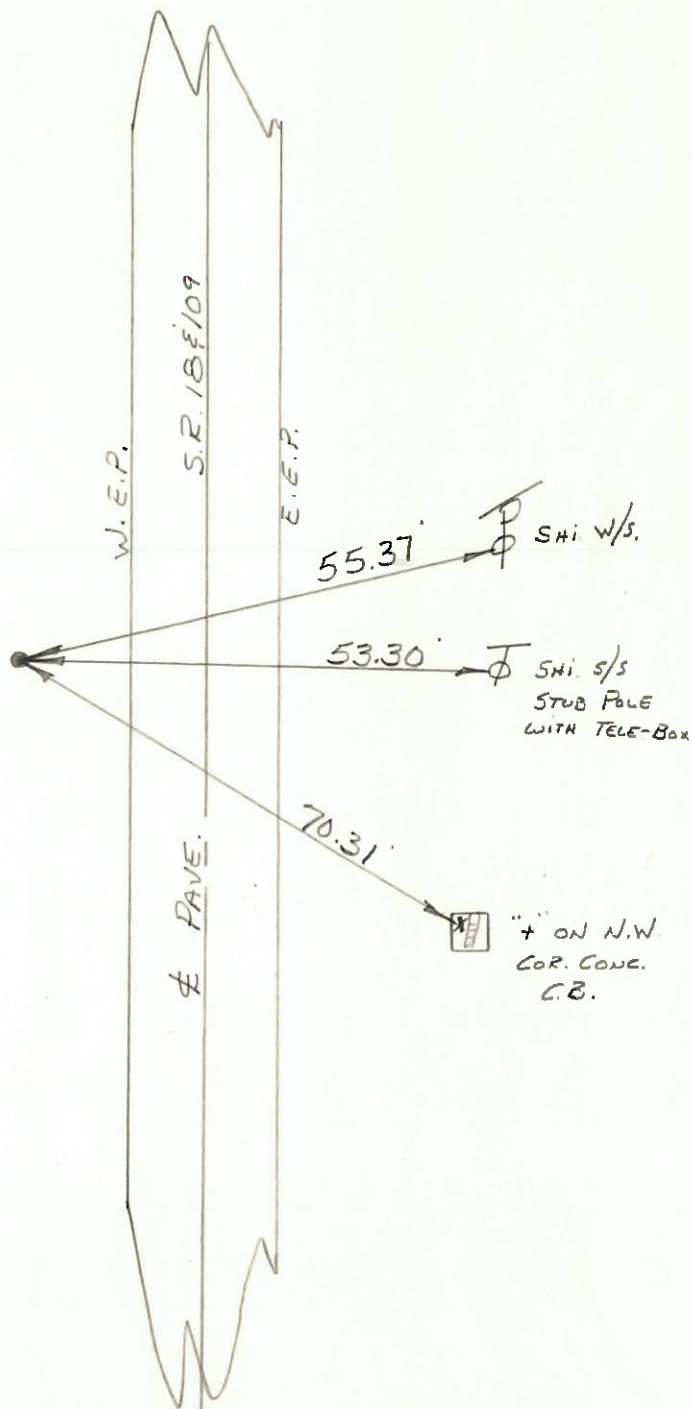
FD. SMALL R.R. SPK. SET
IN WOOD HUB 2"
BELOW SURFACE
10' WEST OF WEST E.P. &
20.3' WEST OF & PAVT.
S.R. 18/109
S.L.M. STA. 565+02±

MEASURED
STA. 565+27
