Ohio Department of Transportation, District 3

2021 Signal Evaluation

**Lorain SR 82, SLM 9.05**

**Boone Rd Intersection**

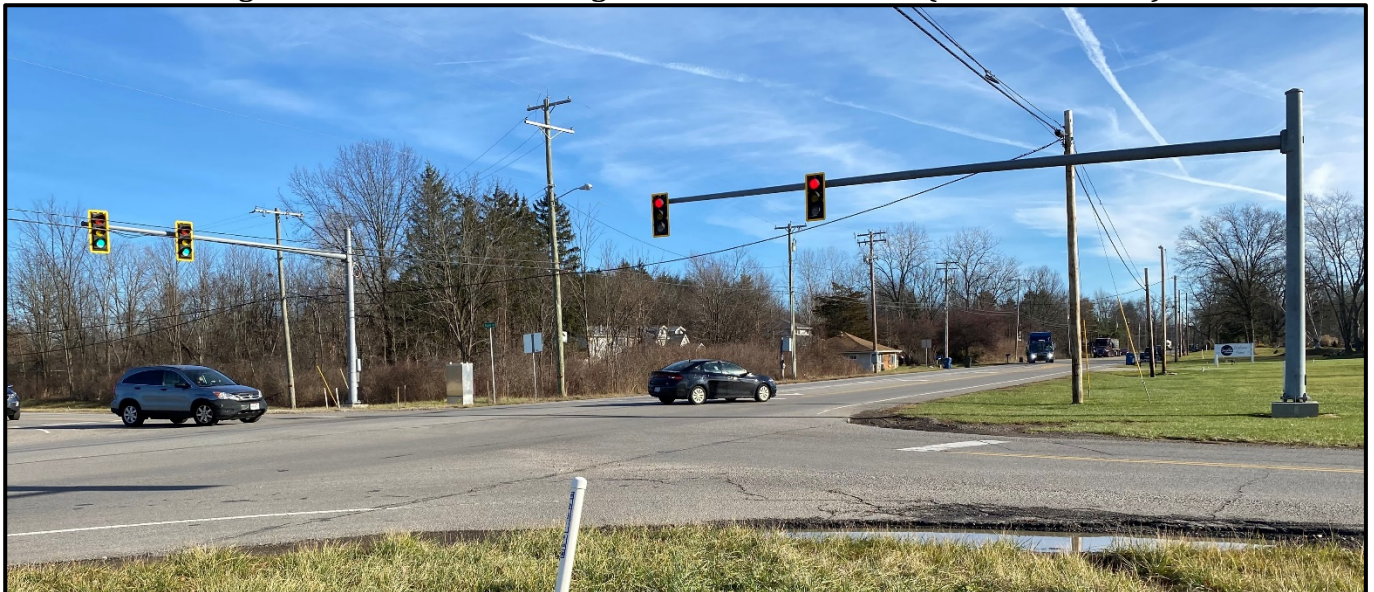
**Image 1 – SR 82 & Boone Rd Signal from the Southwest (December 2021)**

- Photo: See **Image 1** below for a photograph of the intersection.

- Speeds: 45 mph on SR 82 and Boone Rd North, 55 mph on Boone Rd South
- Traffic: Mid-morning traffic was generally light, detection and volume-density appeared to be functioning.

- Update northbound and southbound yellow change intervals from 5.0 to 6.0 seconds
- Increase eastbound and westbound minimum green time to 12 seconds to accommodate pedestrian clearance intervals
- Install radar detection so that the volume-density timings can be removed, and the passage times can be reduced
