THE PROJECT INCLUDES: 1) THE RECONSTRUCTION/WIDENING OF IR-76 EB, IR-76 NB AND IR-77 NB IN THE VICINITY OF THE IR-76/IR-77 INTERCHANGE; 2) THE RECONSTRUCTION/WIDENING OF IR-277 EB AND IR-76 WB IN THE VICINITY OF THE IR-76/IR-277 INTERCHANGE; 3) THE REALIGNMENT AND RECONSTRUCTION OF 3 CONNECTING RAMPS (RAMP T, RAMP V, AND RAMP W); 4) THE WIDENING/RECONSTRUCTION OF 7 CONNECTING RAMPS/ROADWAYS (RAMP N, RAMP M, RAMP U, RAMP J, RAMP L, RAMP A2 AND RAMP B); AND, 5) THE CONSTRUCTION OF APPROXIMATELY 13 NOISE BARRIERS ALONG THE REFERENCED INTERSTATES WITHIN THE PROJECT LIMITS.

| DESIGN AGENCY NEAS, INC. 2800 CORPORATE EXCHANGE DR., STE 240 COLUMBUS, OH 43231 (614) 714-0270 FAX (614) 714-0323 | PID NO. 100713 | SOIL PROFILE | SUM-76-6.15 |

SOIL PROFILE
BEGIN TO STA. 145+00 I.R. 77

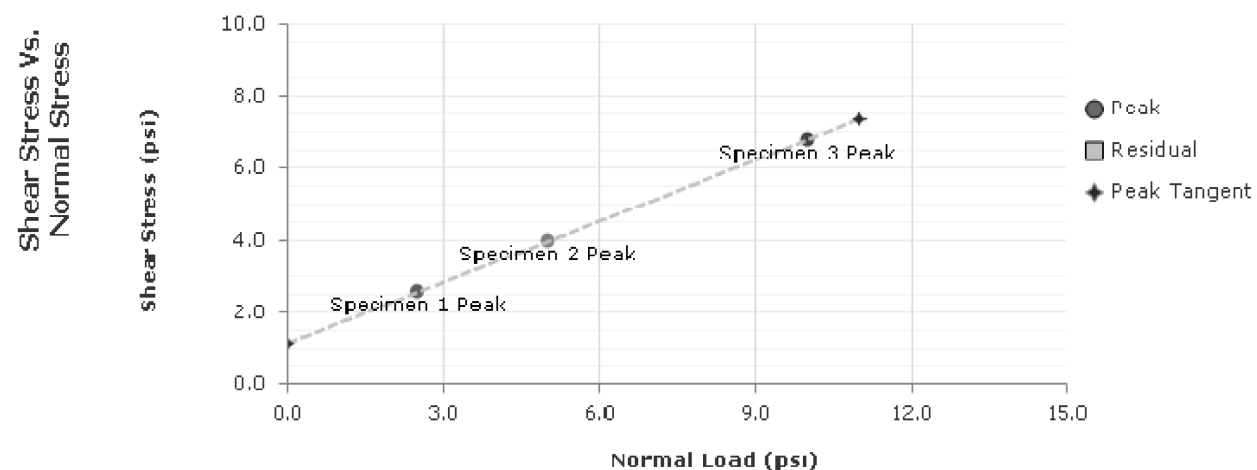
Direct Shear Test

Project: SUM-76-6.15
 Project Number: 100713
 Location: B-017-0-18
 Client Name:

C (psi): 1.2 Residual C (psi): NA
 Phi (°): 29.5 Residual Phi (°): NA

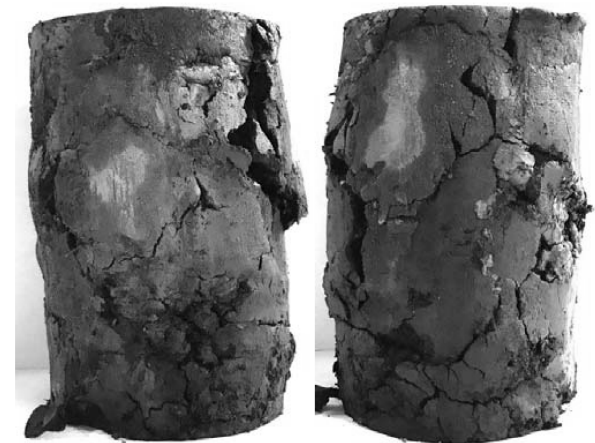
Final Specimen Figure

(Project: SUM-76-6.15 Kenmore, Boring Location: B-034-0-18, ST-2, Depth: 5.0 - 5.5ft)

Notes: Very soft, black with brown, ORGANIC SILT, some sand, little clay, trace gravel, wet. Contains 28.4% organic content.

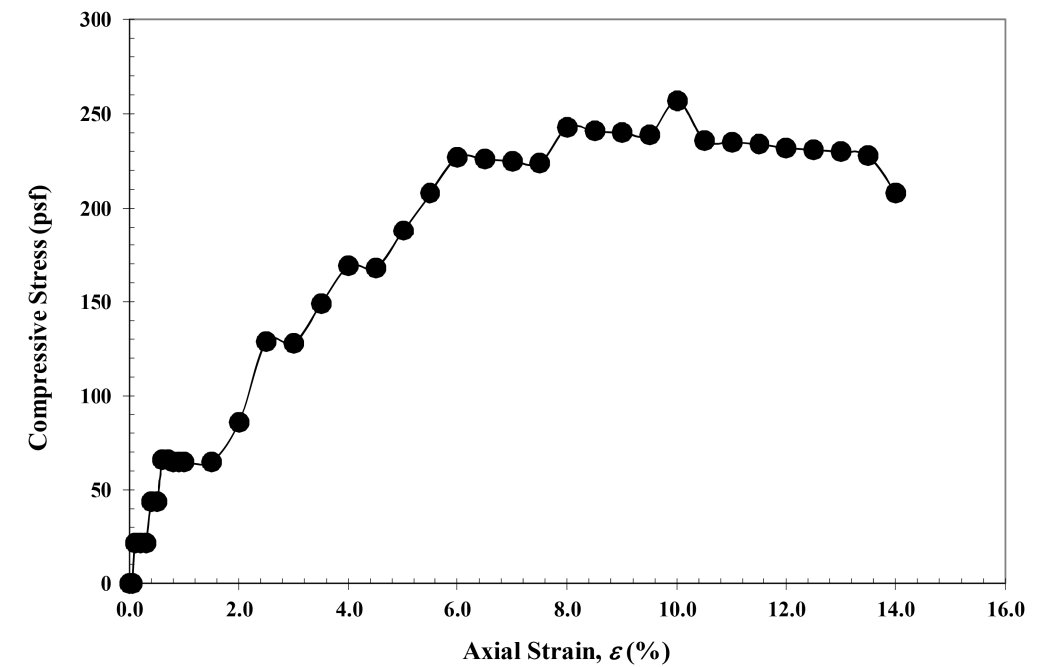
| Unconfined Compressive Strength (psf): | 257 |
| Strain (%): | 10.0 |
