# Main St (US 22) and Columbus St (SR 13)

## Safety Study

Village of Somerset, Ohio  
Ohio Department of Transportation

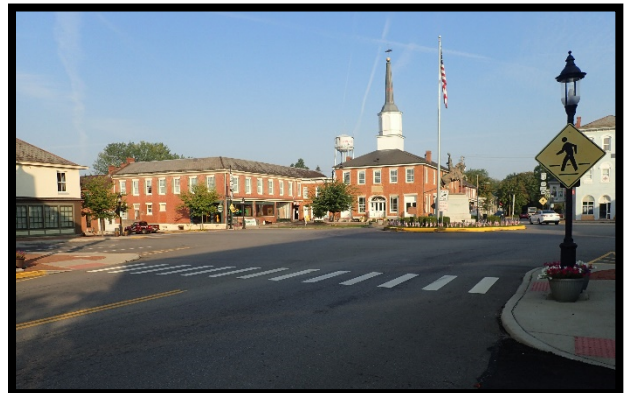
Photo 2: Pedestrian Accommodations

Pedestrian crossing warning signs and high visibility crosswalks are provided on all four approaches to the intersection, shown in **Photo 2**. Pedestrian-scale lighting is provided near all crosswalks.

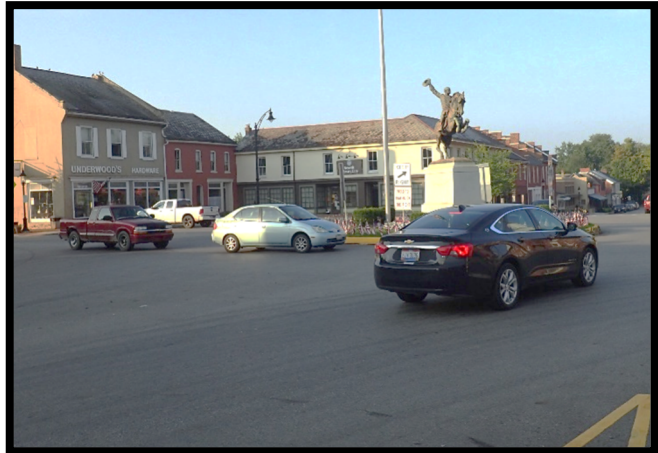
**Photo 3: Traffic Operation Confusion**

confusion related to which vehicle has the right-of-way. **Photo 3** shows two vehicles stopped, with the drivers confused as to who has the right-of-way, resulting in delay at the intersection.

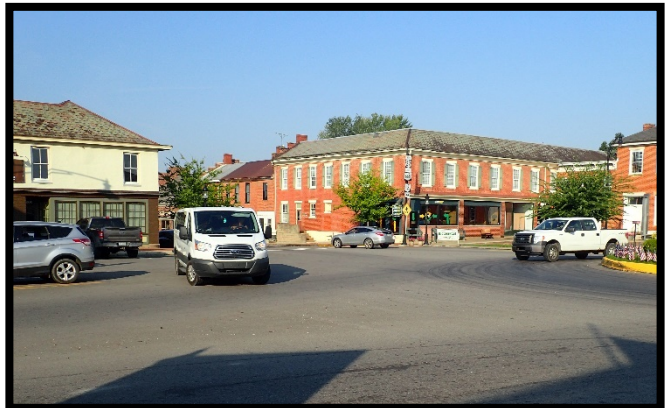
**Photo 4: Vehicle Exiting the Parking Areas**

- **Photo 4** shows a vehicle (white van) that just backed out of the parking space is waiting for a gap to enter the intersection. Parking situations like these result in conflicts between parking vehicles and vehicles within the intersection and caused operational delay in the intersection.

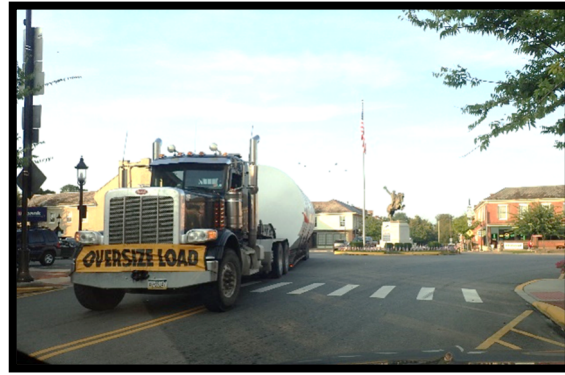
**Photo 5: Oversized Load Truck**

- There is heavy truck traffic through the intersection, including semi-trucks, tanker trucks and trucks carrying oversized loads (**Photo 5**).
  - Many of the trucks do not yield to traffic on the right which resulted in several near misses.
  - One semi-truck stalled in the center of the intersection while yielding to vehicles entering the intersection.

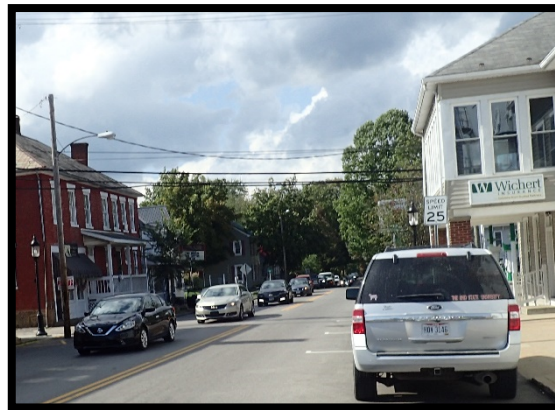
**Photo 6: Queueing on SR 13 in the PM Peak**

- In the PM peak hour, queuing of one to two block lengths occurred on the southbound approach on Columbus Street (SR 13), shown in **Photo 6**, but it dissipated quickly

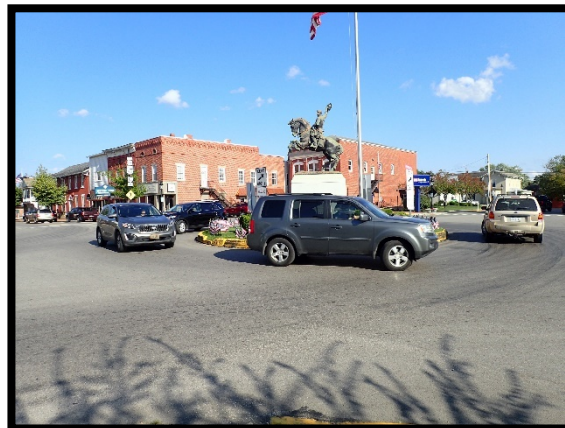
**Photo 7: Traffic Gridlock in the Intersection**

- In the PM peak hour, there were a few situations where all vehicles at the intersection were stopped or were moving extremely slowly. This situation occurred when vehicles inside the intersection were yielding to vehicles on another approach, and the vehicles entering the intersection could not move because there was gridlock within the intersection, shown in **Photo 7**.

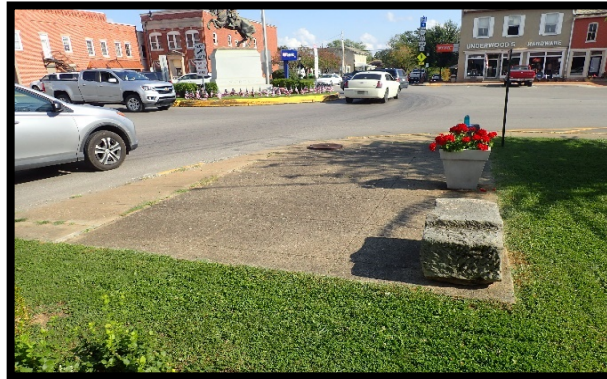
Photo 8: Abandoned Cistern

- Based on conversations with the community, as the routes have become busier, there have been increasing complaints about semi-truck/traffic noise.
- An abandoned cistern built in 1829 is located on the northwest corner of the intersection that is out of commission, shown in **Photo 8**. It occasionally fills with water and the water

needs to be pumped out. The curb and concrete pavement above the cistern has crumbled from vehicle encroachment. There was concern that that continual weight of vehicles passing over the area may lead to a collapse.

- If parking is removed, more enhanced public spaces can be created in the other quadrants. This roundabout layout is provided in **Figure 13**.
  - The empty cistern would need to be filled for either permanent roundabout option to prevent it from collapsing under the truck traffic.

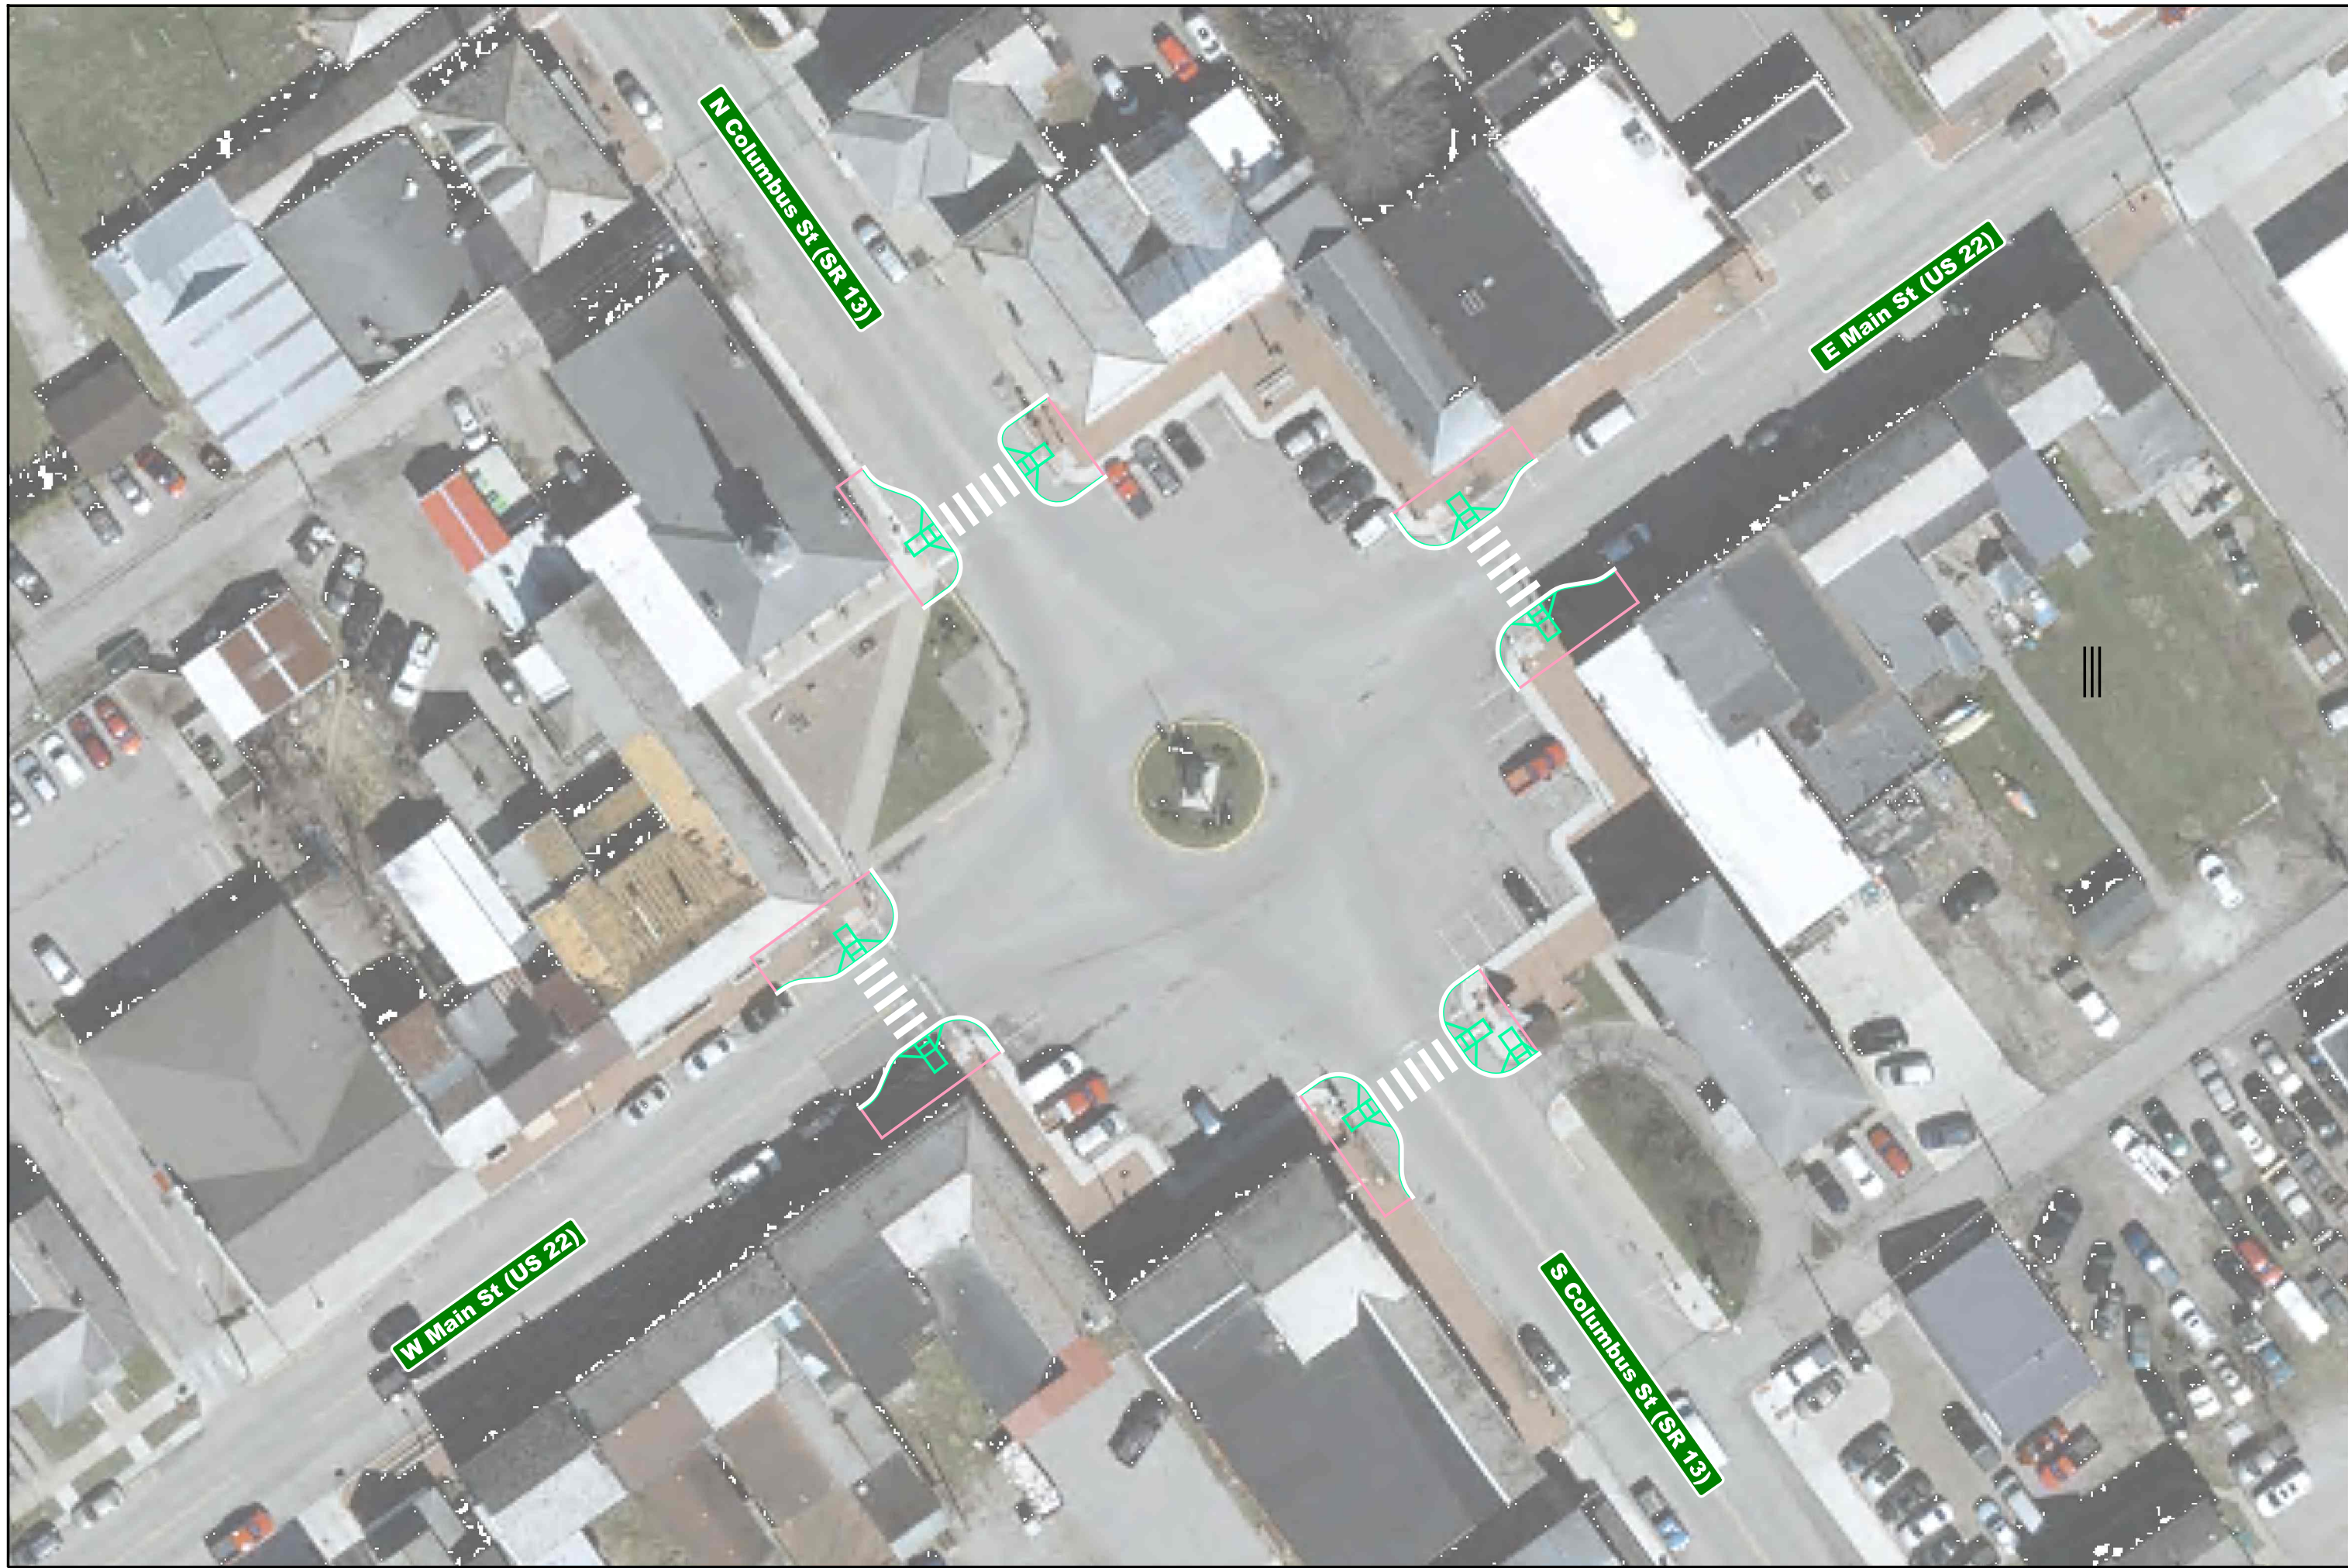
- **Add mountable curb extensions to the intersection crosswalks:** The installation of curb extensions will act as a traffic calming measure by reducing the size roadway cross section. Pedestrians are also more visible with the installation of curb extensions as they are not obstructed by vehicles in the parking lane and have a shorter crossing distance. Mountable curb extensions are recommended in this area due to the high truck traffic traveling through the intersection. A layout of these curb extensions is shown in **Figure 9**.

- **Add mountable curb extensions to the intersection crosswalks:** The installation of curb extensions will act as a traffic calming measure by reducing the size roadway cross section. Pedestrians are also more visible with the installation of curb extensions as they are not obstructed by vehicles in the parking lane and have a shorter crossing distance.

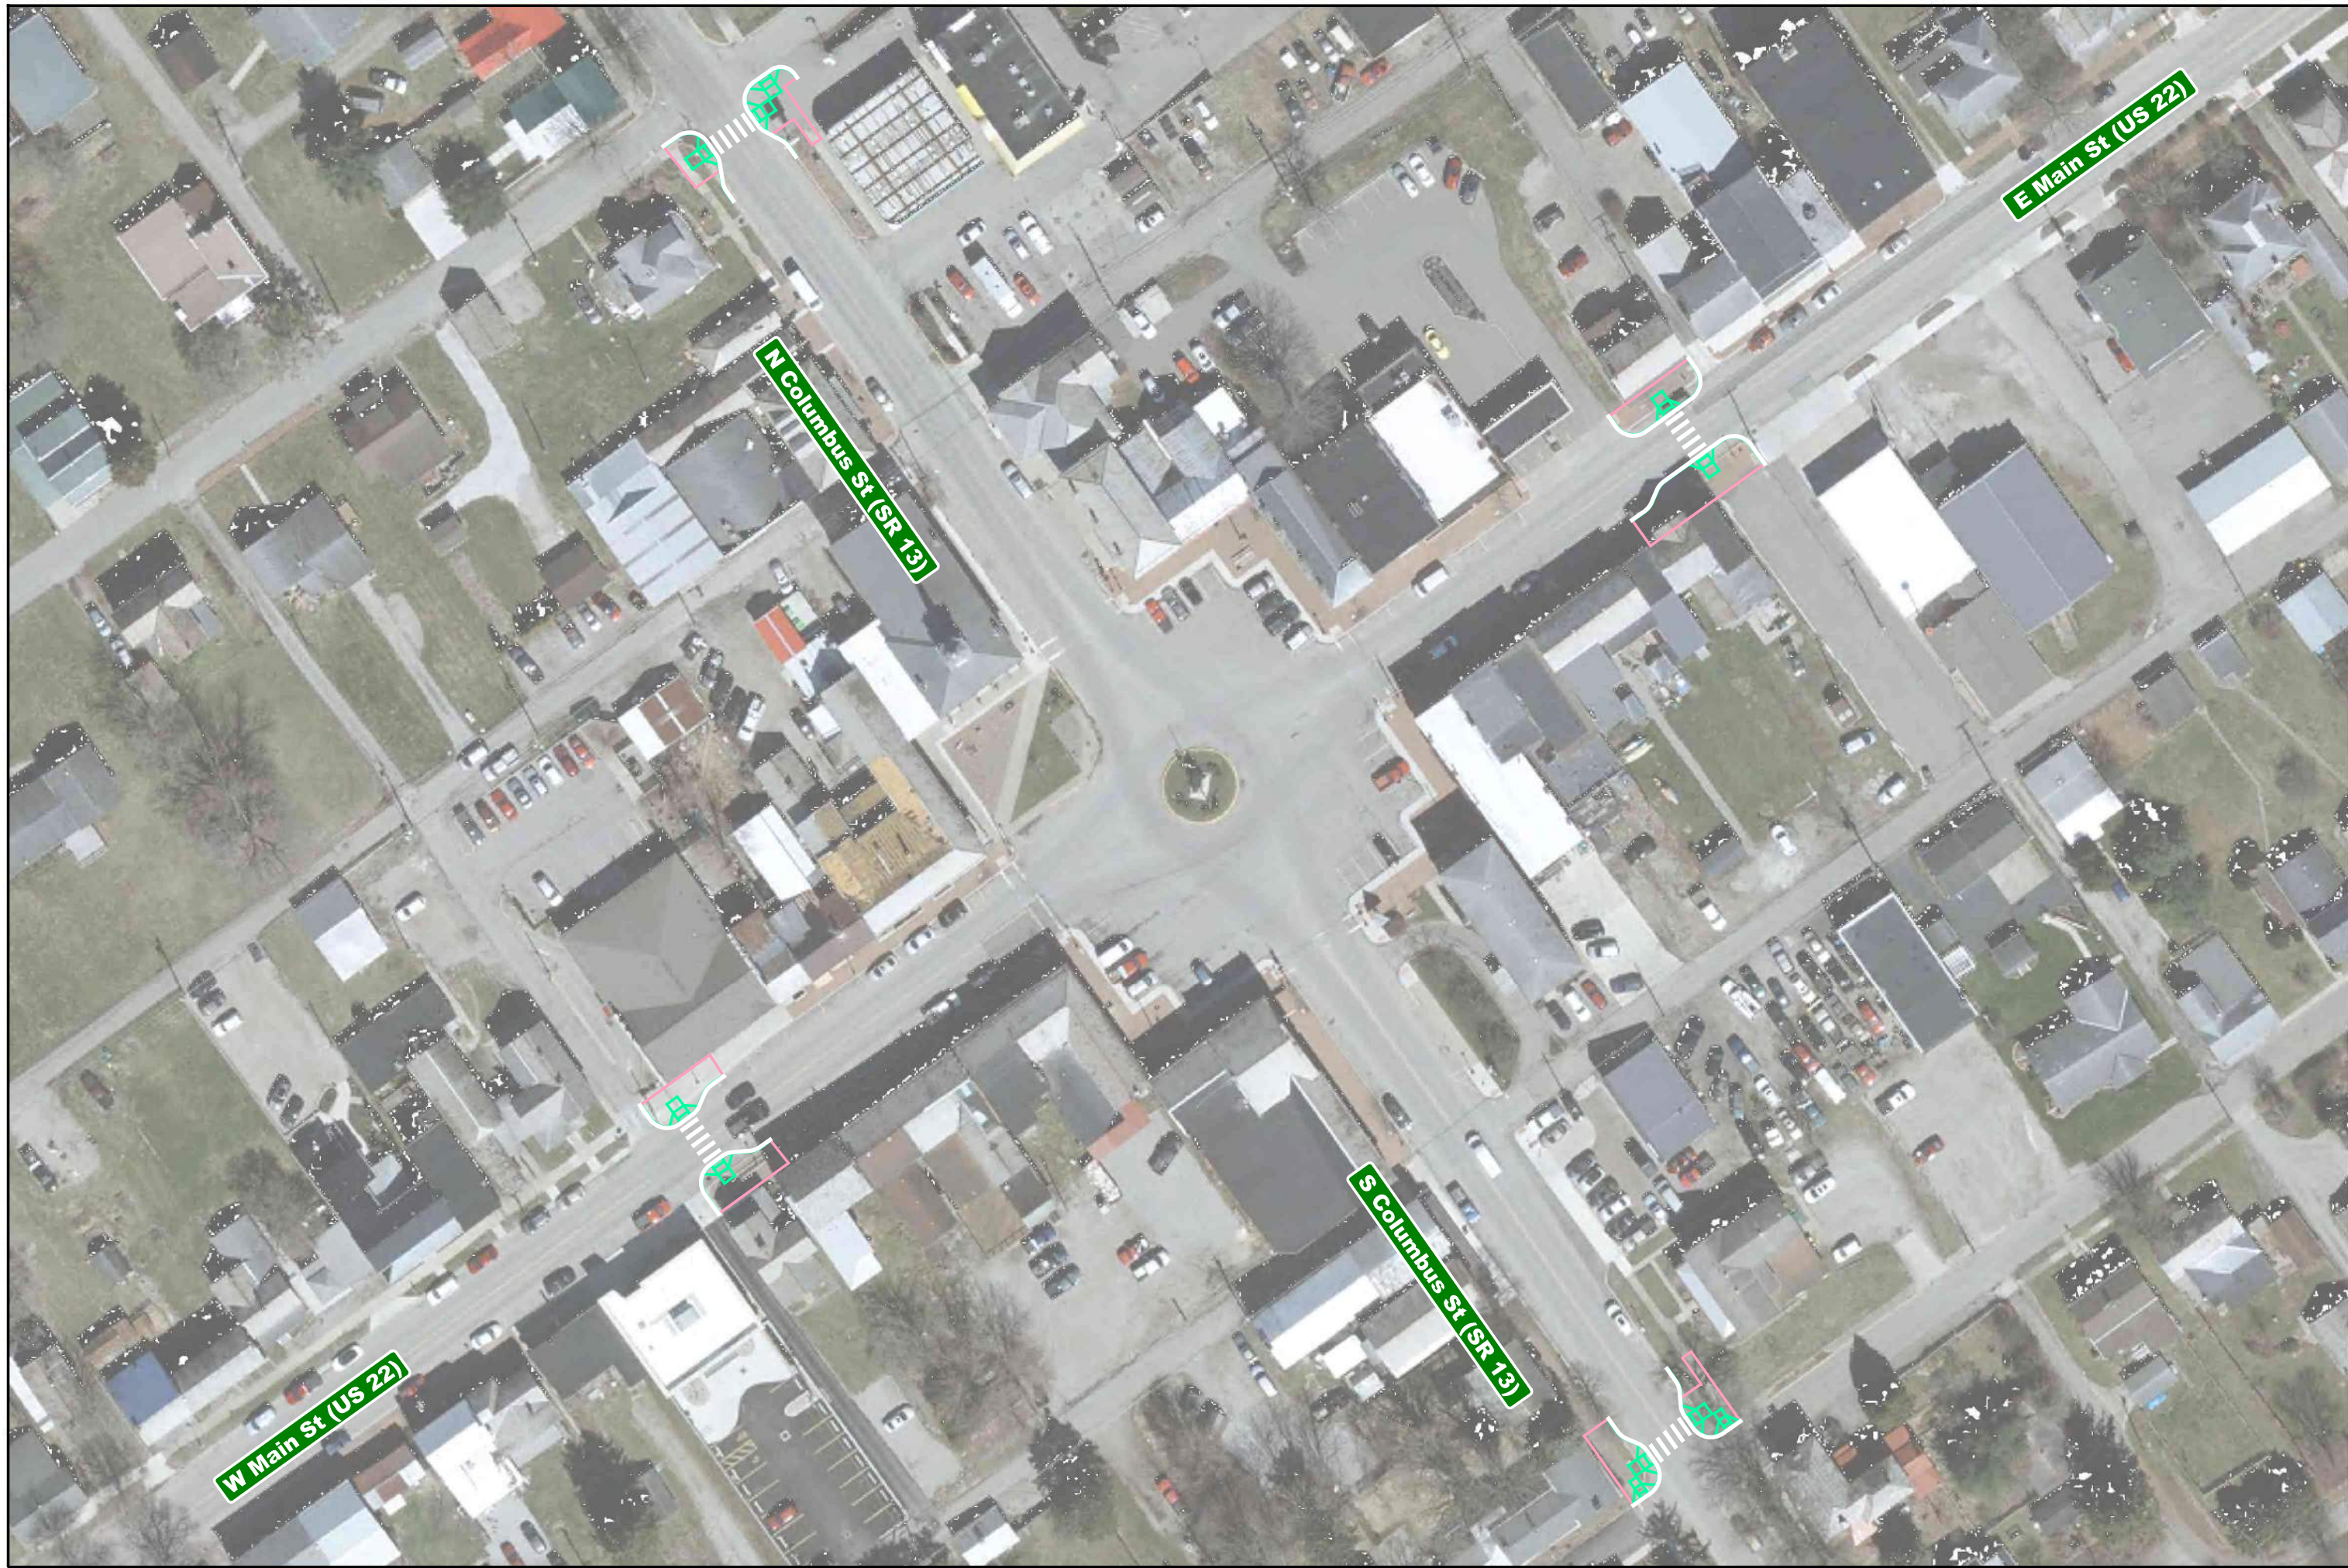
FIG  
10

- **Add curb extensions and crosswalks to the alley/side street intersections on all approaches to the intersection:** Currently the only marked crosswalks are within the intersection area. However, pedestrians cross Main Street (US 22) and Columbus Street (SR 13) outside of the intersection to access businesses and restaurants. The curb extensions, even though they are a distance from the intersection, will still have the traffic calming effect to slow vehicles down as the approach or leave the intersection and will provide an additional visual cue to drivers to be alert for pedestrians. A layout of these extensions is shown in **Figure 10**.

Curb Extensions at the Alley/Side Streets

- **Add curb extensions and crosswalks to the alley/side street intersections:** The curb extensions, even though they are a distance from the intersection, will still have the traffic calming effect to slow vehicles down as the approach or leave the intersection and will provide an additional visual cue to drivers to be alert for pedestrians.
