PIK-32-18.56

PIK-32 & SR 220 Safety Study

August 31, 2023

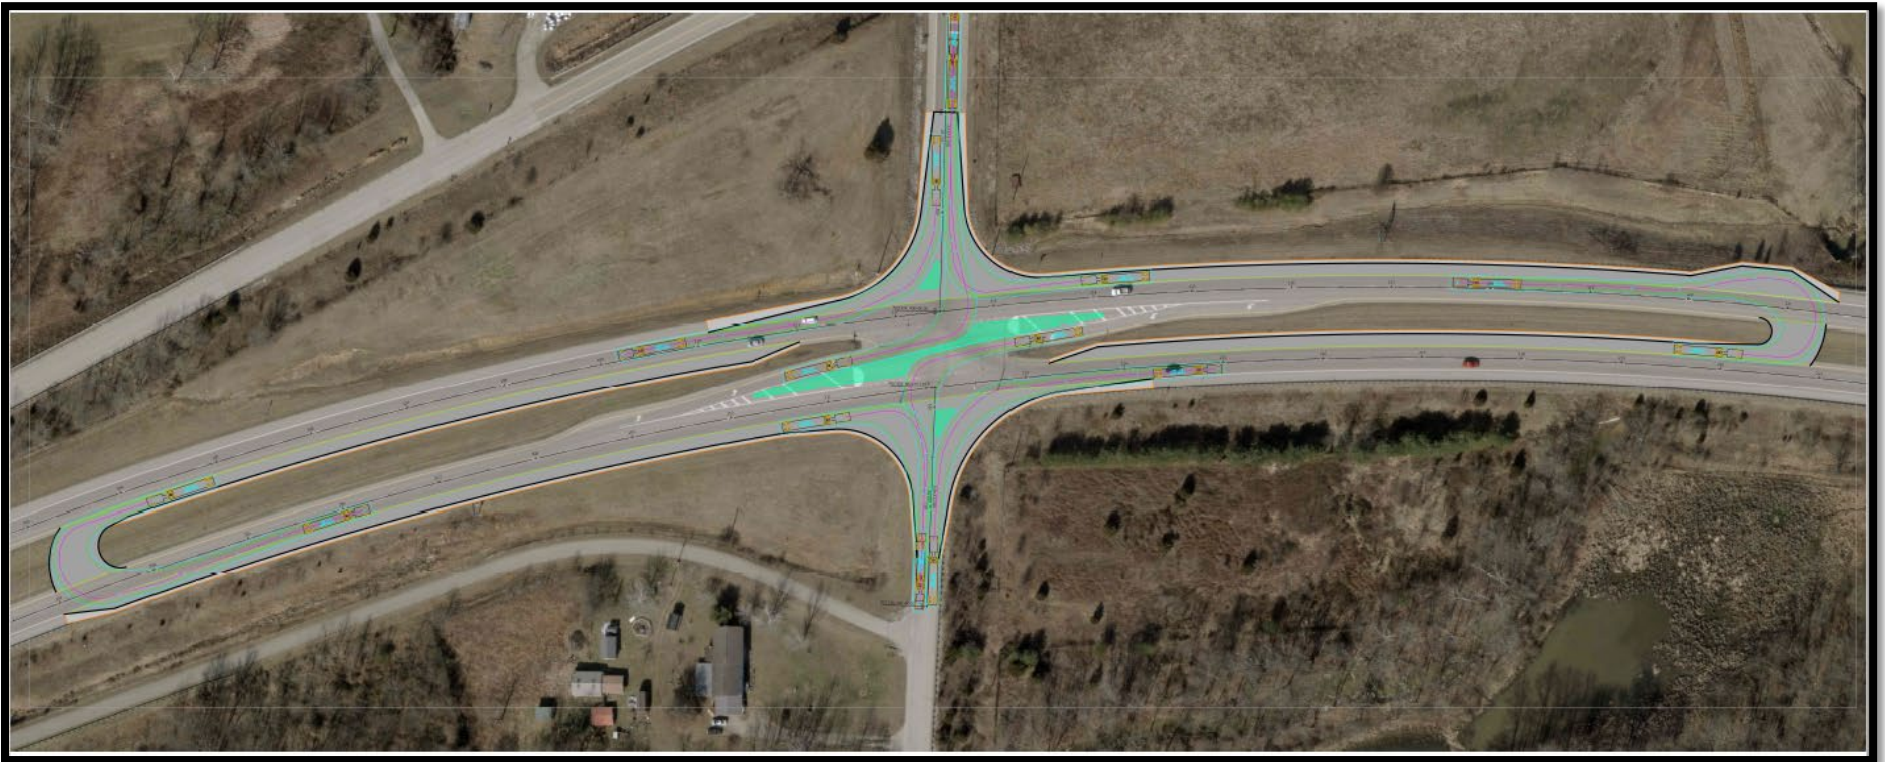
Figure 4: Proposed RCUT Layout

Based on the crash report investigation resulting in an 73% left turn/angle crash pattern being identified, an RCUT proposed at this intersection. RCUTs have been shown to reduce the serious crash types involving median crossing movements for side street traffic. Given the serious crash types observed at the intersection, it is believed that an RCUT is the best solution to the crash pattern observed.

The estimated cost of the RCUT is \$2,234,658. ECAT analysis shows a benefit-cost ratio of 0.22. It is believed that ECAT analysis is underrepresenting the safety benefits of the RCUT. Although the benefit-cost ratio from ECAT is 0.22, it is still believed the RCUT is the best alternative to address the crash types observed.

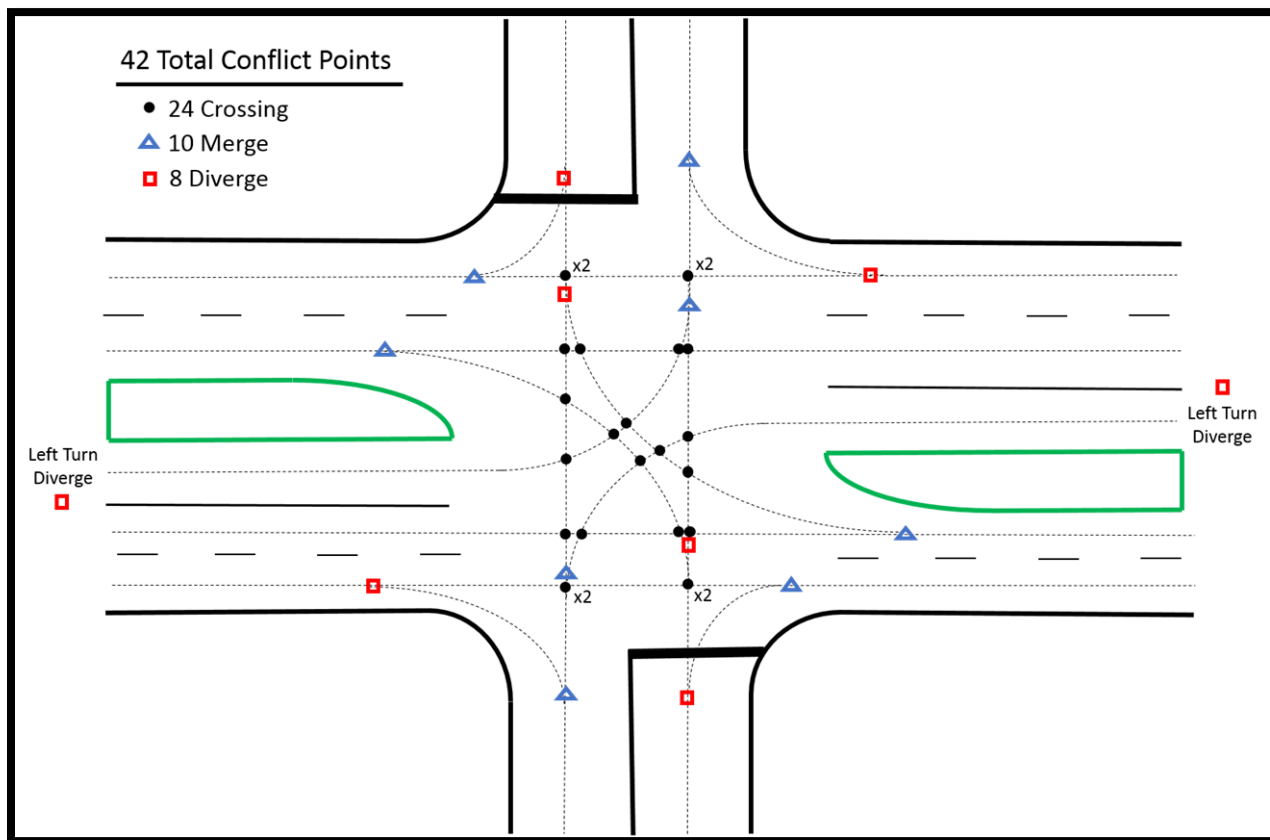
Figure 5: Traditional 4-Lane, Divided Highway Conflict Points

A traditional 4-lane, divided highway intersection has 42 total conflict points, including 24 crossing points, 10 merge points, and 8 diverge points. The RCUT configuration proposed reduces those conflict points down to 24. Those 24 conflict points include 4 crossing points, 10 merge points, and 10 diverge points. **Figure 4** shows the proposed layout of the RCUT configuration. **Figure 5** shows the conflict points of a traditional 4-lane, divided highway intersection. **Figure 6** shows the conflict points of an RCUT configuration.

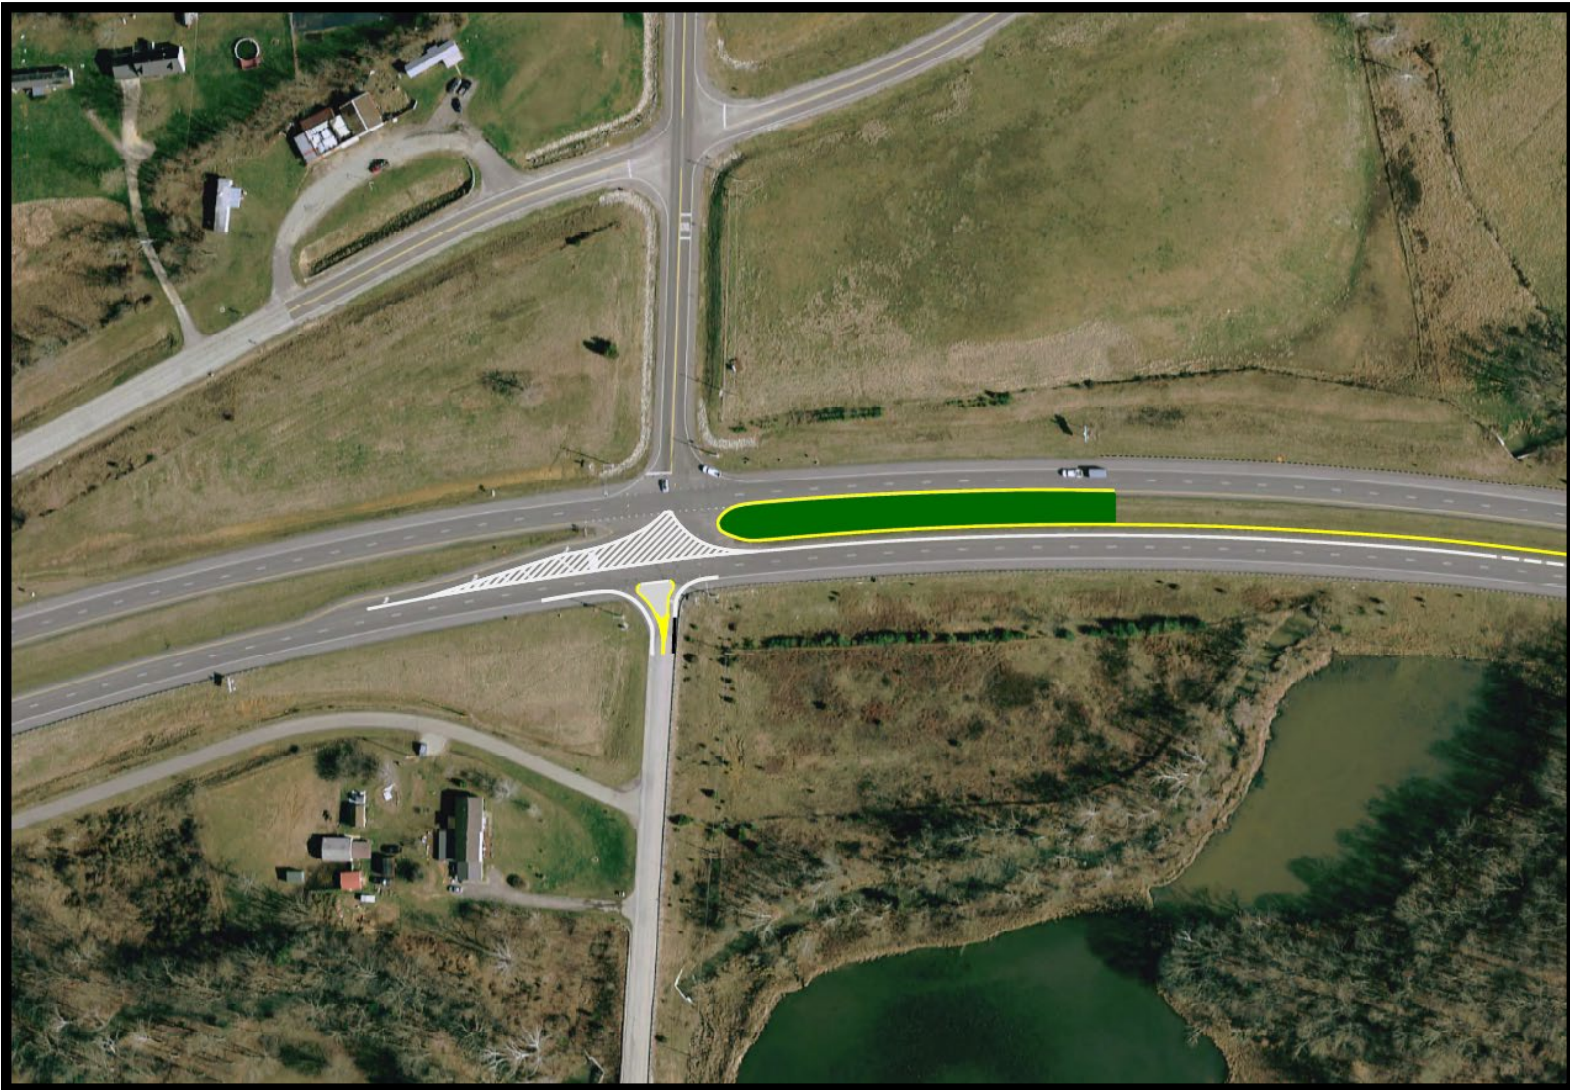
Figure 7: Turbo Lane Layout

Given the crash trends and sight distance issues involving eastbound SR 32 traffic, a Turbo Lane was also considered. It is believed that the RCUT and Turbo Lane configurations would both address the crash trends observed at the intersection. Both RCUT and Turbo Lane configurations exist on this corridor of SR 32 within 2 miles of the intersection, providing two alternatives that drivers in the area would already be familiar with. However, after investigation traffic shifts for the Turbo Lane configuration, it was discovered that traffic on Schuster Rd, that would have their access restricted, would be detoured up to 4.5 miles. For this reason, the Turbo Lane was ruled out. **Figure 7** shows the proposed layout of the Turbo Lane.
