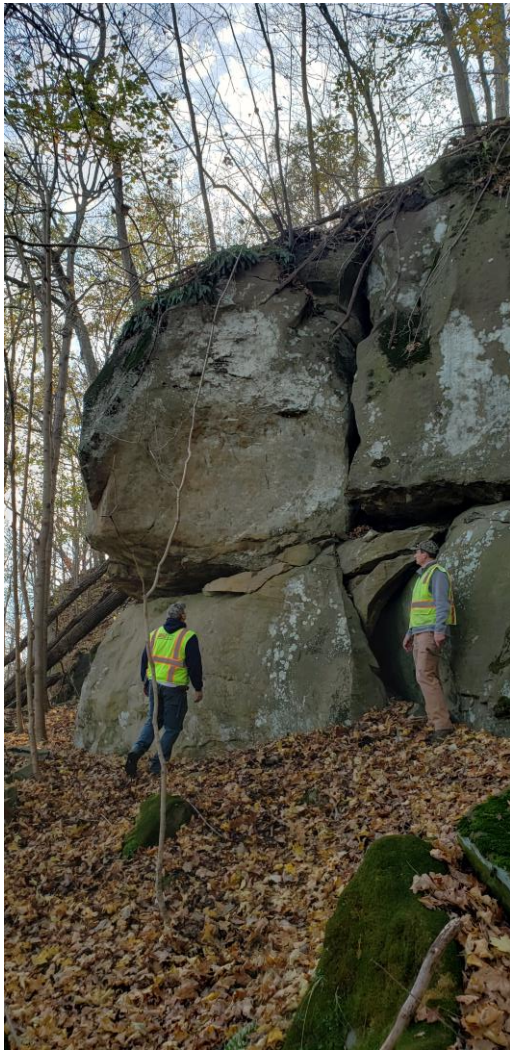
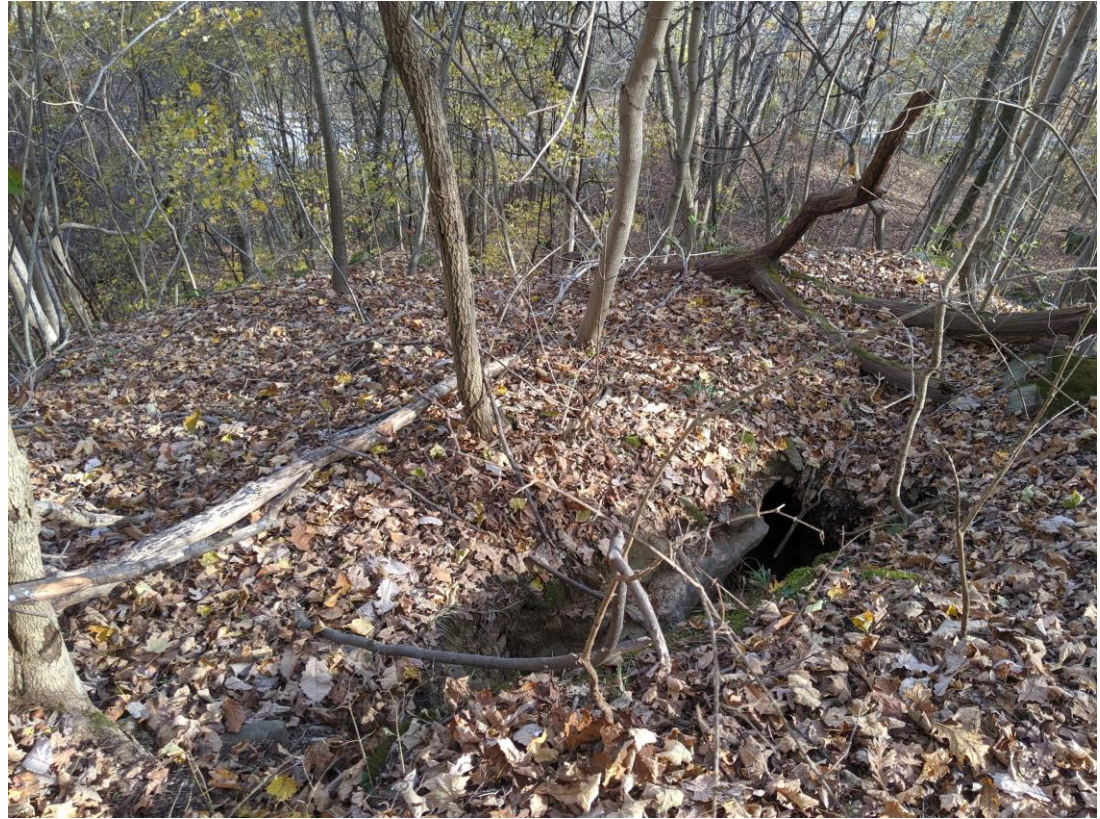
**42' wide x 21' high x 20' deep, 1.5' joint width  
5' overhang about 10' above ground, water flowing into joint from above**

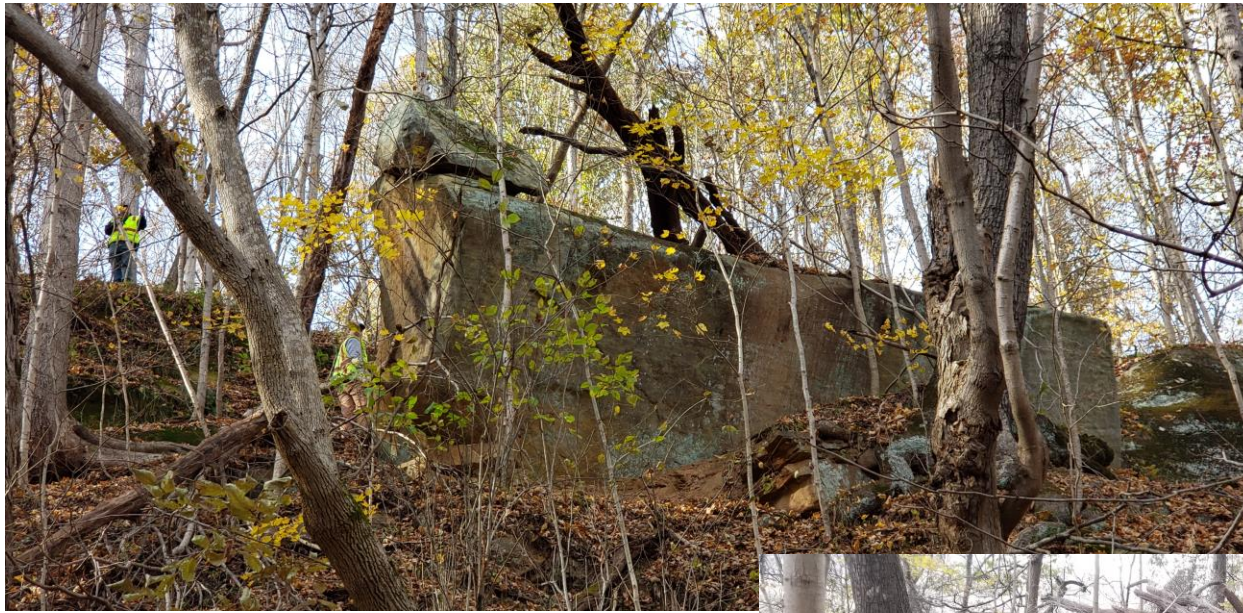
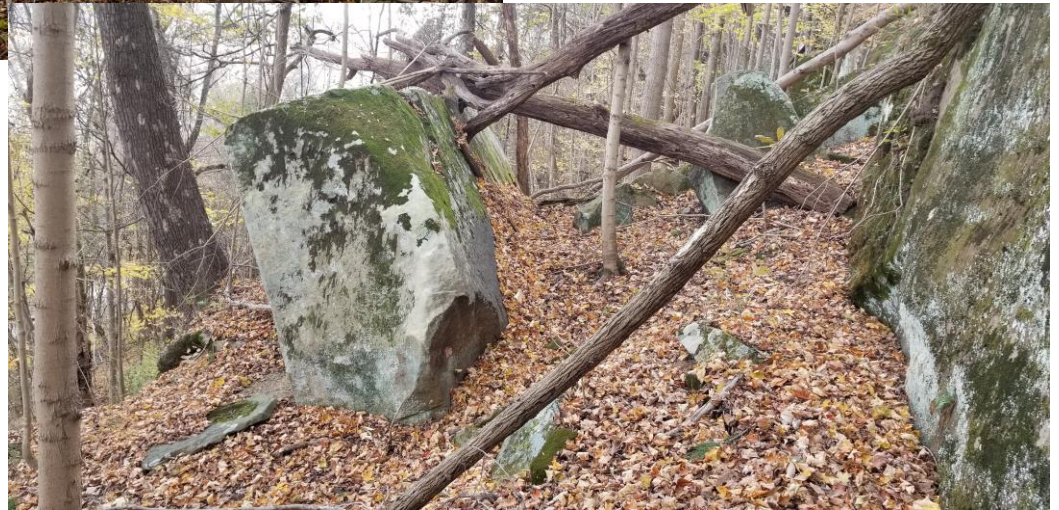
**29' wide x 14' high x 7' deep**  
**Huge block pulled out 9' from slope with smaller block on top**

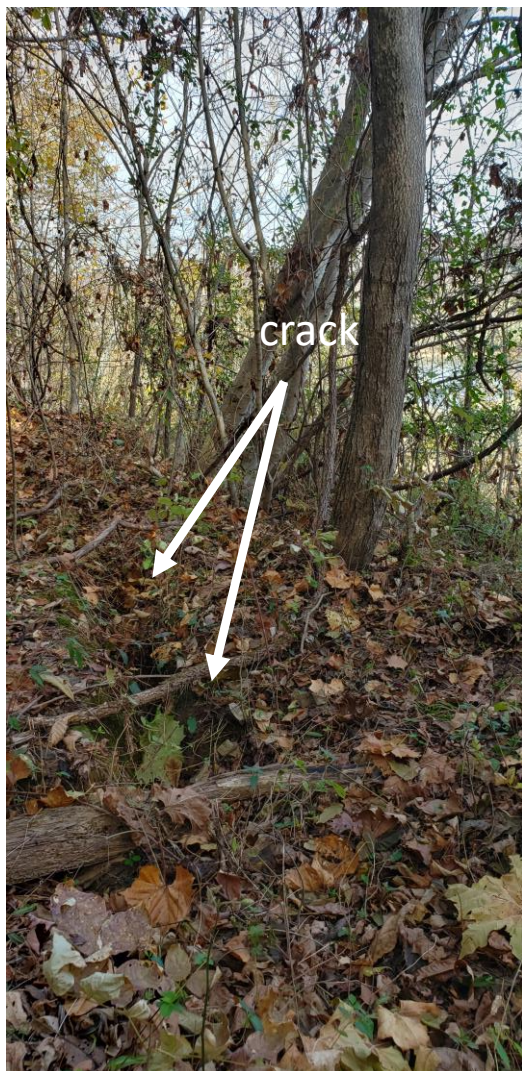
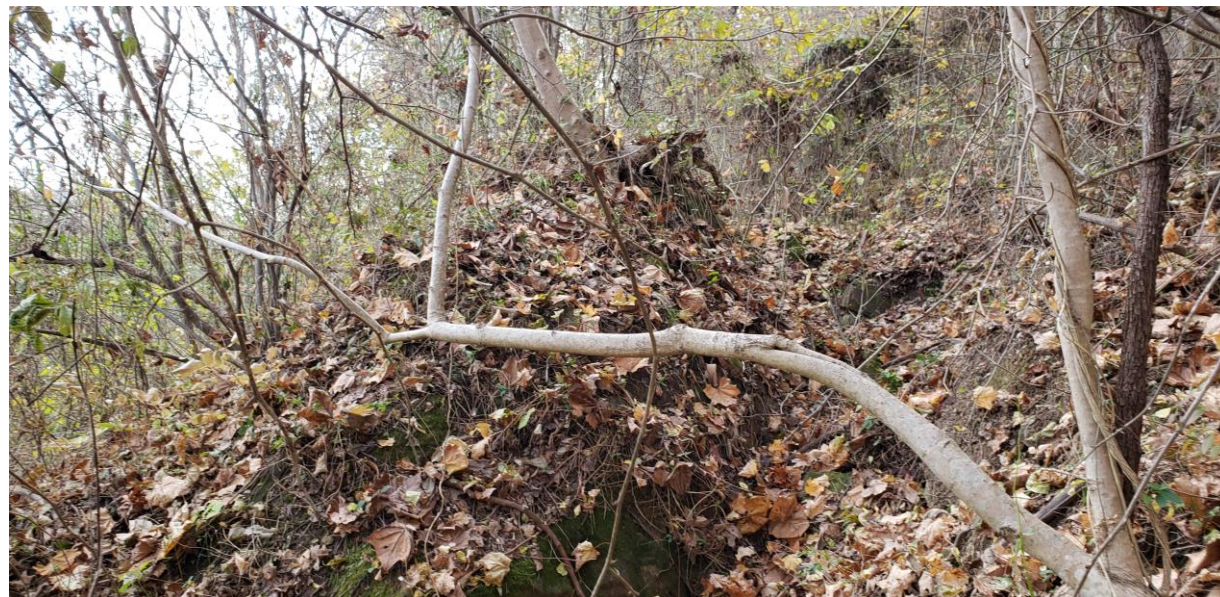
**Existing/future landslide (65' wide along slope)**

**1-foot wide crack/scarp along middle bench – possible translational movement of entire slope**

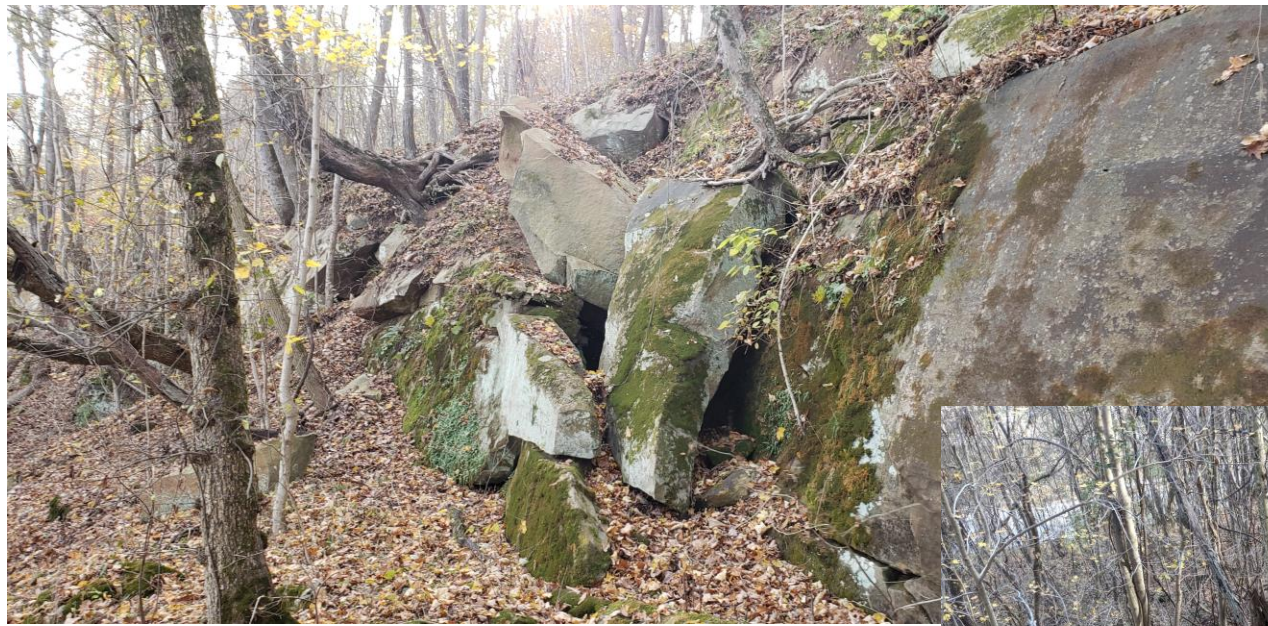
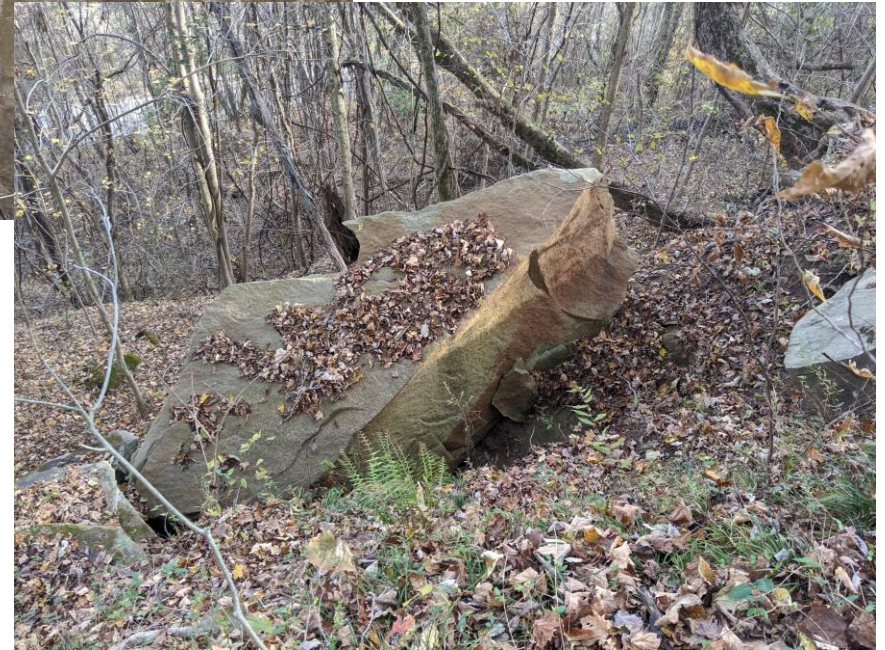
**30' wide x 18' high x 13' deep**  
**Fragmented boulders that fell backward, kicking front face towards slope edge**

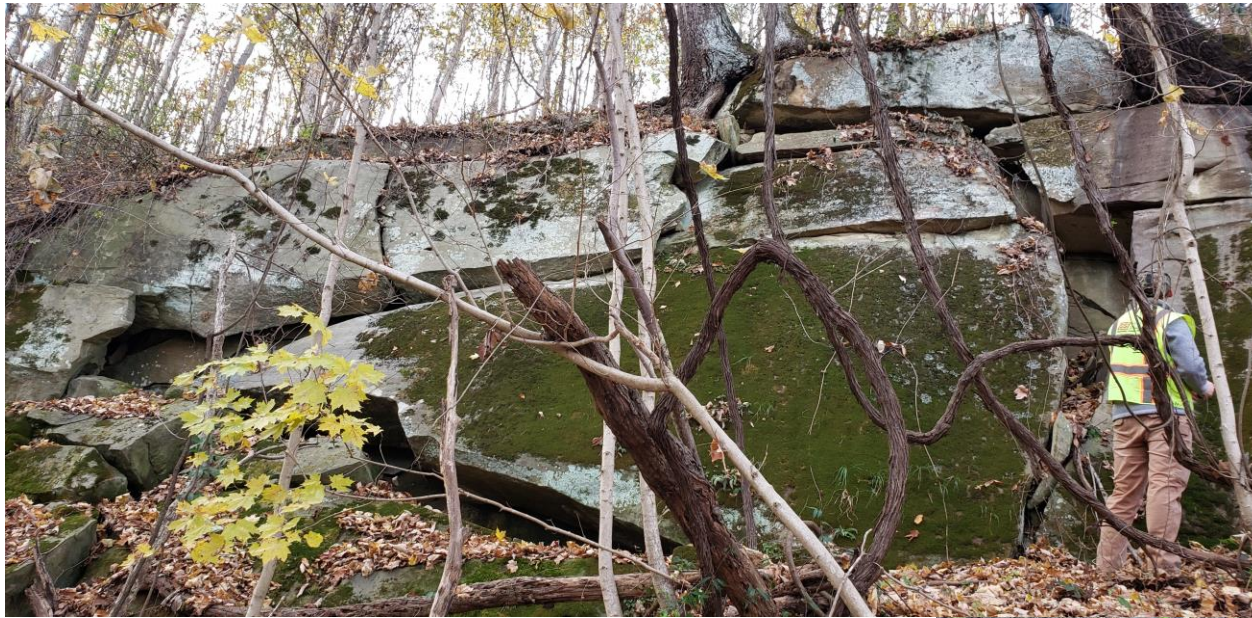
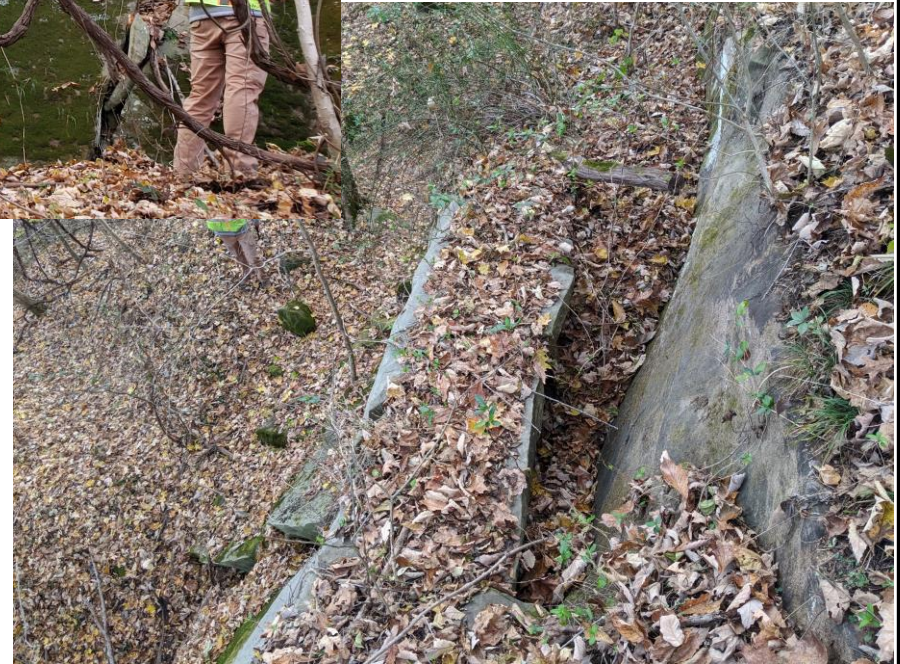
**53' wide x 21' high x 4.5' deep - multiple thin, vertical, fractured, large blocks  
338° joint set on back side (parallel to road), 106° orthogonal joints**

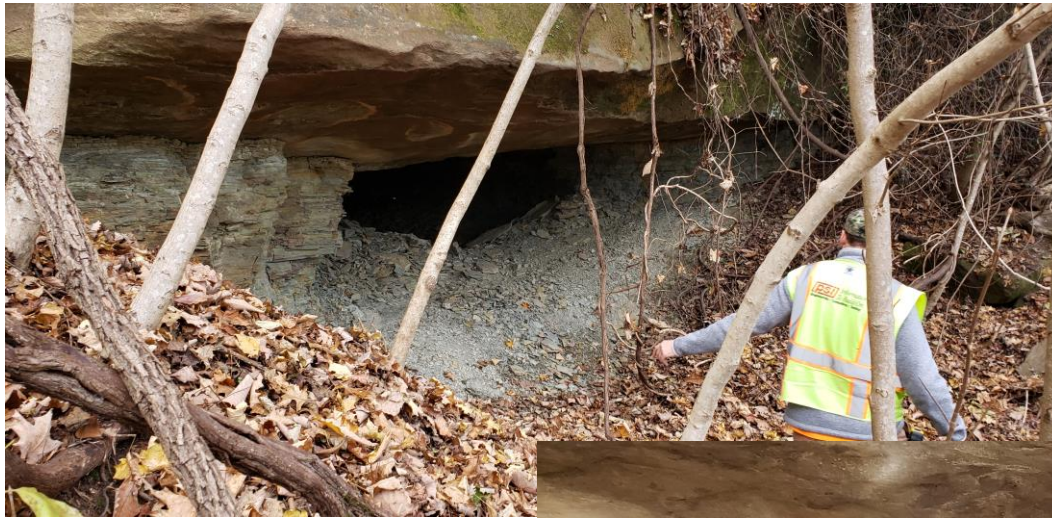
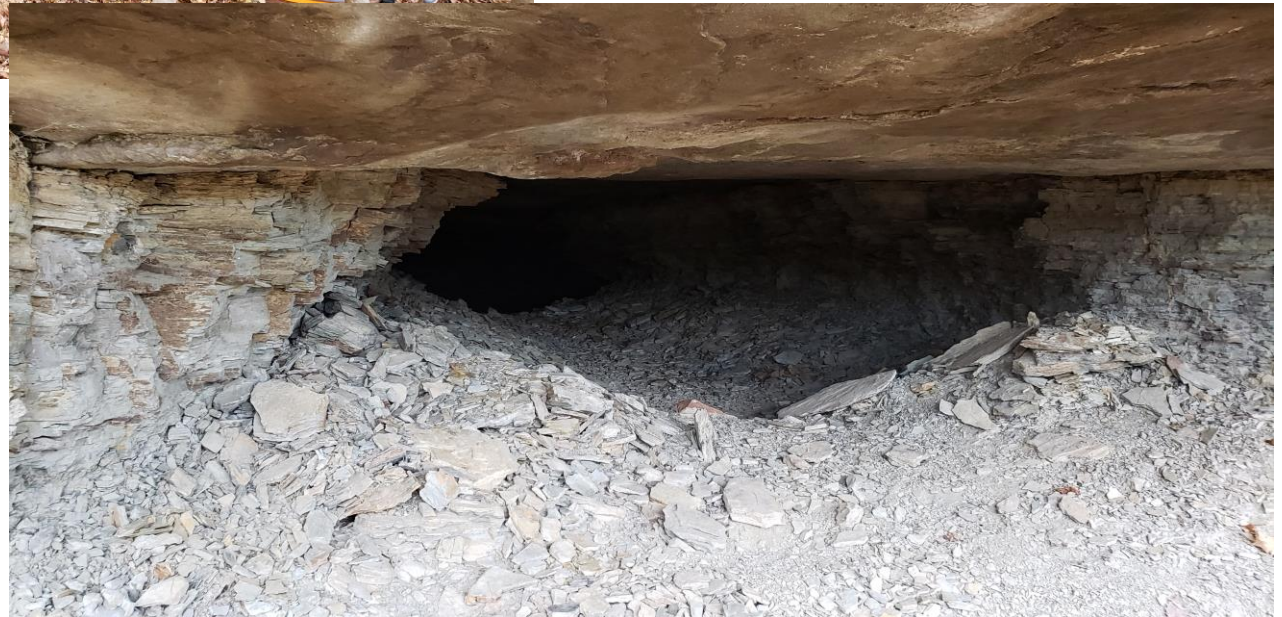
**Large opening below massive boulder – Possible animal den??  
Goes straight about 36-feet then curves downward to the right**

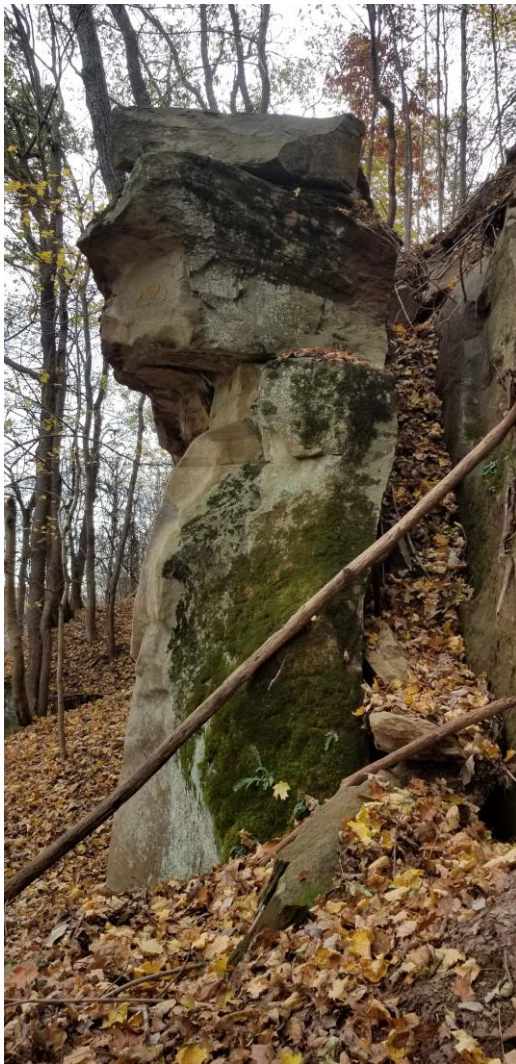
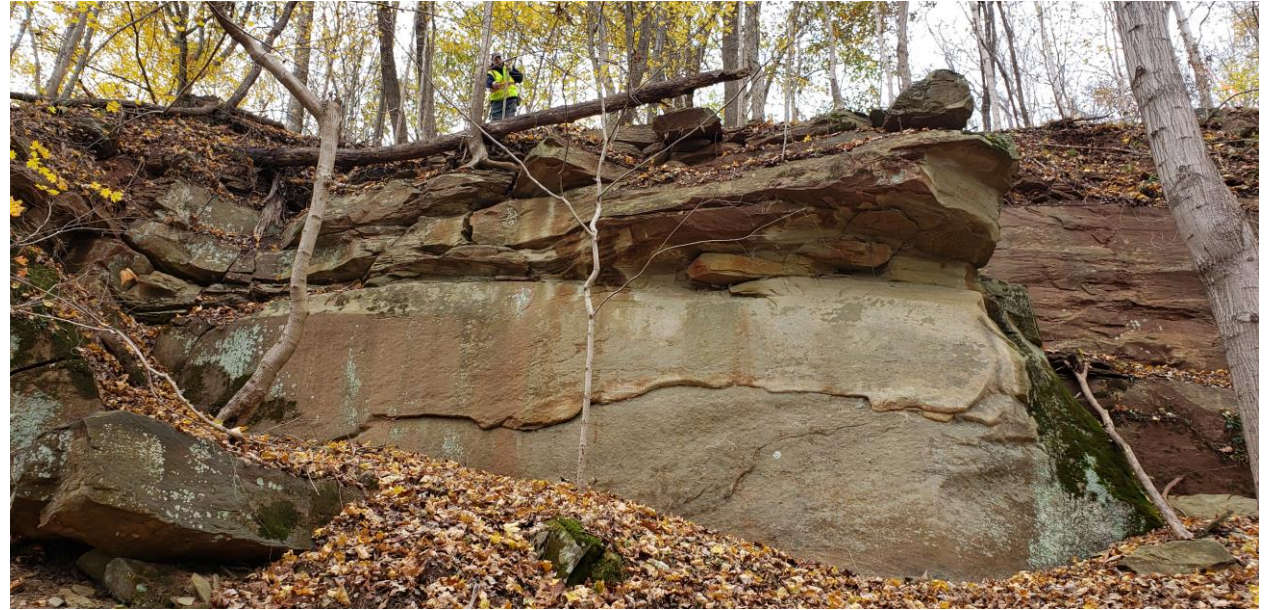
**32' wide x 18' high x 5' deep – Long pointed block facing to the north  
2-foot wide joint on back side – whole top half is fractured, bottom half intact**

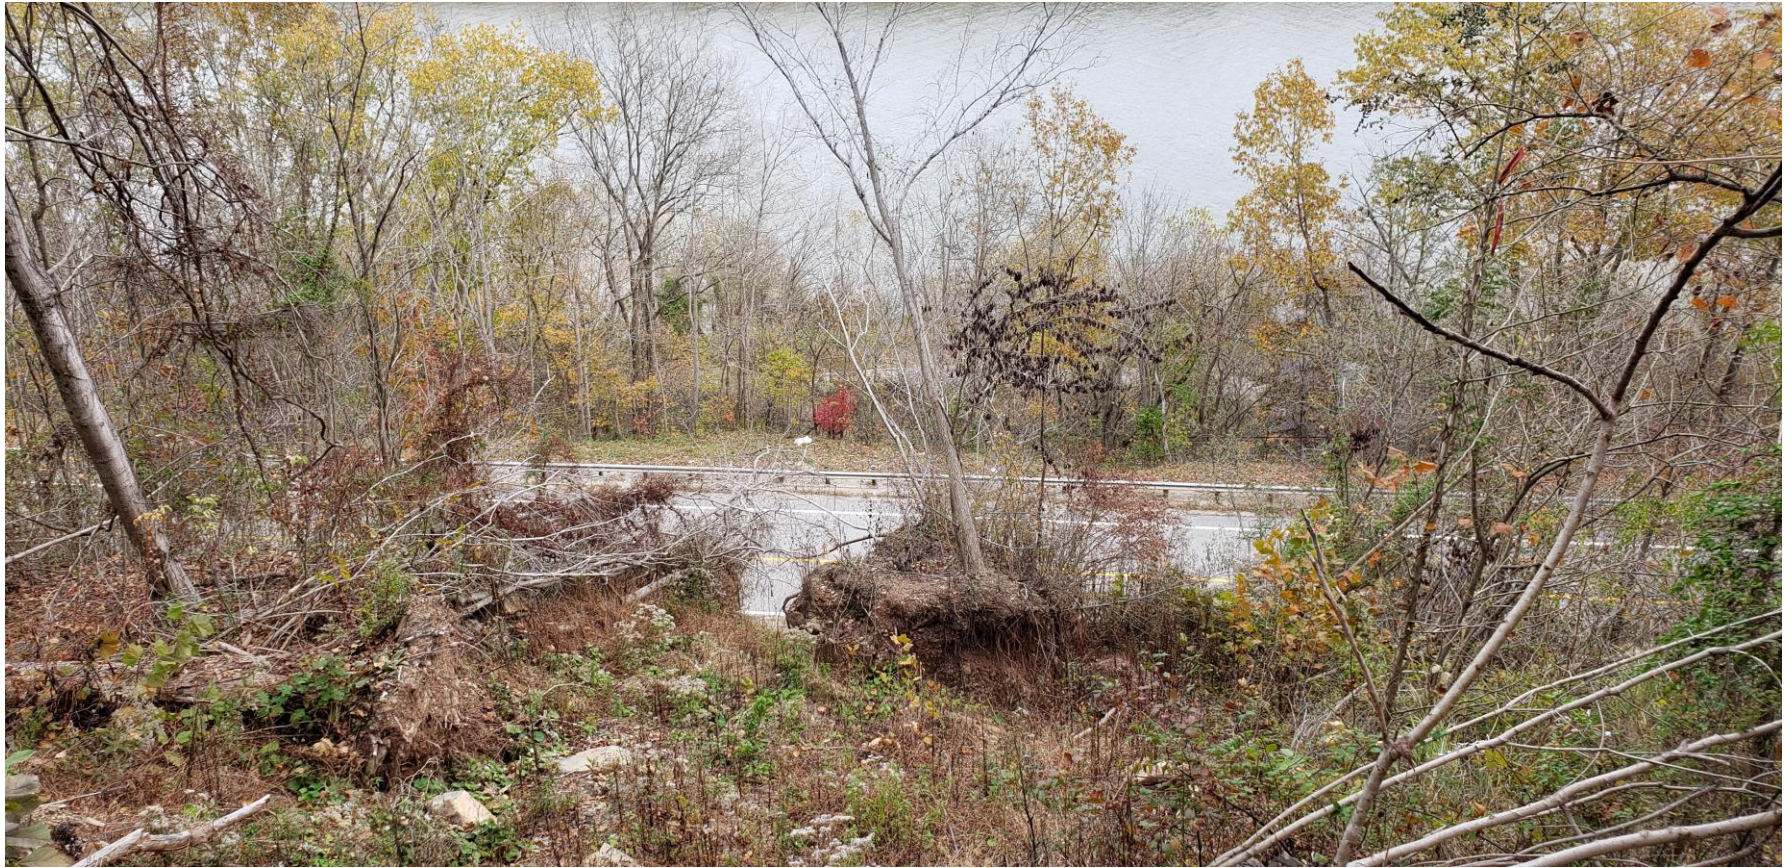
**Translational landslide – Isolated tree on block of soil above road**

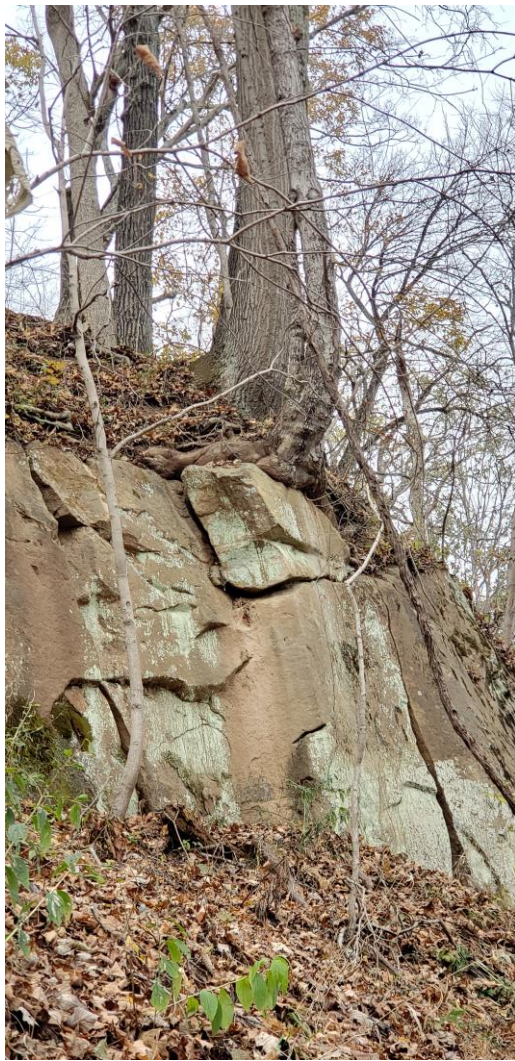
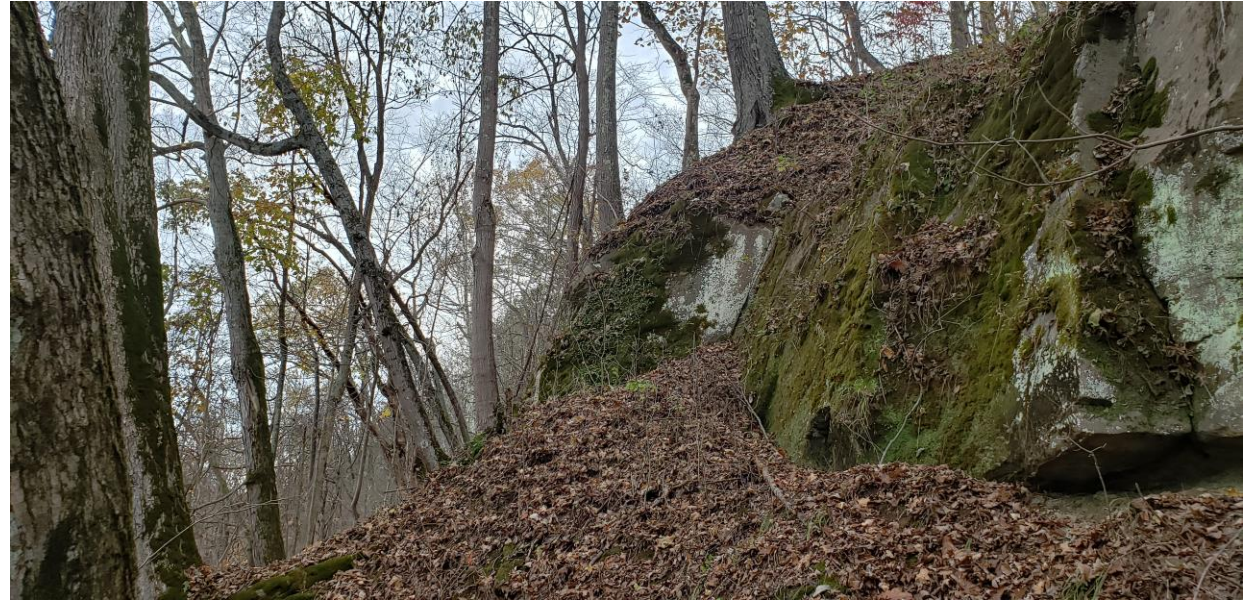
**40' wide x 12' high x 10' deep – Several large blocks with tree overhanging on south end  
3-inch joint on back side**

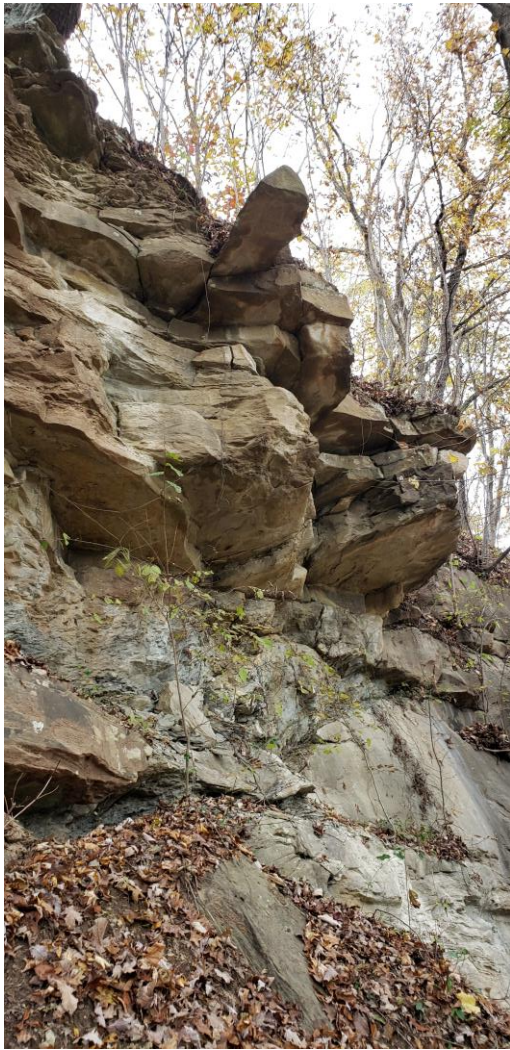
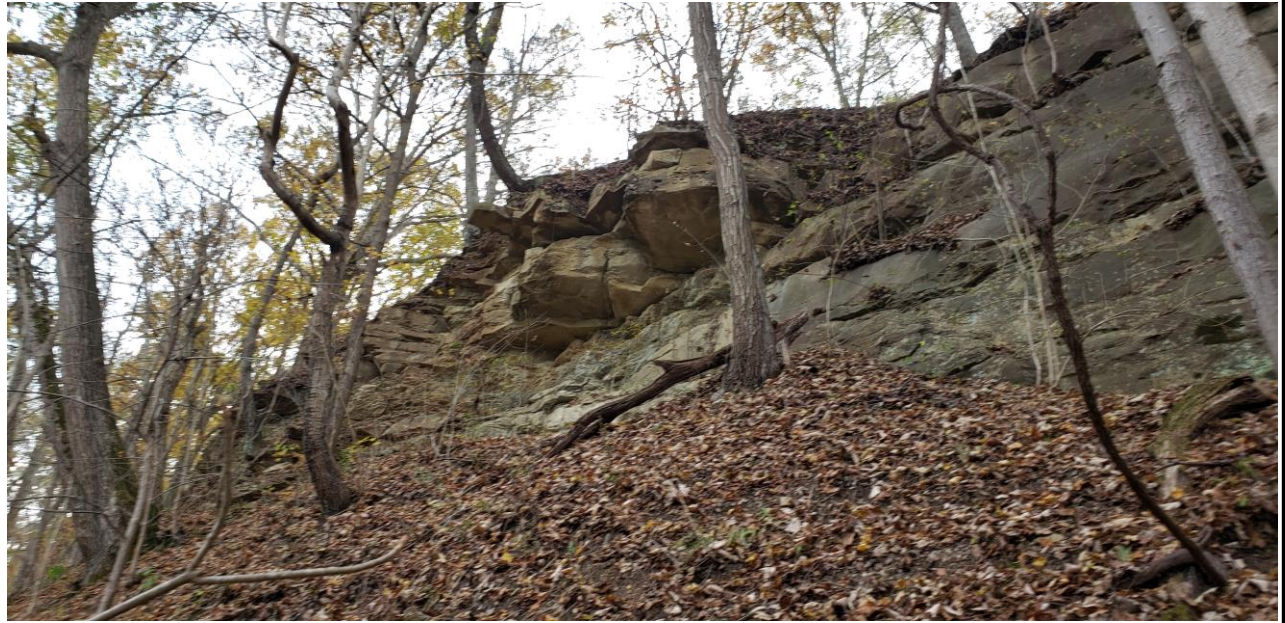
**40' wide x 12' high x 10' deep – Large overhang consisting of numerous blocks  
10-foot overhang about 15-feet above ground level**

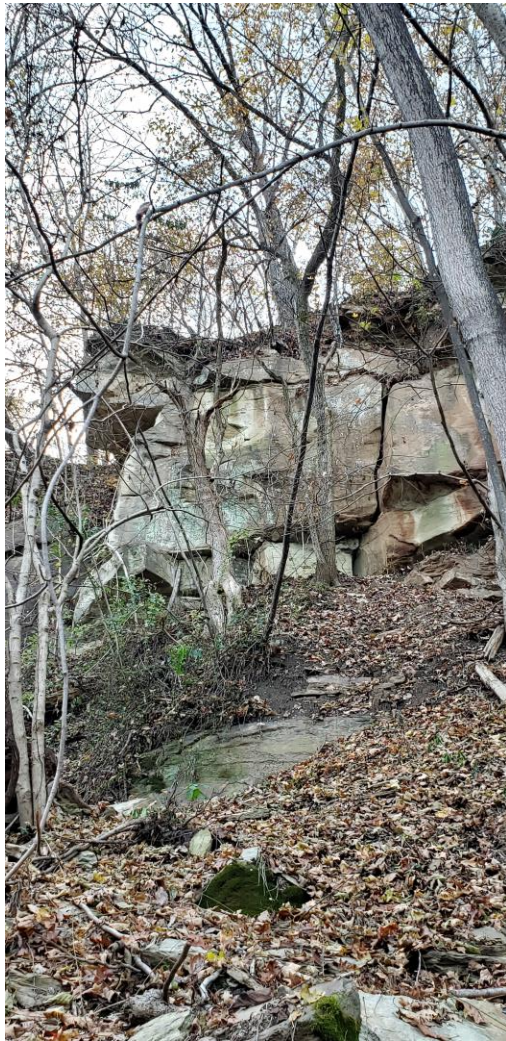
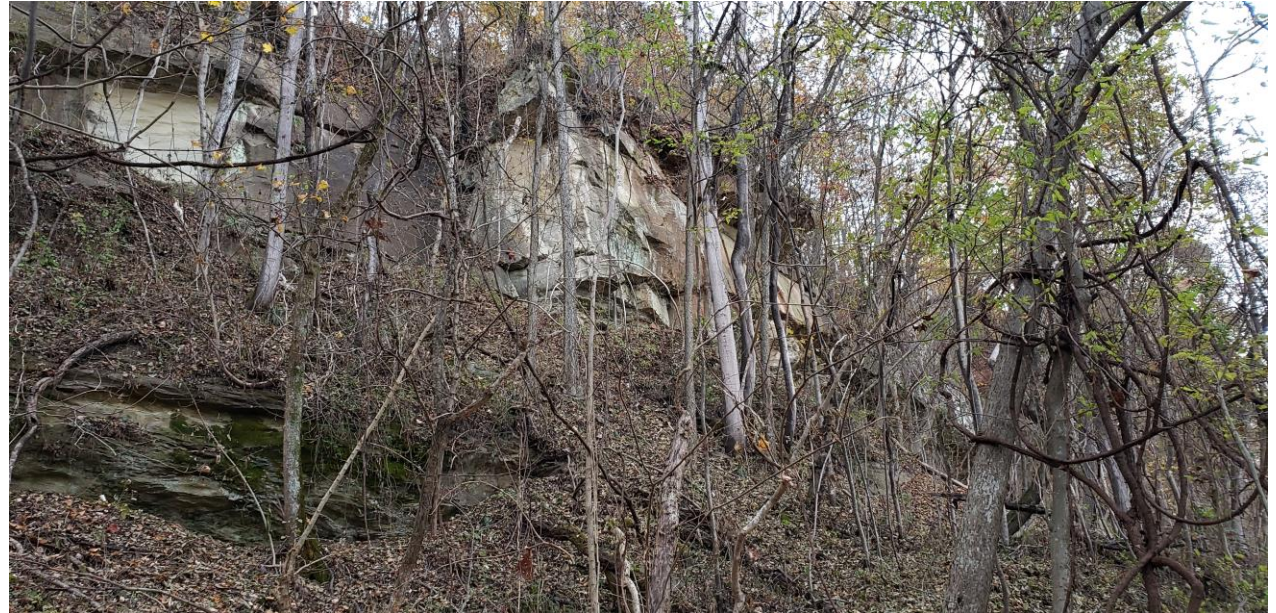
**20' wide x 36' high x 10' deep –Large, long, thin, vertical block with joint parallel to road  
5-foot overhang at south end**

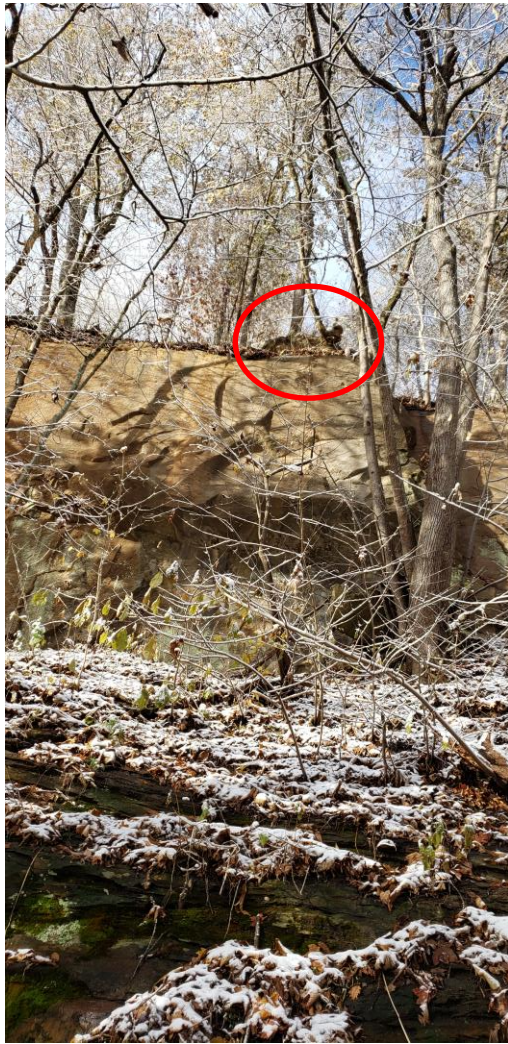
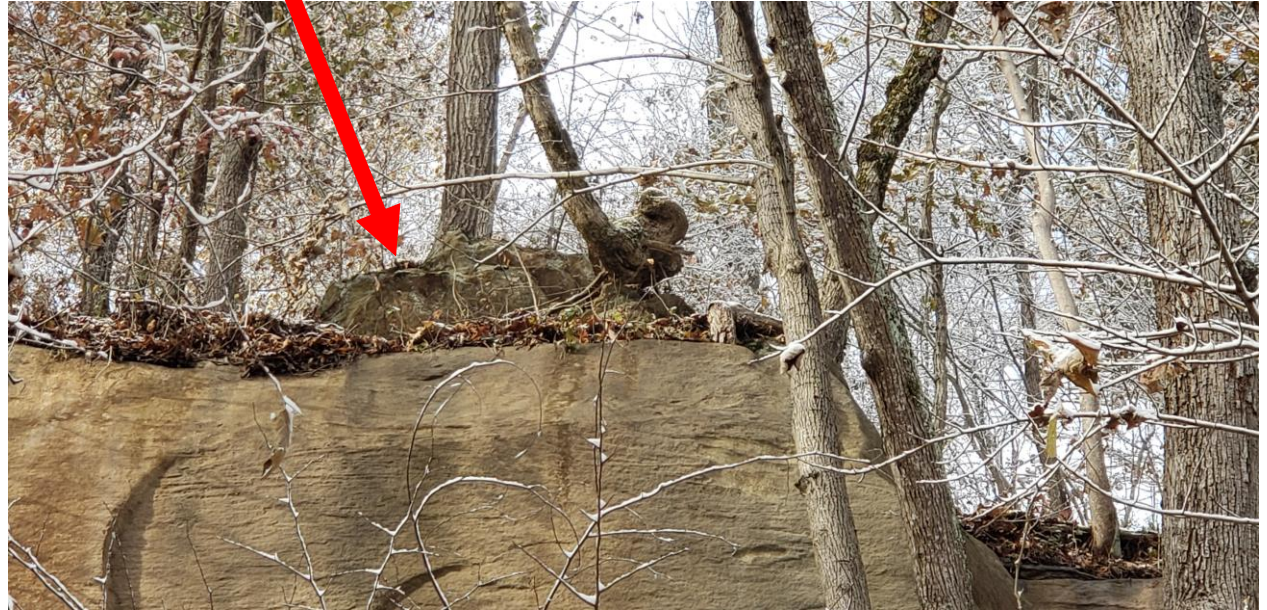
**Boulder at top of upper rock shelf – appears to be hanging on edge  
Could not access from middle bench**

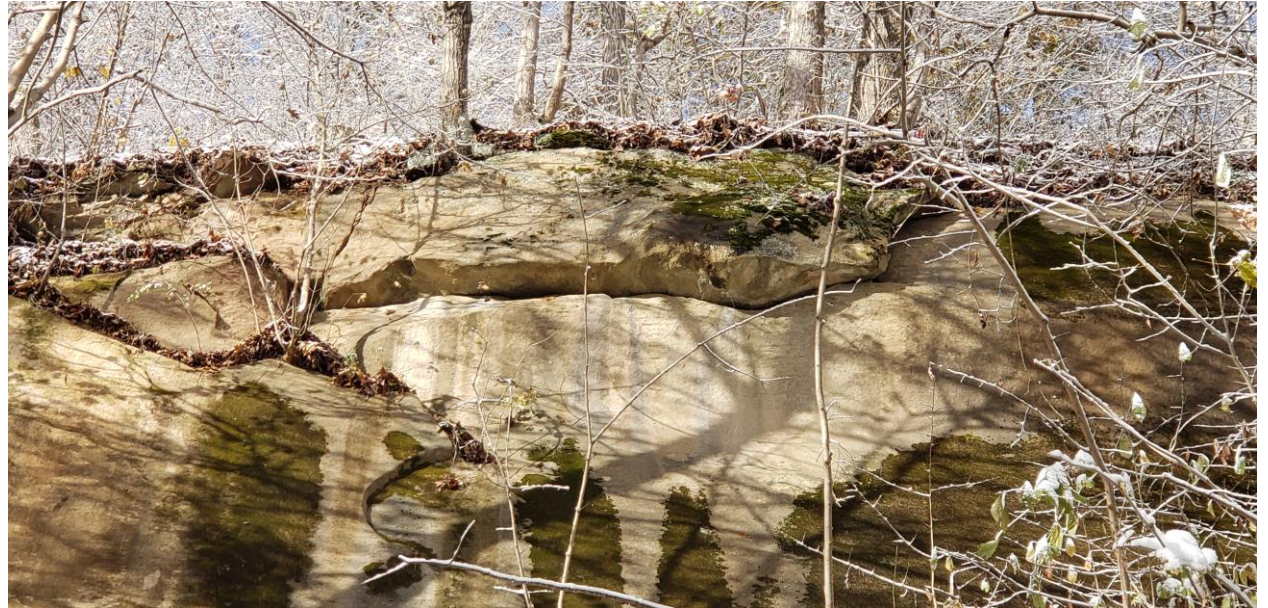
**18' wide x 4' high x 1'-2' deep – Slab being wedged off top rock shelf**

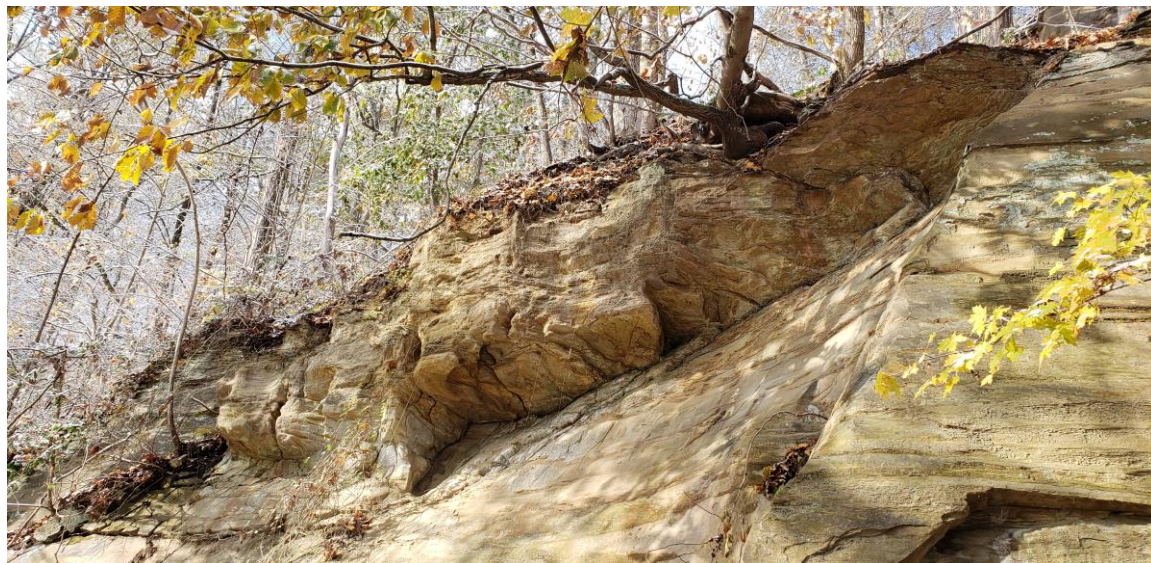
Overhang = 20' wide x 6' high x 4' deep – 4-foot overhang about 13-feet above ground  
 Triangular Corner = 12' wide x 19' high x 4' deep – undercut 6-feet by incompetent shale

Coal Seam

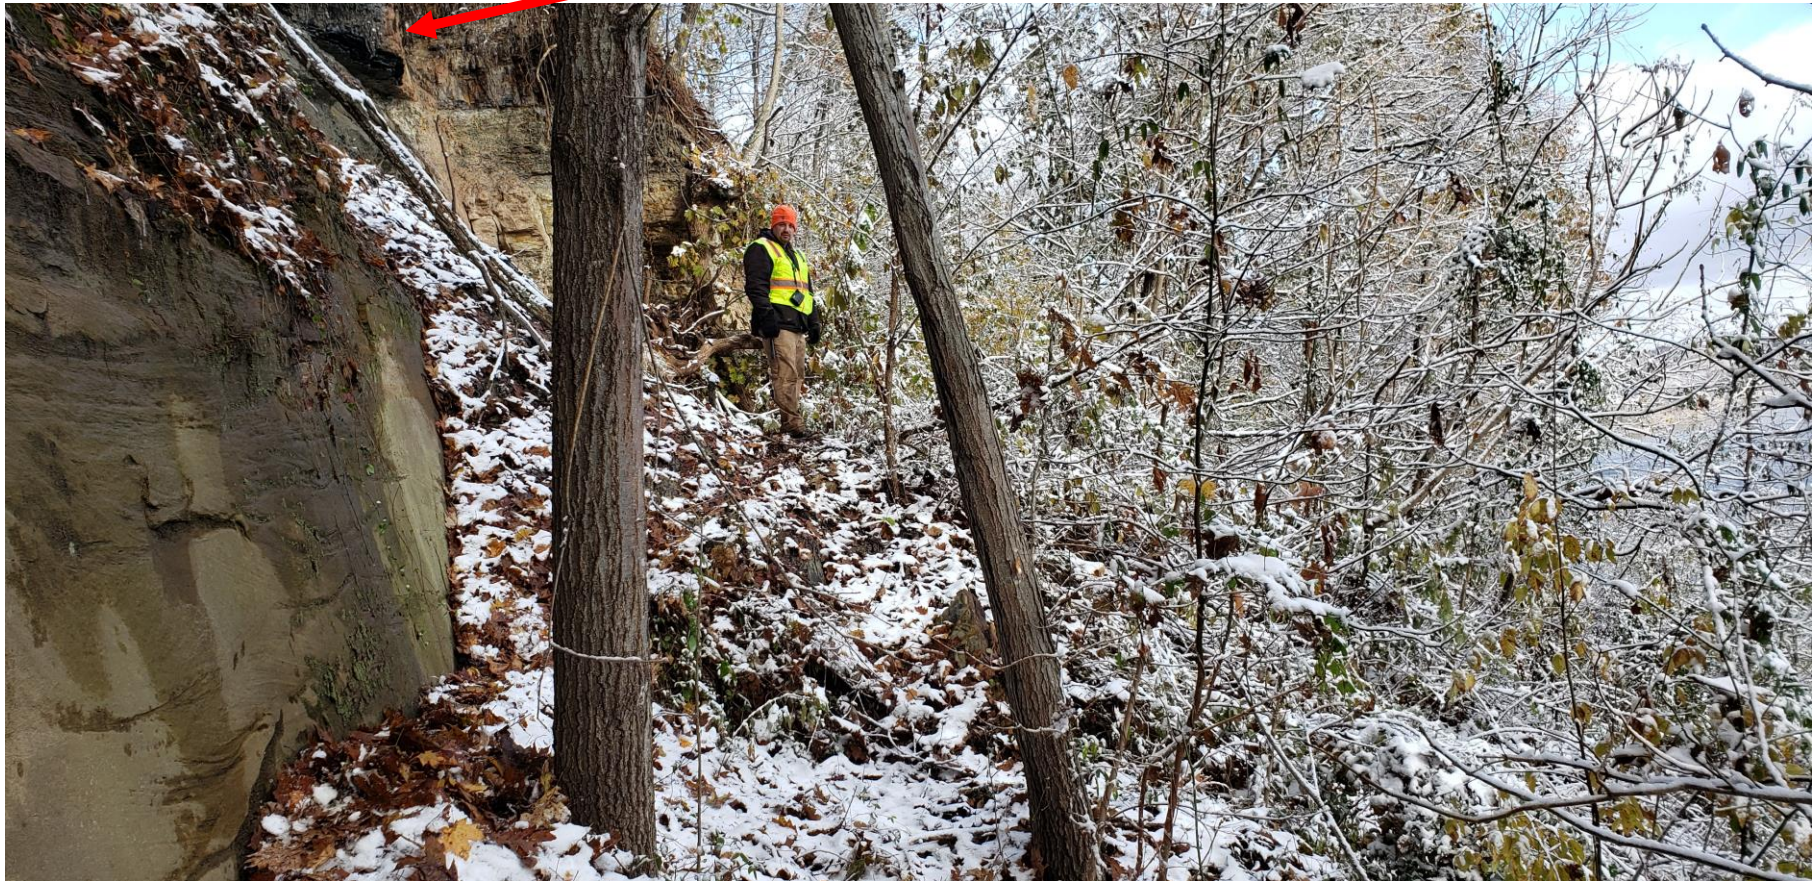
**Existing landslide – may continue to move – directly above pull-off on northbound side of SR7  
51-foot wide – 2-foot coal seam near top of exposed rock at top of slide**

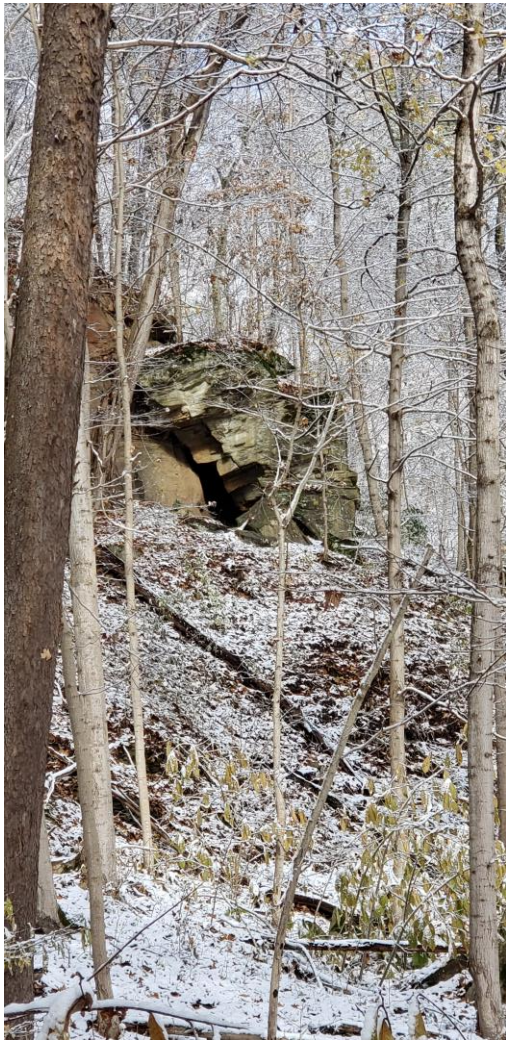
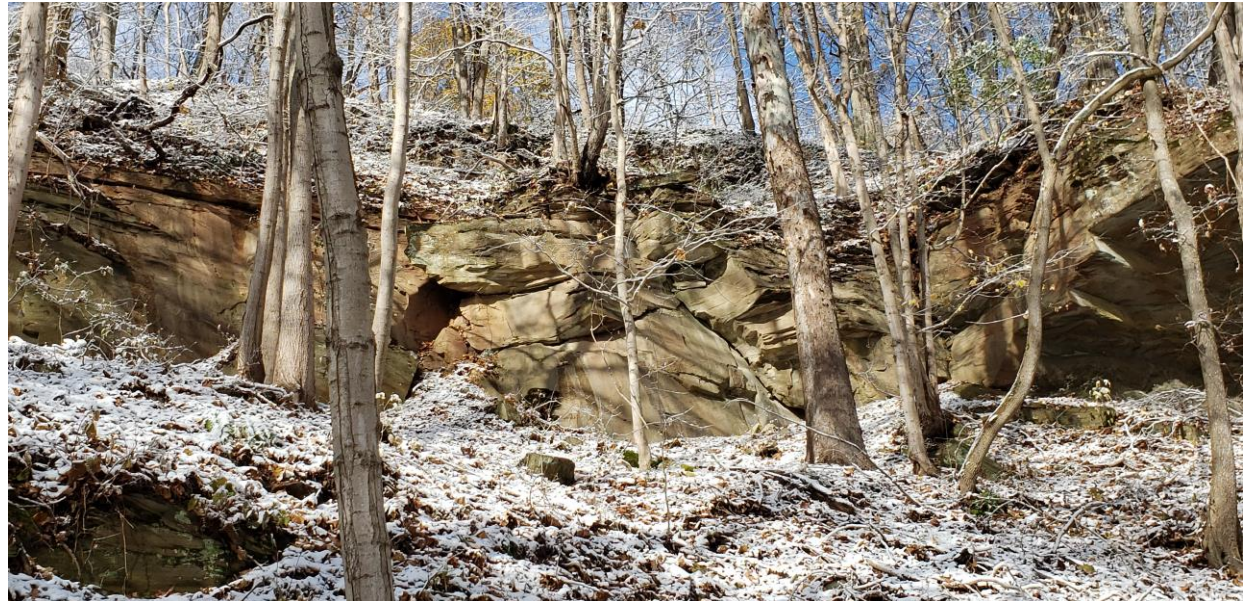
**Section #1 - 32' wide x 21' high x 8'-10' deep – Tall column of fractured rock breaking away from rock face – 354° joint parallel to road (4"-8" joint), 267° orthogonal joint (2"-3" joint) – no infilling**

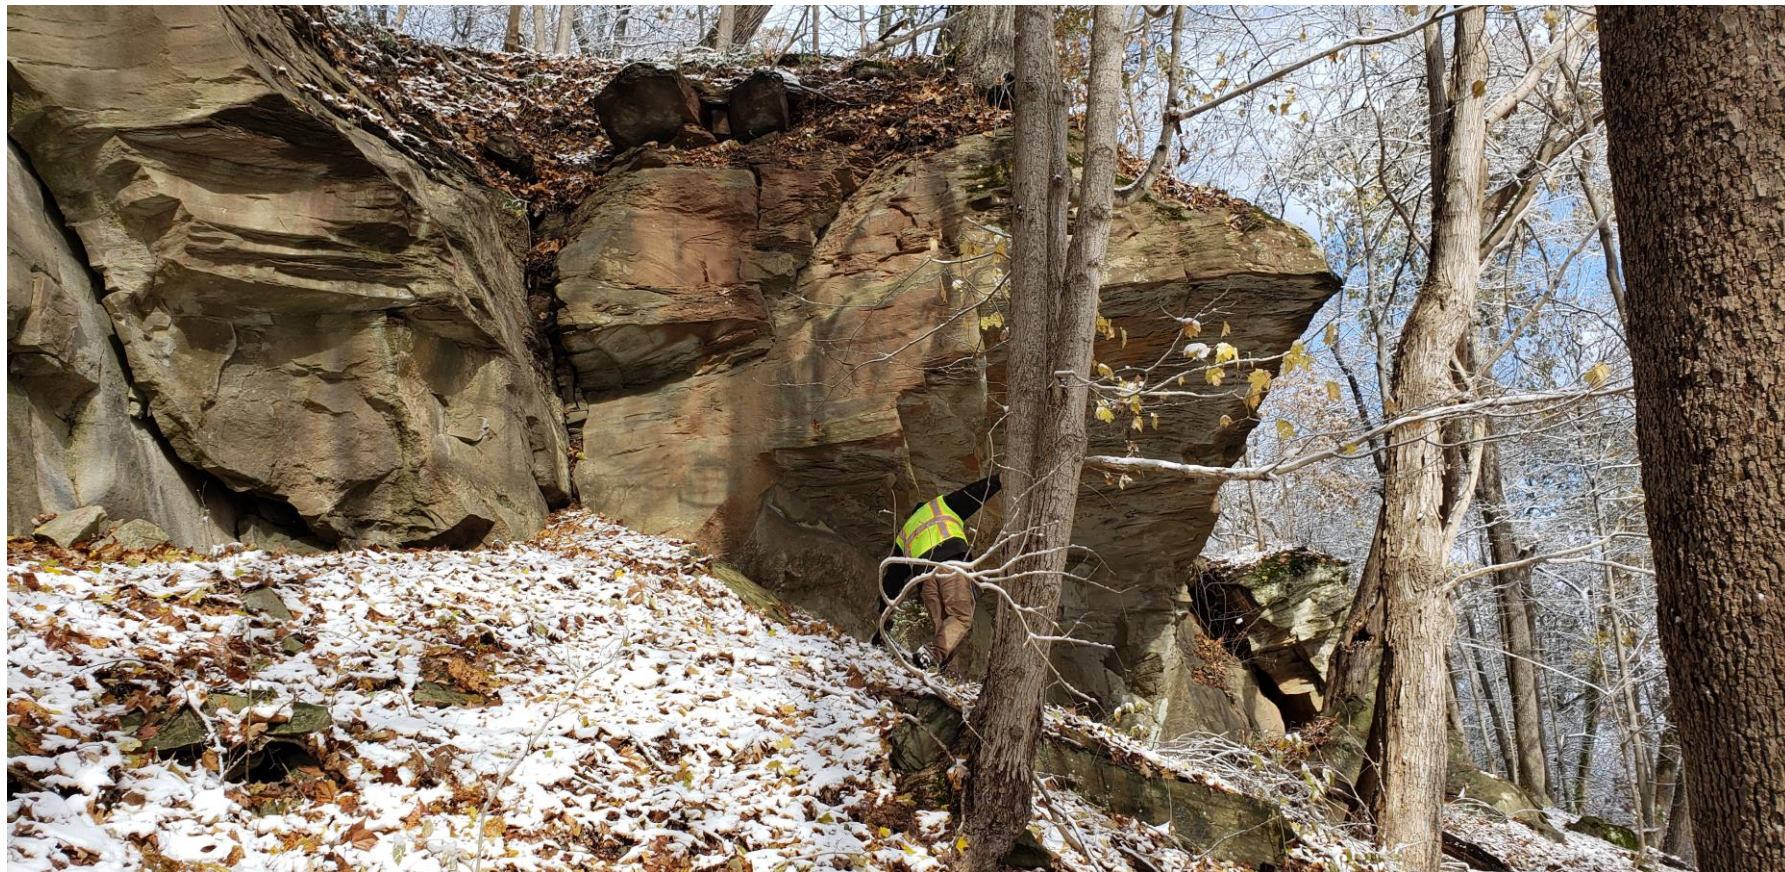
**Section #2 – Large 24-foot overhang – 21-feet above ground – joint along back side parallel to road  
6' thick at overhang – 30' deep total – 54' wide**

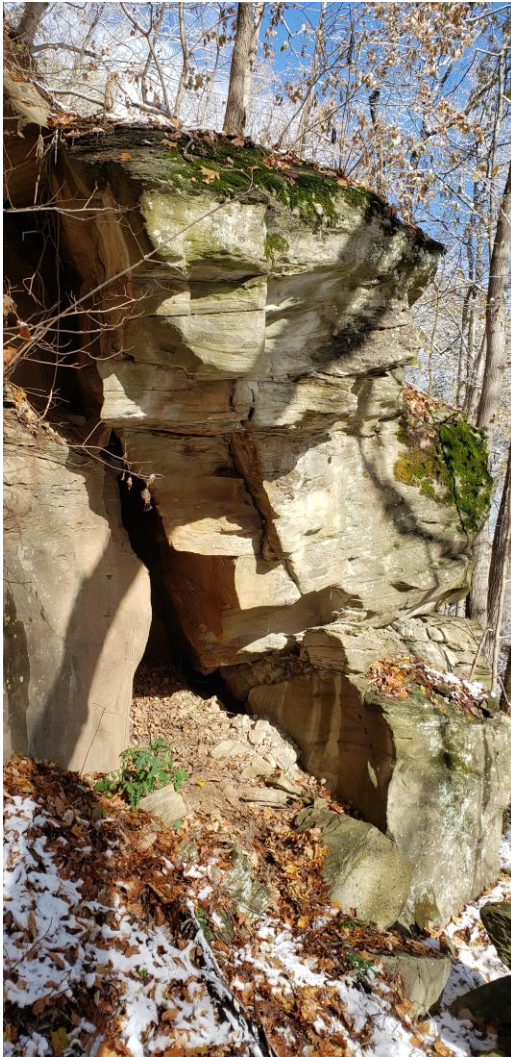
**Section #3 – Large block breaking away from rock face – 6-inch to 6-foot joint width  
24' wide x 18' high x 9' deep**
