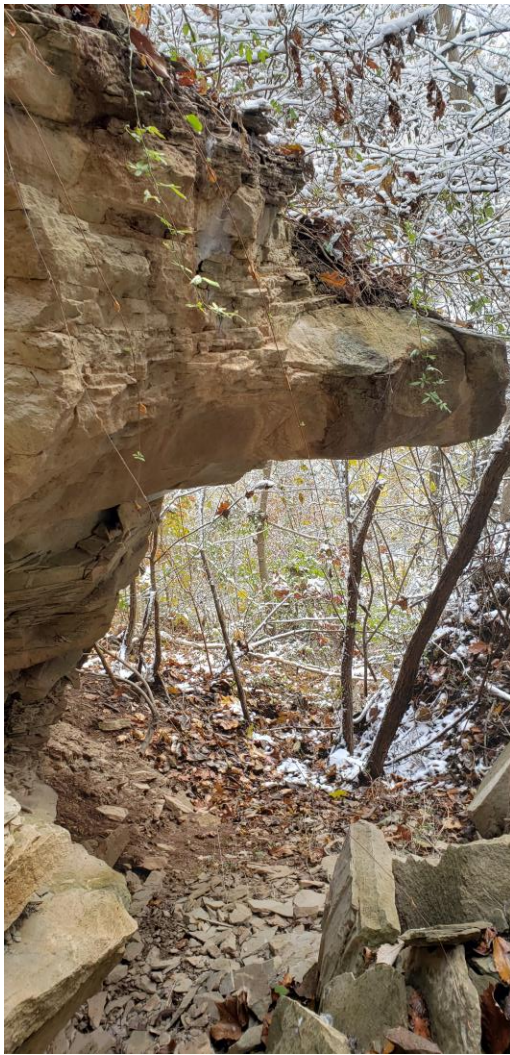
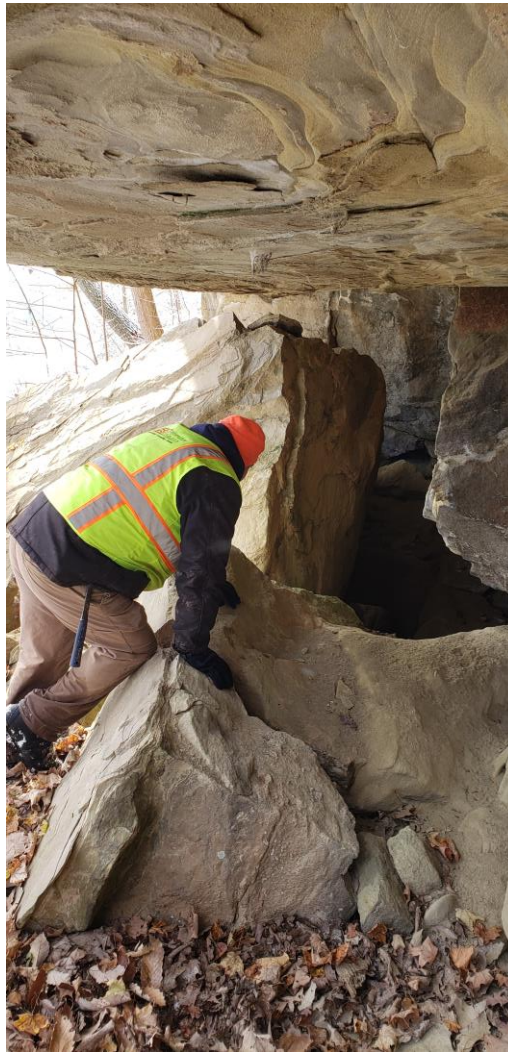
**35' wide x 12' high x 18' deep – Rock blocks with overhang above large slab already fallen  
8-foot overhang about 7-feet above ground – 4' joint parallel to road**

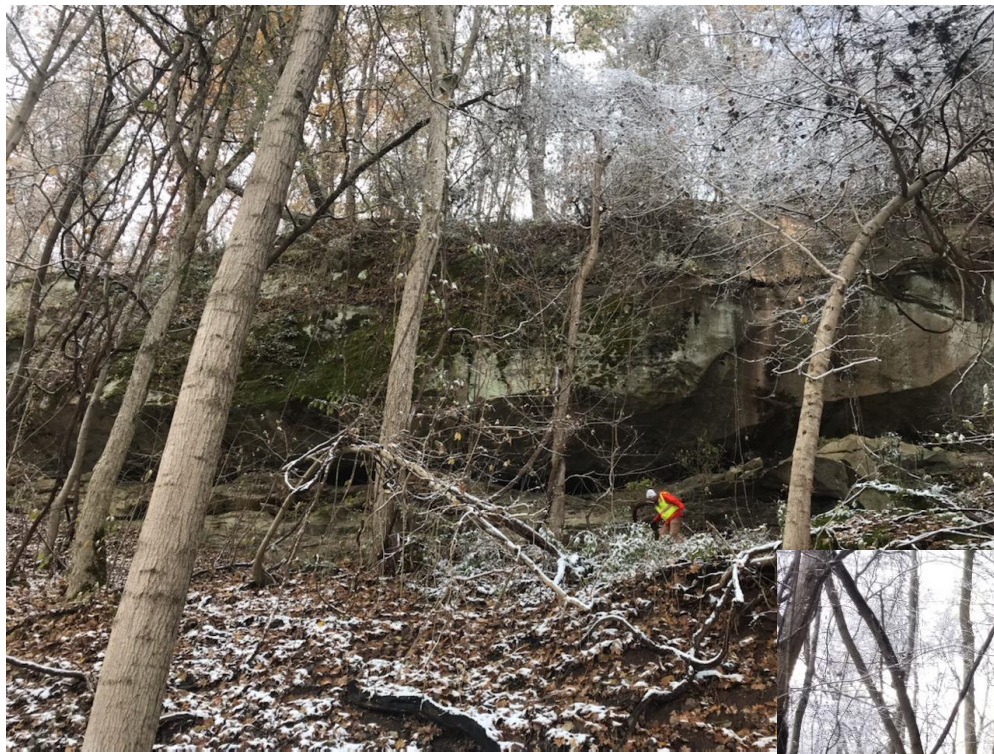
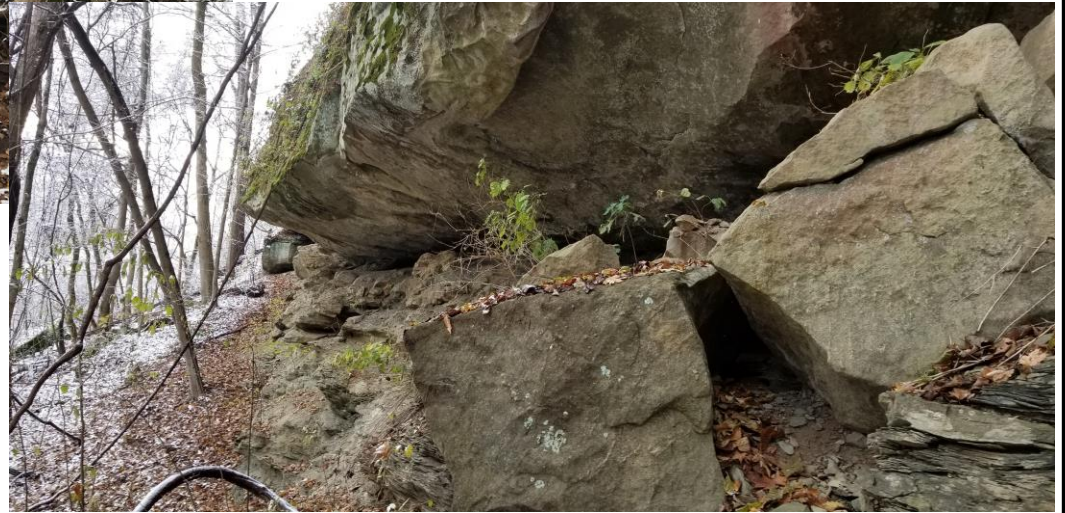
**Large undercut area exposing risk of large blocks falling down slope – 20-foot undercut about 15-feet above ground – blocks at max risk are 40' tall x 30' wide**

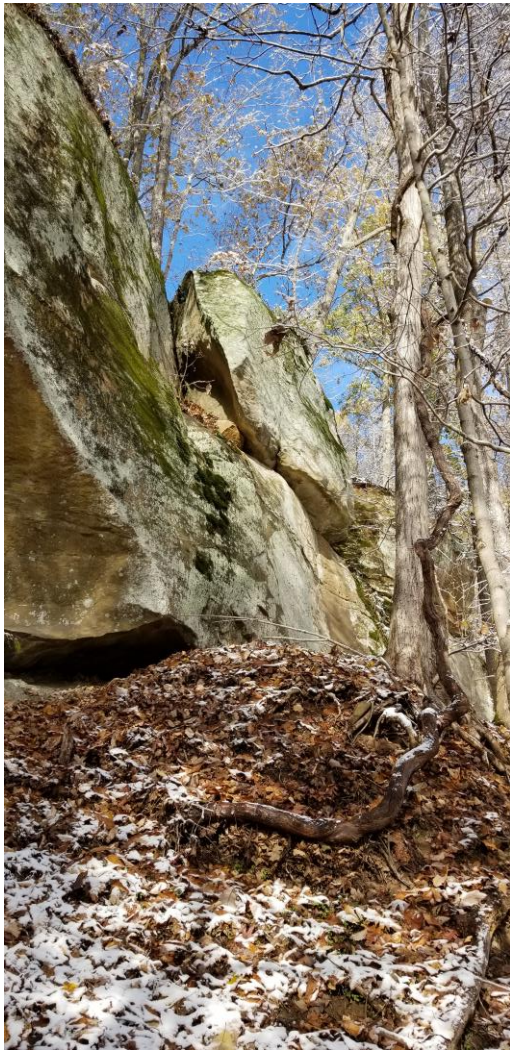
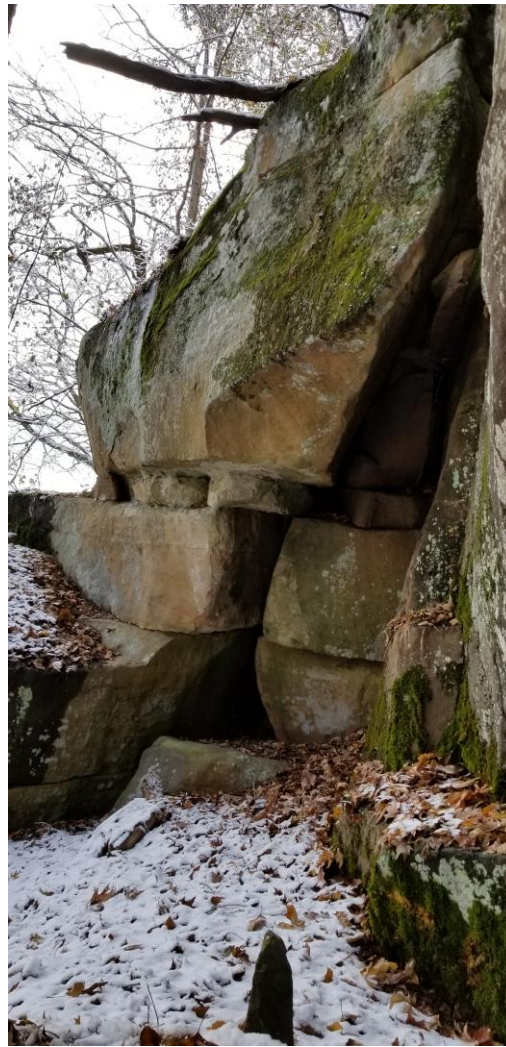
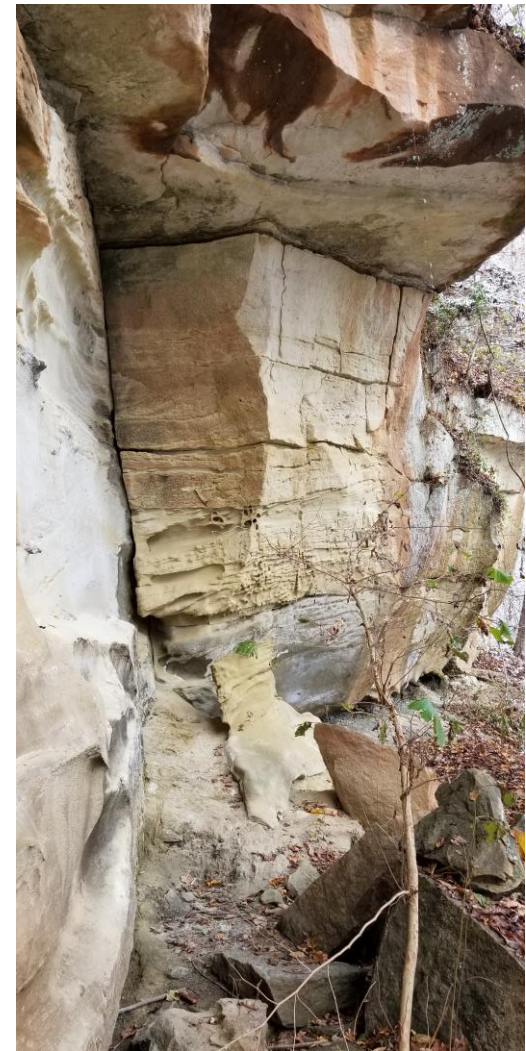
**Area of undercutting causing loose blocks with jointing - 5-foot undercut with 2"-3" joint parallel to road – loose blocks on average are 24' wide x 15' high x 14' deep**

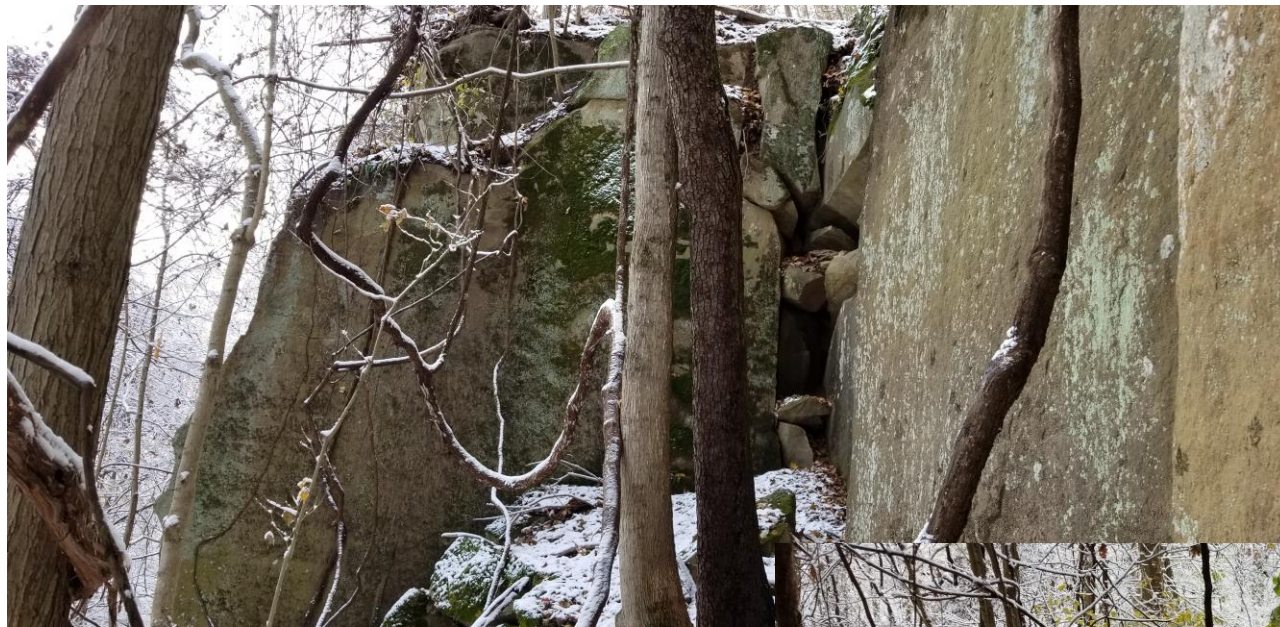
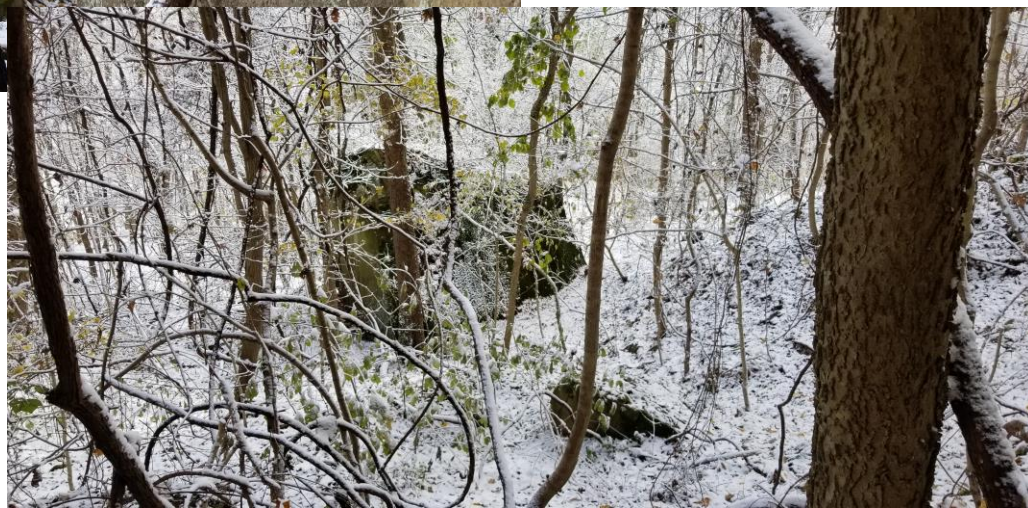
**Undercutting area that is jointed – large boulders have already fallen, with 2 others at risk**  
**Approx. size of boulders are 50' wide x 35' high x 23' deep**

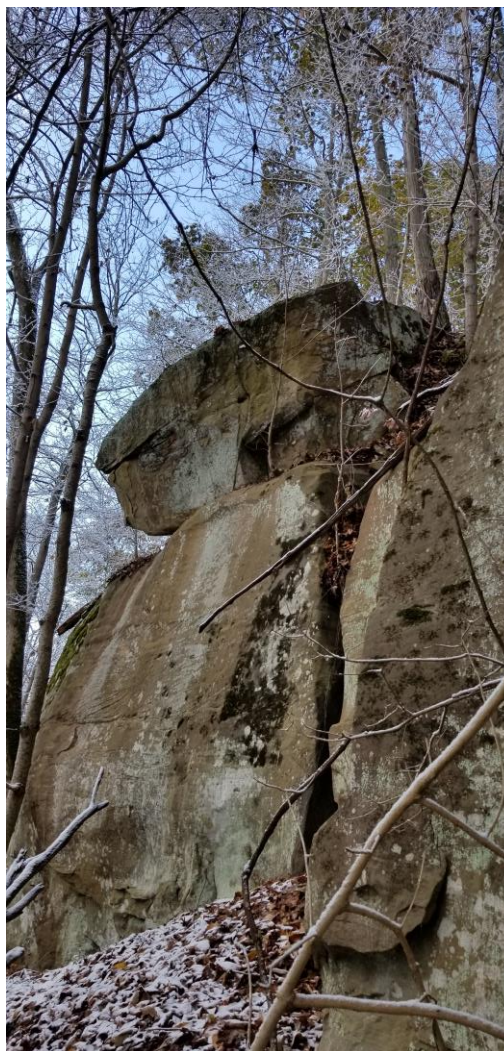
**Loose block on top of vertical sandstone block**  
**Approx. size 14' wide x 4.5' high x 6' deep**

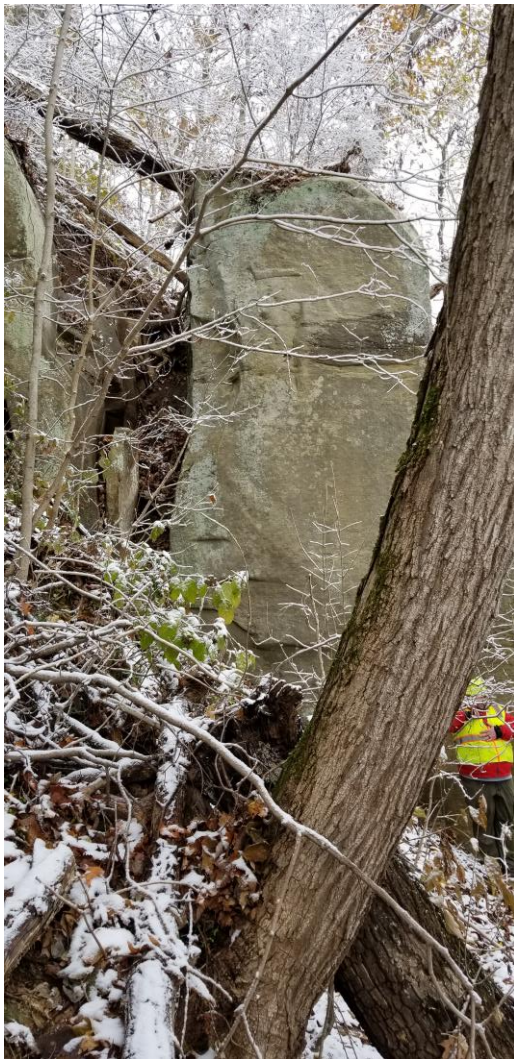
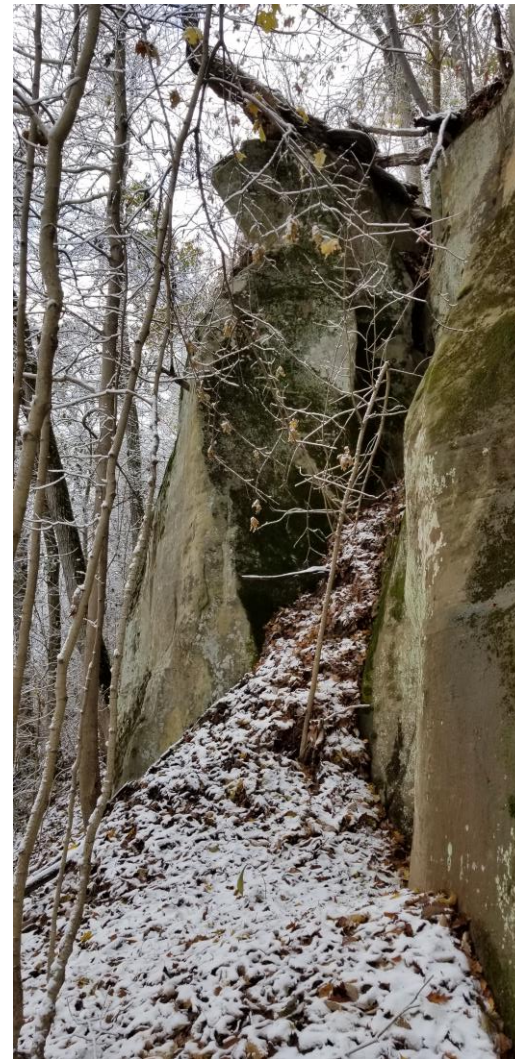
**Large jointed block pulling away from slope – 2-foot joint near base, but joint near top is 7-foot wide  
Total block size is 26' wide x 30' high x 16' deep**
