Intersection Study

**HIG-50-2.18**  
**USR 50 AND SR134**

General Engineering Services Contract  
PID No. 19194

Prepared for: ODOT District 9

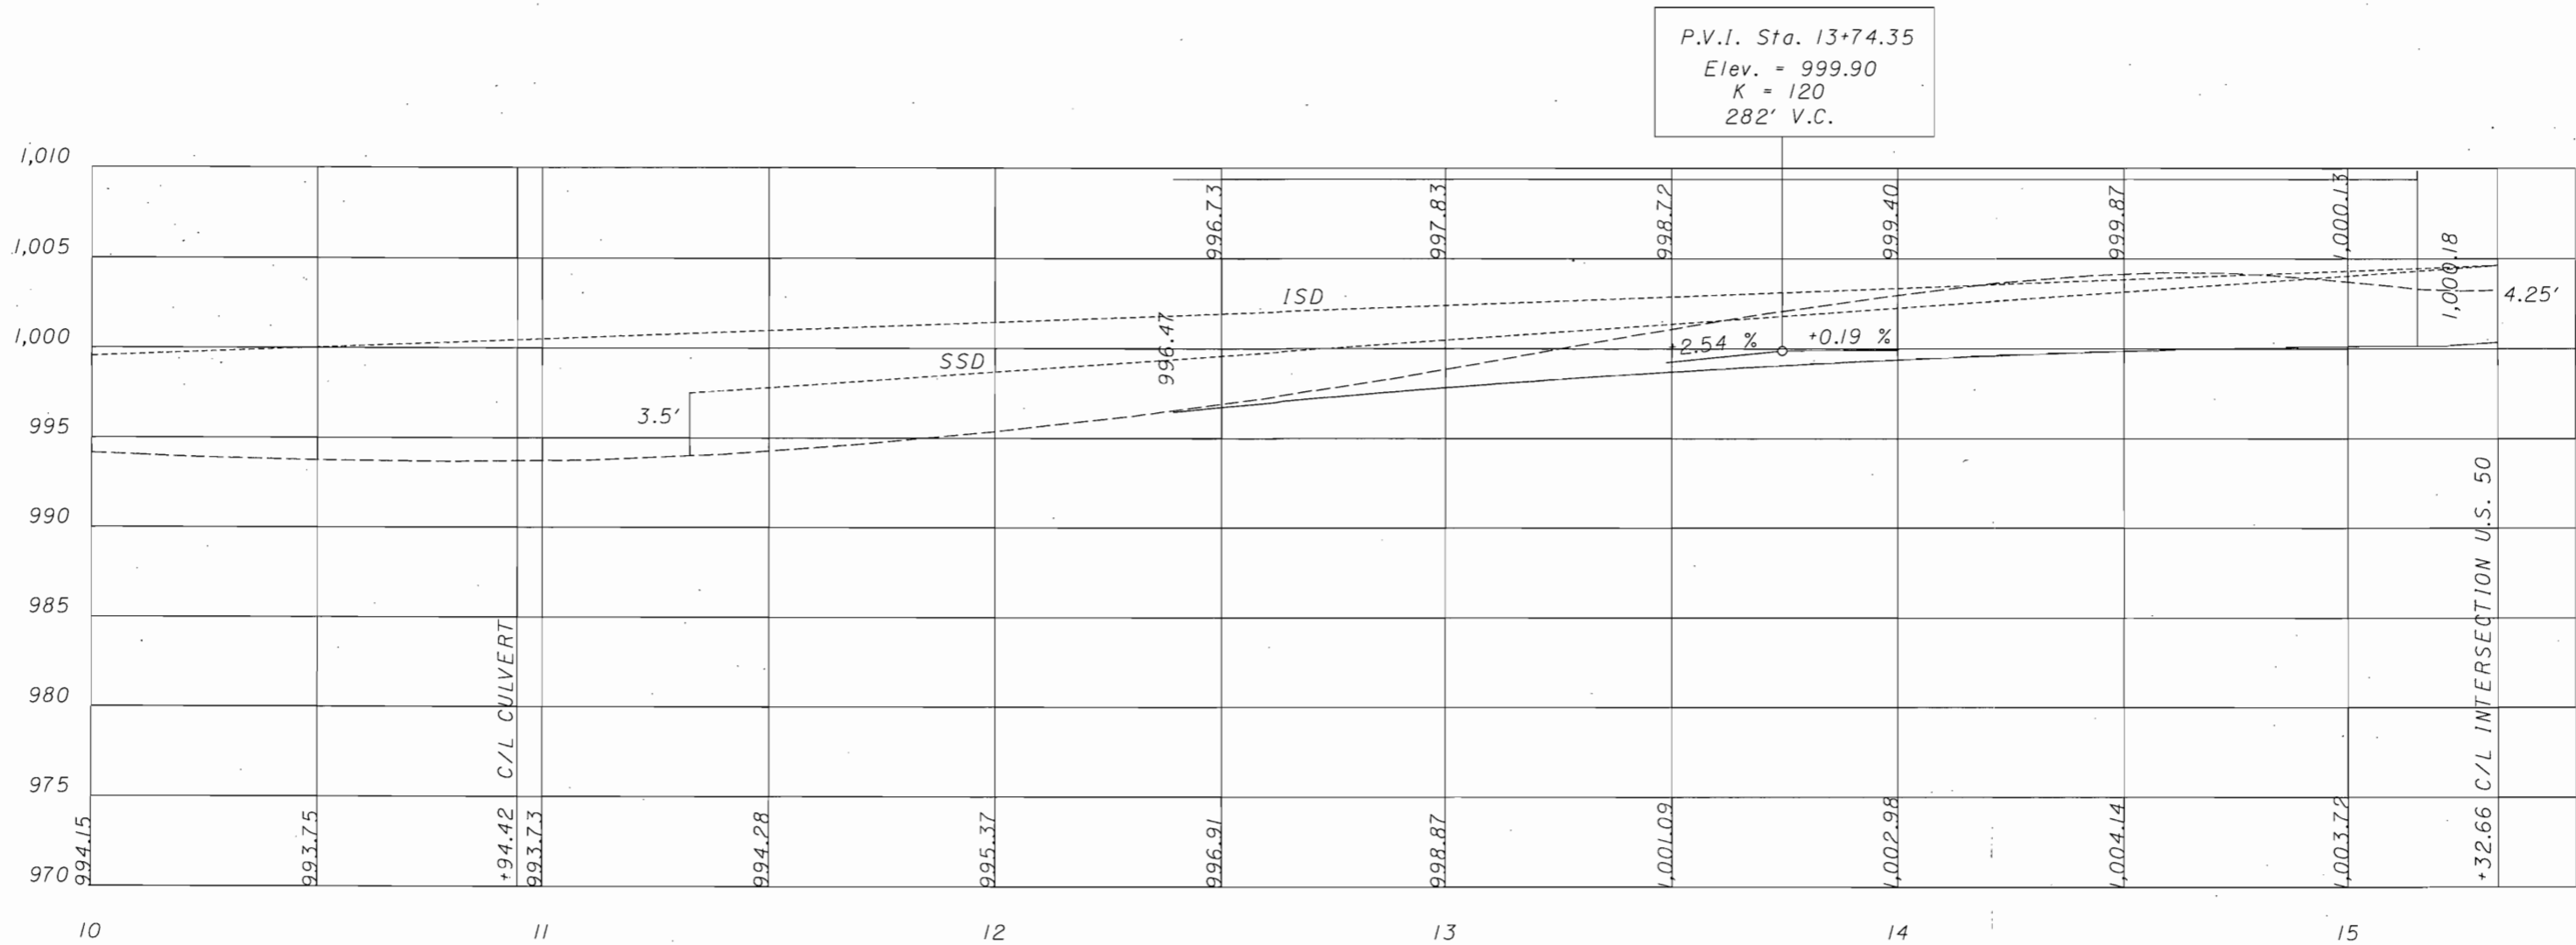
S.R. 134 - Existing Alignment Proposed Profile Alternative No. 1

This alternative consists of two parts. The first is cutting the crest vertical curve or lowering the roadway profile on USR 50 from approximately station 12+75 to station 18+10. The cutting may be severe or moderate depending on cost and cross section impacts on USR 50. The purpose being to improve the stopping sight distance (SSD) and the intersection sight distance (ISD) using a 3.5 feet "height-of-eye" and a 4.25 feet "height-of-object" standards based upon a design speed of 45 MPH.

The second improvement is cutting the crest vertical curve or lowering the roadway profile on SR 134 on the south leg for northbound traffic from approximately station 12+40 to station 15+33. The cutting may be severe or moderate depending on cost and cross section impacts on SR 134. The purpose being to improve the stopping sight distance (SSD) and the intersection sight distance (ISD) using a 3.5 feet "height-of-eye" and a 4.25 feet "height-of-object" standards based upon a design speed of 45 MPH.

<See Figure 1-1a and 1-1b>

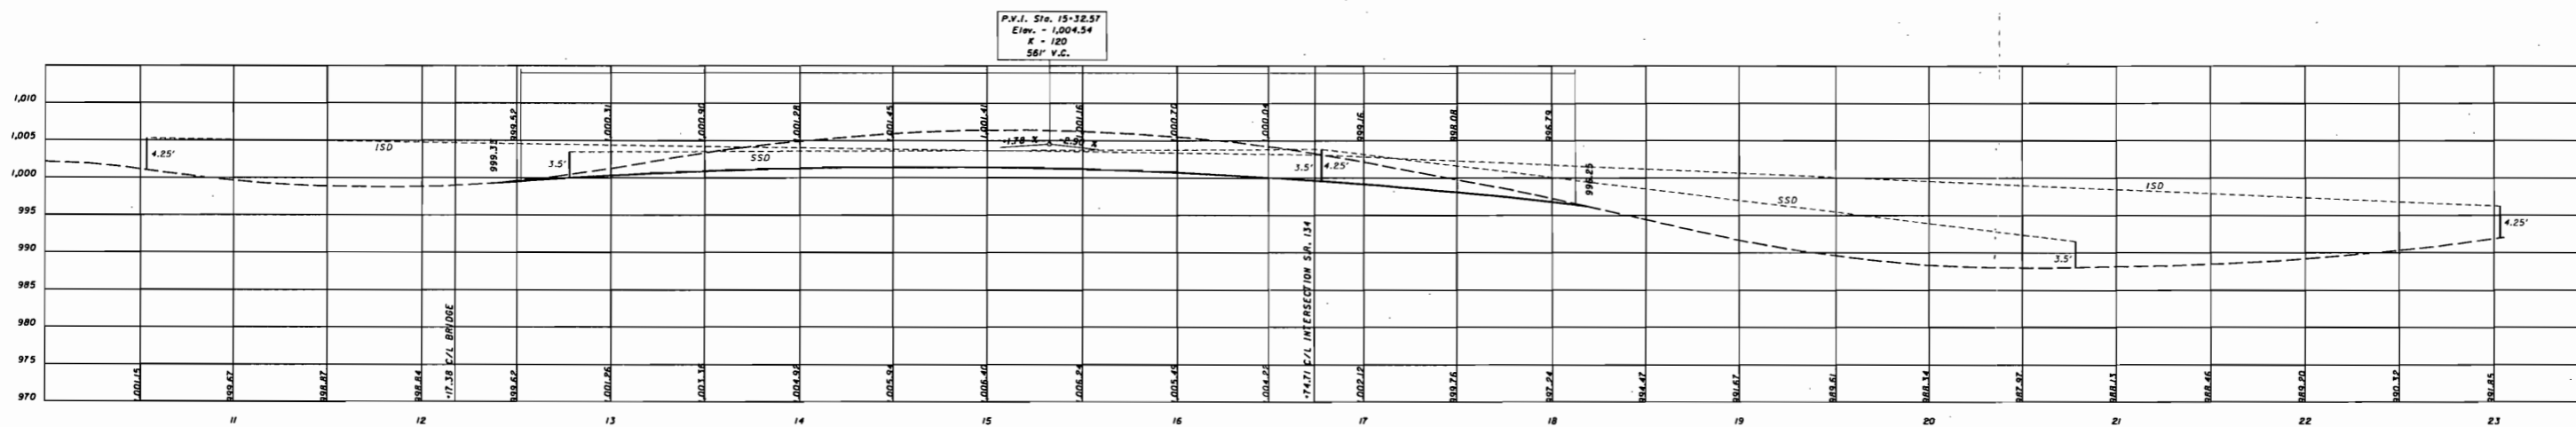
Figure 1-1b

U.S. 50 - Existing Alignment Proposed Profile Alternative No. 1

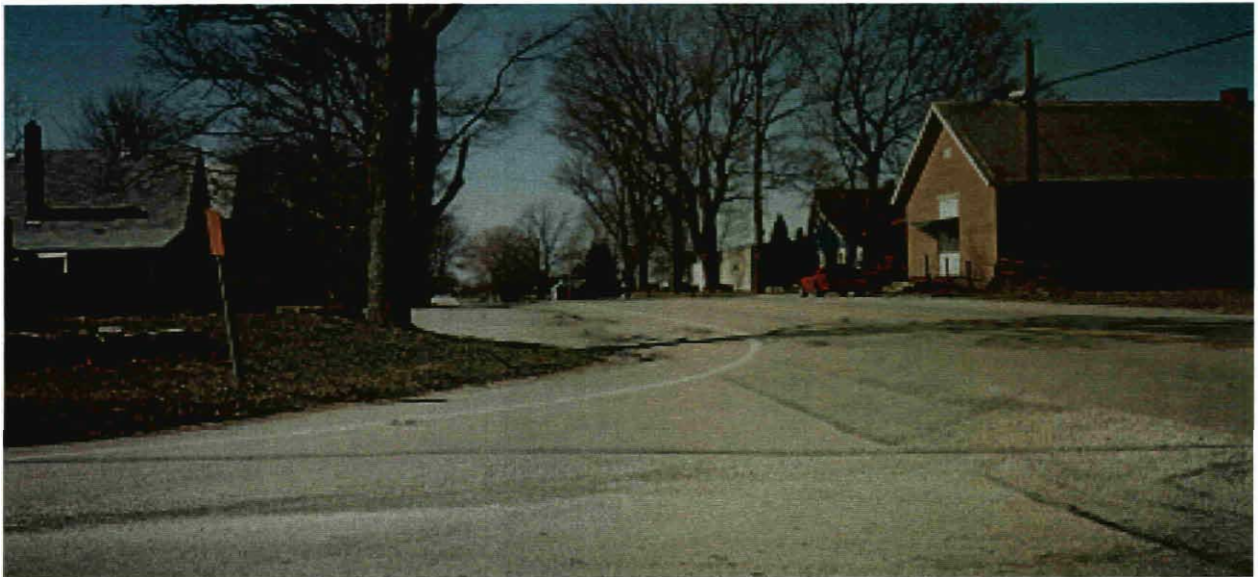
ISD(CCSD)--LOOKING WEST FROM SR 134 NORTHBOUND APPROACH  
OR SOUTH LEG AT WEST INTERSECTION

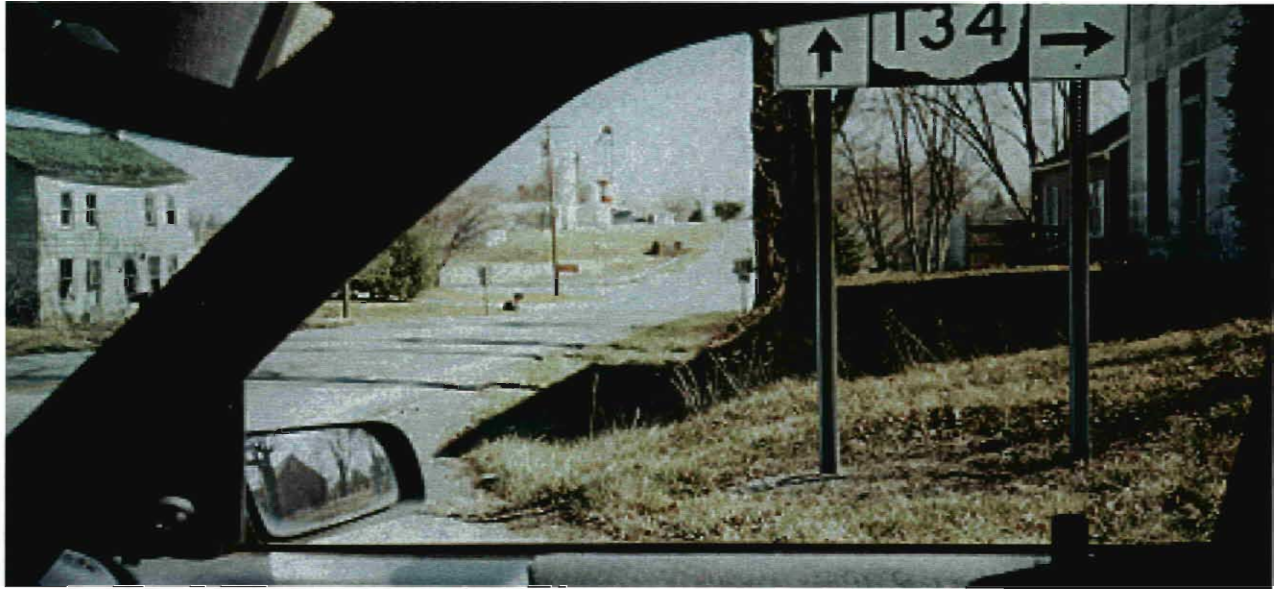
ISD(CCSD)--LOOKING EAST FROM SR 134 NORTHBOUND APPROACH  
OR SOUTH LEG AT WEST INTERSECTION

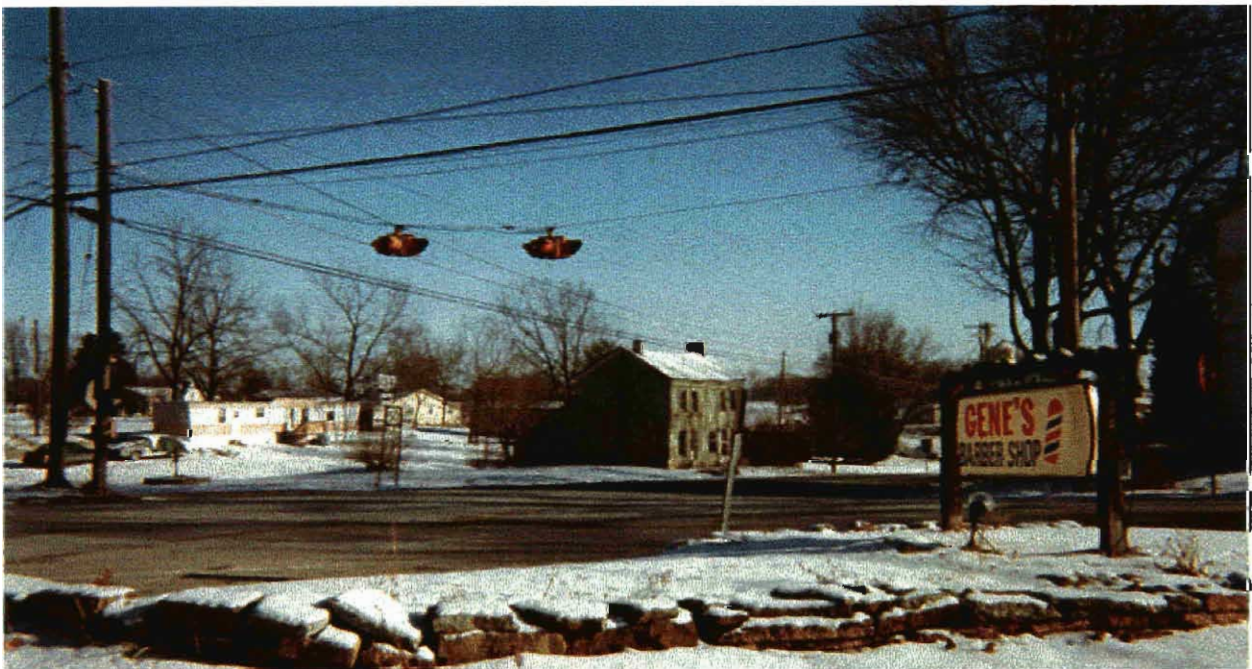
INTERSECTION CONTROL BEACON (WEST INTERSECTION)

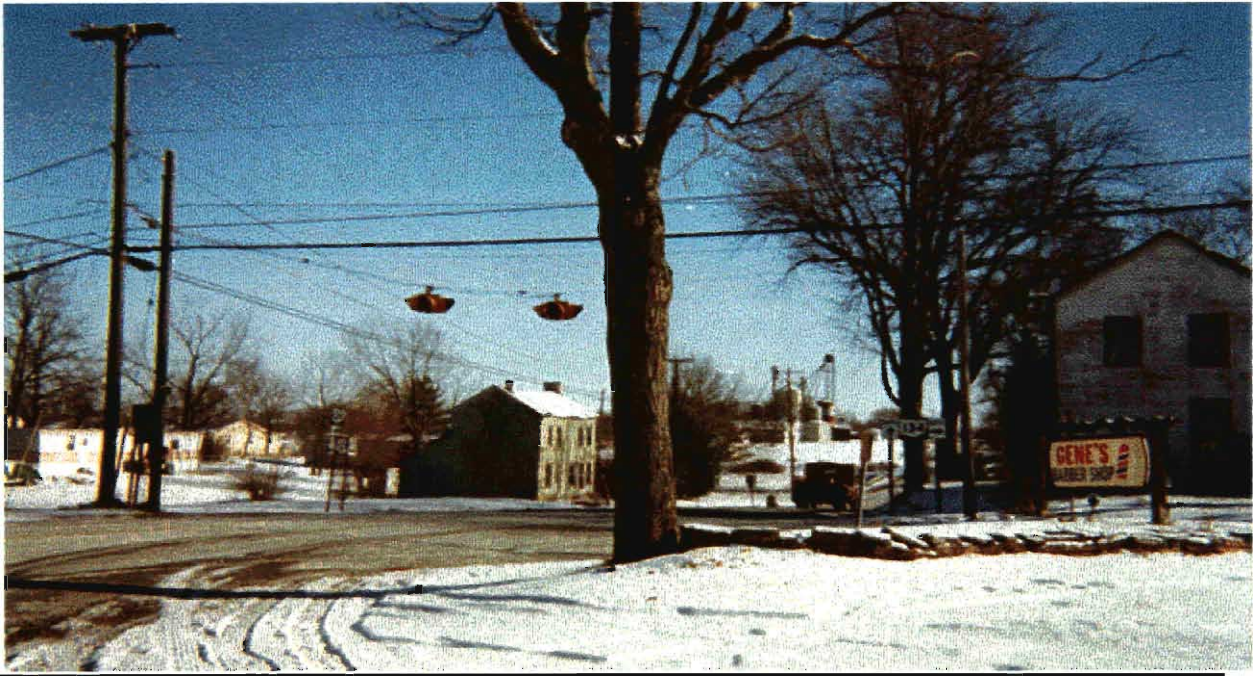
INTERSECTION CONTROL BEACON (WEST INTERSECTION)

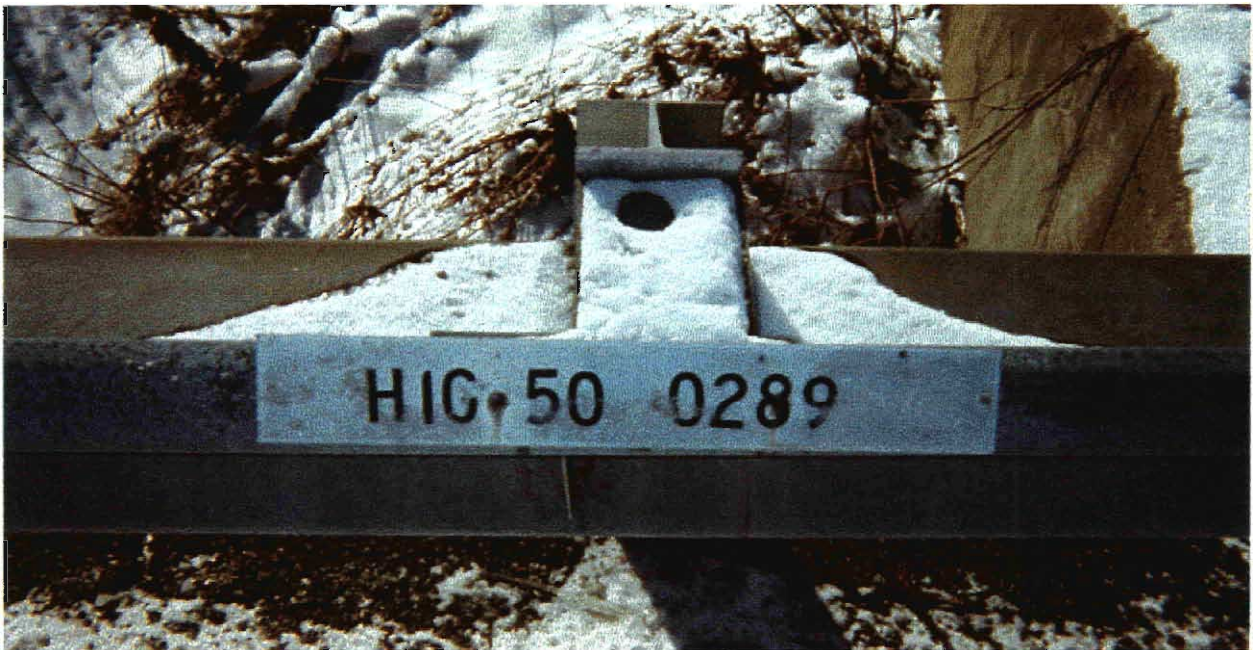
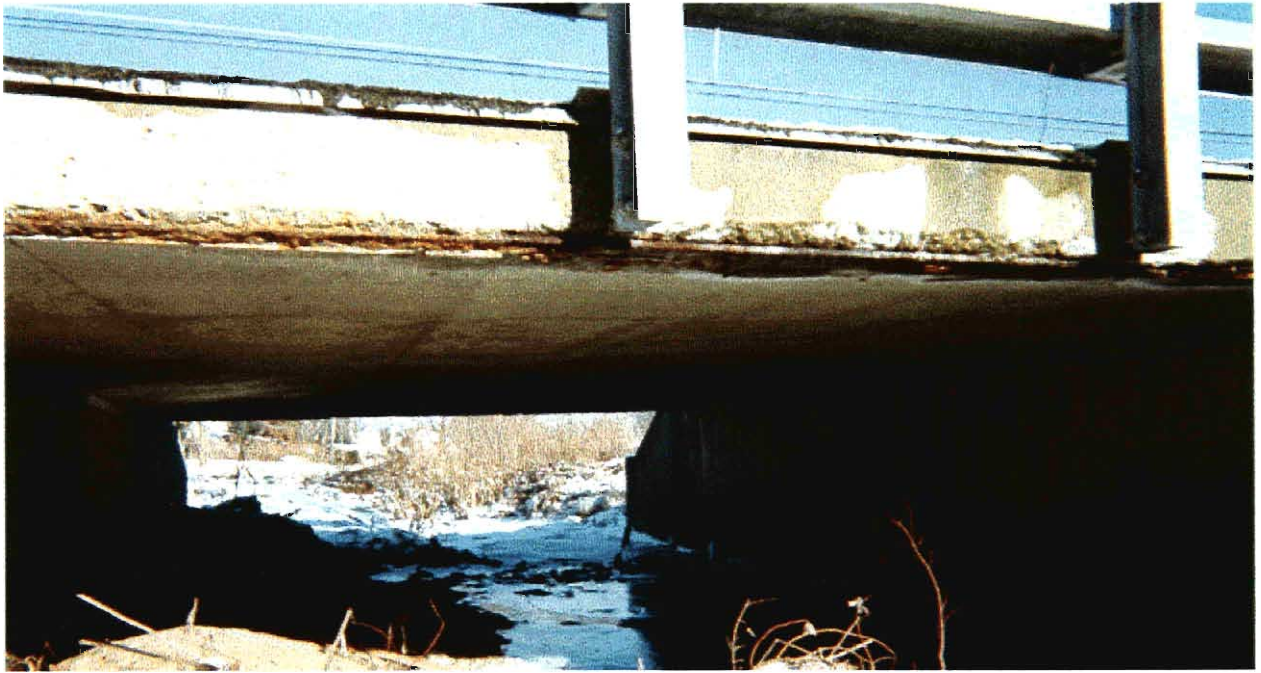
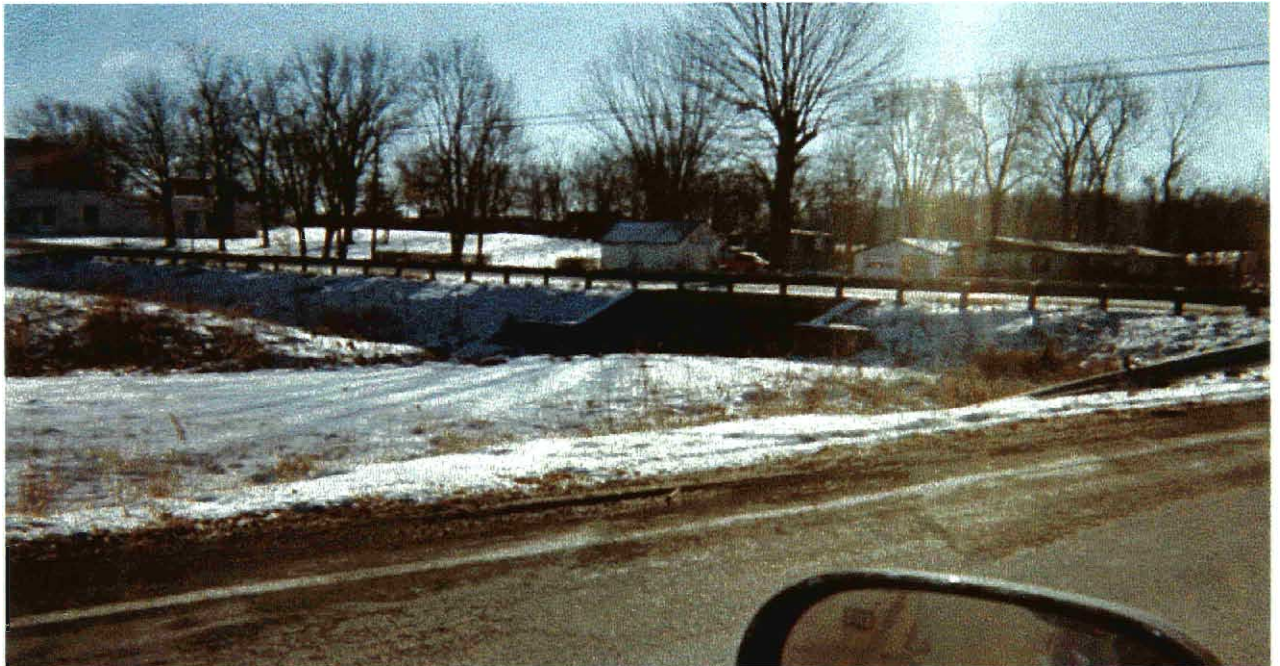
CULVERT ON US 50, EAST OF PROJECT
