# John Scott Connector

## Rehabilitation and Reconstruction Study

Prepared for the City of Steubenville, Ohio

## John Scott Highway Pavement Evaluation Jefferson County, Ohio

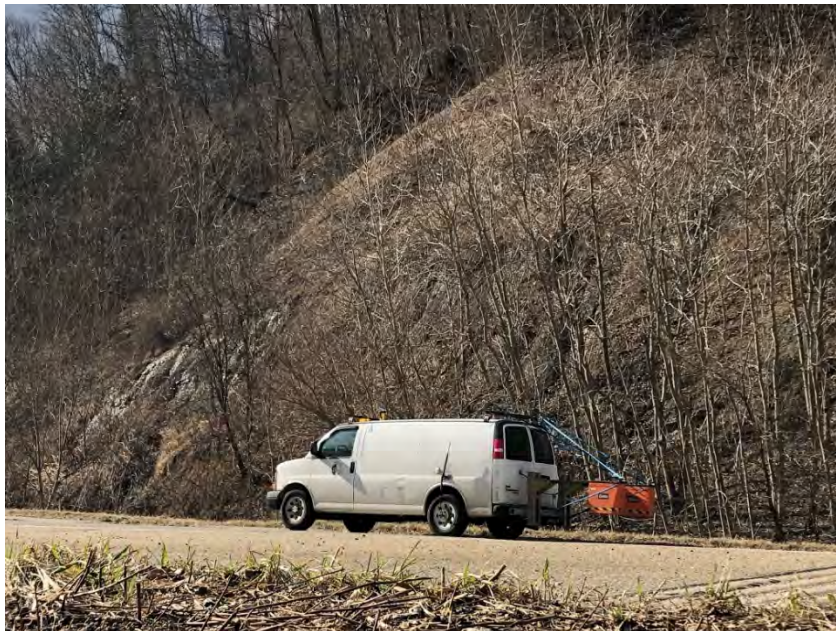
**Photograph 1. GPR system used during data collection**

The GPR system used during data collection is shown in Photograph 1. The GPR survey was conducted on March 15, 2019.

Rii used an automated survey vehicle to collect continuous GPR data on pavement layer thicknesses. The type of GPR system used during this project utilizes the non-contact horn antenna with a center frequency of 1 GHz, which is suspended 19 in. over the surface of the pavement and which can perform surveys at highway speed. This system has the advantage of providing near-surface information, and under typical conditions, the depth of signal penetration reaches 24 in.

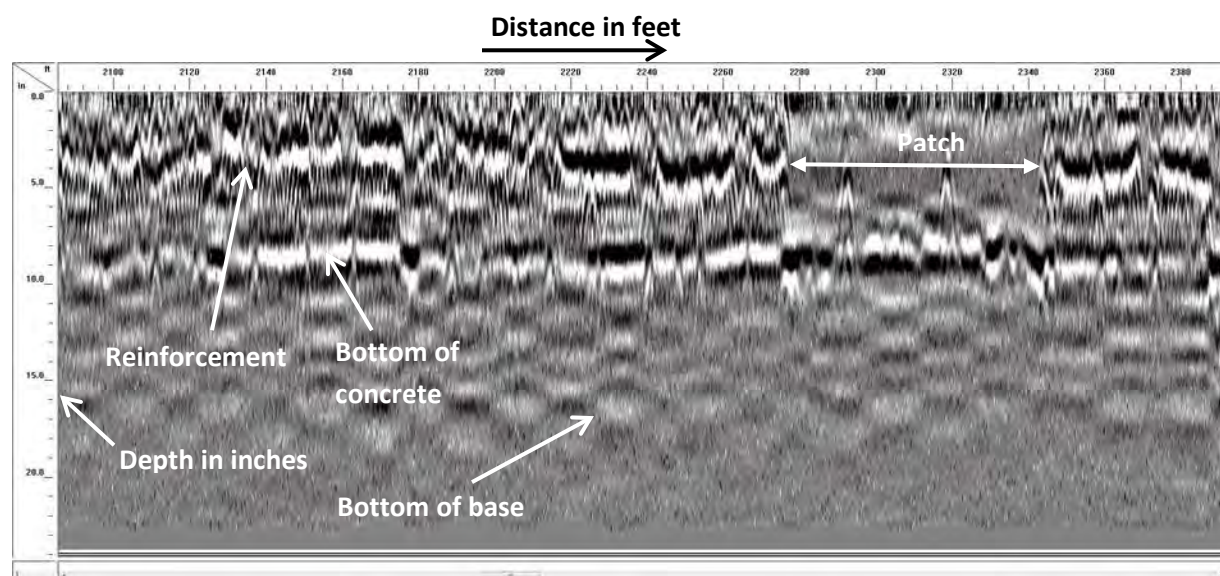
**Figure 1. GPR scan showing concrete and base layers and a large patch**

GPR was used in this project to obtain the thickness of the concrete pavement layer and the thickness of the aggregate base layer. The concrete and base layer thicknesses are reported at fifty (50) feet interval, and included in Appendix A. Figure 1 is a typical GPR scan showing the concrete and base layers for a section of the one mile pavement. Table 3 lists the average thicknesses of concrete and base layers for each lane of the John Scott Highway pavement.

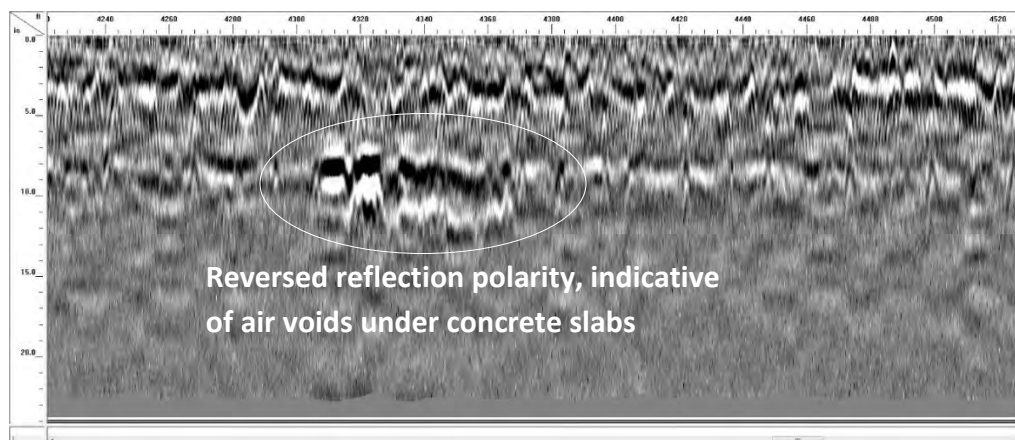
**Figure 2. GPR image from JSH pavement showing the existence of air-voids under concrete slabs**

Voids under concrete slabs, either air or water-filled, are high contrast targets. However, they have to be at least 0.6 in. thick to produce a reflection. Voids show as strong reflections with a white-black-white sequence of colors (reversed reflection polarity). This happens when the electromagnetic wave travels from a material with a certain dielectric constant to a material with a lower dielectric constant, concrete-air interface, for instance. Reflections at locations with no voids appear dim, revealing a low concrete-base dielectric contrast. All the GPR scans were carefully examined for existence of voids under the concrete slabs. The GPR image of Figure 2 shows air-voids under the concrete slabs of the pavement. All detected voids were mapped on the plan views of the pavement and reported in Appendix B.

GPR data collected from all lanes indicated that there were voids under the concrete slabs at various locations. Also, there are transverse mid-slab cracks throughout the length of all lanes. Since, there are no dowels to transfer the load across these transverse cracks and there is a possibility of voids under the slabs, therefore, it was considered appropriate to analyze the edge and corner load conditions to accommodate these critical field conditions.

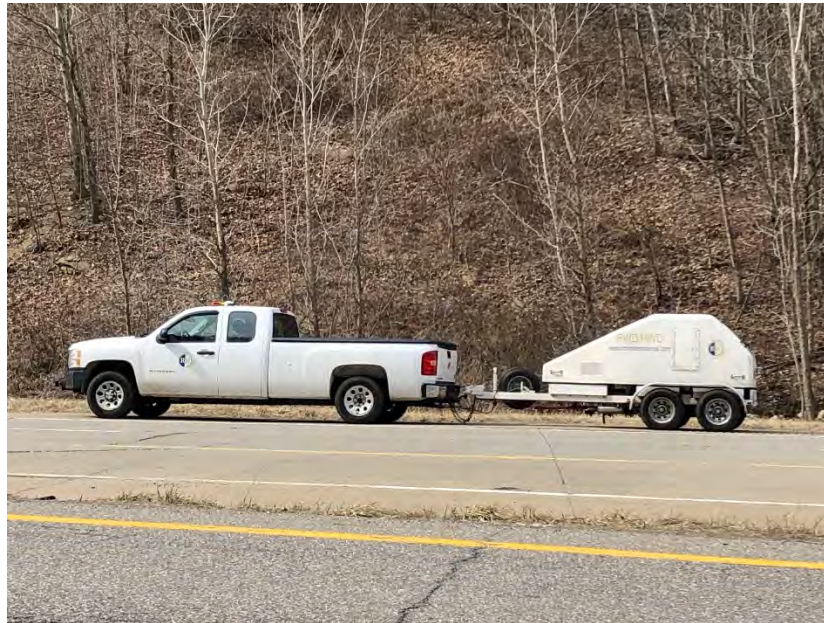
**Photograph 2. FWD system used during data collection**

Rii performed Falling Weight Deflectometer (FWD) testing and used the deflection information to back-calculate stiffness-related parameters of the existing pavement structure and the joint load transfer efficiency (LTE). Rii uses a JILS-20HD heavy FWD for use with thick pavement structures and where heavy truck loading is normal. Photograph 2 shows the FWD system used for this project. Drop weights of approximately 16,000 pounds were used in testing the pavement at every 250 feet in the outer wheel path of driving and passing lanes of the roadway.

Eight geophones were used during field testing at locations 0, 8, 12, 18, 24, 36, 48, and 60 inches from the center of the load plate. The determination of the LTE makes use of the deflections from the two geophones positioned at each side of the joint (deflections at offsets 0, and 12) while deflections at offsets 0 through 60 inches were used to back-calculate the elastic layer moduli. The elastic moduli of individual layers were calculated based on surface deflections induced by the FWD load and the pavement layer thicknesses determined by GPR data.

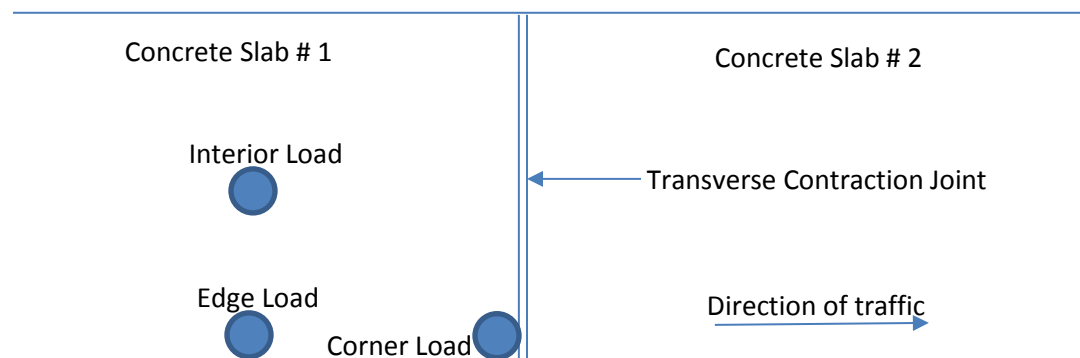
**Figure 3. Possible Wheel Load positions on the pavement slabs**

Considering the above scenario of the wheel placements, we decided to analyze the effect of load placement on the pavement slabs when the wheels are close to the edge of the pavement or the corner of the slab, as shown in Figure 3 below. The interior load position shown in the sketch below was also included in the analysis for the sake of completeness.

According to the drawing of the vehicle that will carry the load on the pavement of the highway, the vehicle has axle width of 19'-11 7/16" (see Appendix F). Since the current lane width of the pavement is 12', therefore, the entire length of each axle of the vehicle will occupy two lanes of the highway. Therefore, it is assumed that on a straight path, the outer wheels of the axle will be within 2' from the edge of the lane. However, on curves, the outer wheels may be some times either on the edge of pavement or even on the shoulders.

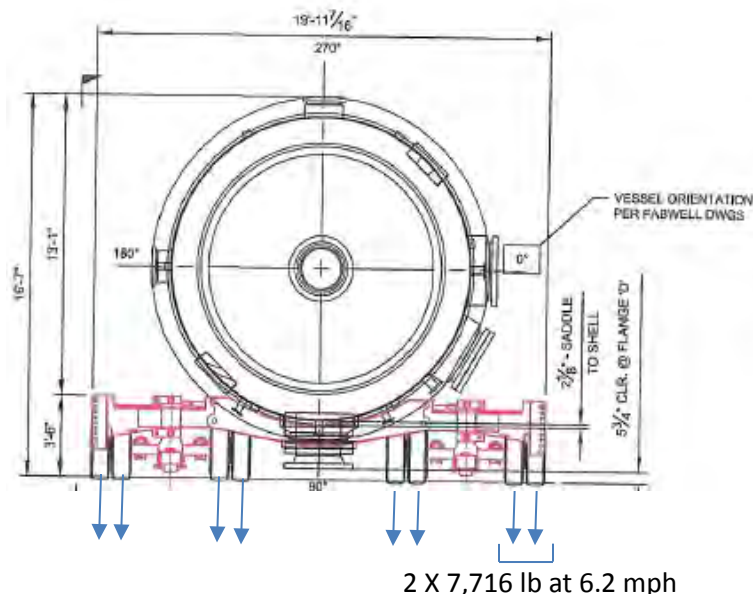
**Figure 4. Loads applied by the vehicle on each wheel at 6.2 mph speed.**

Figure 4 shows the load applied by each wheel of the vehicle when travelling at a speed of 6.2 miles per hour.

The data listed in Table 8 indicates that the applied wheel load increases with the slower speed. Since, it is anticipated that the vehicle may travel slower than 6.2 mph, therefore, to accommodate this condition, we used a wheel load of 8,000 lbs on each wheel or 16,000 lbs on the dual wheels of the axle in our analysis.

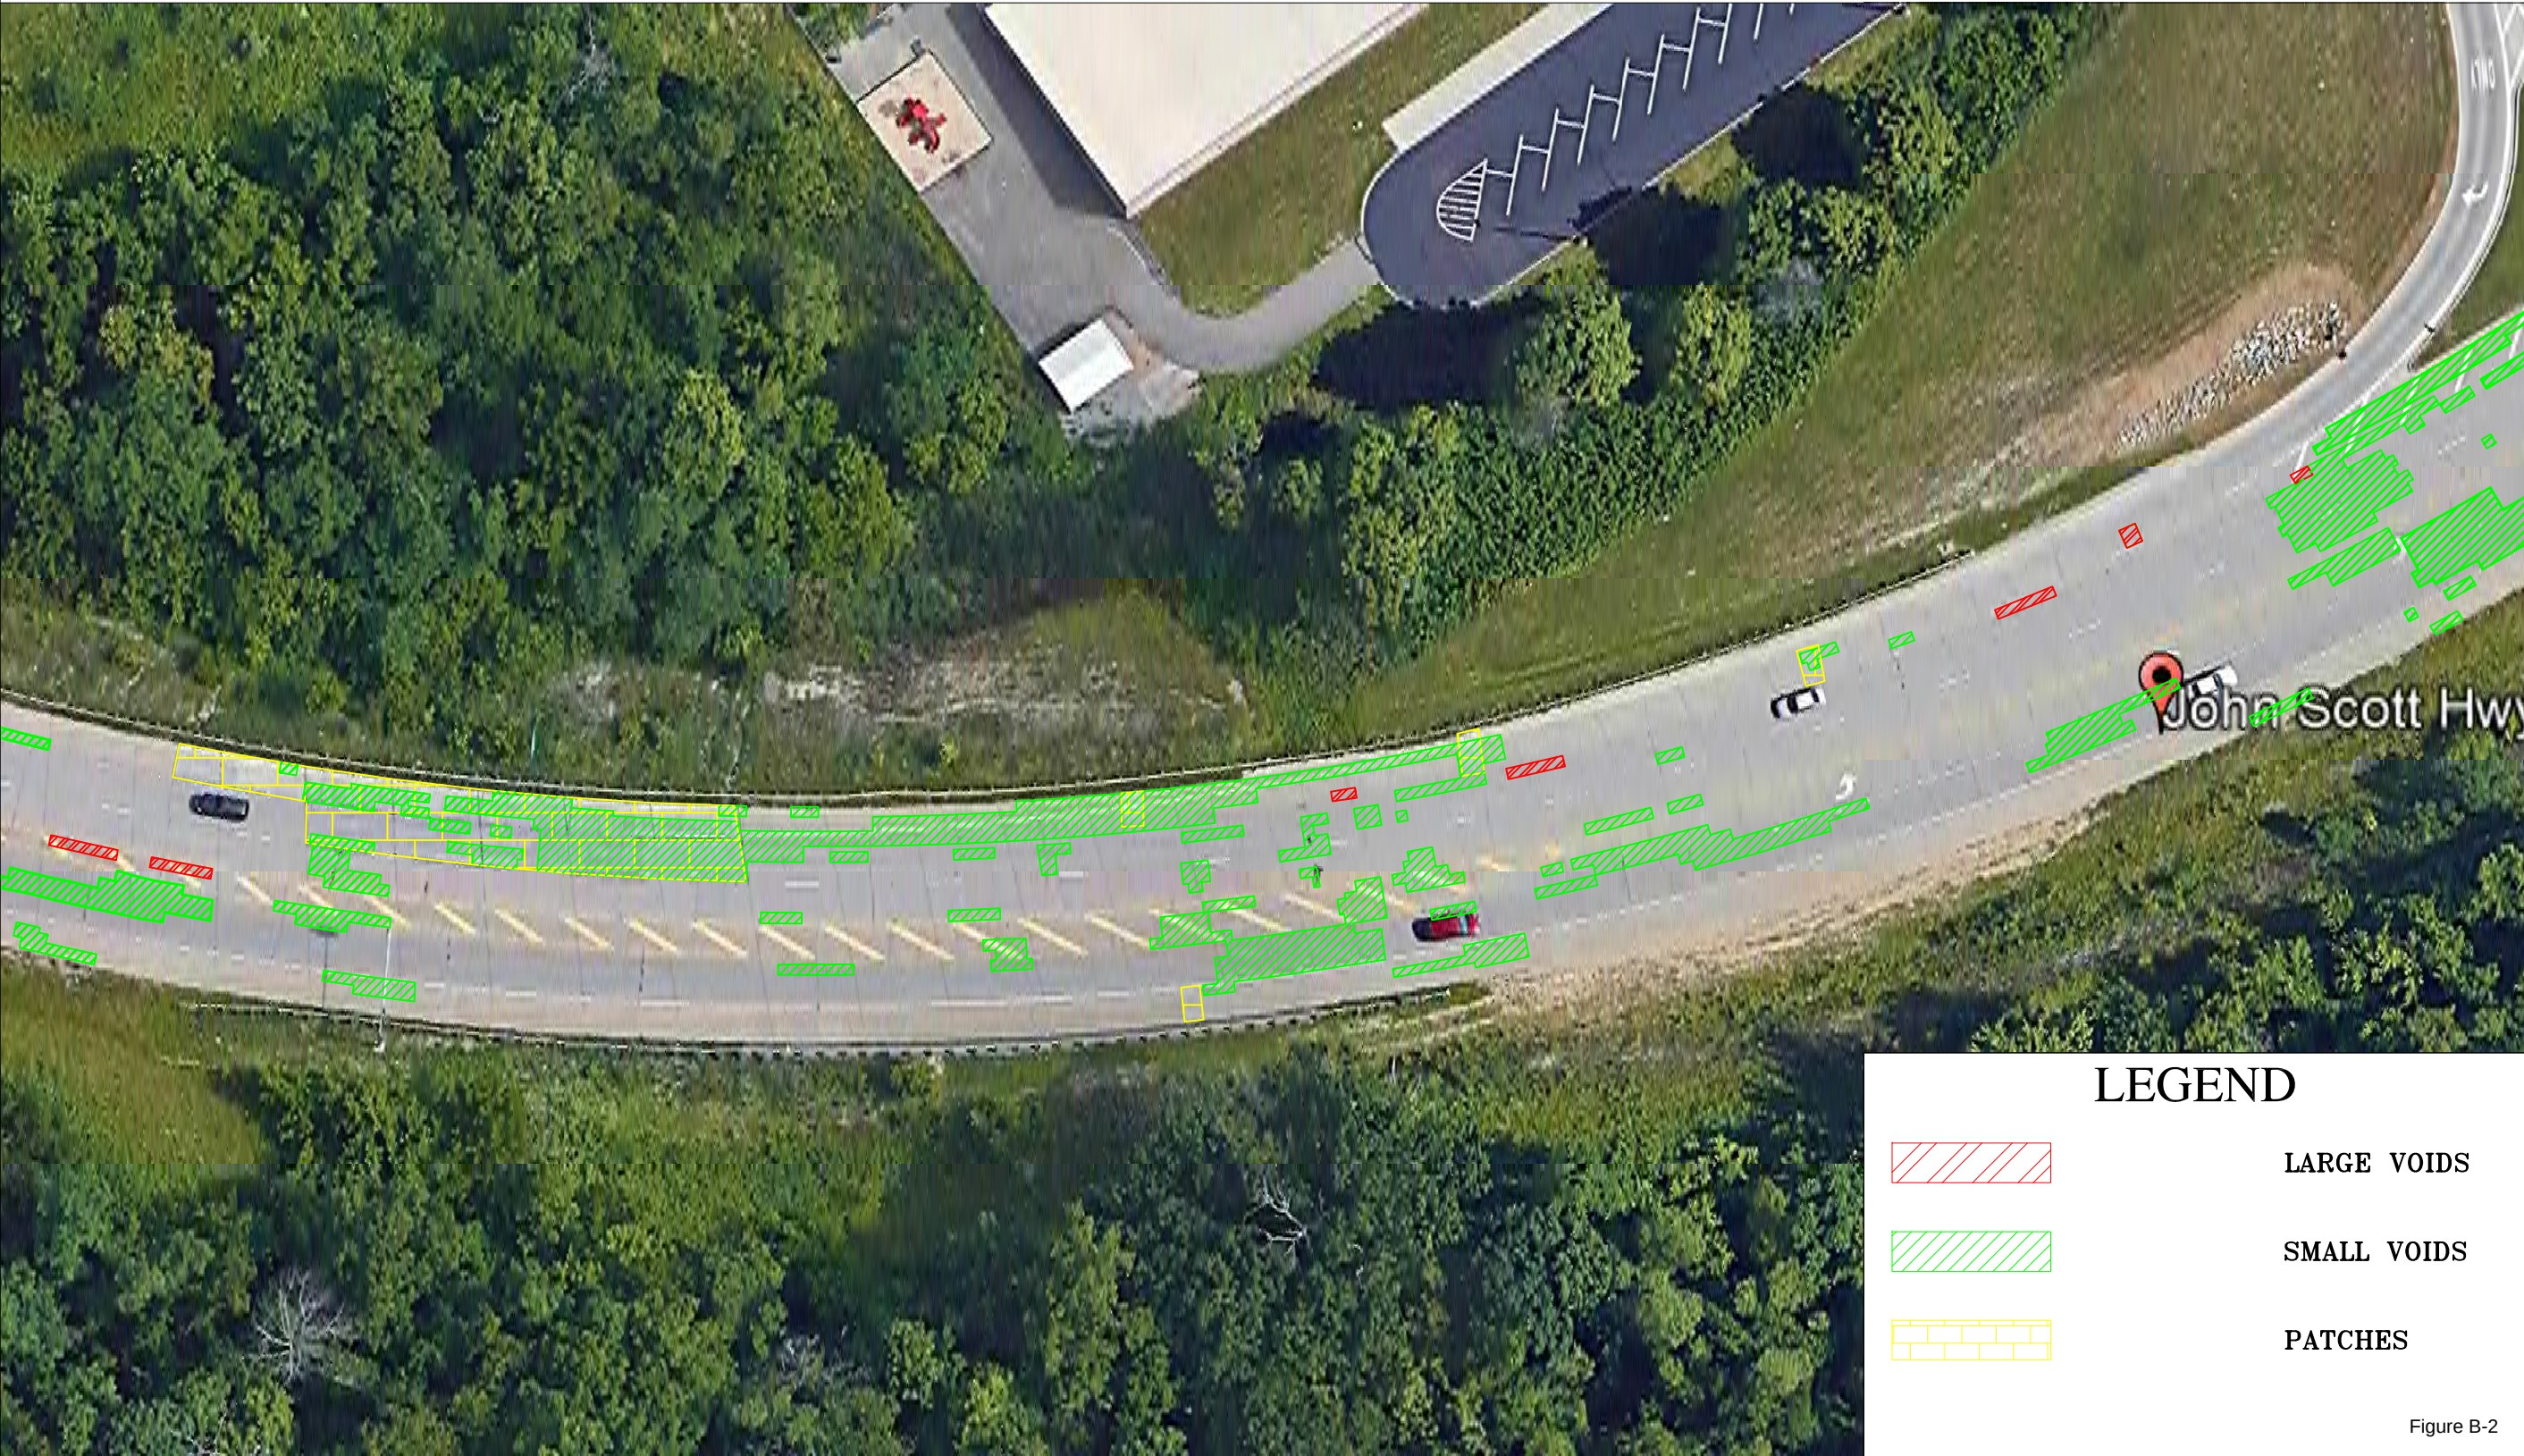
Figure B-1

GPR VOID MAP  
JOHN SCOTT HIGHWAY  
FROM KINGSTON AVE TO SR 22 ON RAMP  
JEFFERSON COUNTY  
STATE OF OHIO

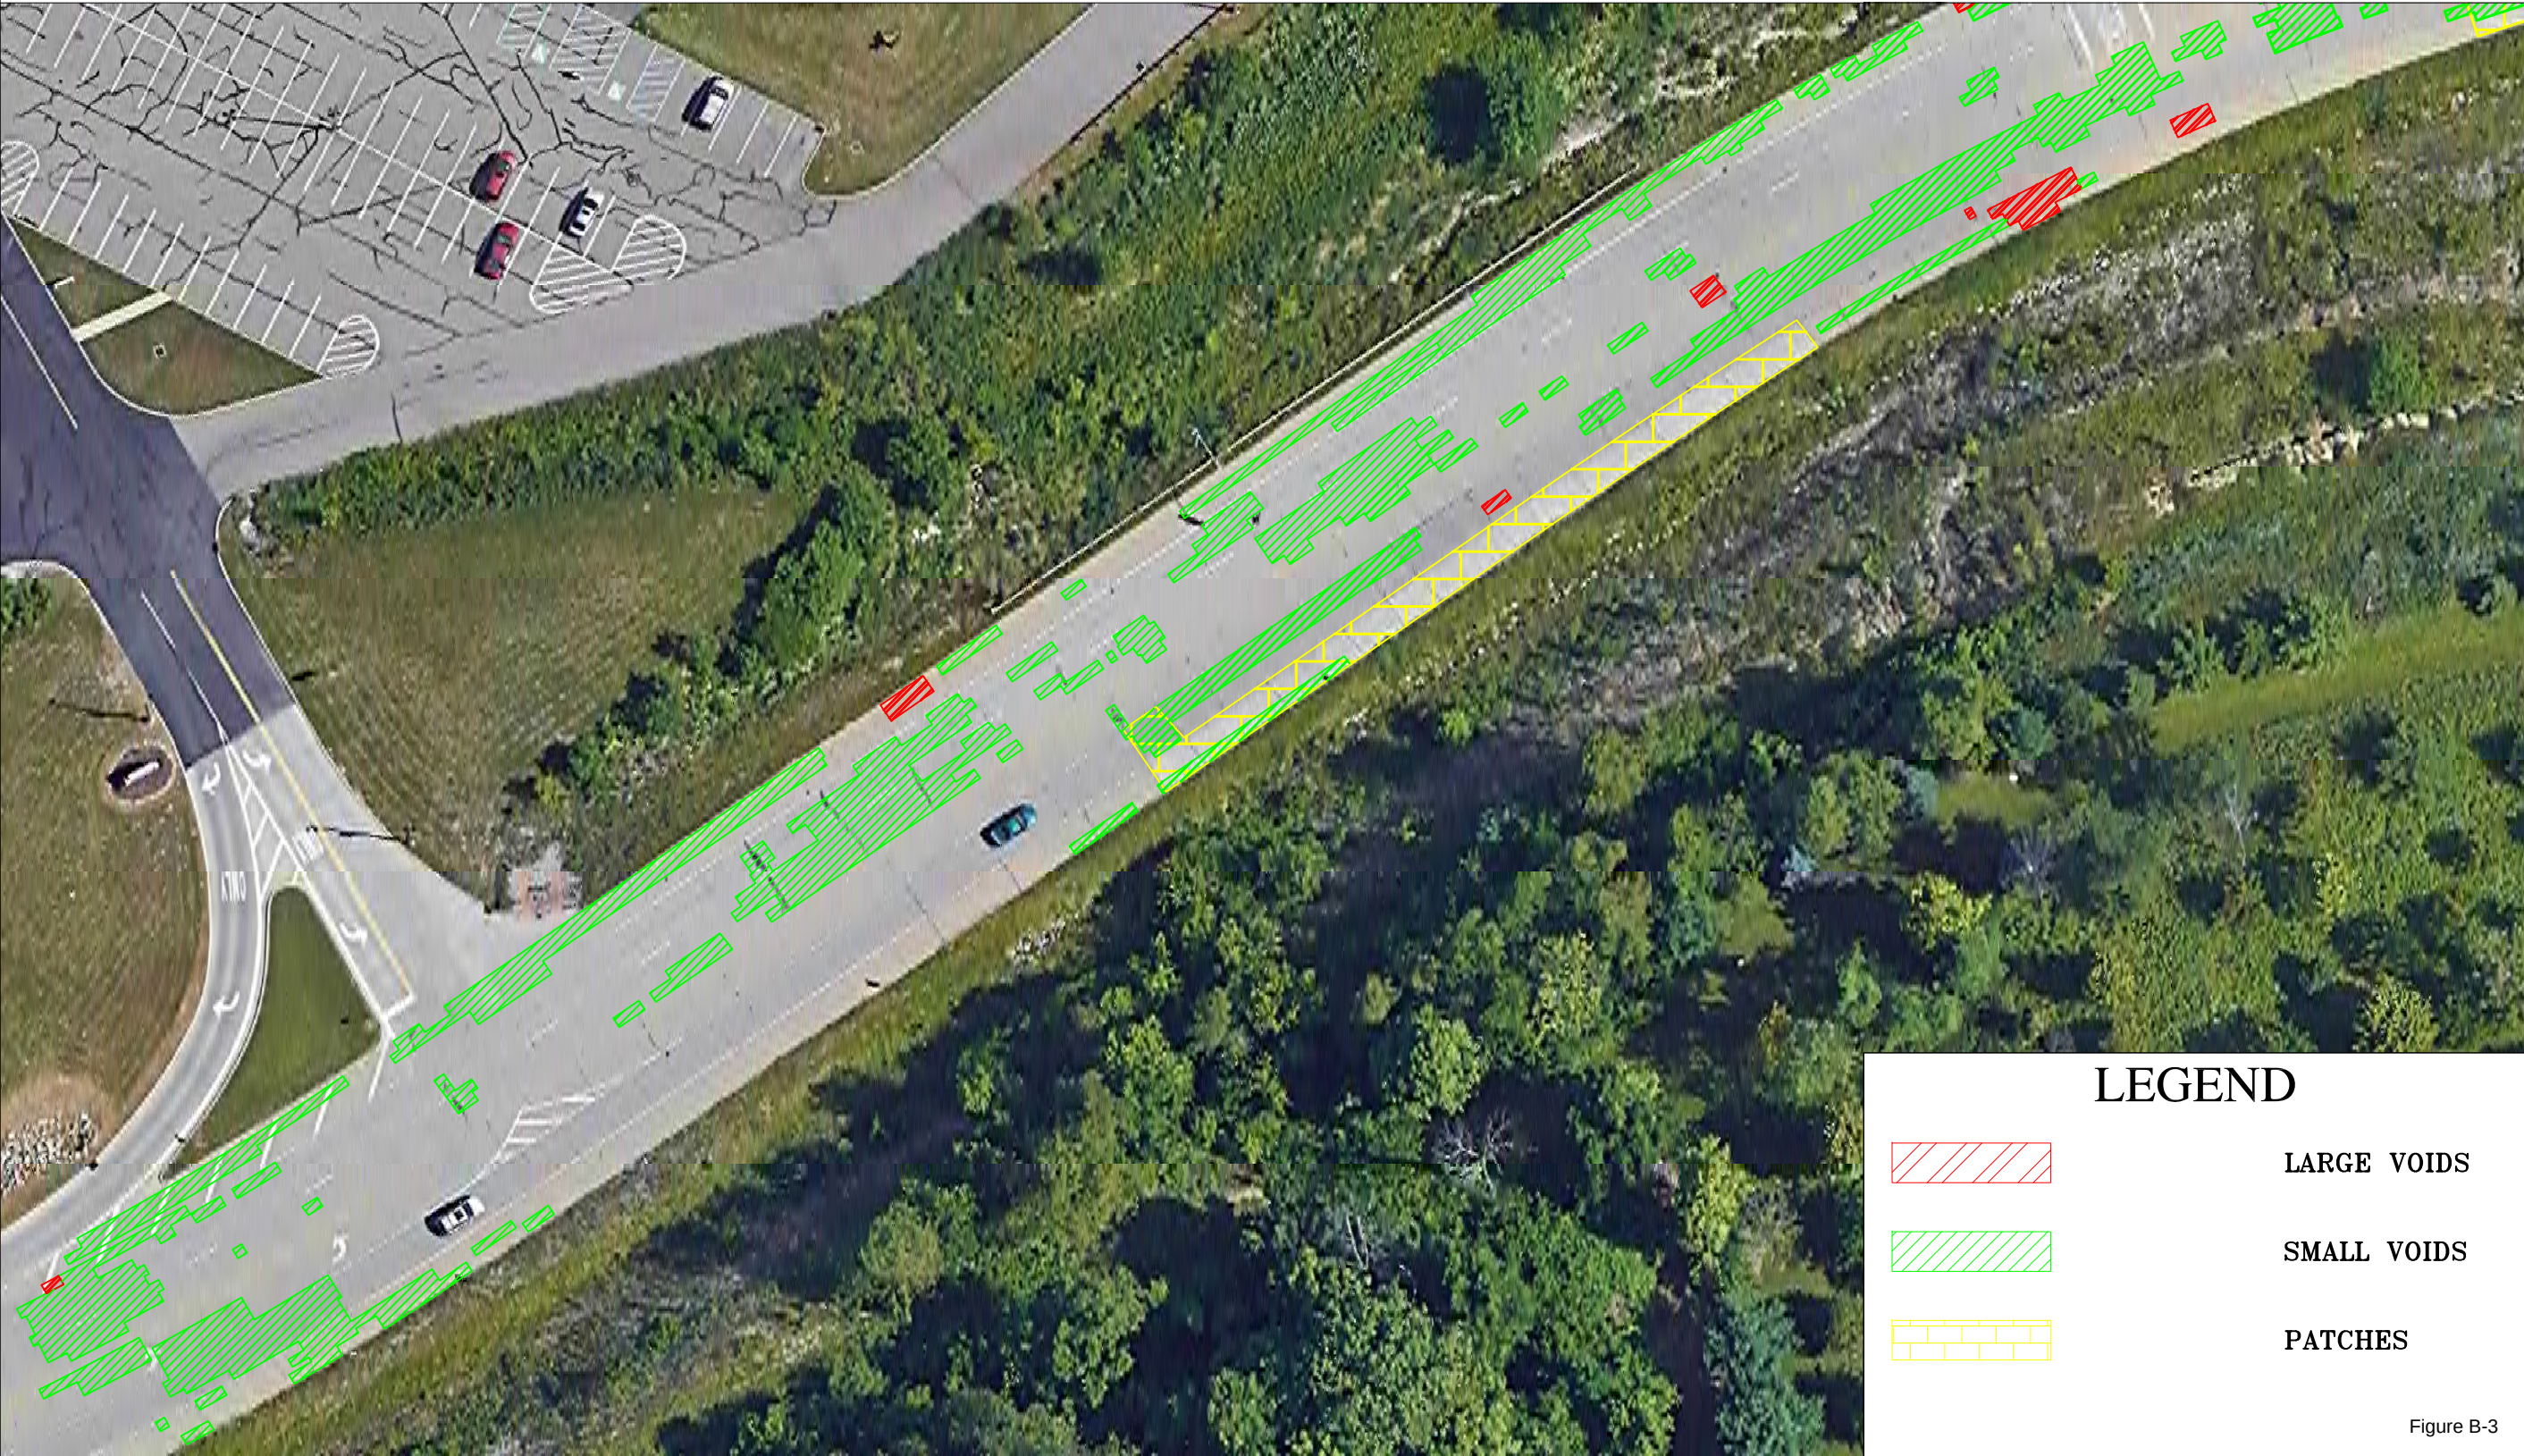
Figure B-2

GPR VOID MAP  
JOHN SCOTT HIGHWAY  
FROM KINGSTON AVE TO SR 22 ON RAMP  
JEFFERSON COUNTY  
STATE OF OHIO

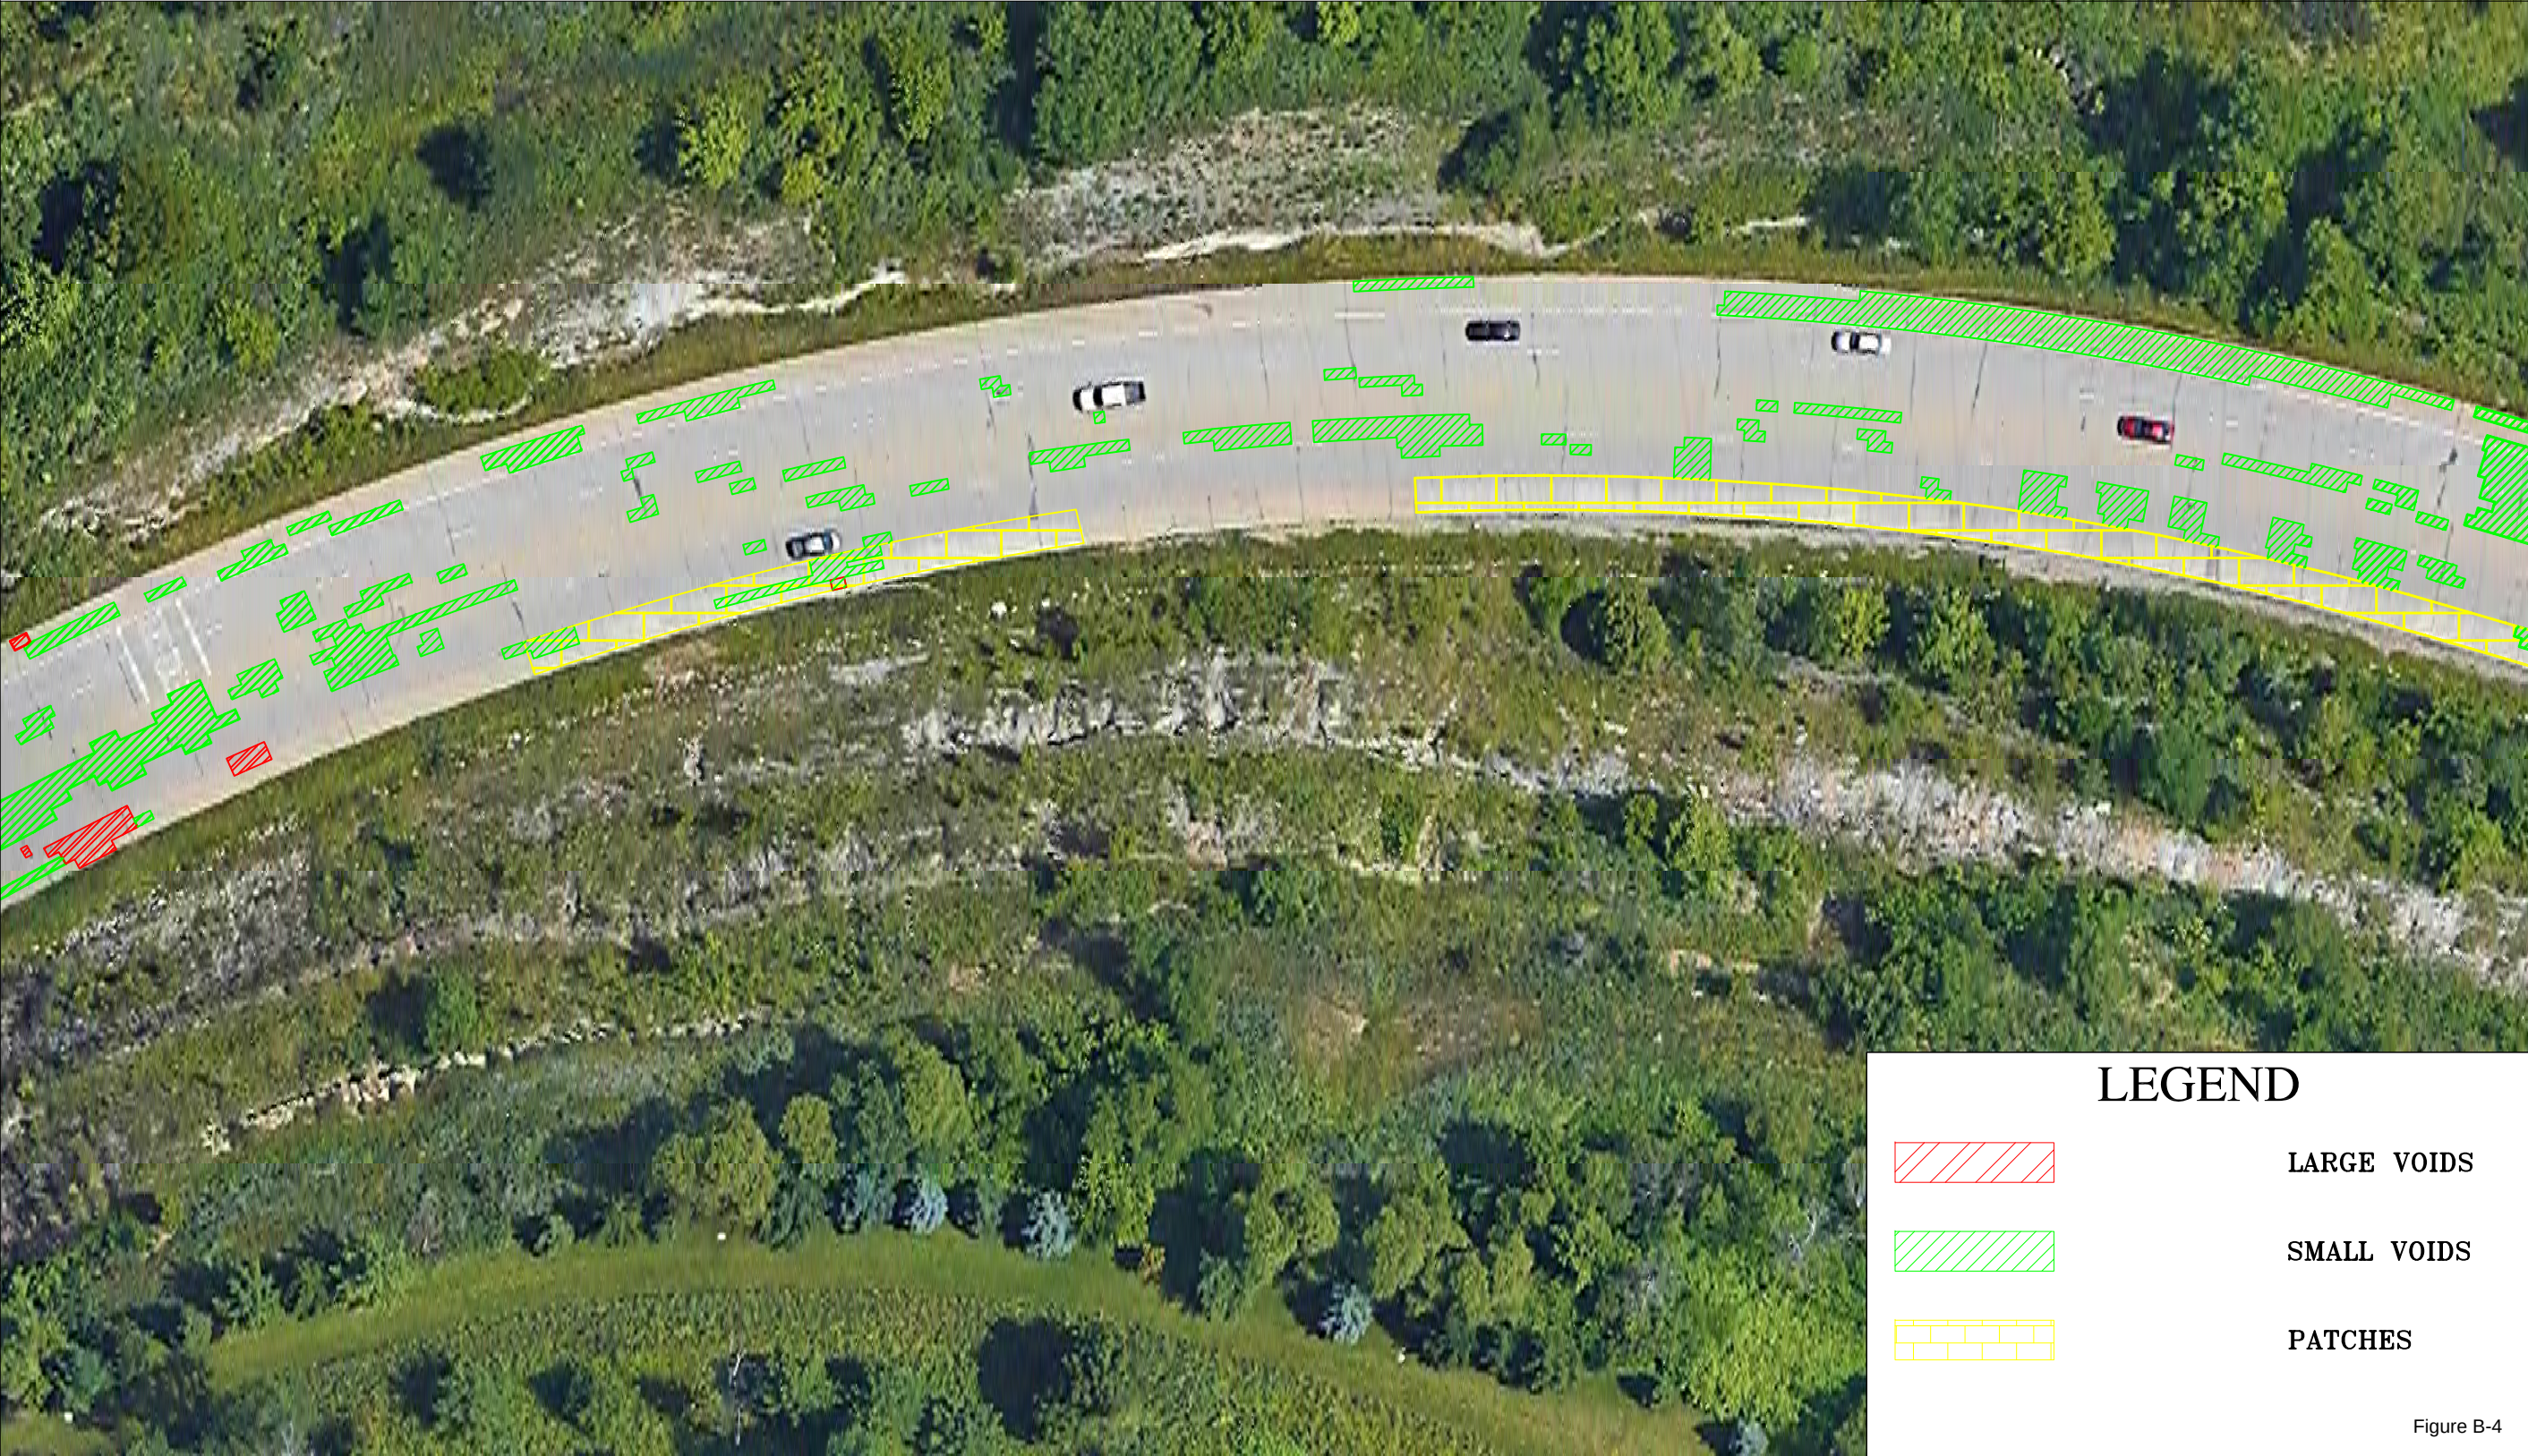
Figure B-3

GPR VOID MAP  
JOHN SCOTT HIGHWAY  
FROM KINGSTON AVE TO SR 22 ON RAMP  
JEFFERSON COUNTY  
STATE OF OHIO

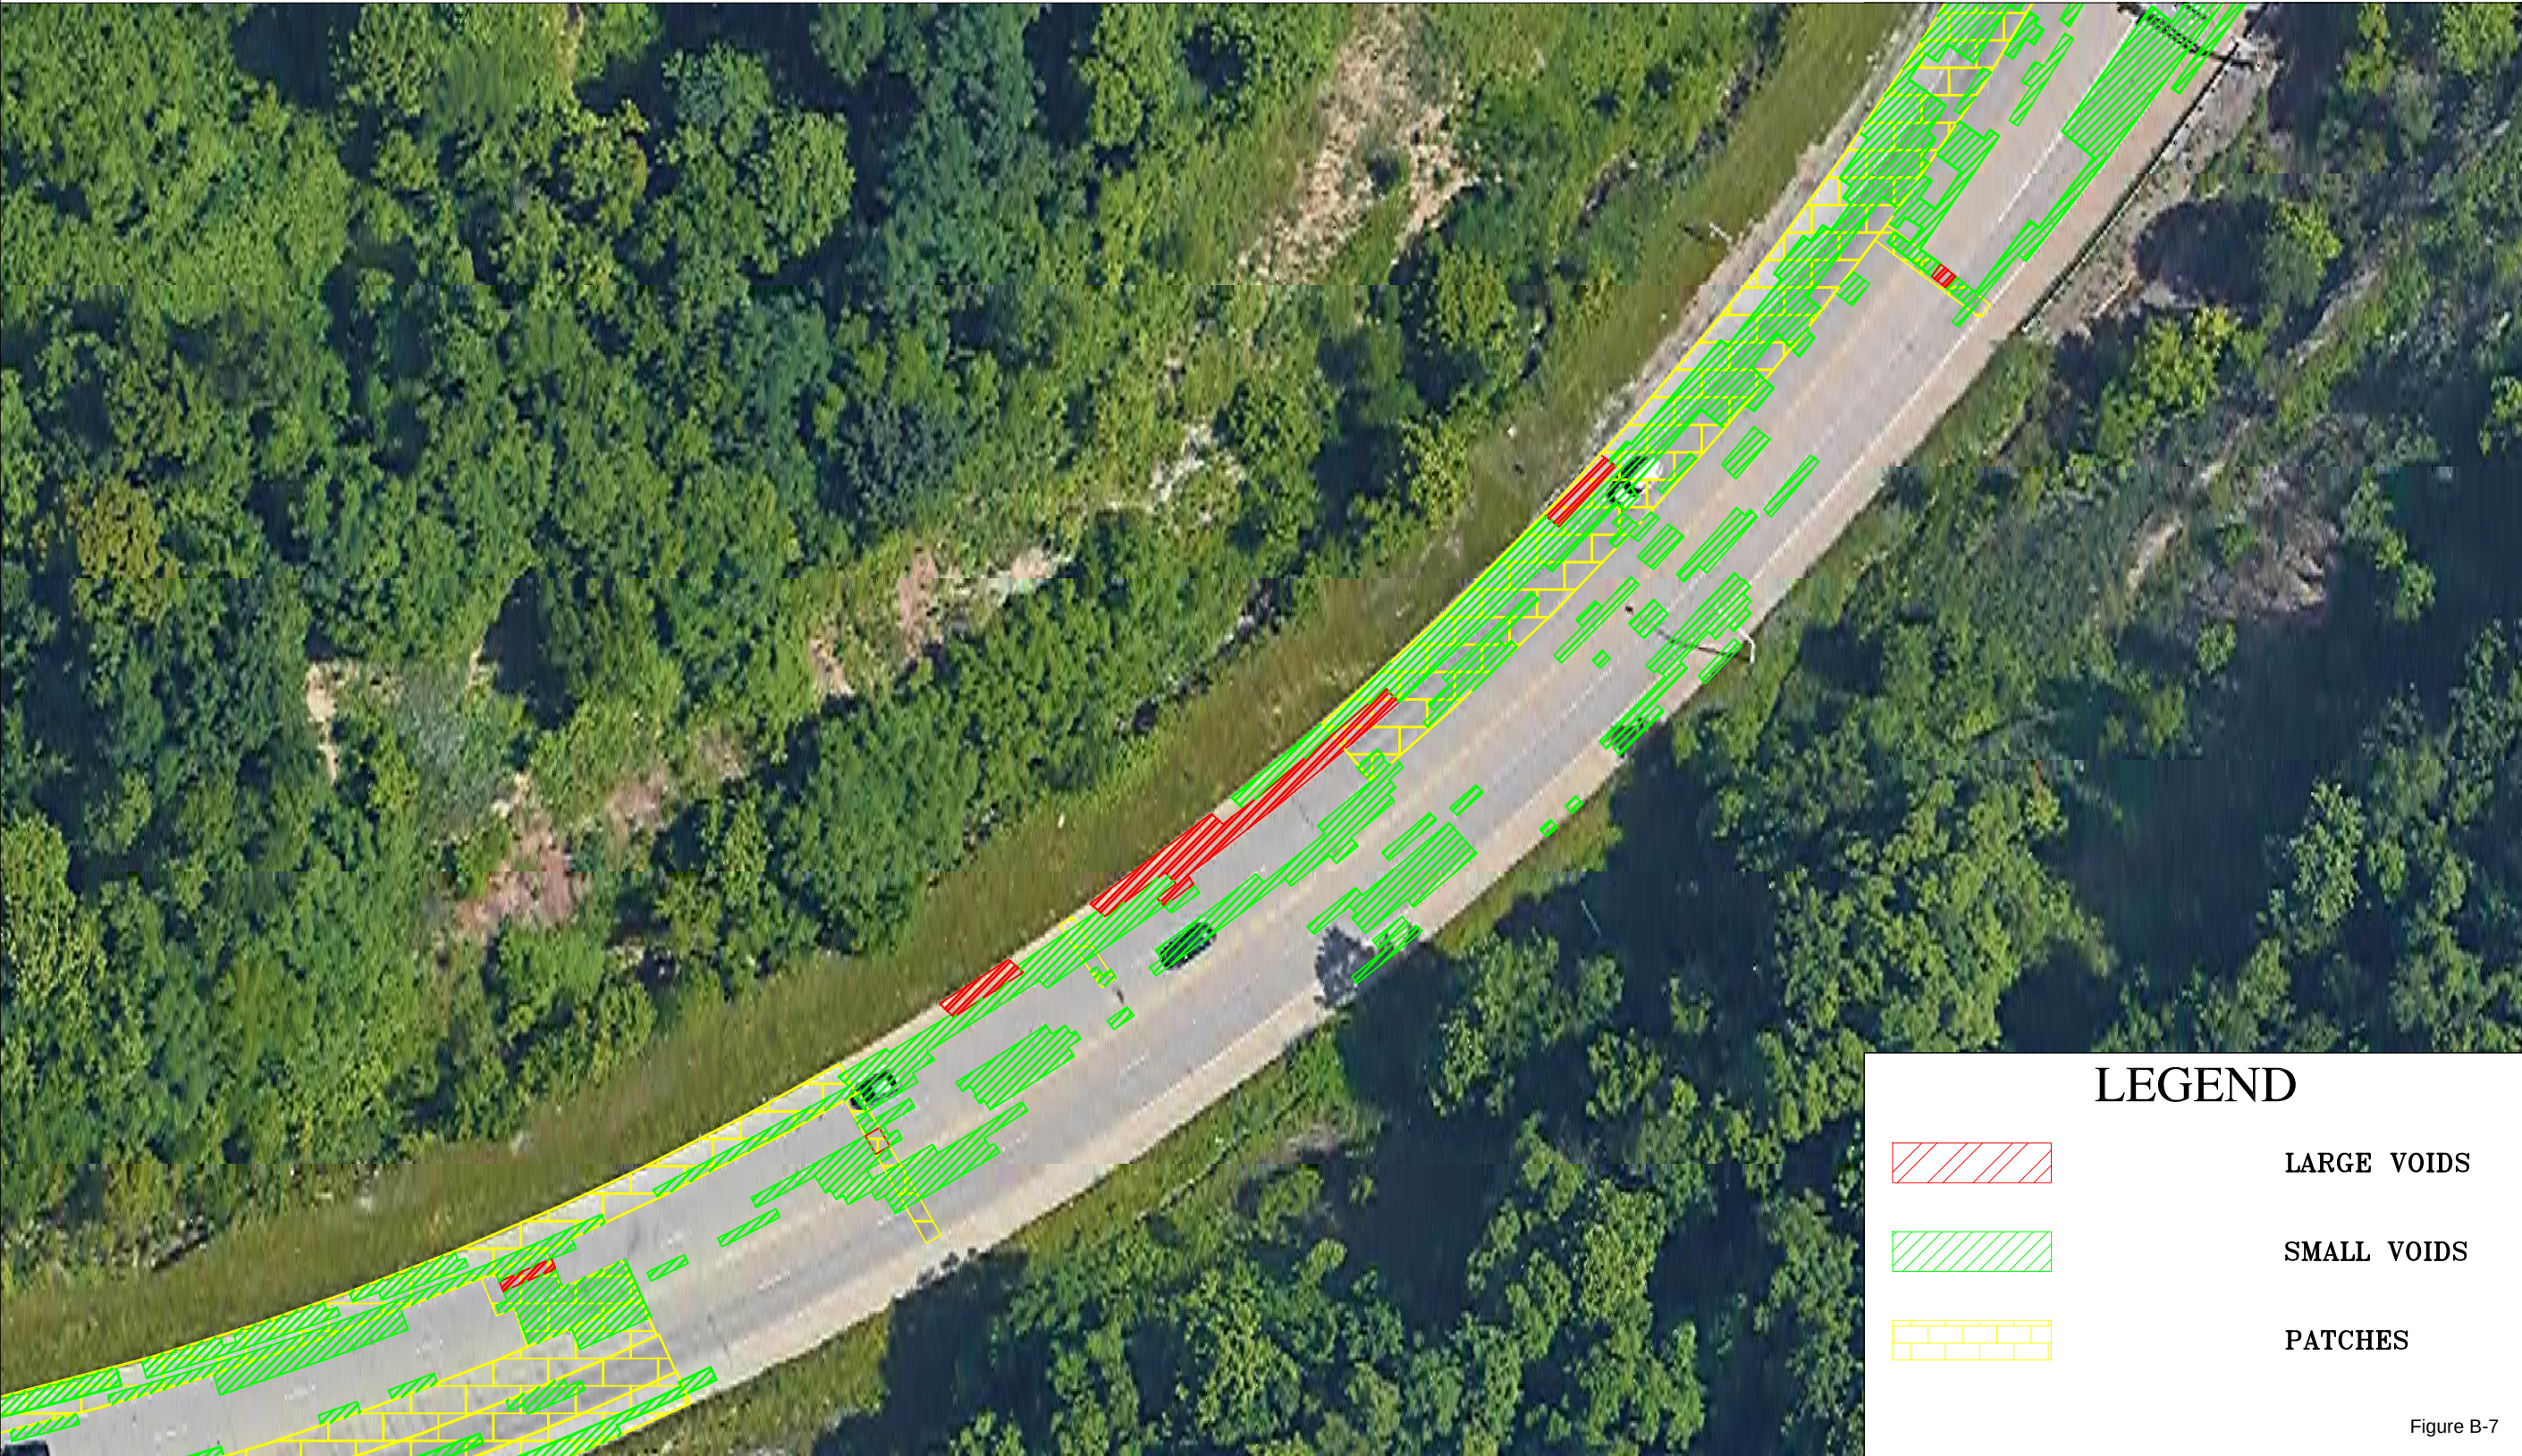
Figure B-6

GPR VOID MAP  
JOHN SCOTT HIGHWAY  
FROM KINGSTON AVE TO SR 22 ON RAMP  
JEFFERSON COUNTY  
STATE OF OHIO
