# John Scott Connector

## Rehabilitation and Reconstruction Study

Prepared for the City of Steubenville, Ohio

## John Scott Highway Pavement Evaluation Jefferson County, Ohio

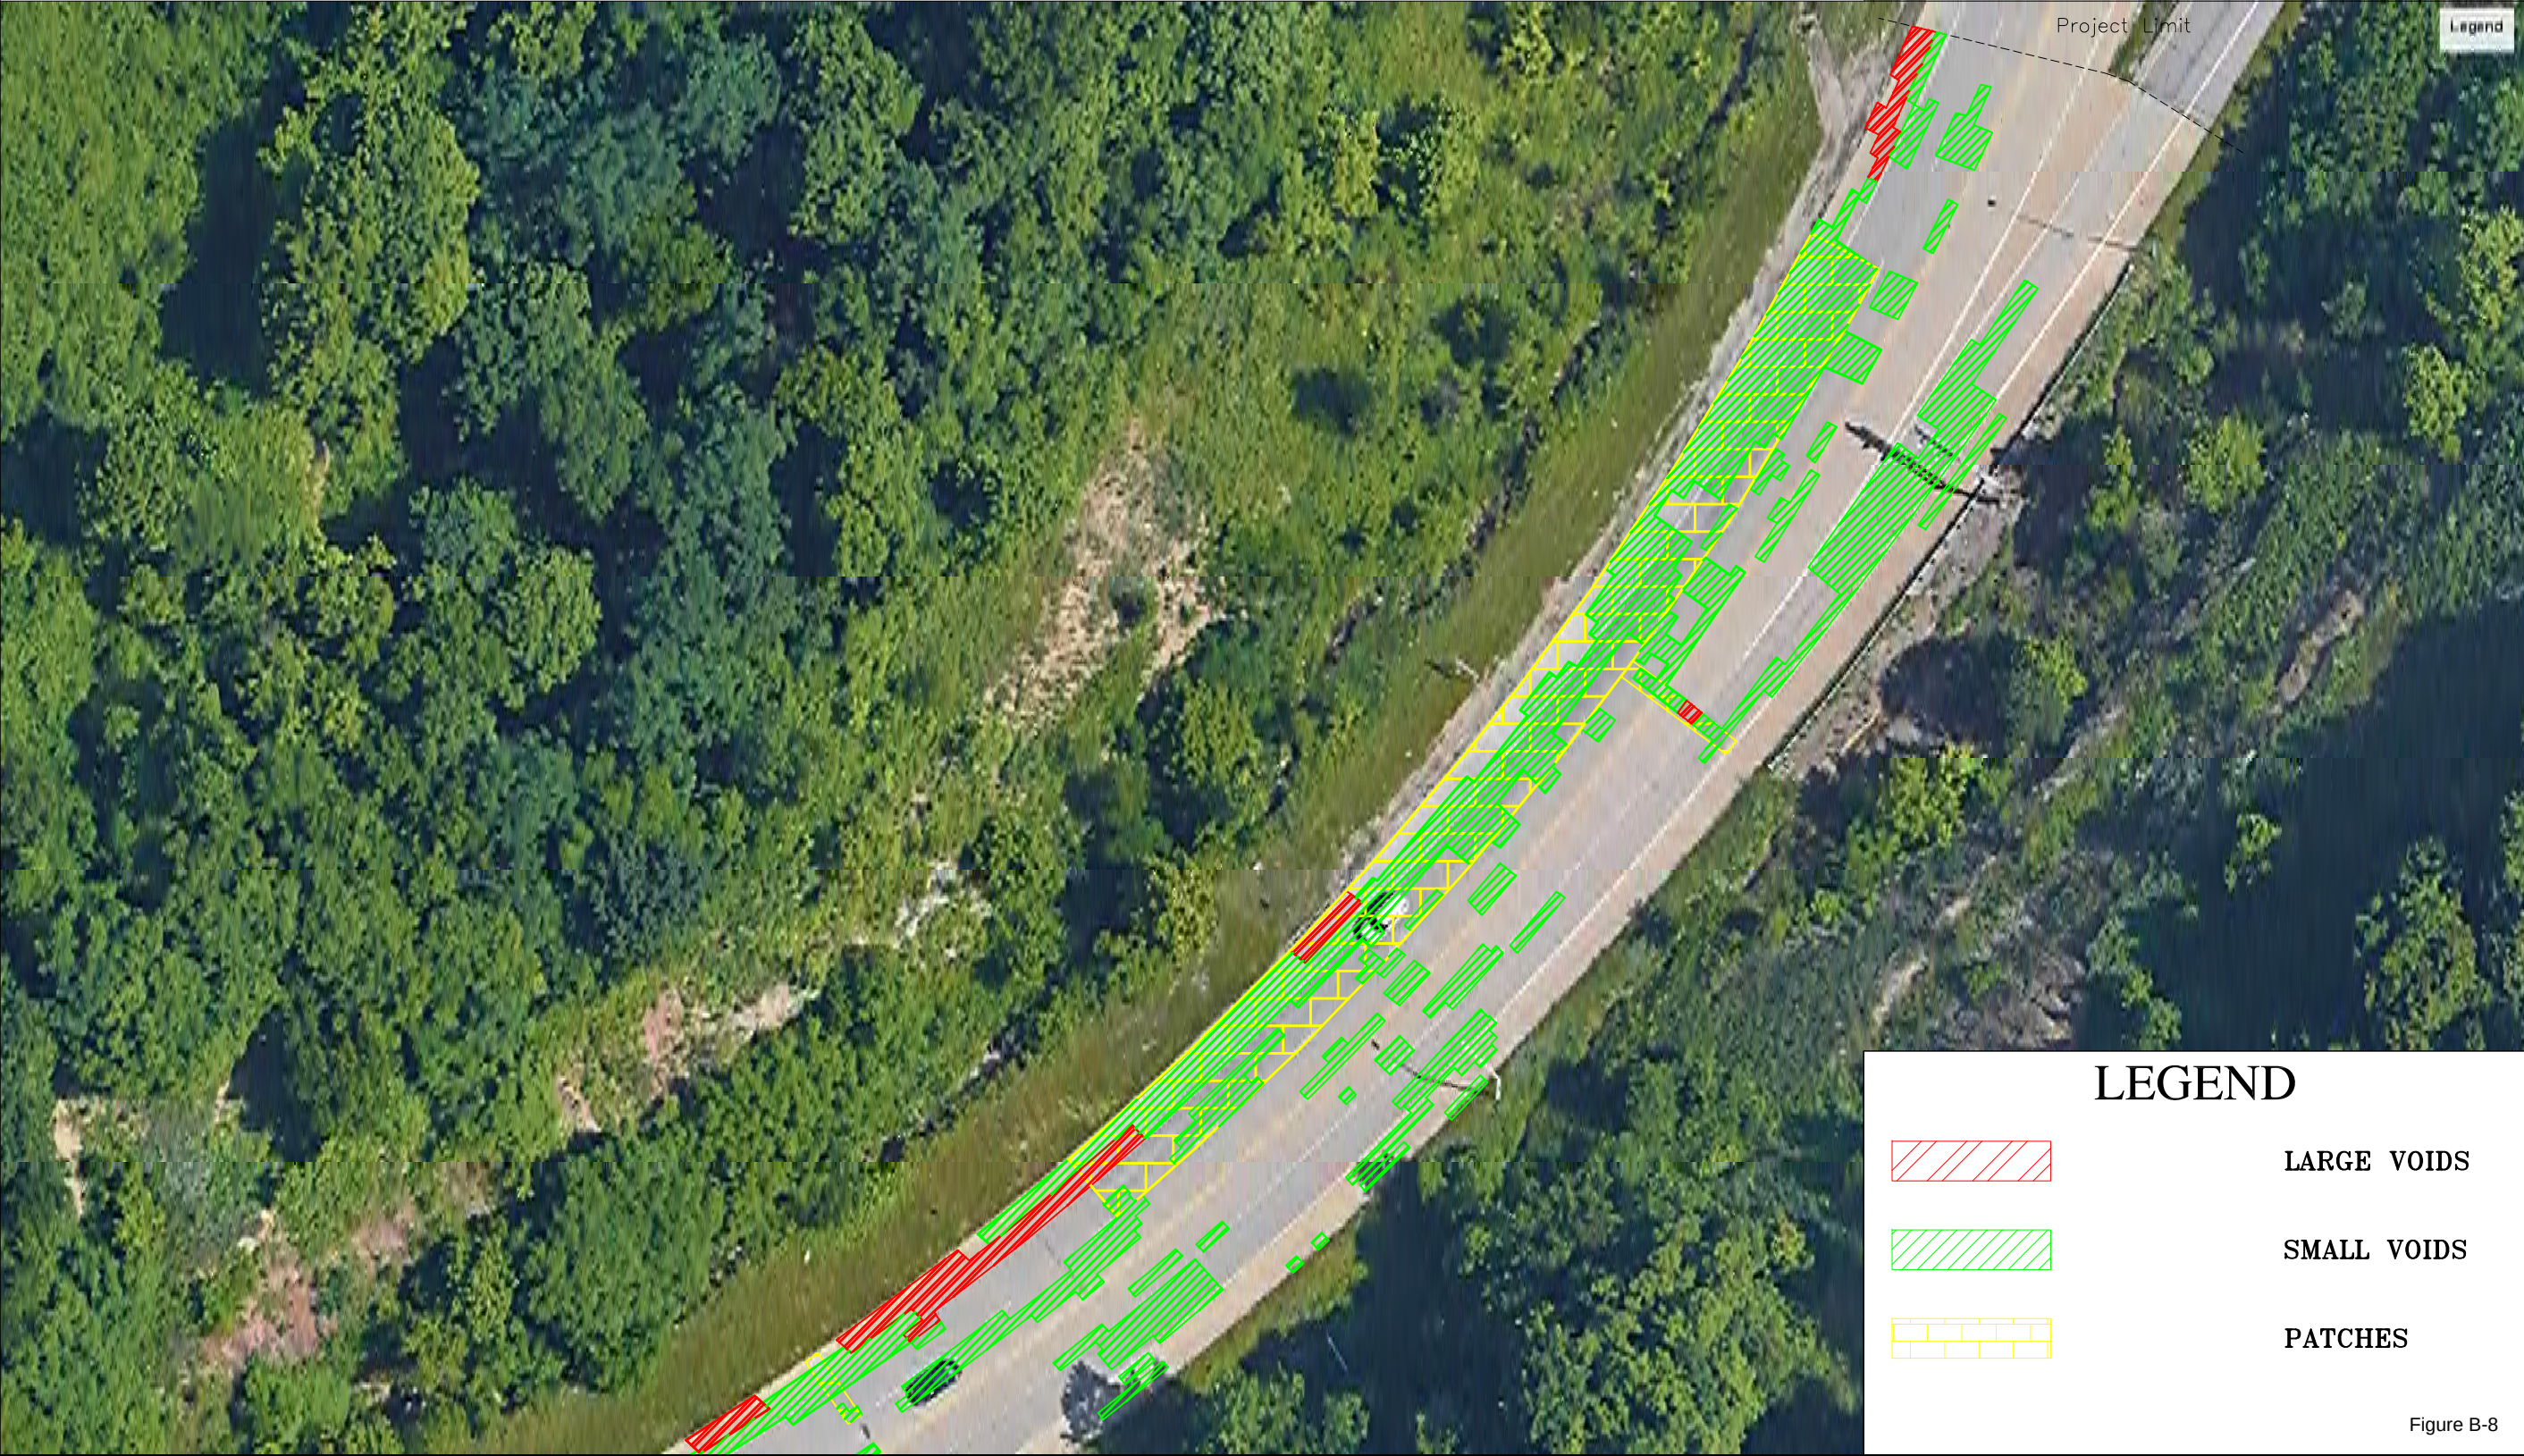
Figure B-7

GPR VOID MAP  
JOHN SCOTT HIGHWAY  
FROM KINGSTON AVE TO SR 22 ON RAMP  
JEFFERSON COUNTY  
STATE OF OHIO
