Cellular West Approach 1800930

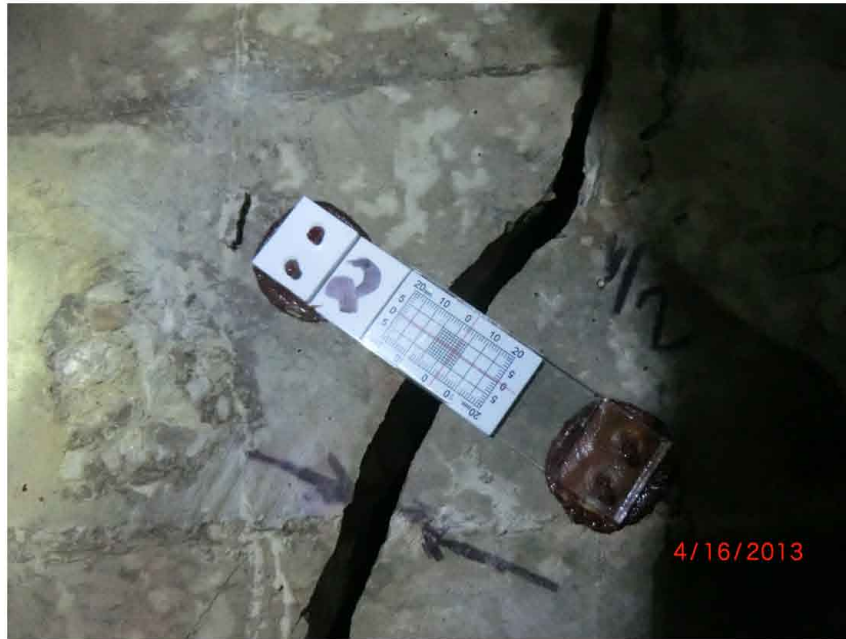
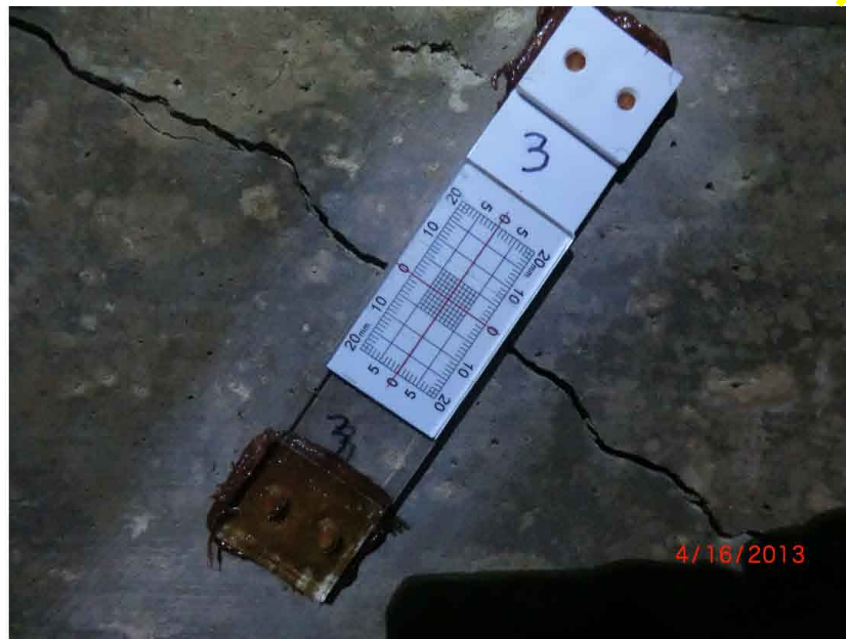
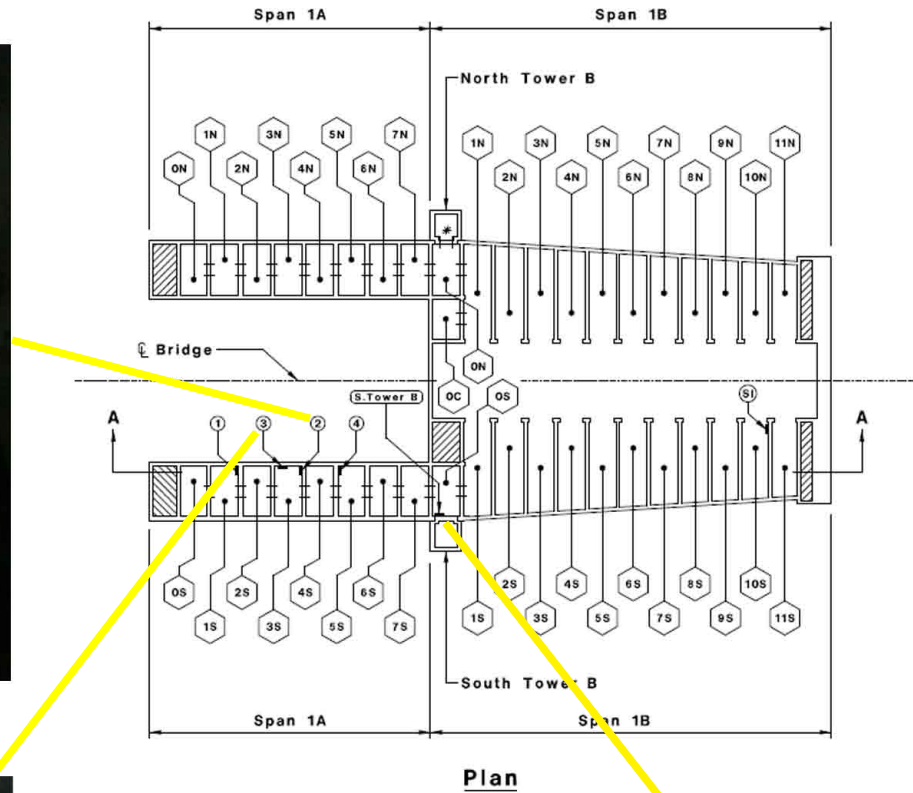
Slightly over 2 mm of growth in crack width over 6 years for Gauge 2, a N/S oriented wall. No growth in Gauge 3, a E/W oriented wall.

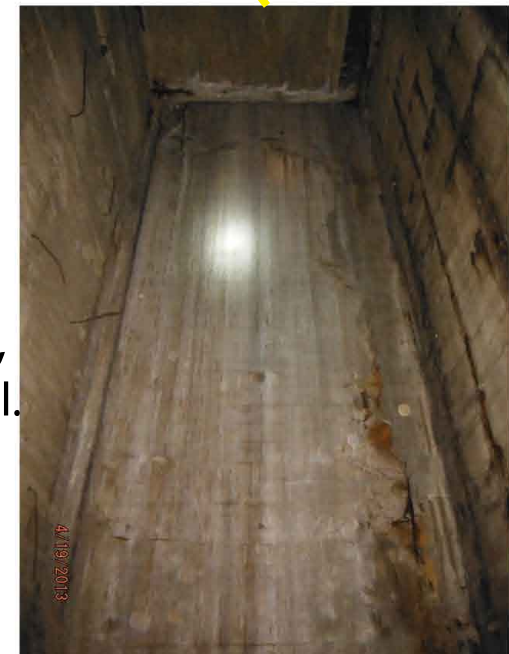
Large crack in wall behind Tower B
