Formal Study, CUY-82 (3.00-3.60) 2010 Safety Analyst Rank #25 and #41 Non-Freeway Locations

Ohio Department of Transportation, District 12
Office of Planning and Engineering
5500 Transportation Boulevard
Garfield Heights, OH 44125
(216) 584-2102
July 31, 2012

The State Route 82 (Royalton Road) corridor from the northbound entrance ramp of Interstate Route 71 to 400 feet east of Ordner Drive was selected for a formal traffic study due to the high occurrences of crashes. The area encompassed by the study had 289 crashes occur between mile post 2.70 and mile post 3.70 from 2008 to 2010. The corridor is comprised of 6 signalized intersections and no unsignalized intersections. The most critical intersection included in the study is the Howe Road and SR 82 intersection which was analyzed due a high frequency of crashes occurring in and around the intersection.

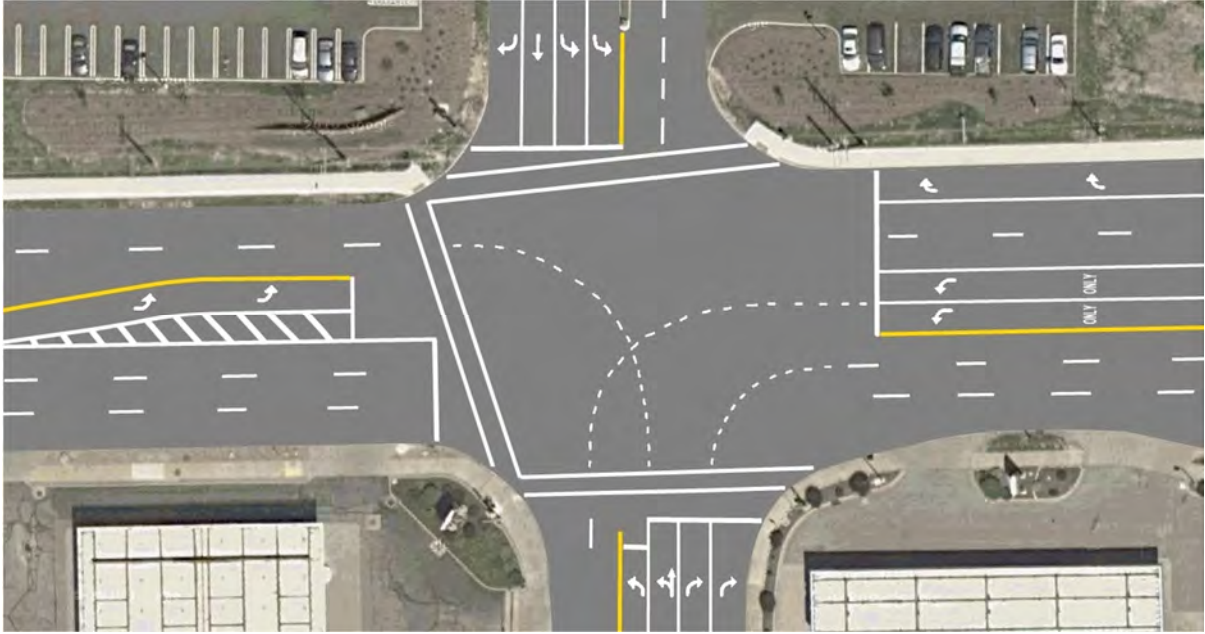
Figure 2. Plan view of Howe Rd. and State Route 82, showing existing lane use.

The SR 82 and Howe Road intersection is a four legged intersection with SR 82 running west to east, Howe Road at the south approach, and the shopping area access drive at the north approach. Left lanes are provided on all four approaches. Specifically, the east approach of SR 82 and the northern shopping area exit have two dedicated left turn lanes, while the Howe Road approach and west approach of SR 82 have one dedicated left turn. The Howe Road approach also has a shared-use lane which provides the opportunity for a left turn or through movement. The 2010 annual average daily traffic (AADT) for SR 82 at Howe Road is approximately 29,000 vehicles per day with 4% heavy vehicles. (ODOT Traffic Survey Report 2010.)

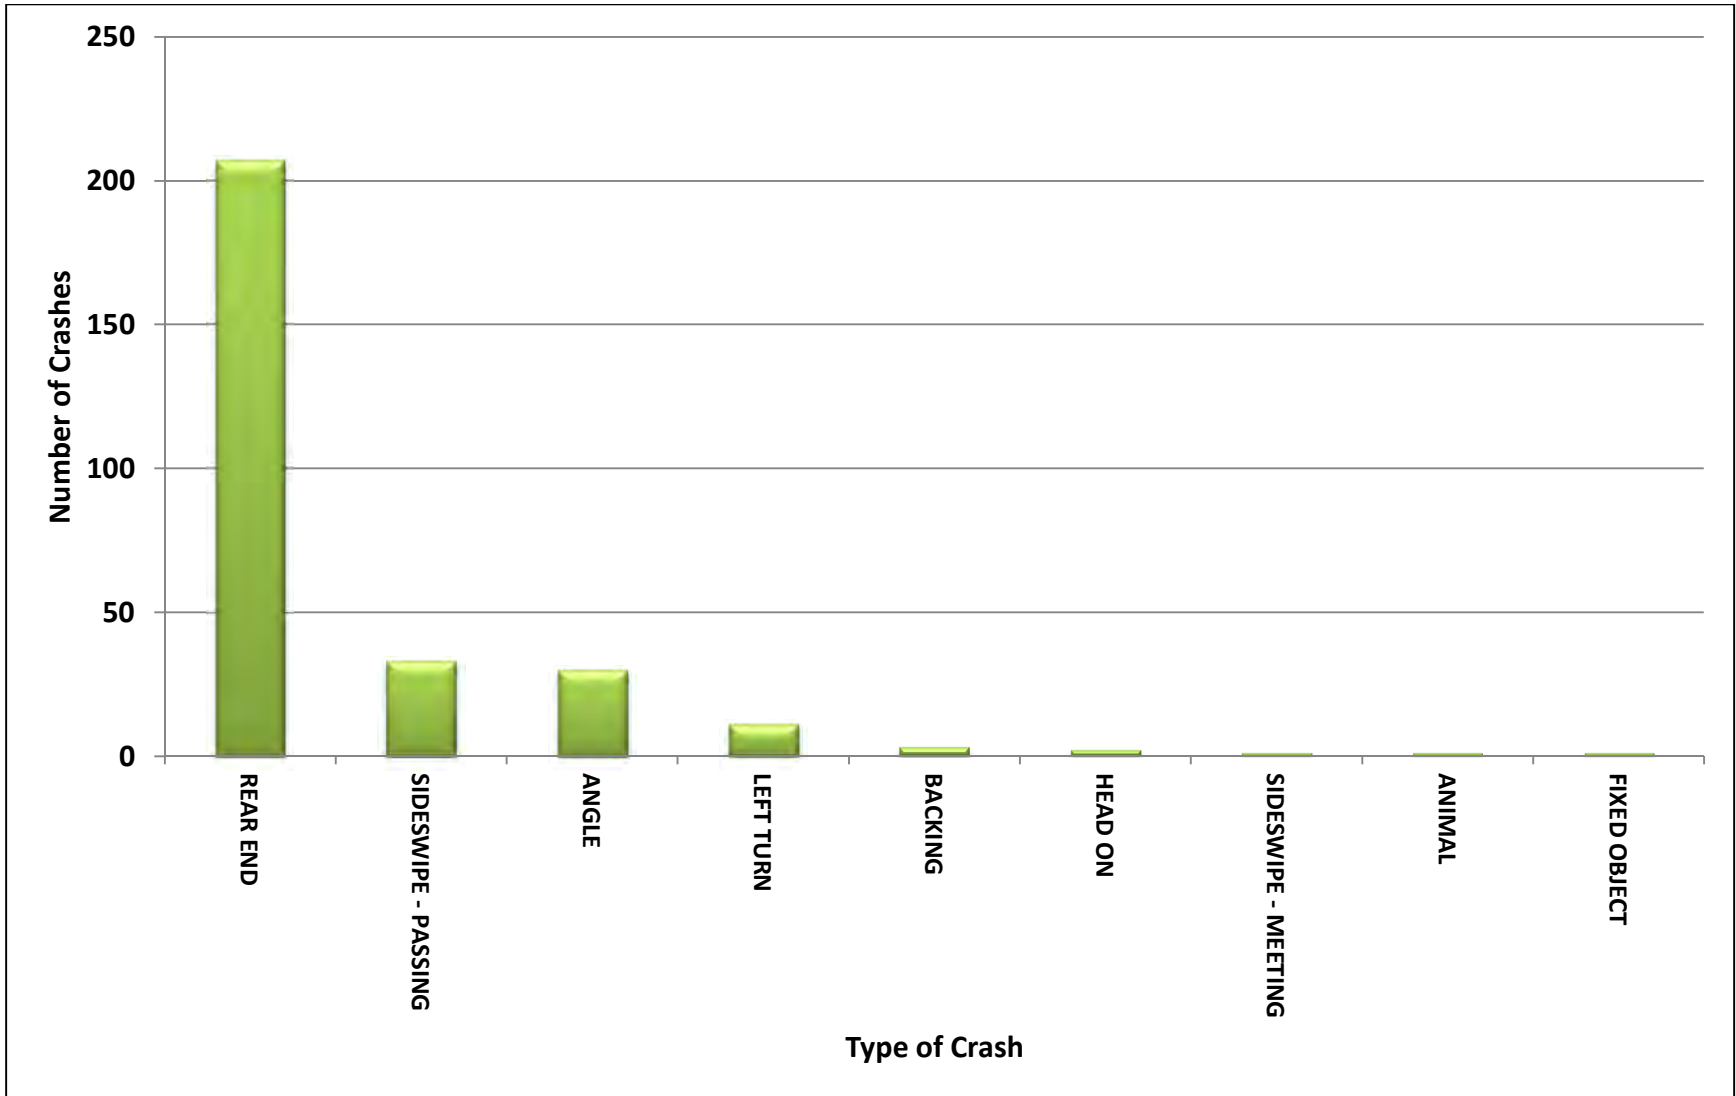
Figure 3. Frequency of Crashes by Type of Crash

Of the 289 total crashes in the area, 113 (39.0%) occurred at log points 3.2-3.3, corresponding with the intersection of S.R. 82 and Howe Rd. For this intersection area, rear end crashes were the most frequent type, consisting of a total of 74 crashes (65.5%). Of all the rear end occurrences, 35.7% were at log points 3.2-3.3, corresponding with the intersection of S.R. 82 and Howe Rd. Furthermore, 58.0% of the rear ends occurred within the immediate area surrounding the intersection of S.R. 82 and Howe Rd.

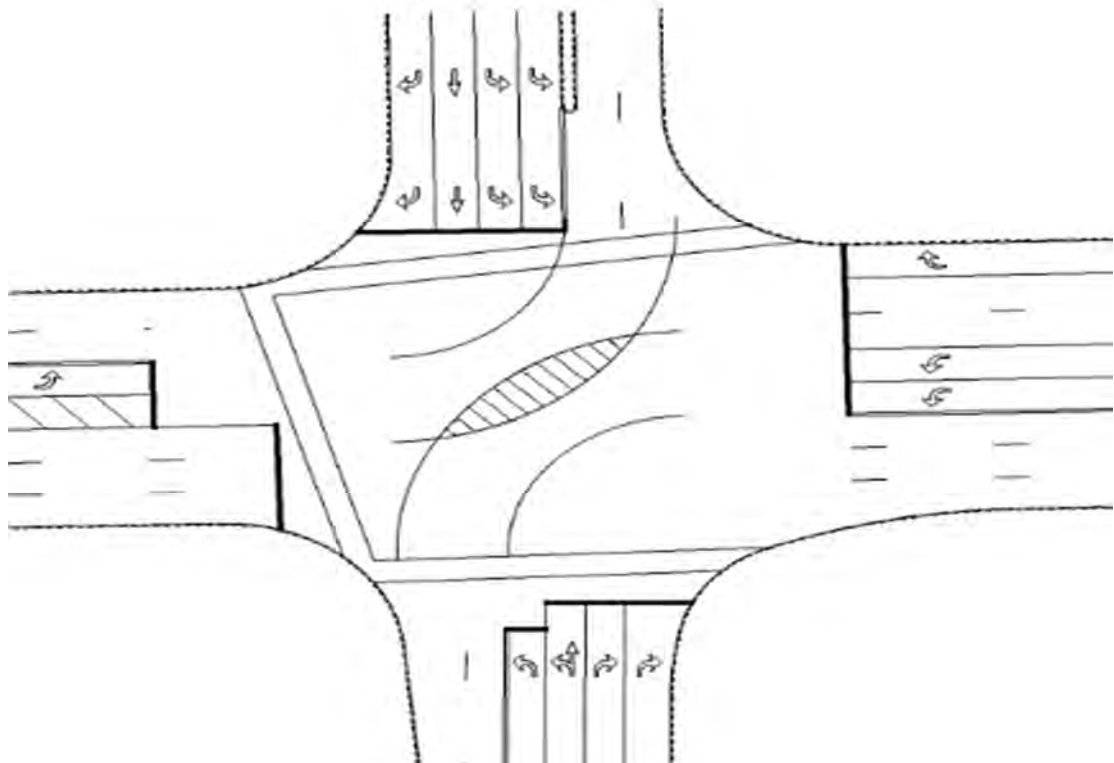
Figure 5. Double Lane Left Turn into Shopping Center North of Howe Rd.

A double lane left turn into the Shopping Center North of Howe Road was considered as a possible short term countermeasure. However, after referencing the Location and Design Manual Vol. 1 Figure 401-11E, it was determined that an extended throat width of 31 feet is required. Given the Double Lane Left on the opposite approach, the throat widths for the 2 movements crossed. A Lead/Lag left turn condition could be considered.

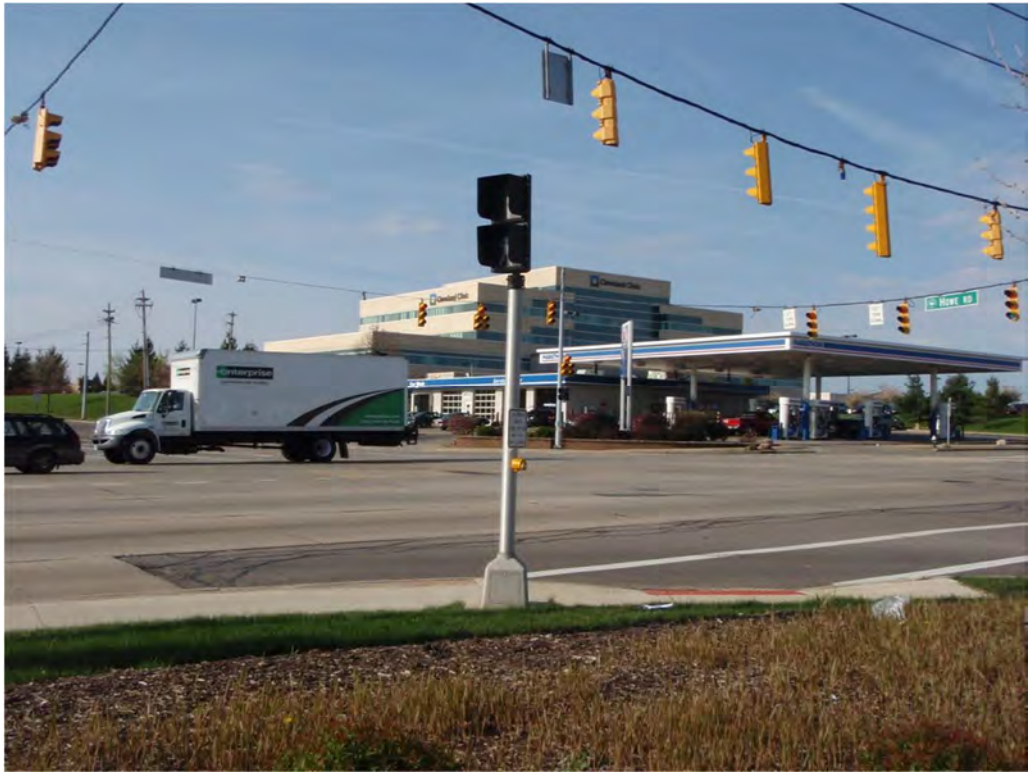
Photo 10. S.R. 82 and Howe Rd. rotated pedestrian head

4. Turn the pedestrian signal head located at the northeast corner of the Howe Rd. intersection so it is facing west in the direction of the crosswalk. See Photo 3 of the Appendix.

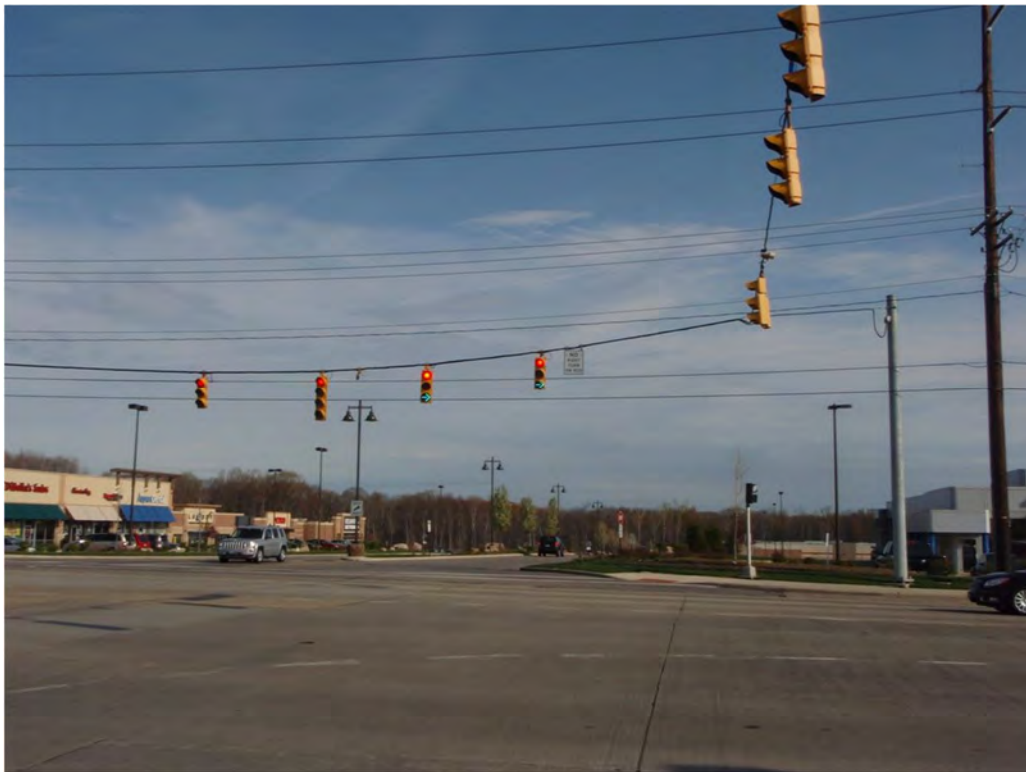
Photo 26. Red Ball and Green Arrow on Howe Rd., looking north

1. Eliminate Display of Red ball for Howe Road northbound right turn overlap. This signal indication violates driver expectation and is not permitted by the Ohio Manual of Uniform Traffic Control Devices (OMUTCD) as it further conflicts with the No Right Turn on Red Sign (R10-11b) posted next to the signal head. See Photos 19 and 20 of the Appendix.
