**CUY-90-14.90**

**PID 82119**

**APPENDIX GE-09**

**Soil Profile  
(Reference Document)**

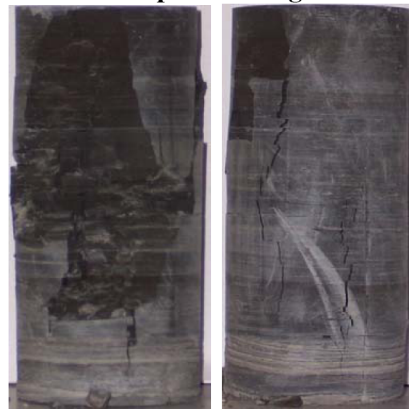
**Final Specimen Figure**

Unconfined Compressive Strength (psi): 3425  
Strain (%): 1.6

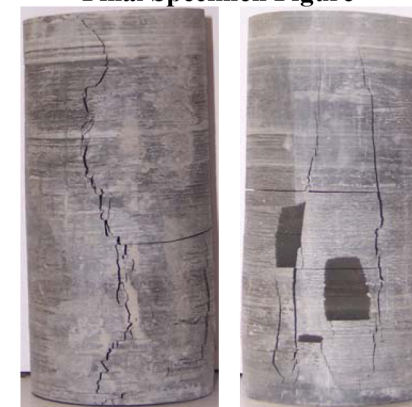
**Final Specimen Figure**

Unconfined Compressive Strength (psi): 2310  
Strain (%): 1.1

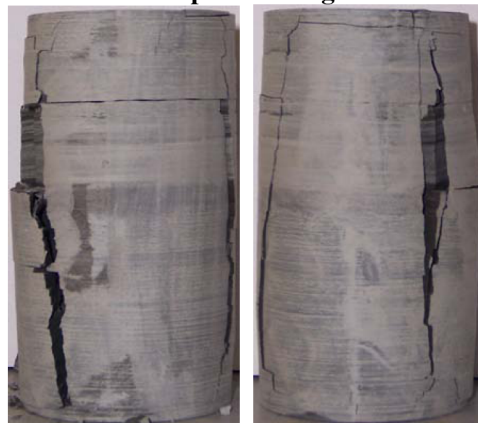
**Final Specimen Figure**

Unconfined Compressive Strength (psi): 2179  
Strain (%): 1.3

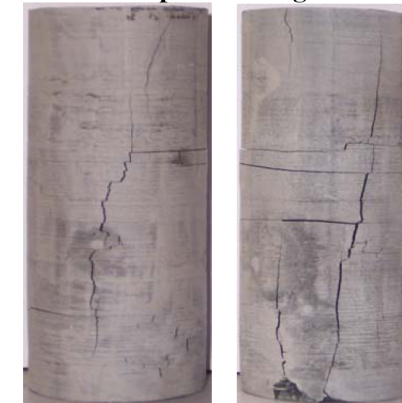
**Final Specimen Figure**

Unconfined Compressive Strength (psi): 1656  
Strain (%): 1.2

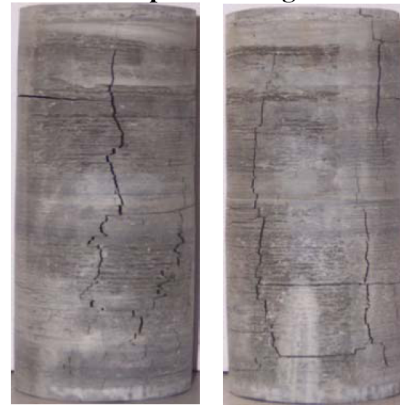
**Final Specimen Figure**

Unconfined Compressive Strength (psi): 1305  
Strain (%): 1.7

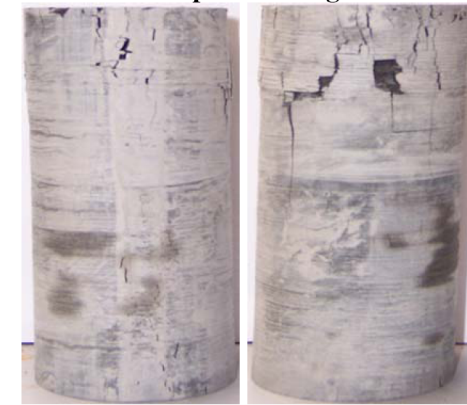
**Final Specimen Figure**

Unconfined Compressive Strength (psi): 1771  
Strain (%): 2.0

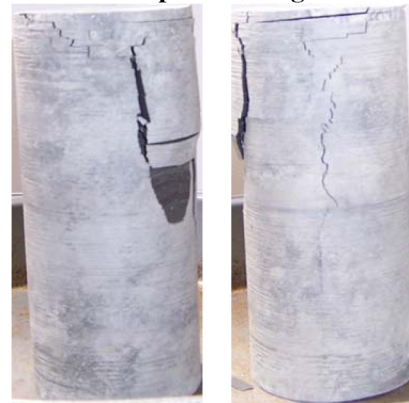
**Final Specimen Figure**

Unconfined Compressive Strength (psi): 1374  
Strain (%): 0.6

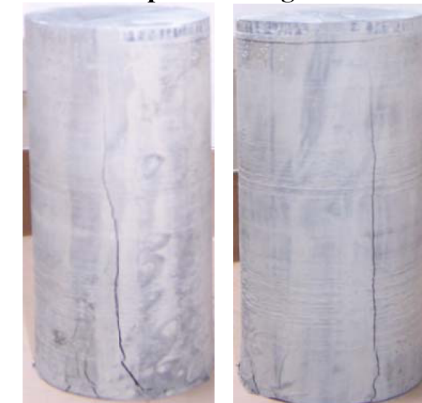
**Final Specimen Figure**

Unconfined Compressive Strength (psi): 2246  
Strain (%): 1.5

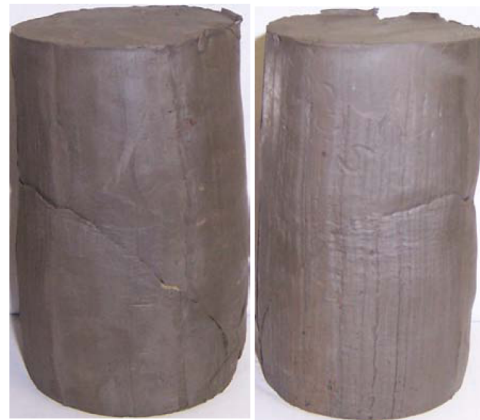
**Final Specimen Figure**

Unconfined Compressive Strength (psf): **1876.2**  
Strain (%): **13.5**

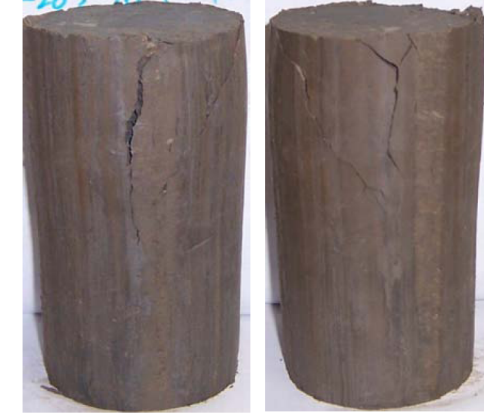
**Final Specimen Figure**

Unconfined Compressive Strength (psf): **6042.7**  
Strain (%): **7.5**
