CORRIDOR SAFETY STUDY

CUY-43-10.61 (PID 85360)

Broadway Avenue to Warrensville Heights Corporation Line

City of Cleveland, Cuyahoga County, Ohio

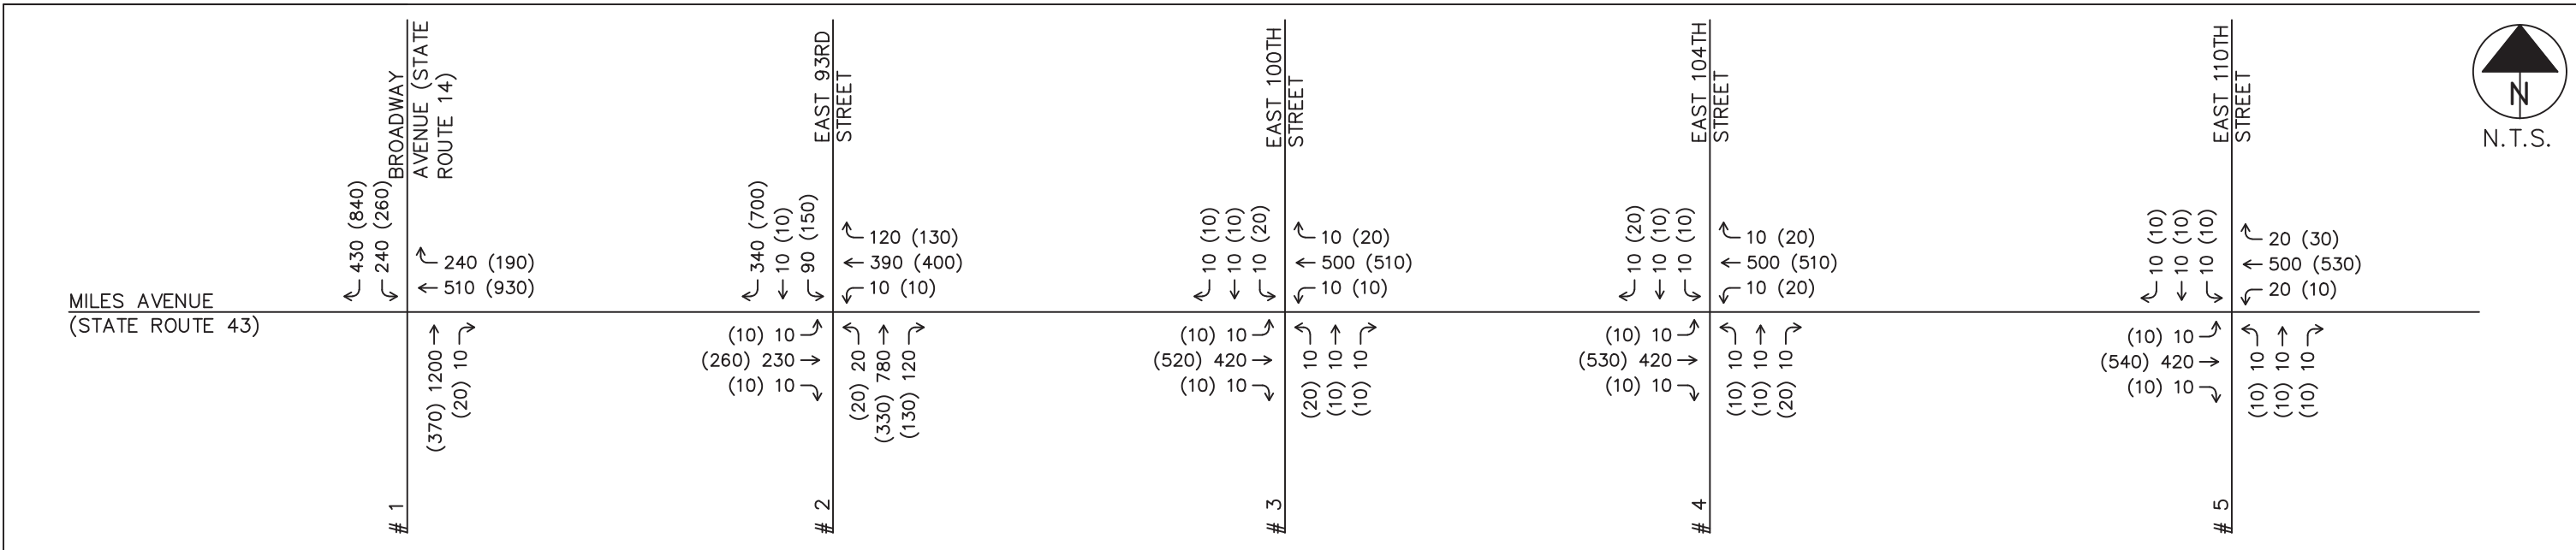
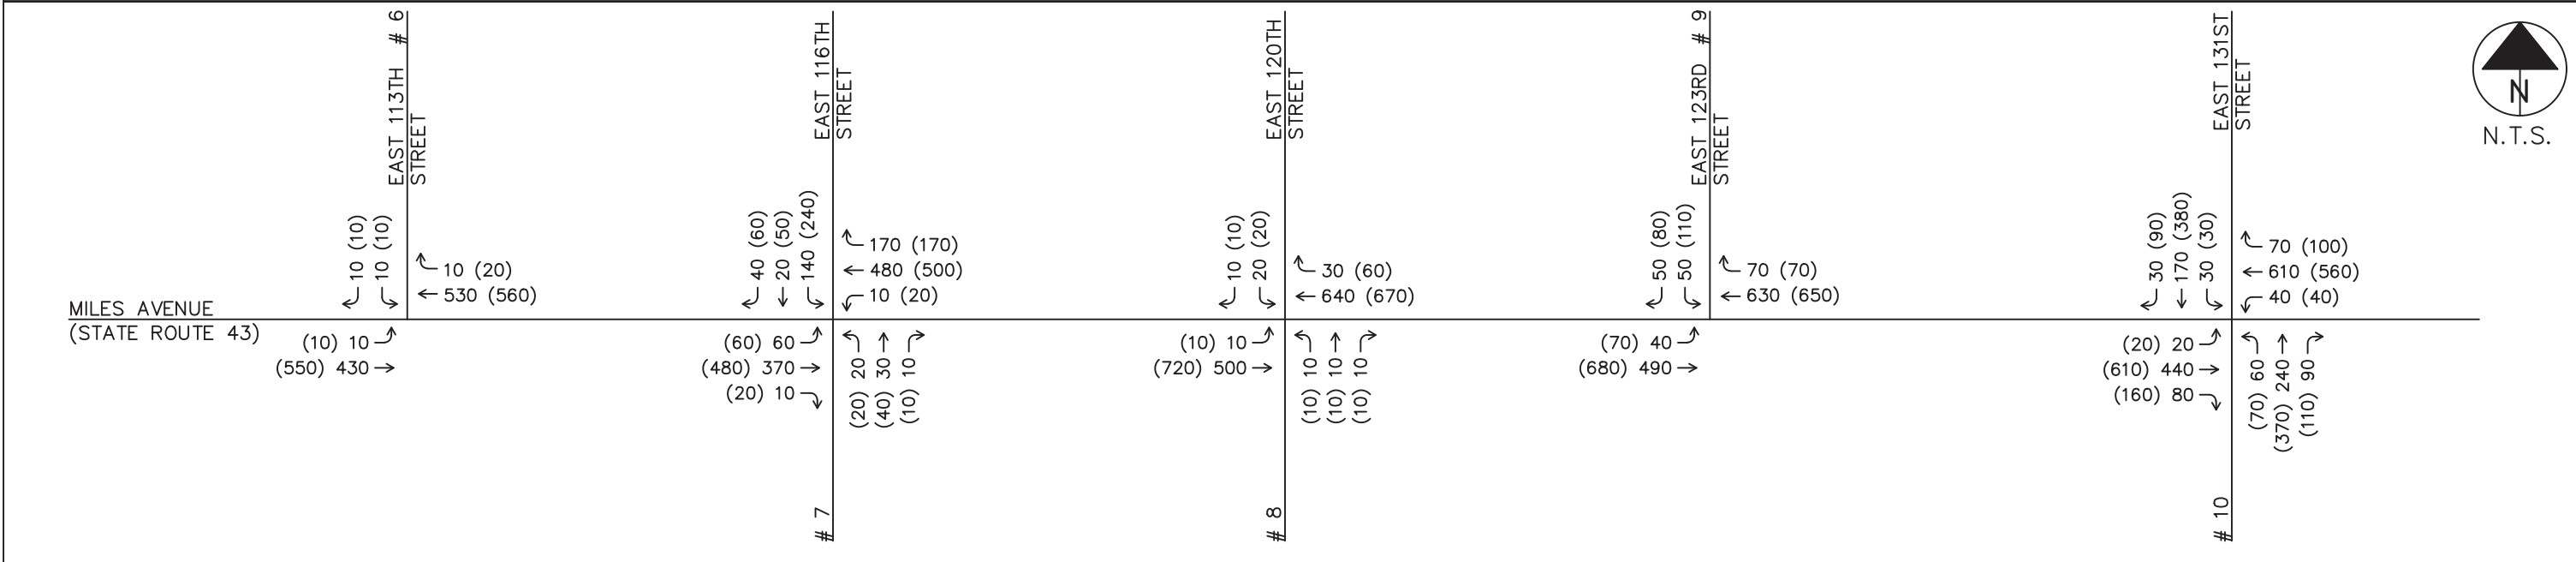
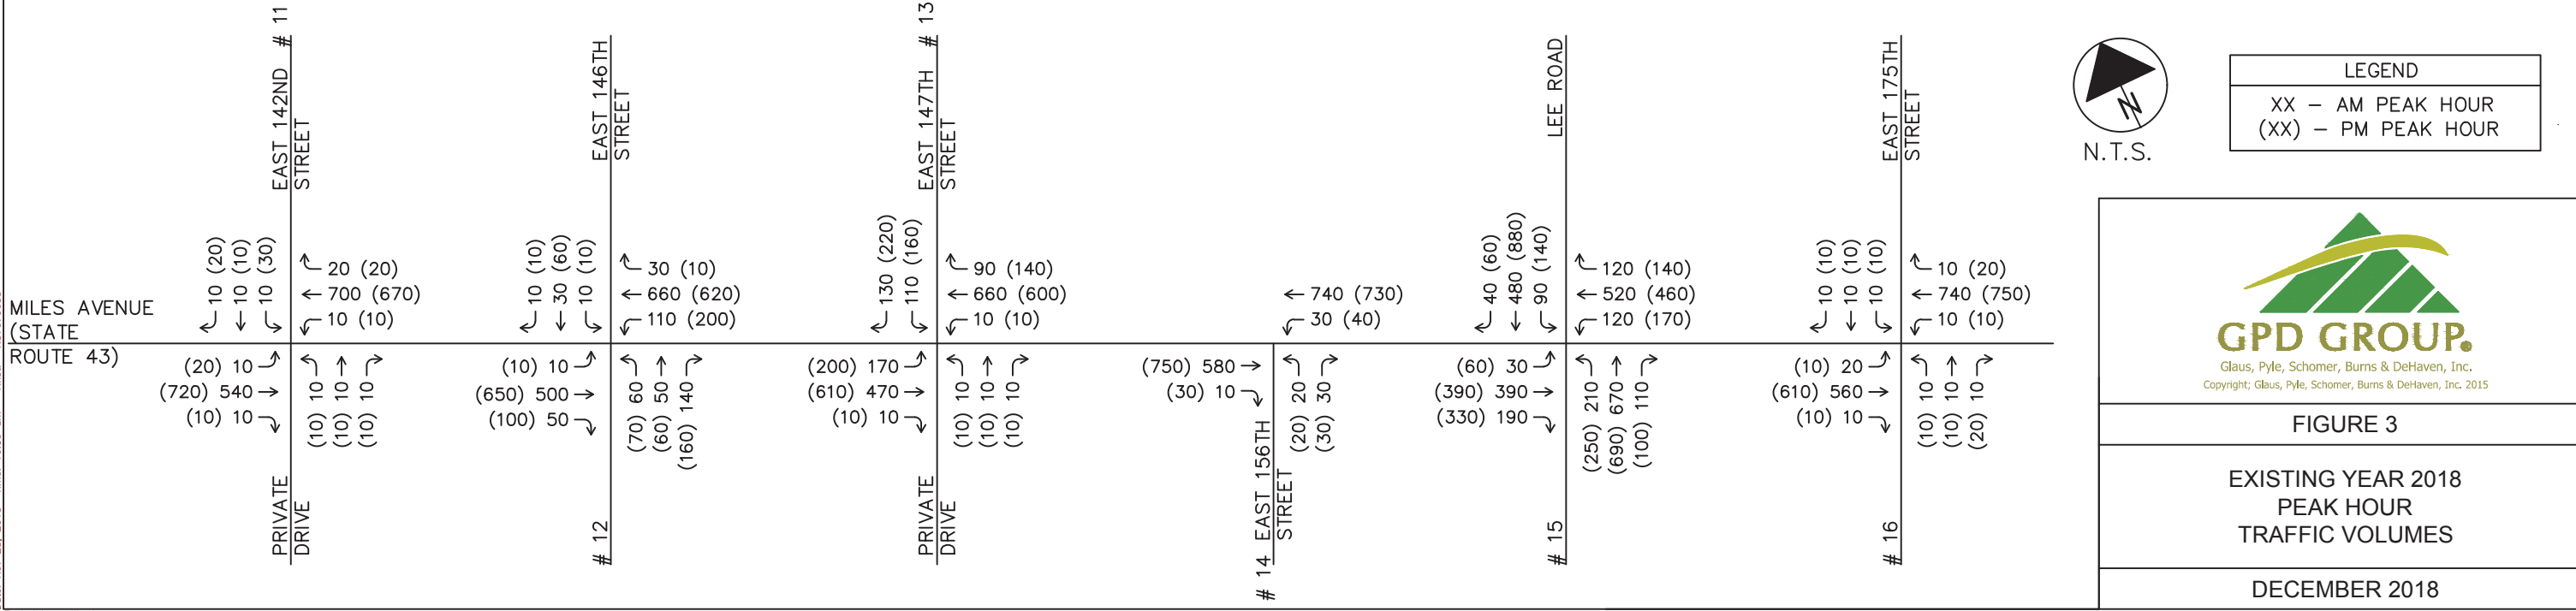
FIGURE 3

**EXISTING YEAR 2018
PEAK HOUR
TRAFFIC VOLUMES**

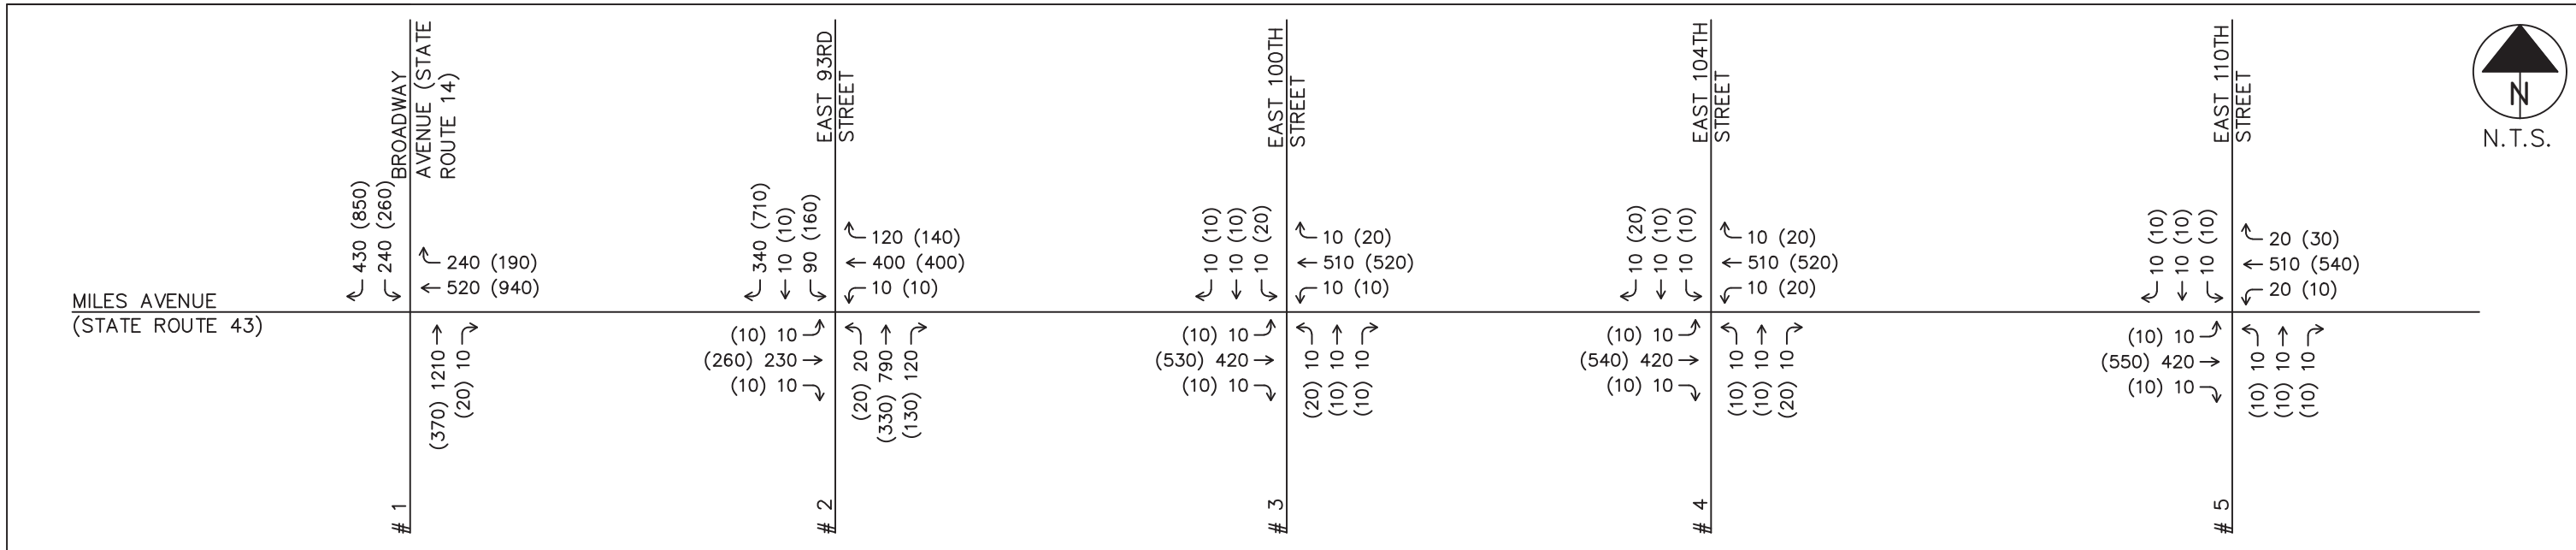
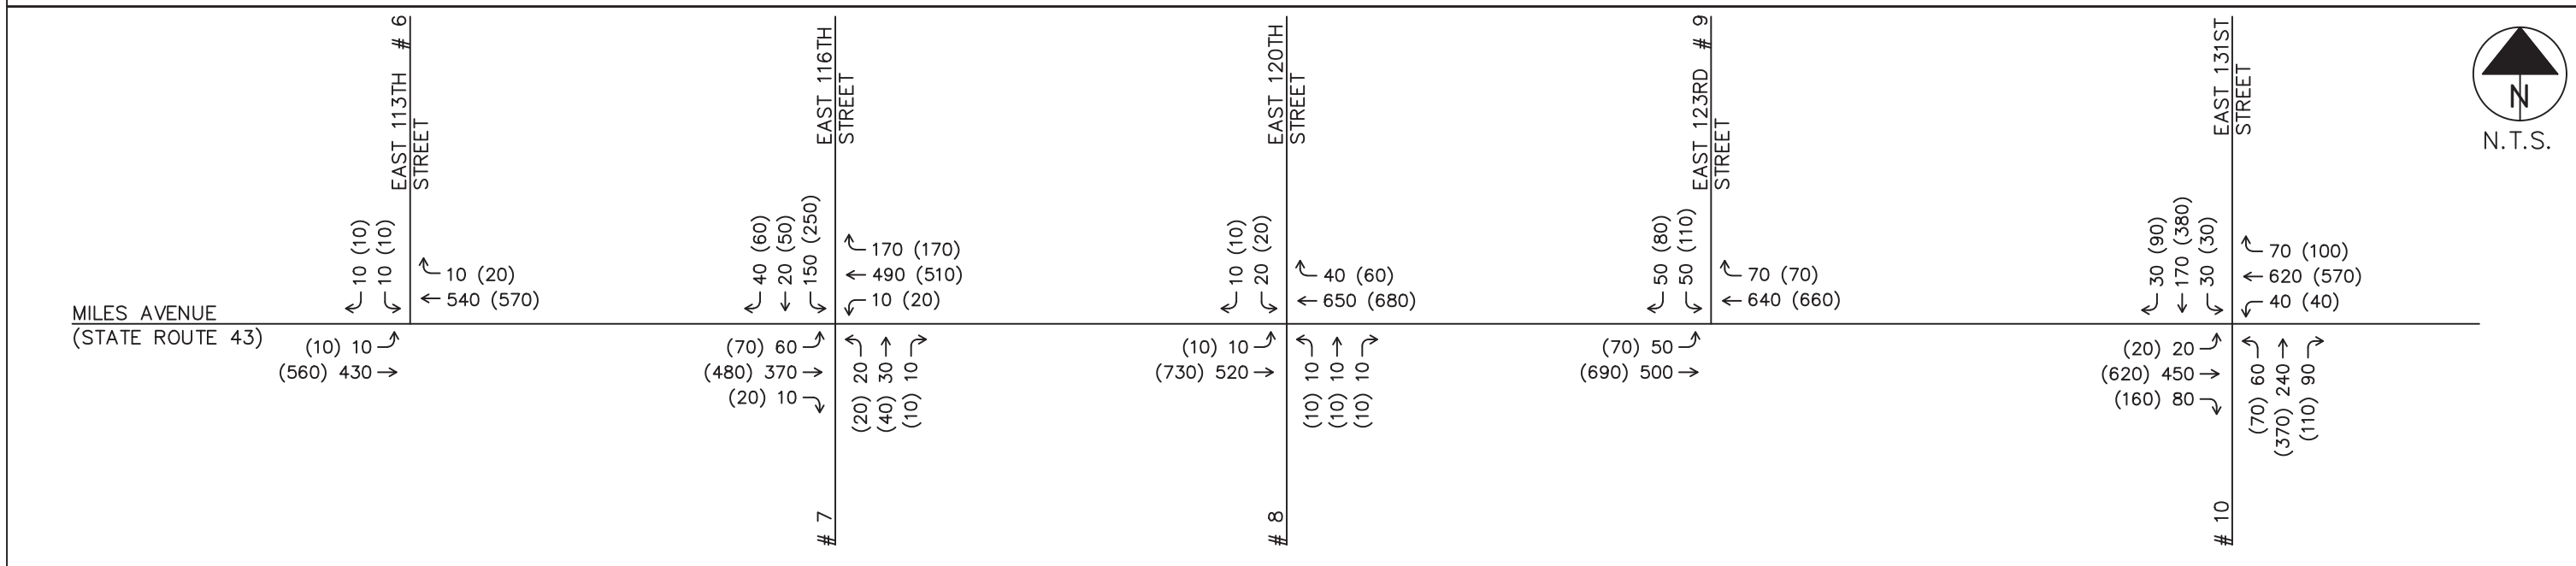
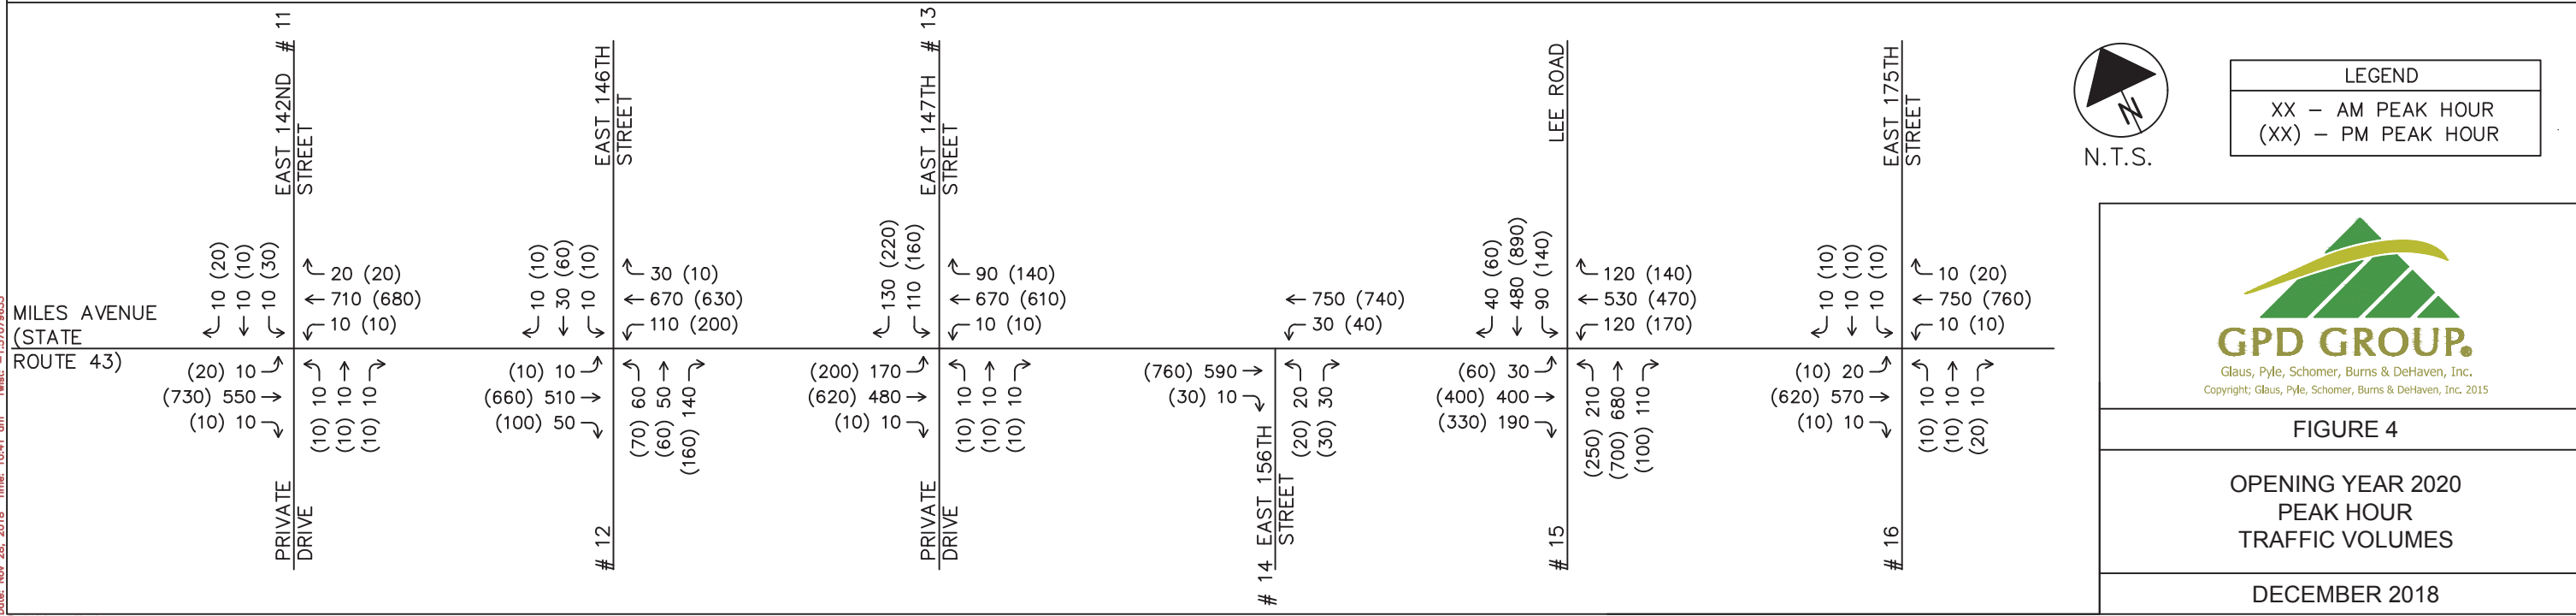
FIGURE 4

OPENING YEAR 2020
 PEAK HOUR
 TRAFFIC VOLUMES

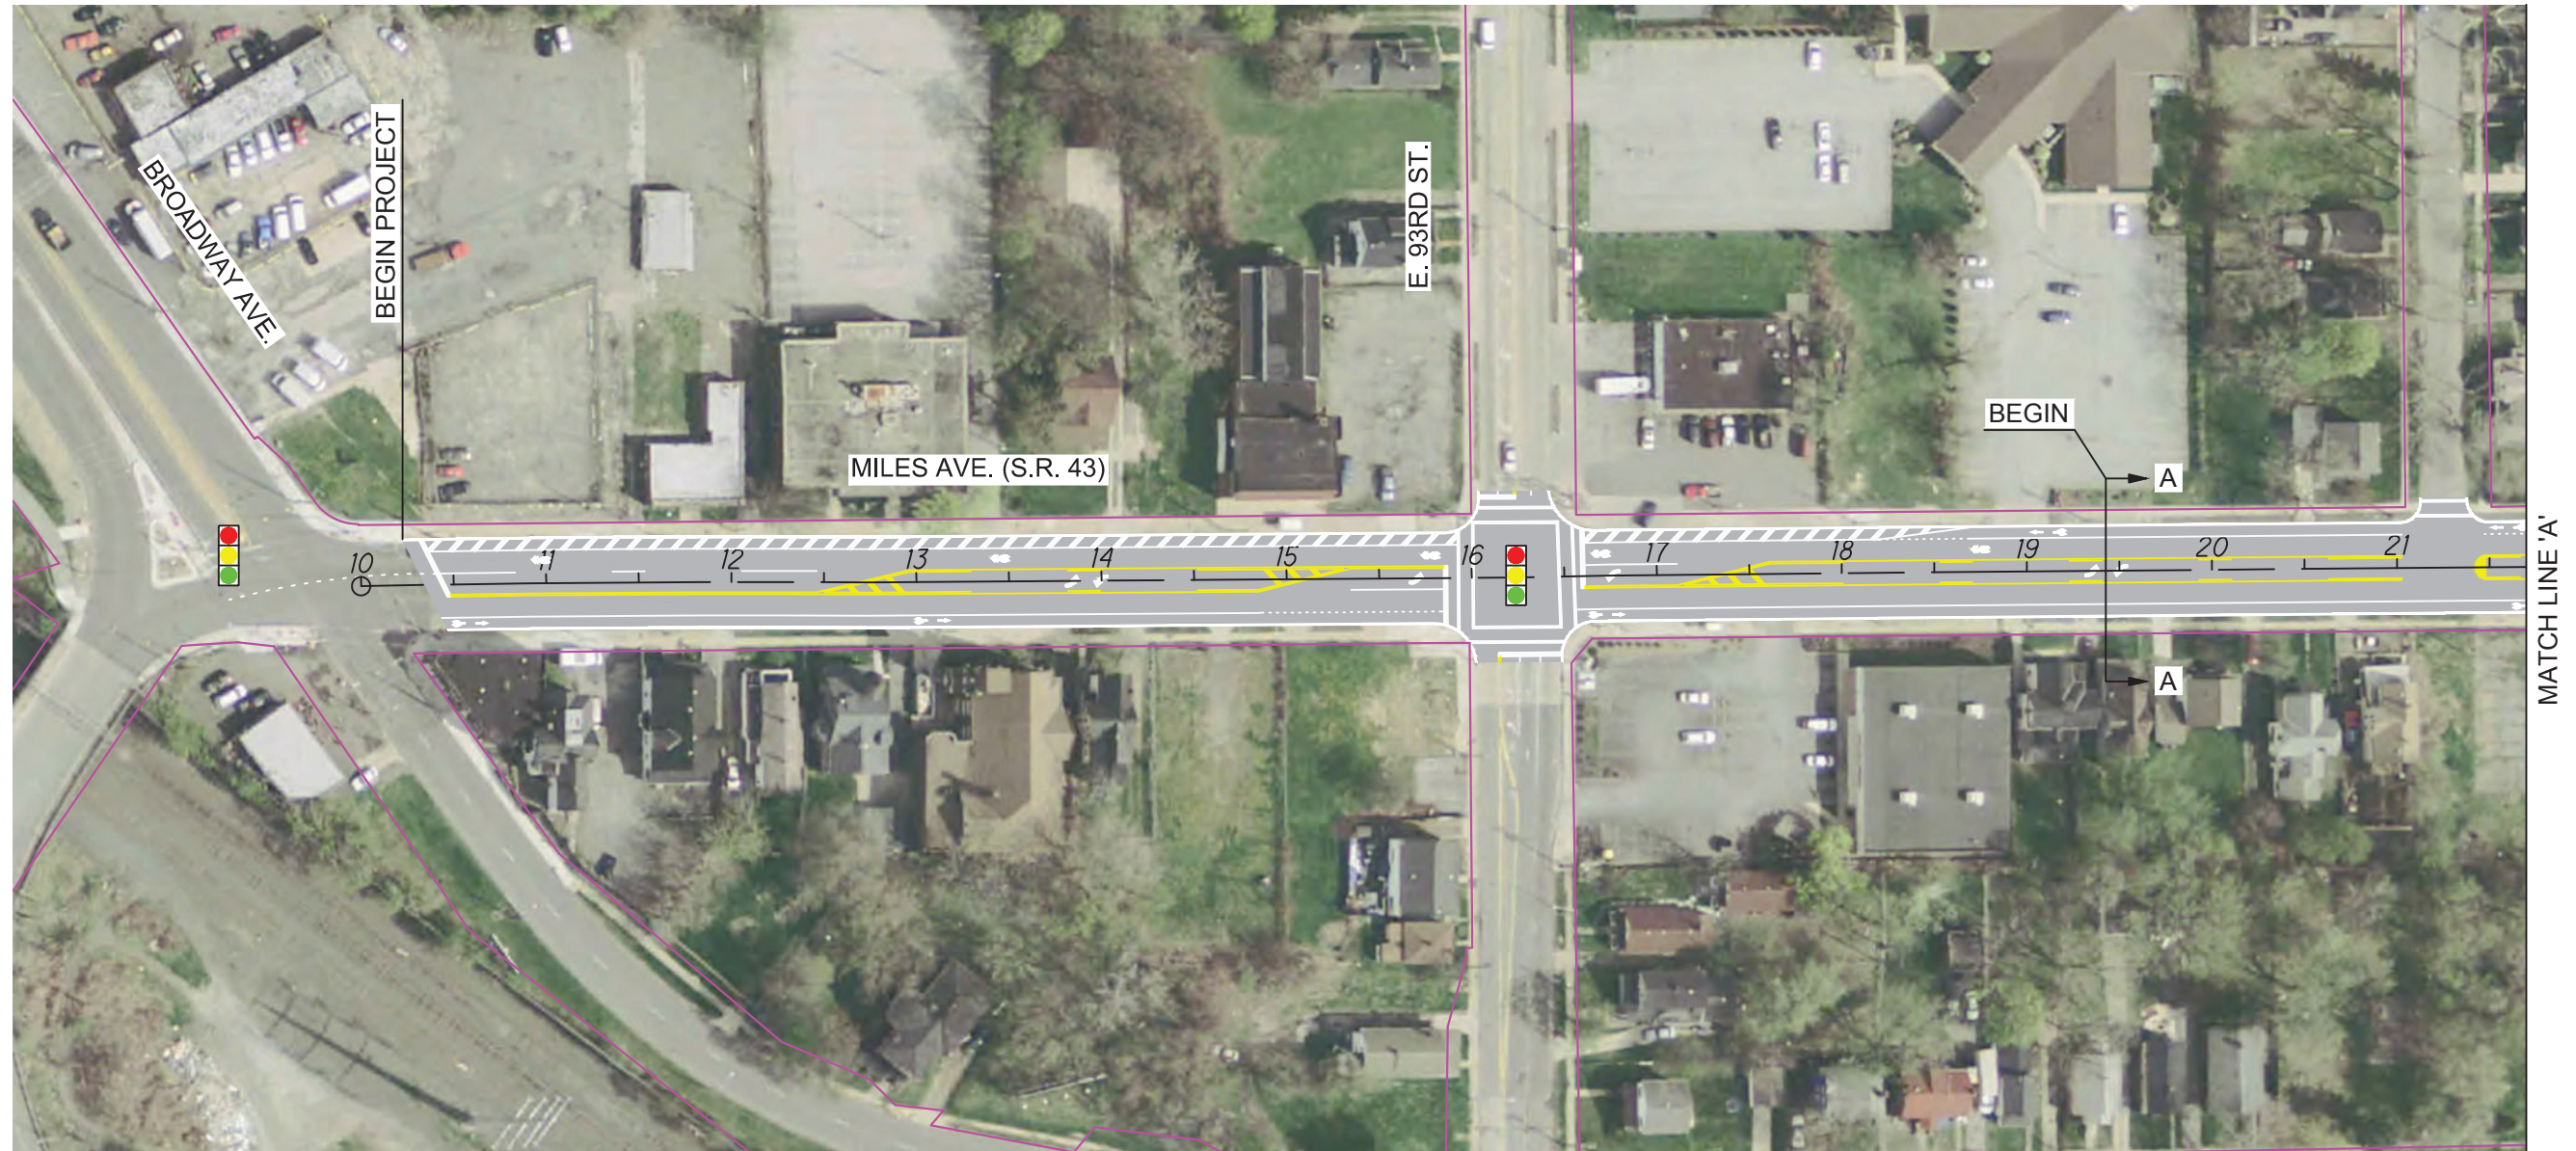
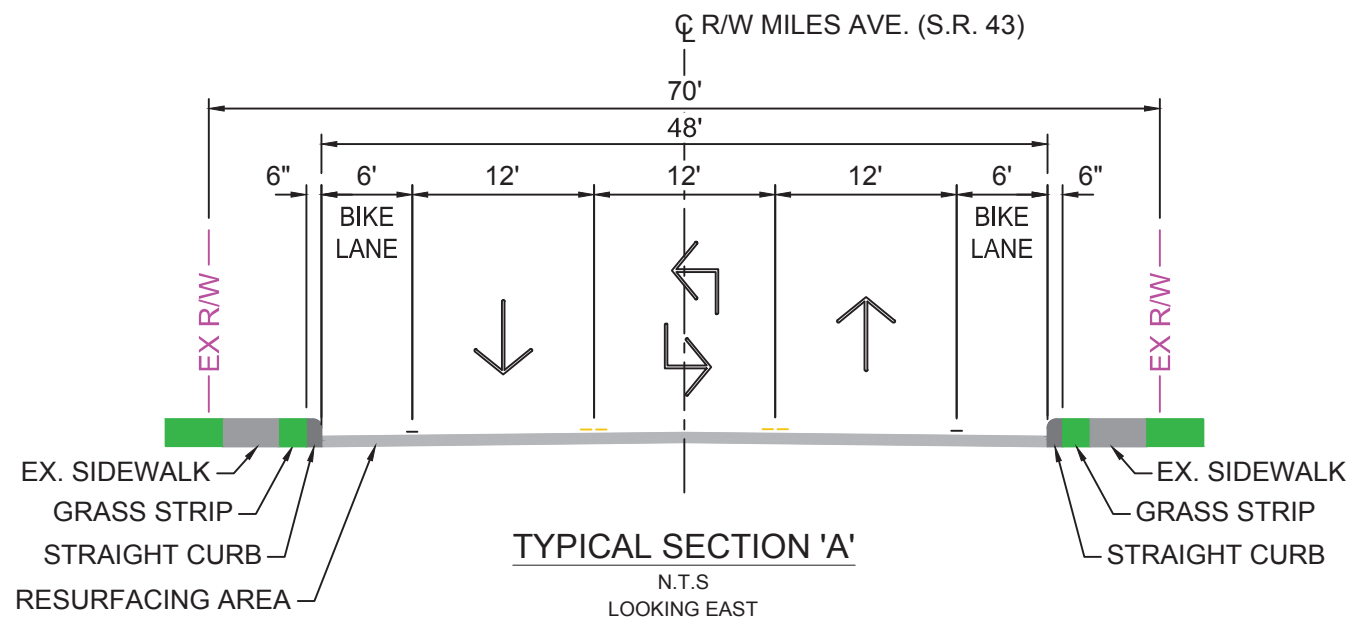
FIGURE 6

PROPOSED IMPROVEMENT RENDERING
SHEET 1 OF 15

1. Perform a road diet along Miles Avenue along the entire study corridor.
2. Resurface Miles Avenue along the entire study corridor.
3. Add bike lanes on the north and south sides of Miles Avenue between East 131st Street and Broadway Avenue.
4. Remove six (6) traffic signal along the study corridor.
5. Reconstruct six (6) traffic signals along the study corridor.
6. Rehabilitate four (4) traffic signals along the study corridor.

All long term improvements will occur simultaneously throughout the study area. The existing crash patterns and capacity analyses along Miles Avenue support the conclusion that left turn lanes at the signalized intersections and a center two-way left turn lane would be beneficial along the study corridor and the existing capacity analysis shows that capacity is not a concern along the corridor. Because Miles Avenue is currently a four (4) lane roadway, with no left turn lanes, a road diet has been recommended as a solution for the existing crash patterns that were identified. A road diet would provide a center two way left turn lane while maintaining one (1) travel lane in the eastbound and westbound directions, as well as introduce dedicated left turn lanes at the signalized intersections throughout the corridor. This center two-way left turn lane will provide motorists the opportunity to move out of the thru traffic stream to make left turns and the dedicated left turn lanes at all signalized intersections will make those turns safer by improving sight distance to oncoming traffic and removing these left turners from the thru traffic stream. To ensure that the proposed pavement markings are clearly discernable and properly placed along the corridor, Miles Avenue should also be resurfaced as part of this project.
