RECONNAISSANCE & SAMPLING PLAN

CUY/SUM - 271- 0.00/14.87
PID 80418

Prepared by The Ohio Department of
Transportation

Aerial Mapping of Potential Impact Points

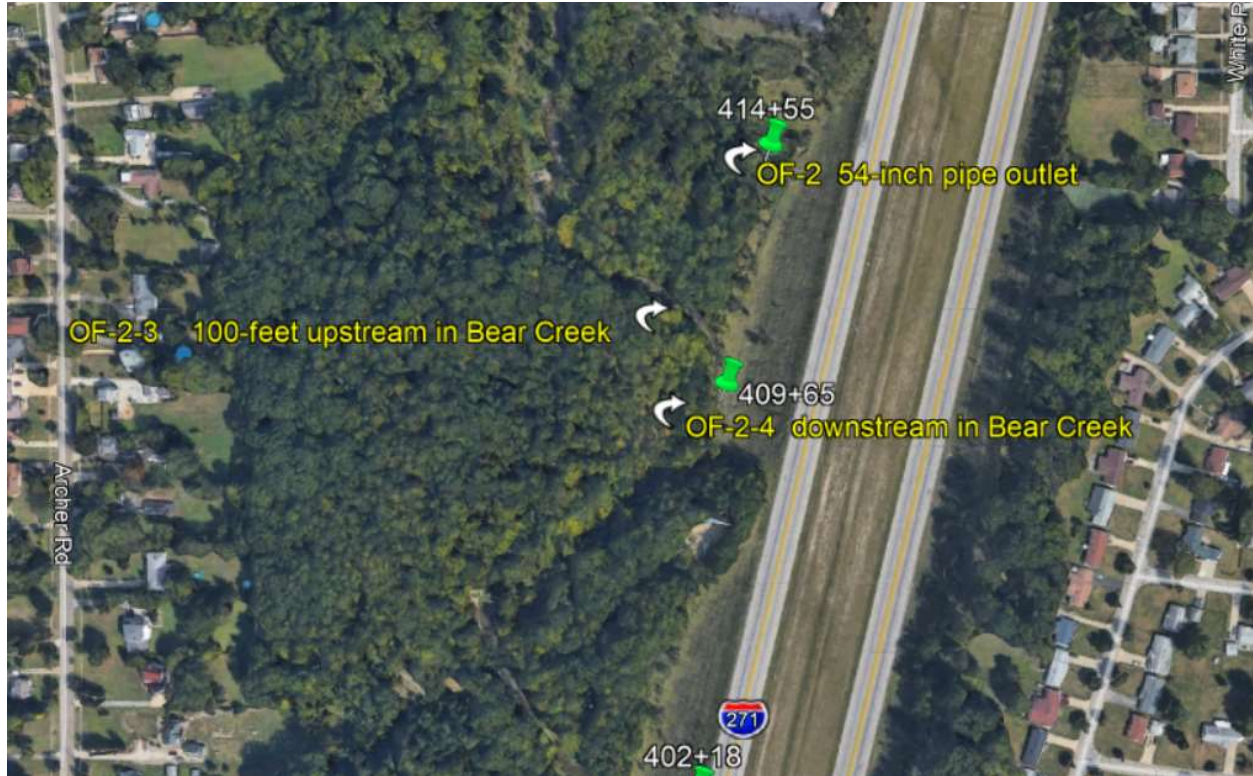
OF-2: at the 54-inch pipe outlet

OF-2-3: 100-feet upstream of where the OF-2 drainage outlet merges with Bear Creek

OF-2-4: Location downstream of where the OF-2 drainage outlet merges with Bear Creek. This will be measured at 3 times the width of the stream downstream from the merge point.

Site ID	Location Description	Station
OF-2	at the outlet of the pipe.	414+55 Figure 2
OF-2-3	In Bear Creek, 100-feet upstream of merge with OF-2 outfall drainage.	411+65 Figure 2
OF-2-4	3x stream width downstream of where OF-2 drainage enters Bear Creek.	409+85 Figure 2
OF-3	At outlet of pipe.	289+92 Figure 3
OF-3-2	Approximately 50-feet downstream from OF-3, located after the 60-inch outlet pipe.	289+92 Figure 3
OF-4	At outlet of pipe.	325+78 Figure 4
OF-4-2	3x stream width downstream of where OF-4 enters stream	Approx. 326+08 Figure 4

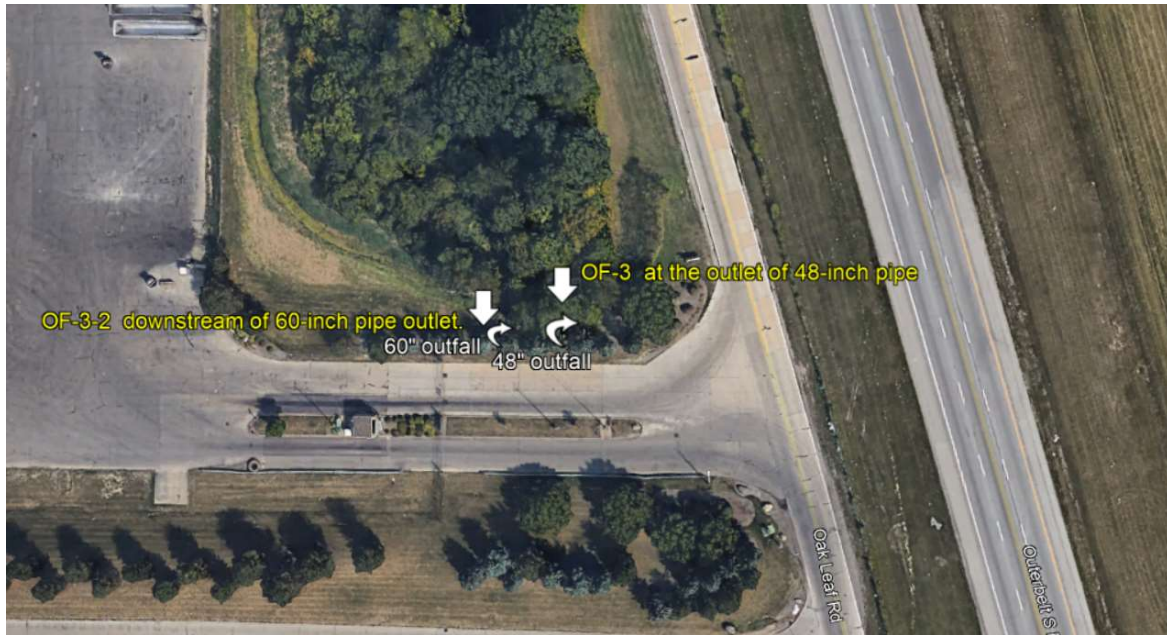
Figure 3

OF-3: at the outlet of 48-inch pipe.

OF-3-2: downstream of the mixing point of where the 60-inch pipe enters the stream.

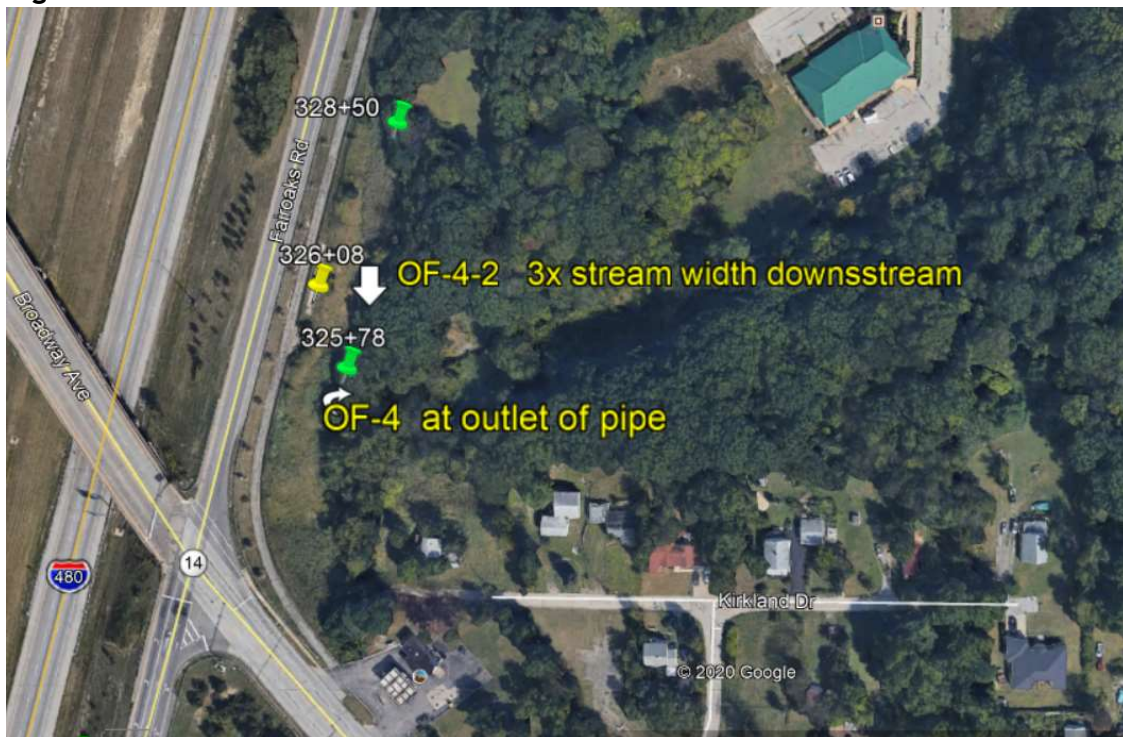
Figure 4

OF-4: at the outlet of the pipe.

OF-4-2: 3x the stream width downstream of discharge point

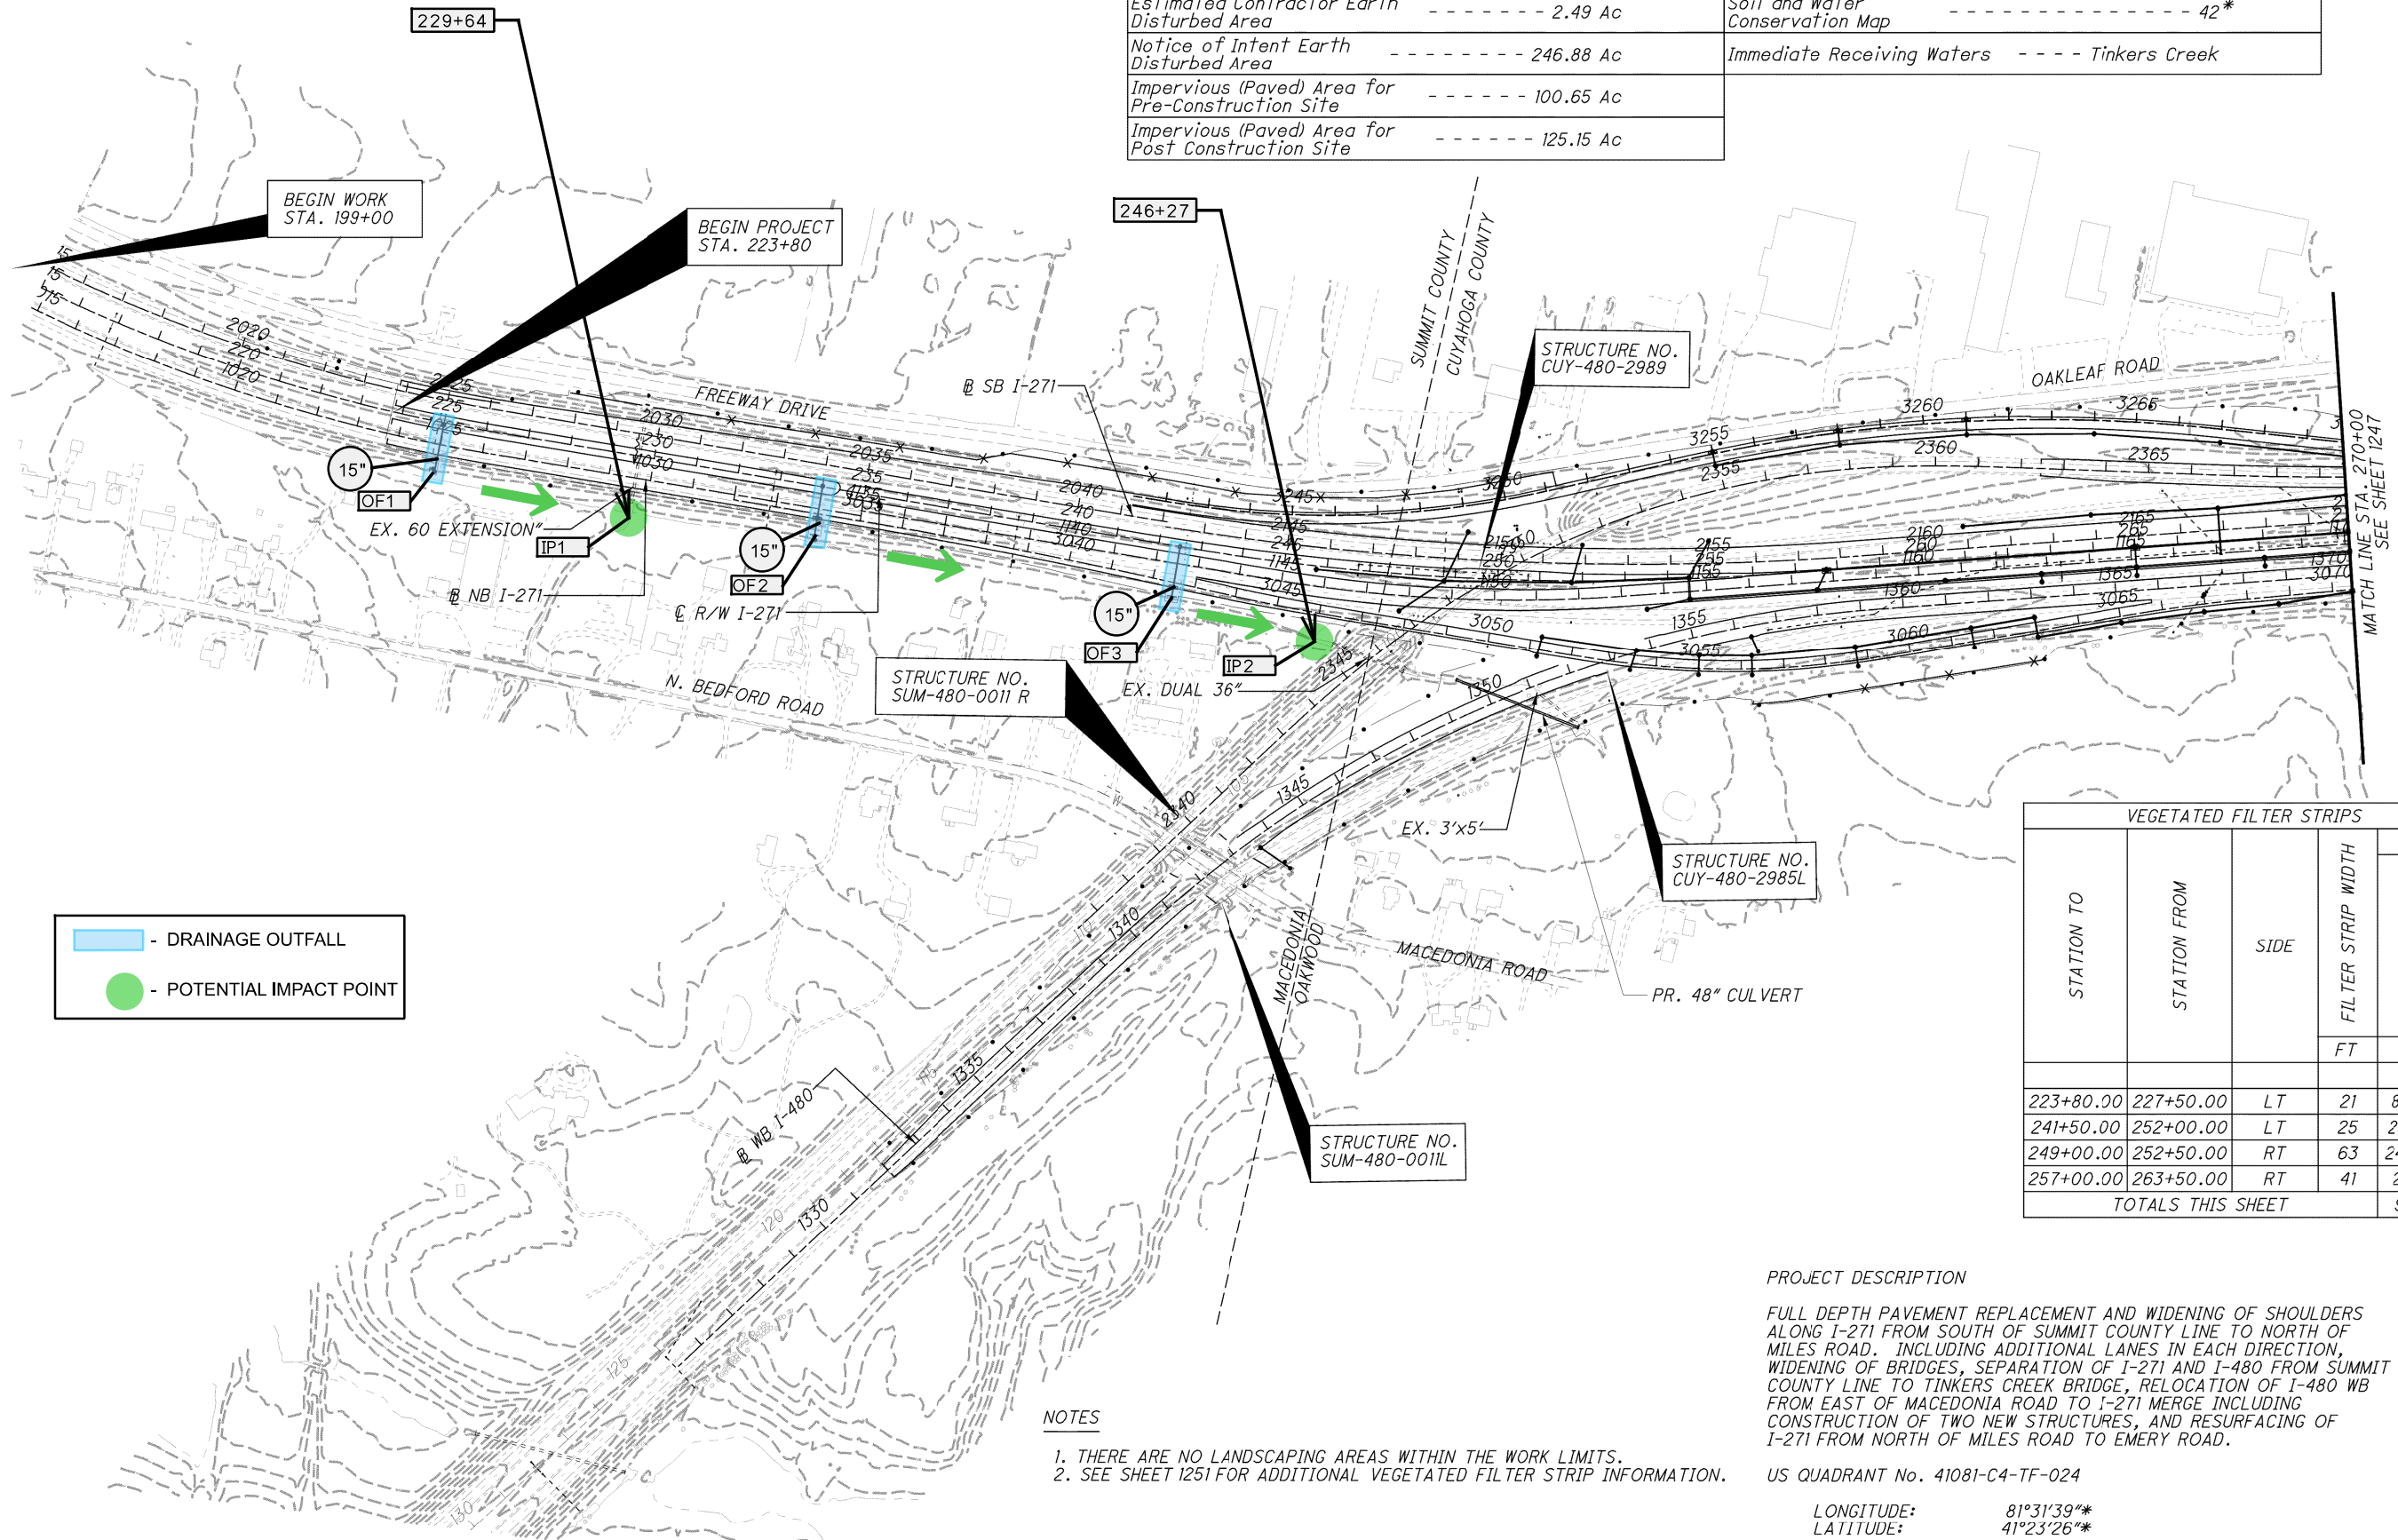
PROJECT SITE PLAN
BEGIN TO I-271 STA. 270+00

- DRAINAGE OUTFALL
- POTENTIAL IMPACT POINT

Twenty-four (24) PIPs have been identified within the current construction limits. A PIP is where a drainage channel exits the ODOT property within the IR-271 project limits. The attached plan sheets highlight the PIP. ODOT will collect and report the following data during the inspection of each PIP.

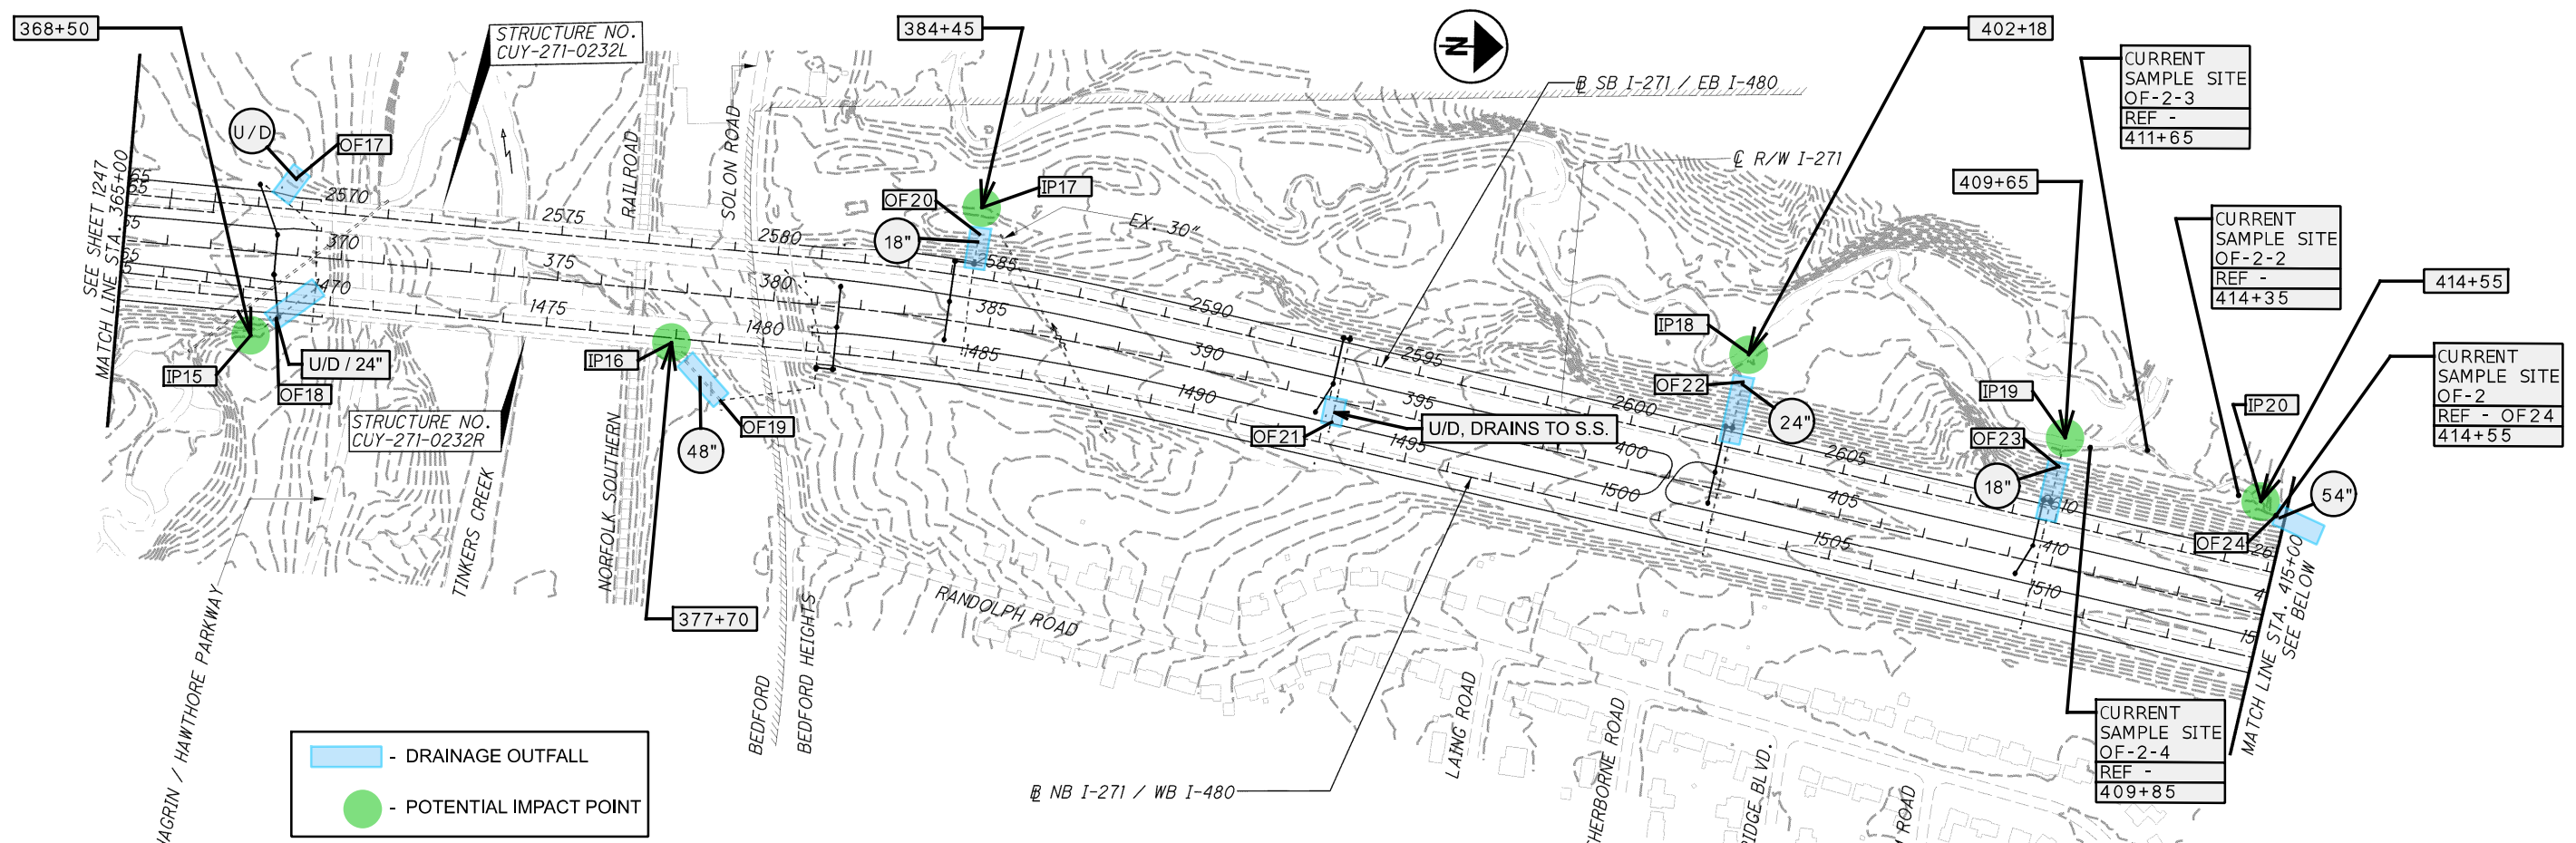
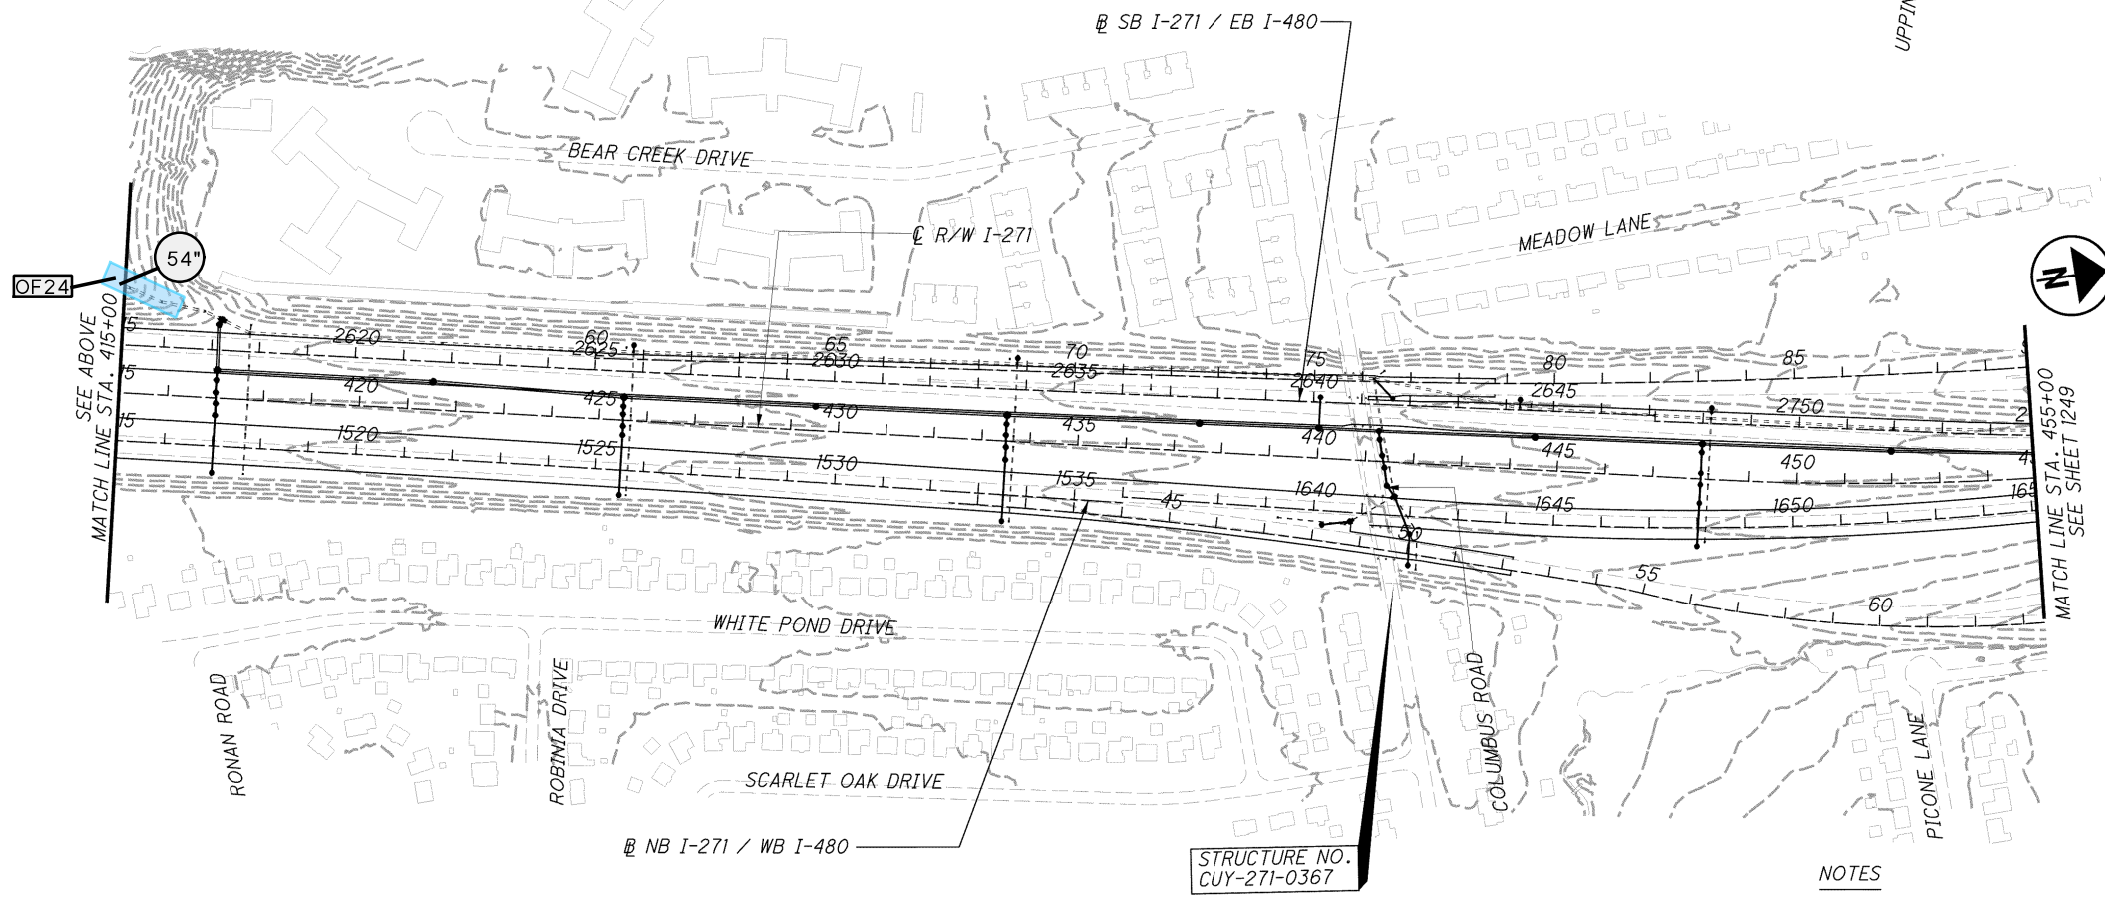
PROJECT SITE PLAN
I-271 STA. 365+00 TO STA. 455+00

— - DRAINAGE OUTFALL
● - POTENTIAL IMPACT POINT

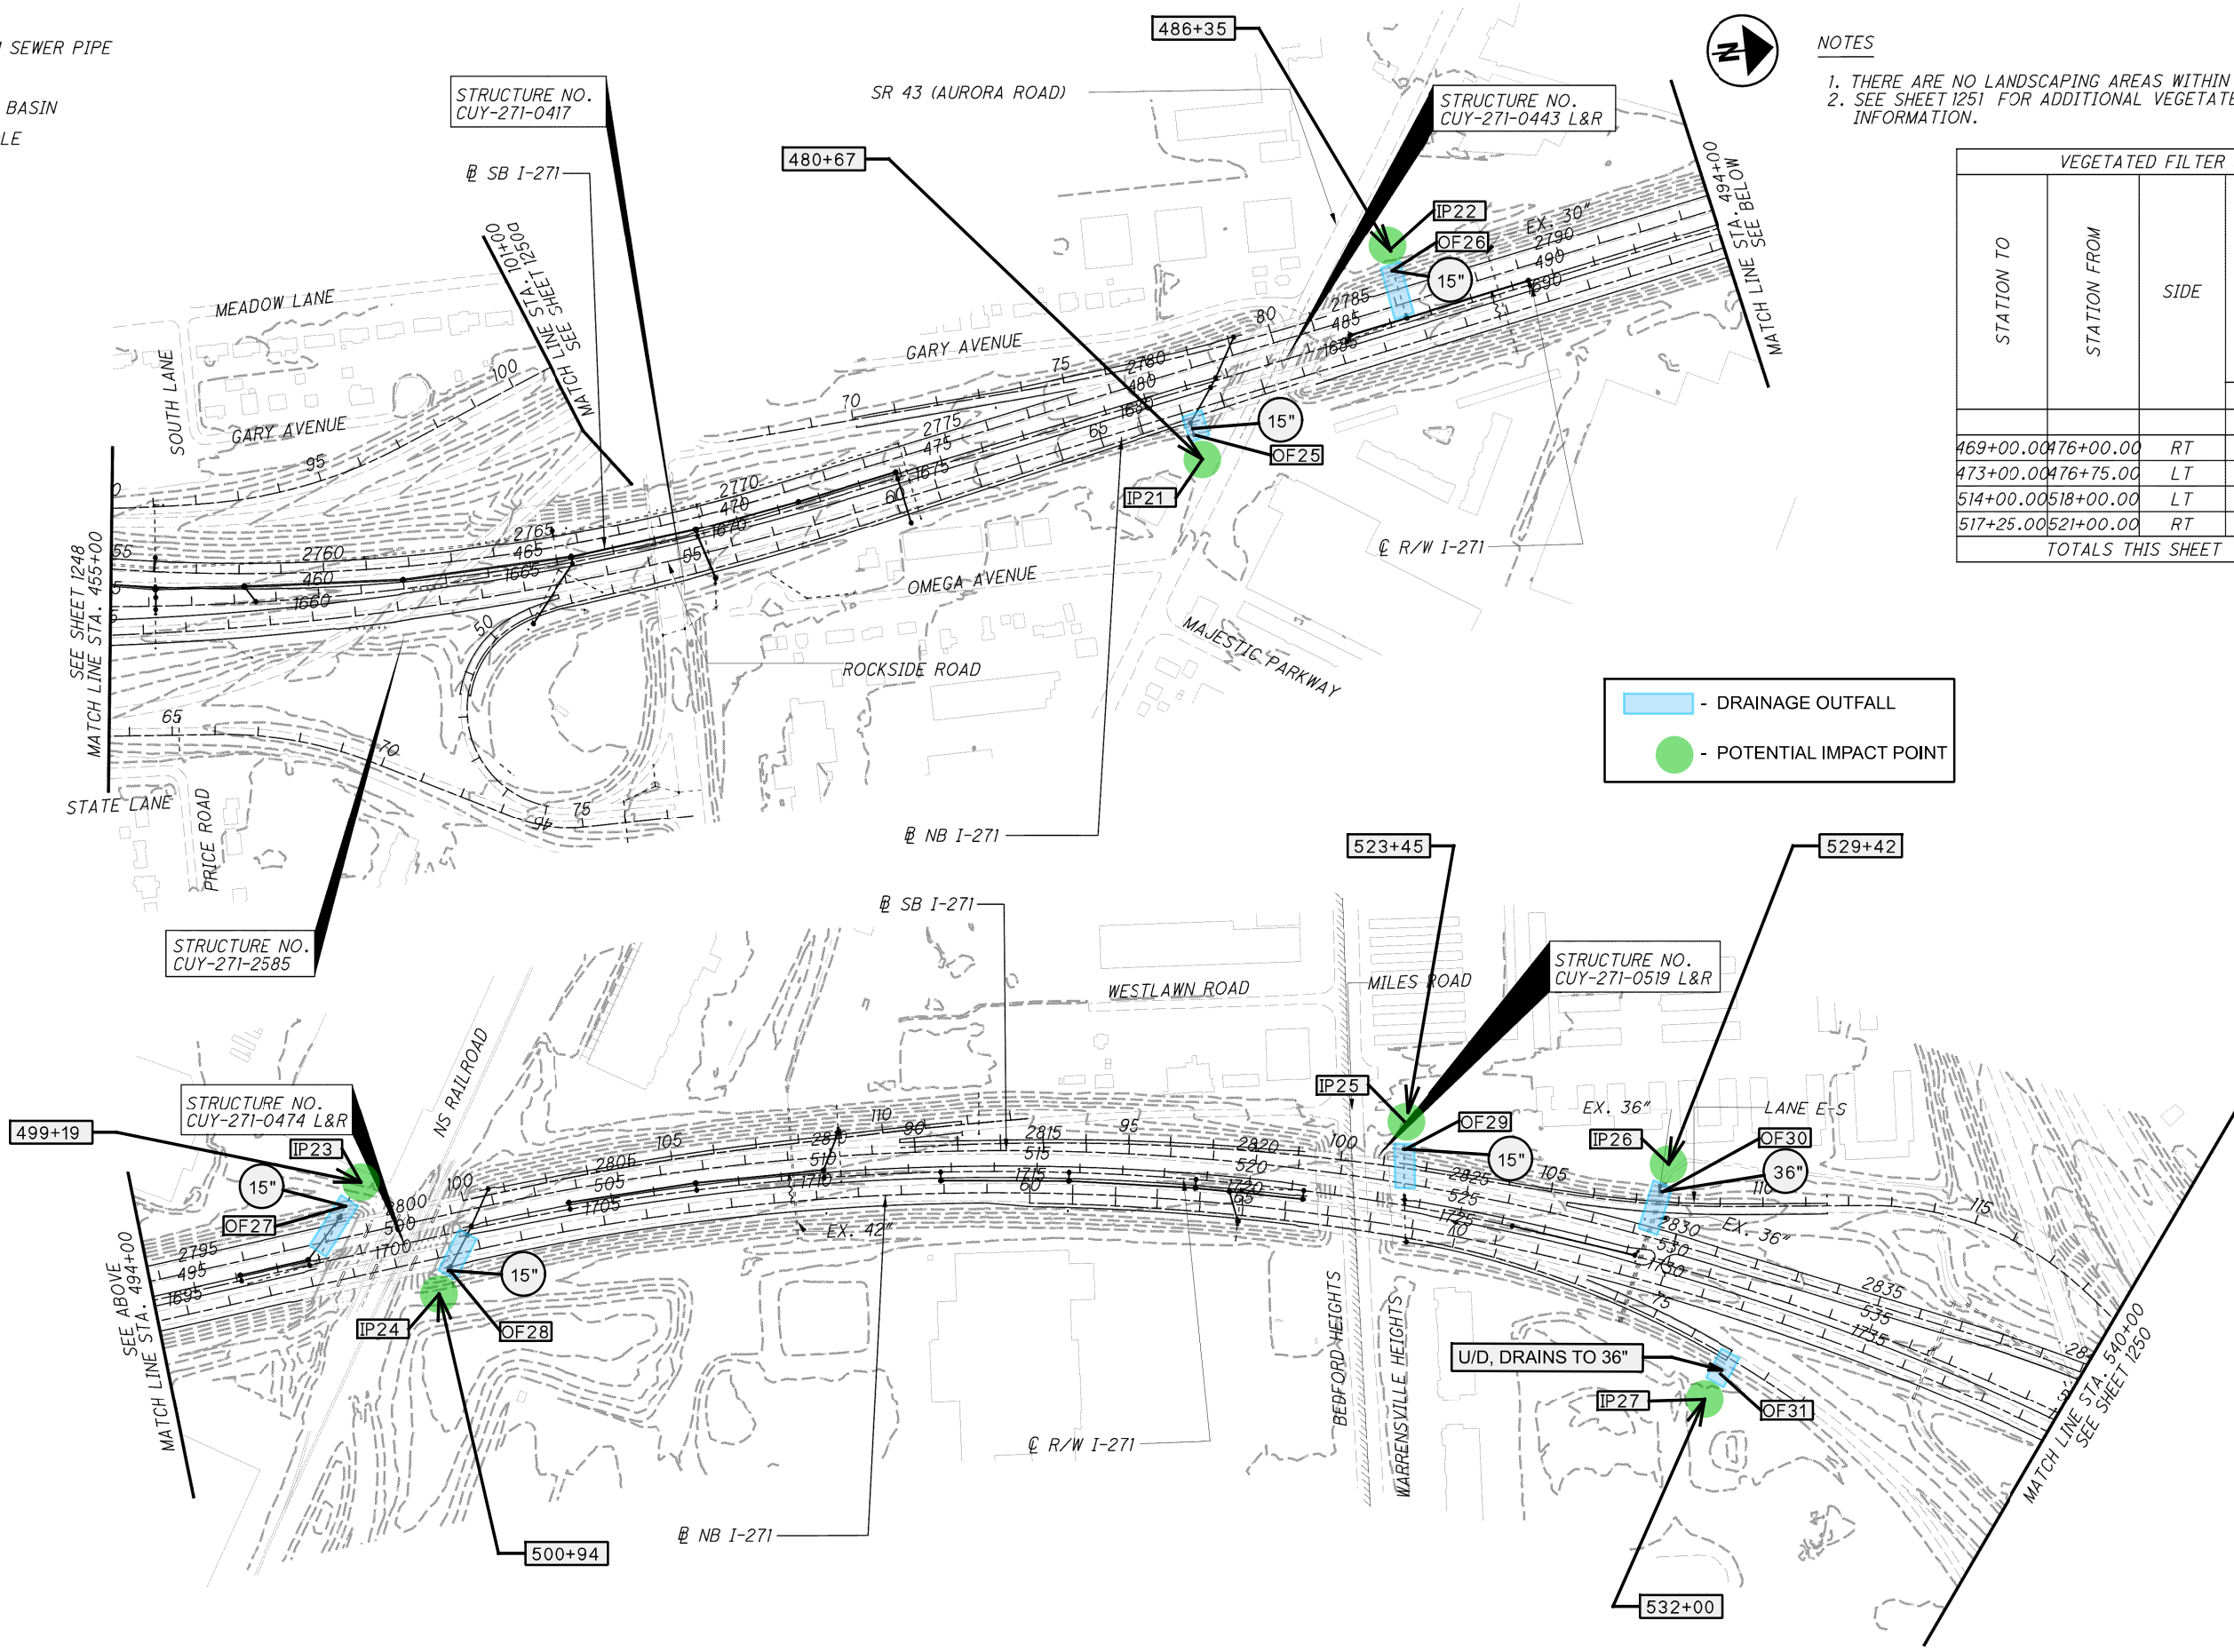
PROJECT SITE PLAN
I-271 STA. 455+00 TO STA. 540+00
 CUY / SUM-271-00.00 / 14.87
 CUY / SUM-480-29.58 / 00.00
 1249
 2013

- DRAINAGE OUTFALL
 - POTENTIAL IMPACT POINT
