Appendix A

Preliminary Schematic Plan View Exhibits

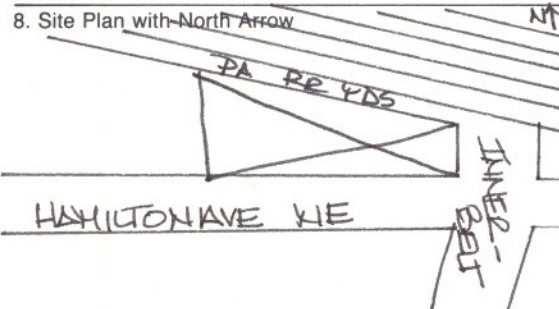
18a. Style of Addition or Element(s)		31. Wall Construction concrete block

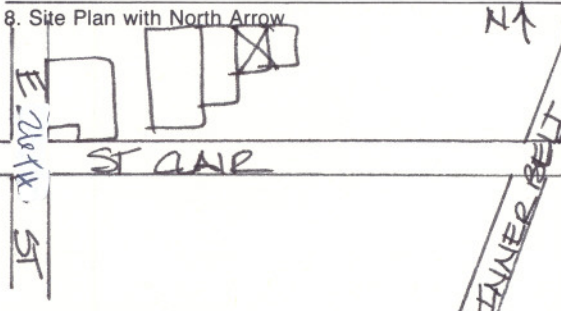
19. Architect or Engineer		32. Roof Type & Material flat	
9. U.T.M. Reference Quadrangle Name 63 5 44 17 443780 4495670				19a. Design Sources		33. No. of Bays Front 4 Side	
Zone		Easting		Northing		34. Exterior Wall Material(s) brick facing
