CONSOLIDATION TEST REPORT

Project No. 0121-
Project: SCI-823-0.00

Client: TranSystems, Inc.

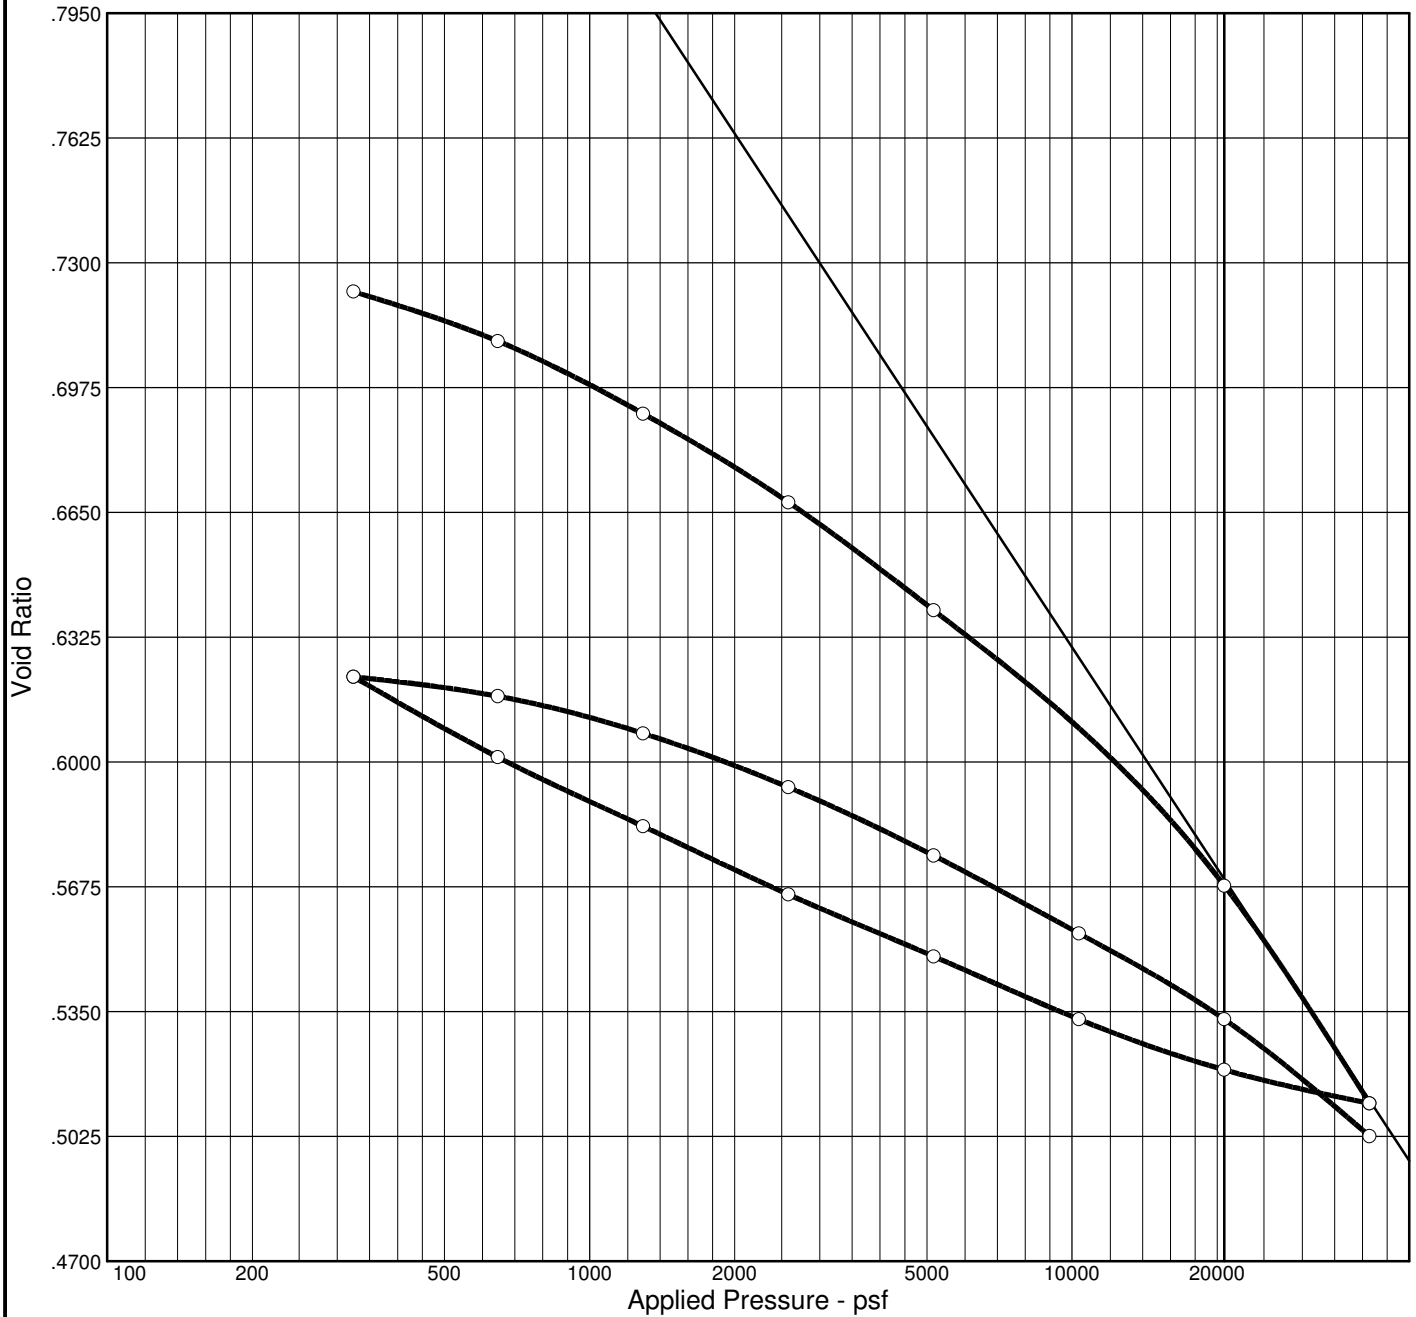
Natural		Dry Dens. (pcf)	LL	PI	Sp. Gr.	USCS	AASHTO	Initial Void Ratio
Saturation	Moisture							
98.7 %	25.9 %	100.4	42	19	2.78	CL	A-7-6(21)	0.729

Lean clay

Sample No.: P1

Elev./Depth: 10.0

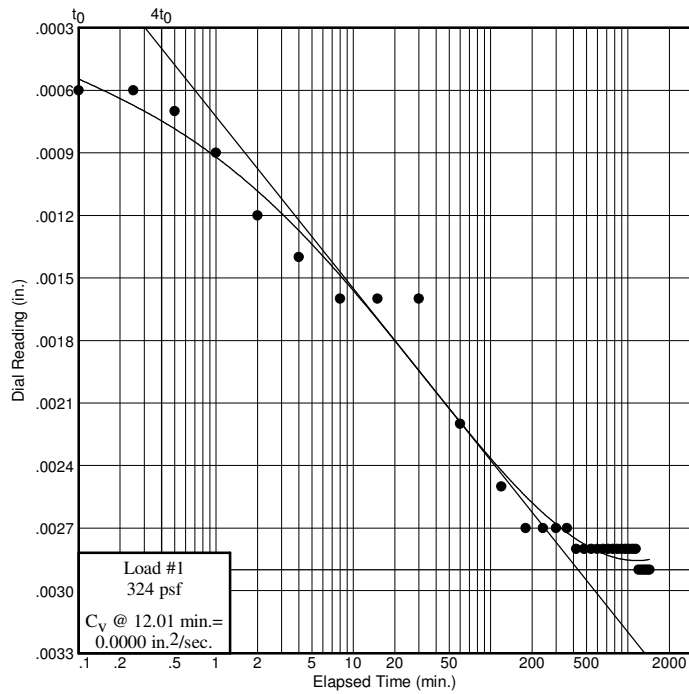
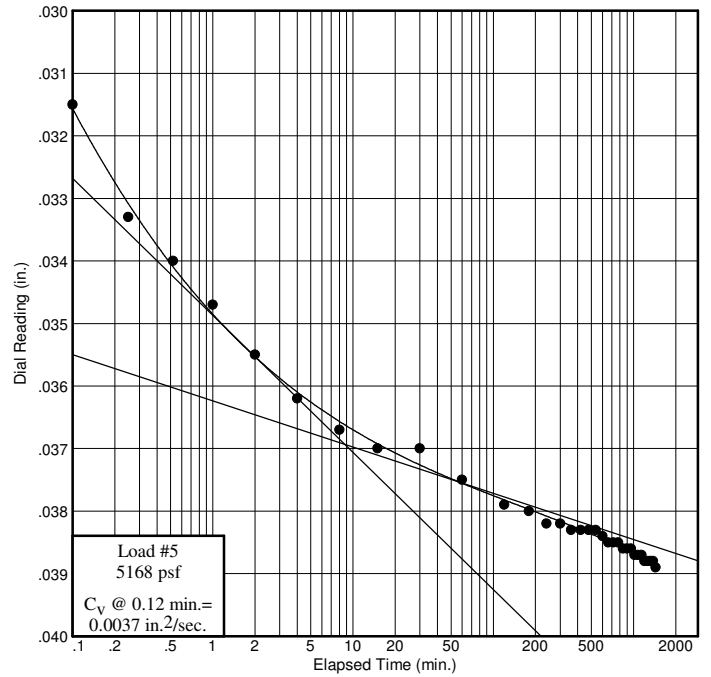
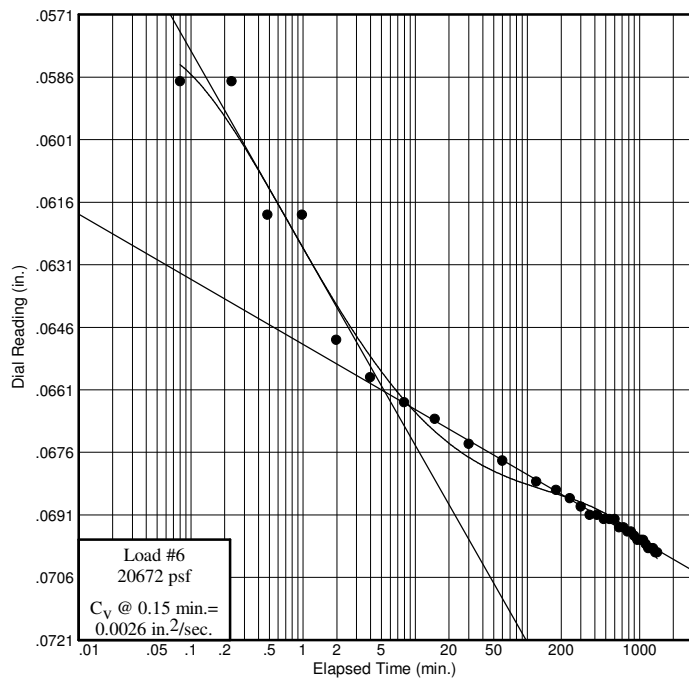
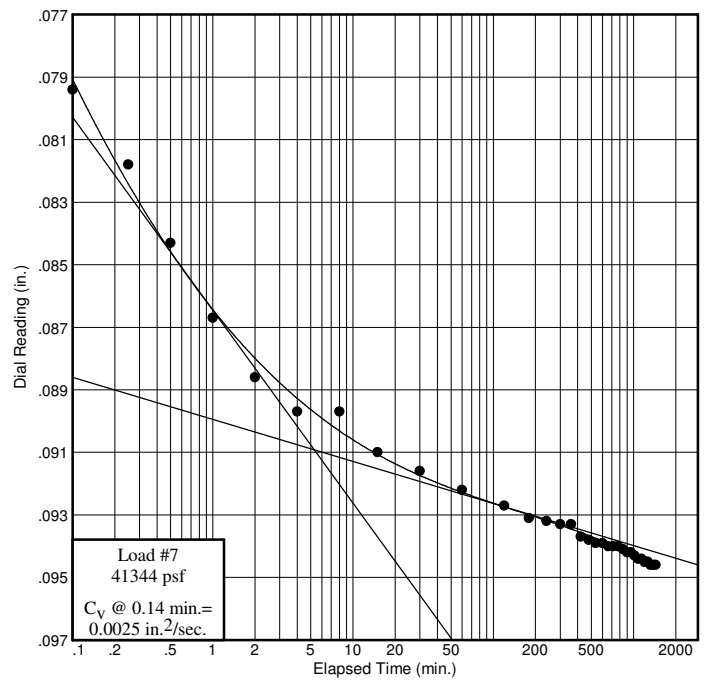
Dial Reading vs. Time

Sample No.: P1

Elev./Depth: 10.0

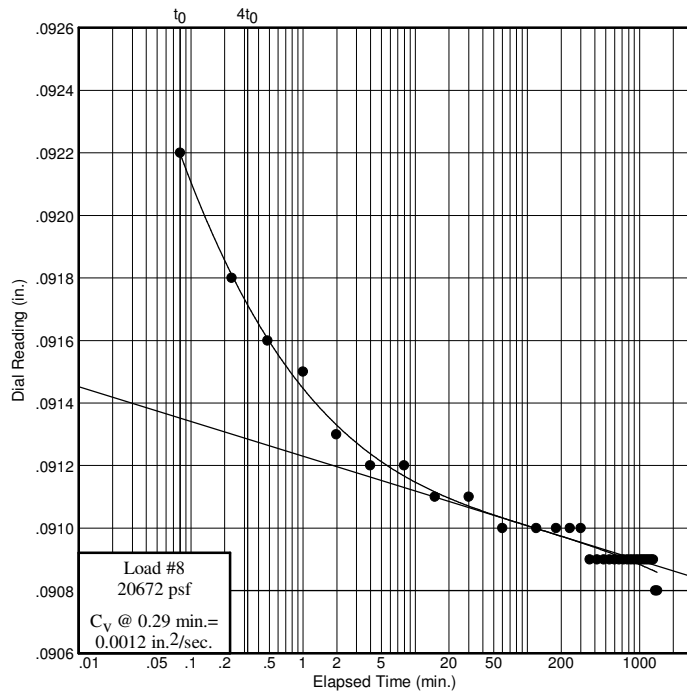
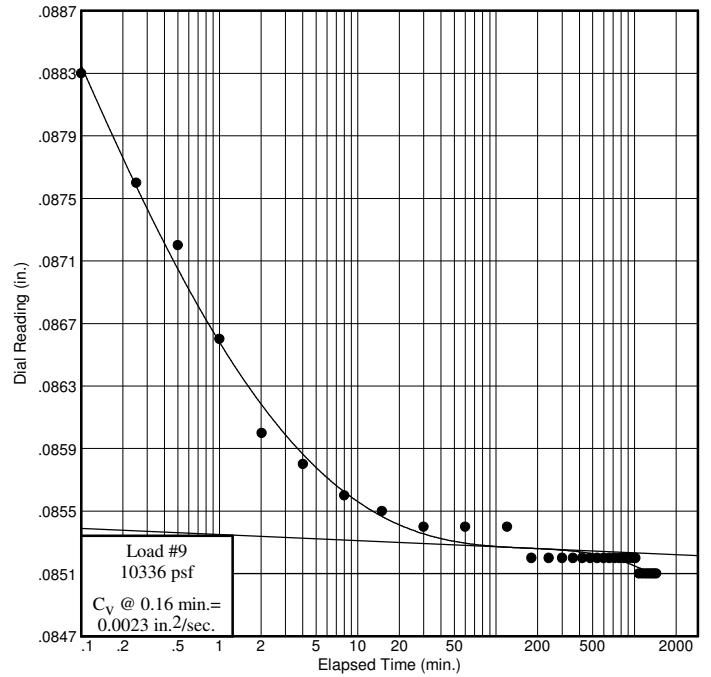
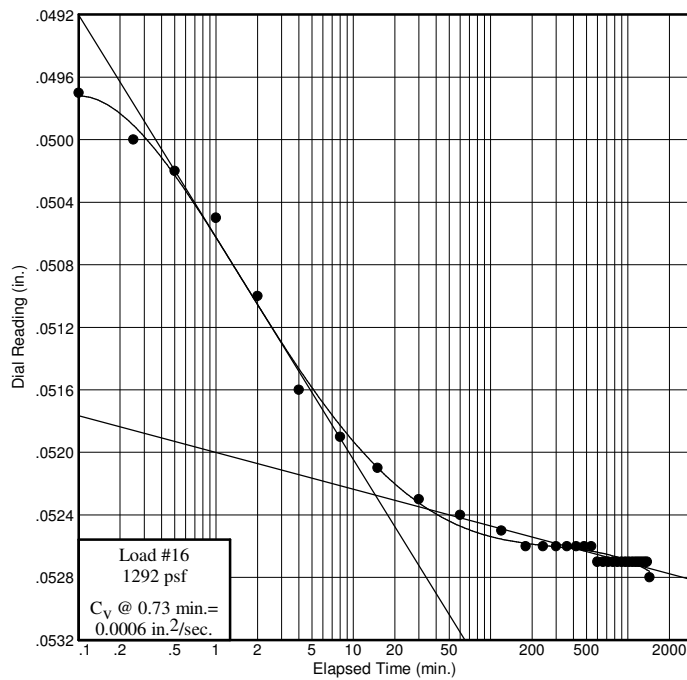
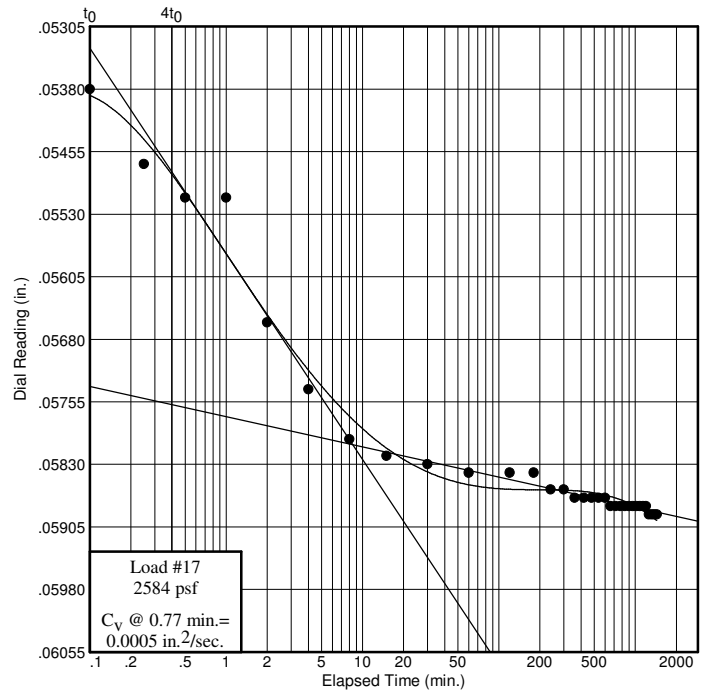
Dial Reading vs. Time

Sample No.: P1

Elev./Depth: 10.0

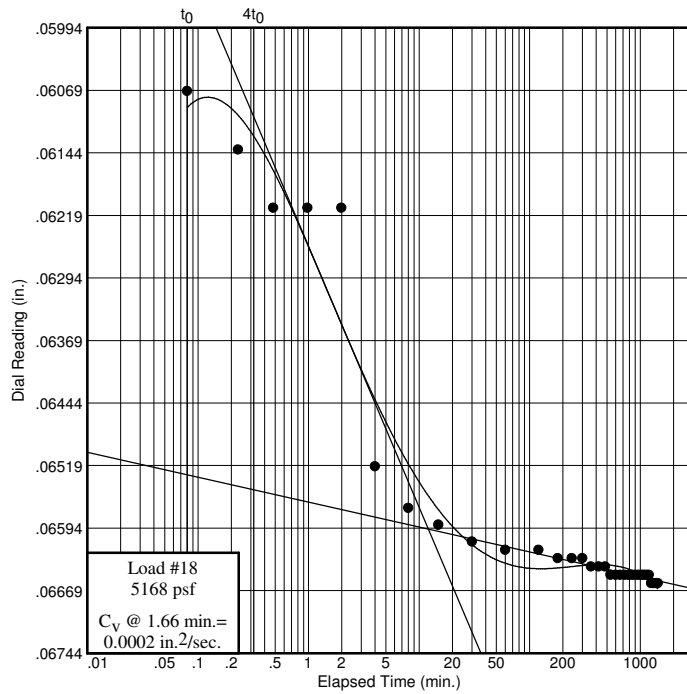
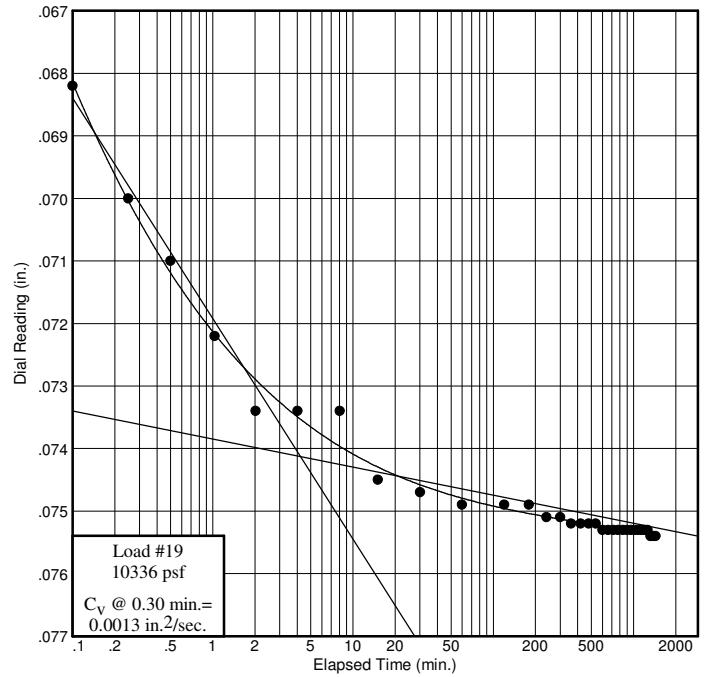
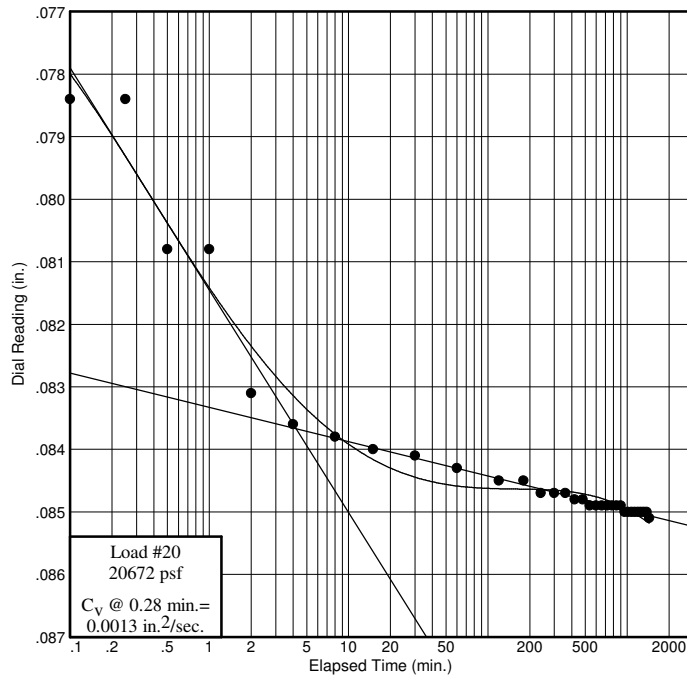
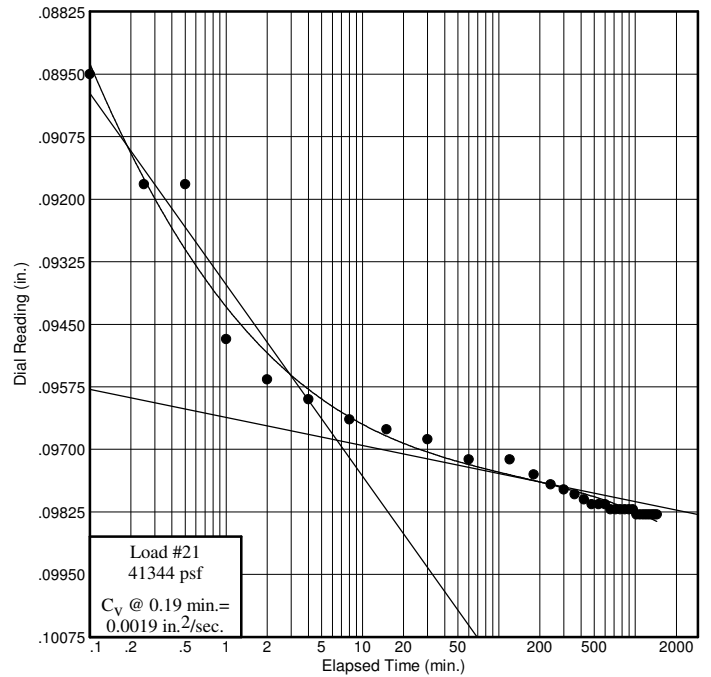
Dial Reading vs. Time

Sample No.: P1

Elev./Depth: 10.0

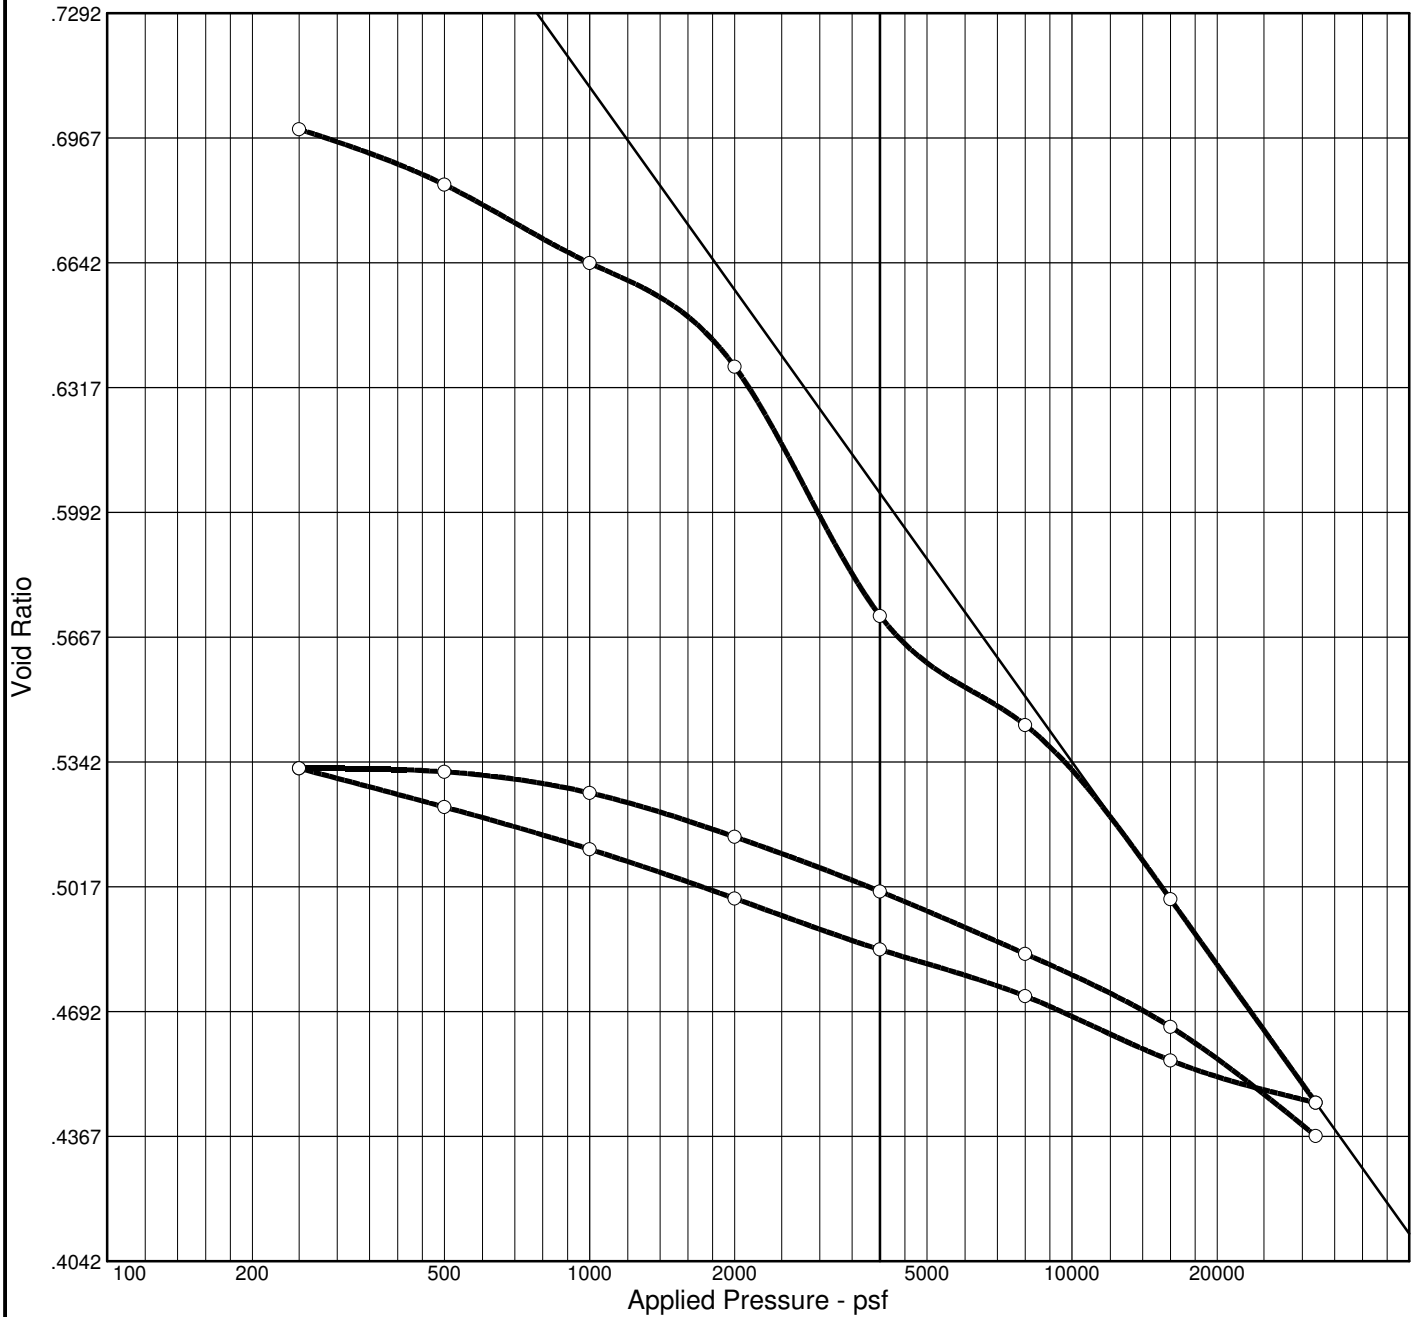
CONSOLIDATION TEST REPORT

Natural		Dry Dens. (pcf)	LL	PI	Sp. Gr.	USCS	AASHTO	Initial Void Ratio
Saturation	Moisture							
94.9 %	24.5 %	101.0	38	16	2.78	CL	A-6(17)	0.719

Lean clay

Sample No.: P2

Elev./Depth: 26.0

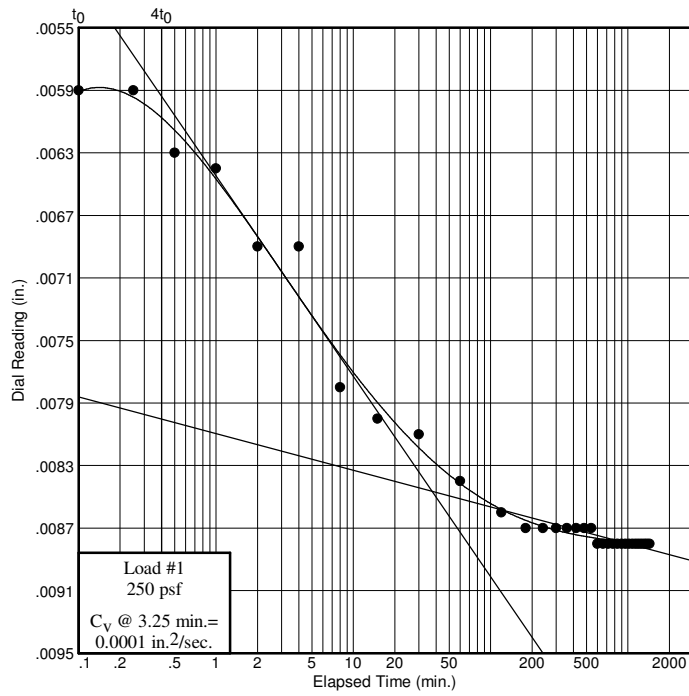
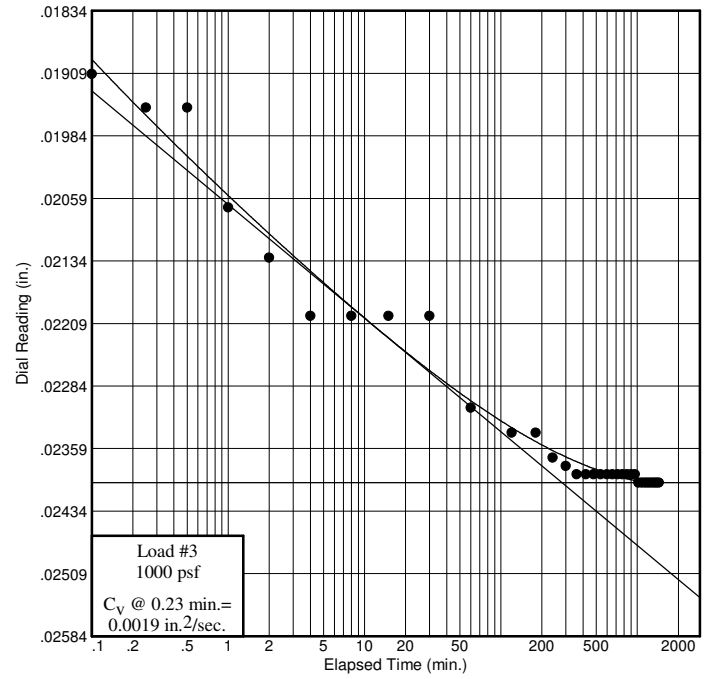
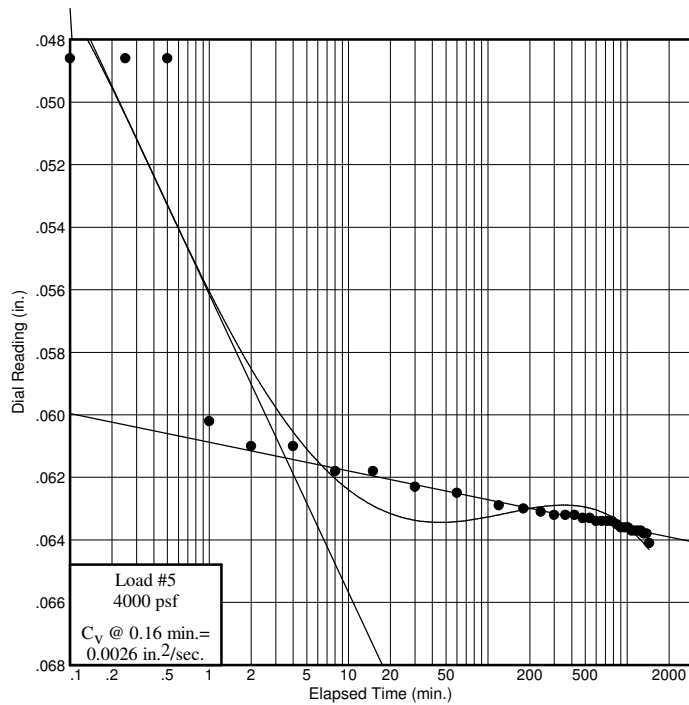
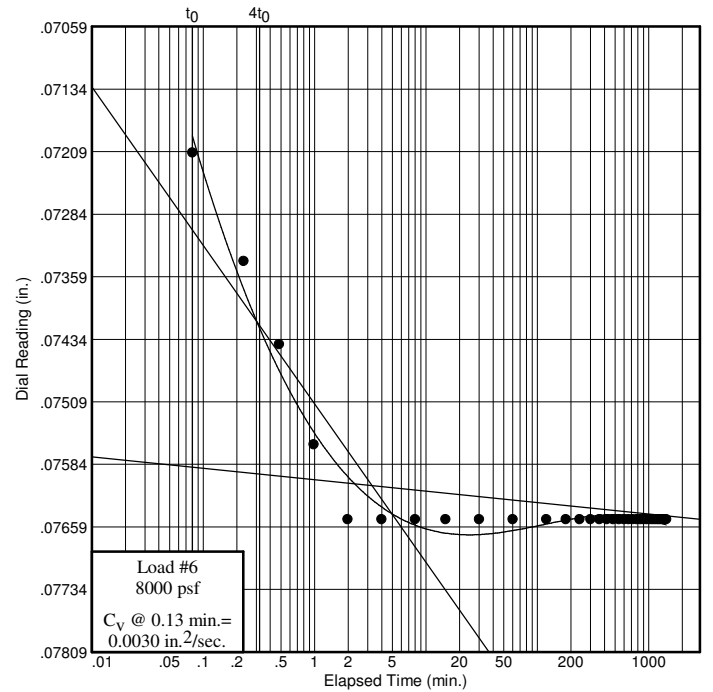
Dial Reading vs. Time

Sample No.: P2

Elev./Depth: 26.0

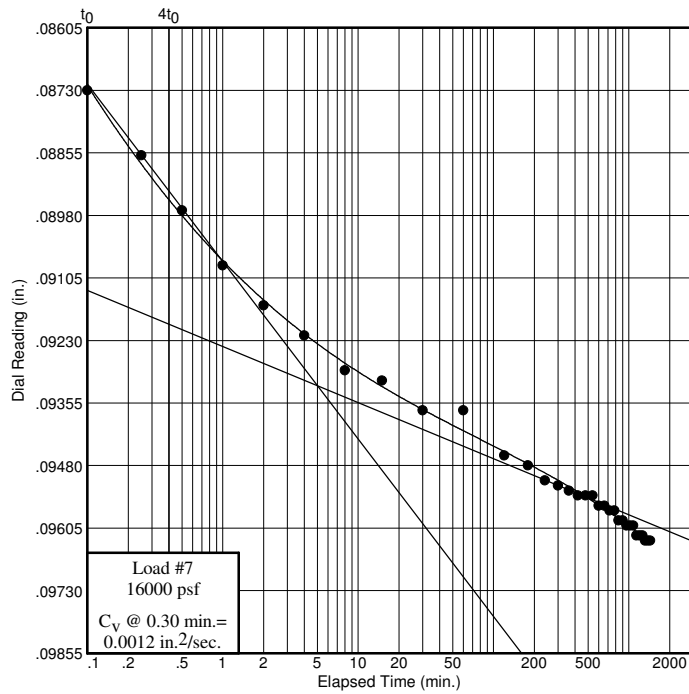
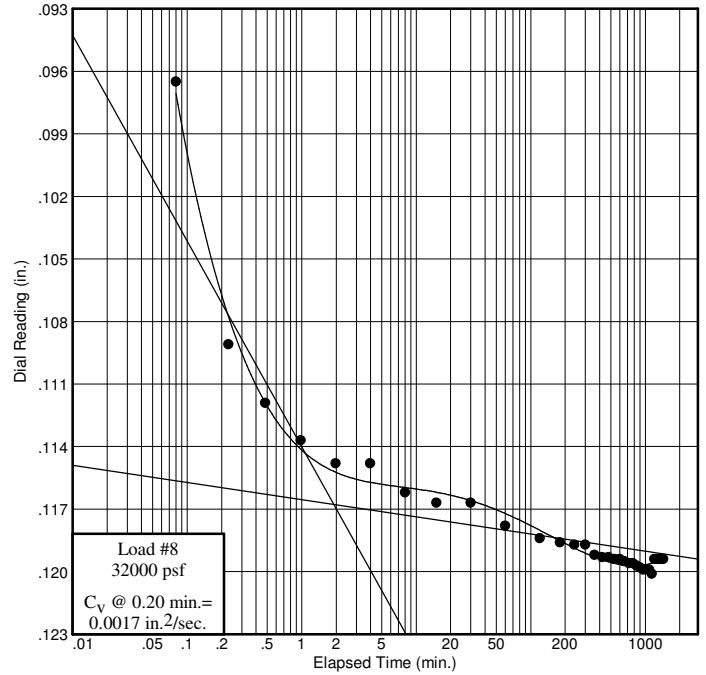
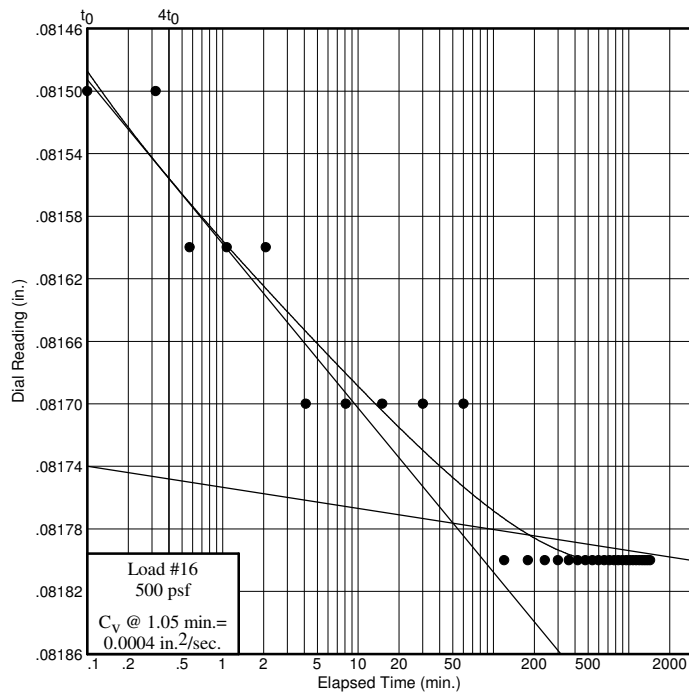
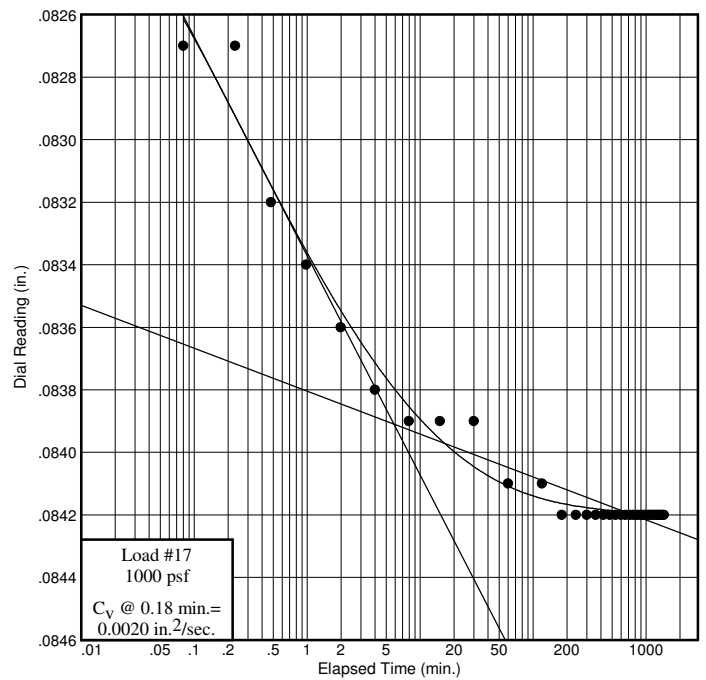
Dial Reading vs. Time

Sample No.: P2

Elev./Depth: 26.0

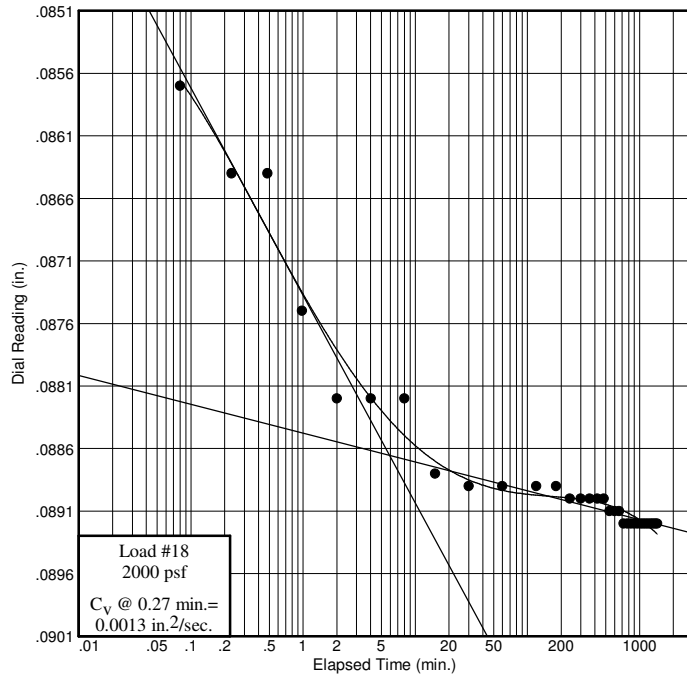
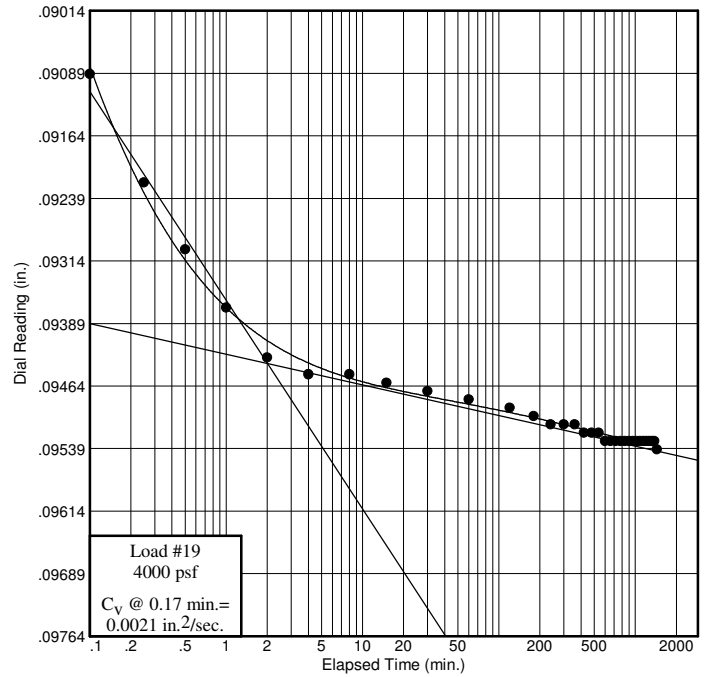
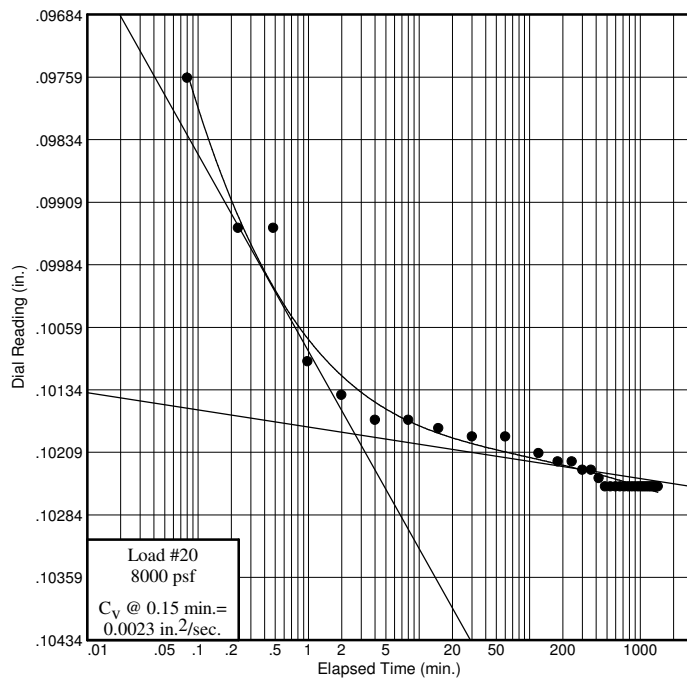
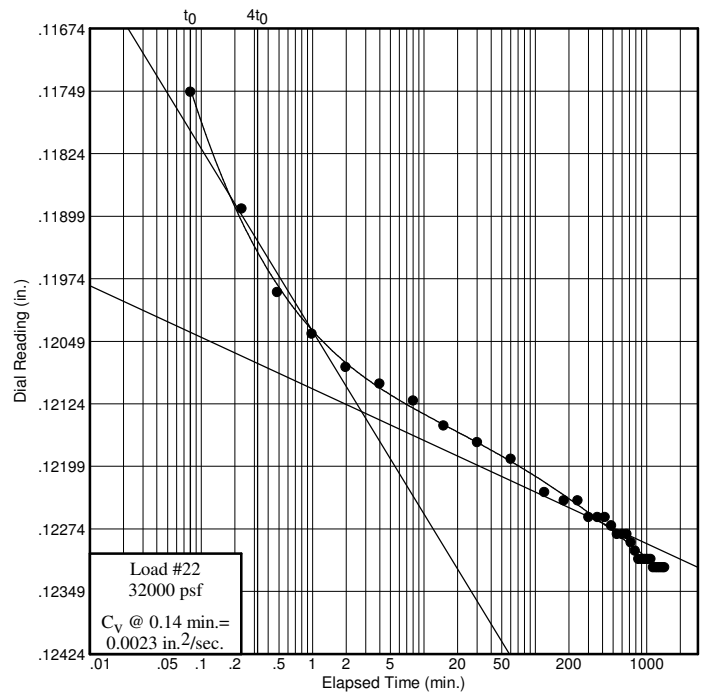
Dial Reading vs. Time

Sample No.: P2

Elev./Depth: 26.0
