Subject: Regulated Material Investigation including Stockpiled Material Sampling for Ohio Department of Transportation Project CUY-14-6.93 (PID 104132) Agreement Number 36311: Task Order Contract Work Order Number 39097-7 for Parcel 14 Located in Garfield Heights, Cuyahoga County, Ohio 44115.

PHOTOGRAPHIC LOG

Parcel 14

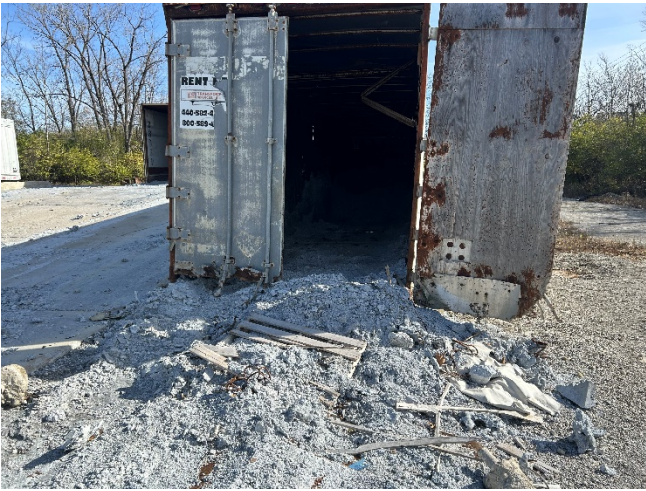
View of the entrance to the trailer with stockpiled material.

Samples were collected of a stockpiled material suspected of being recycled magnesium. The material consisted of a dark gray, fine, powdery substance. The stockpile near the entrance of the trailer was segregated into three (3) approximately equal areas, and a total of three (3) surface composite samples was collected. The samples were submitted to Summit Environmental Technologies (SET) to be analyzed for total aluminum, magnesium, and manganese using U.S. EPA Method 6000/7000 series methods.

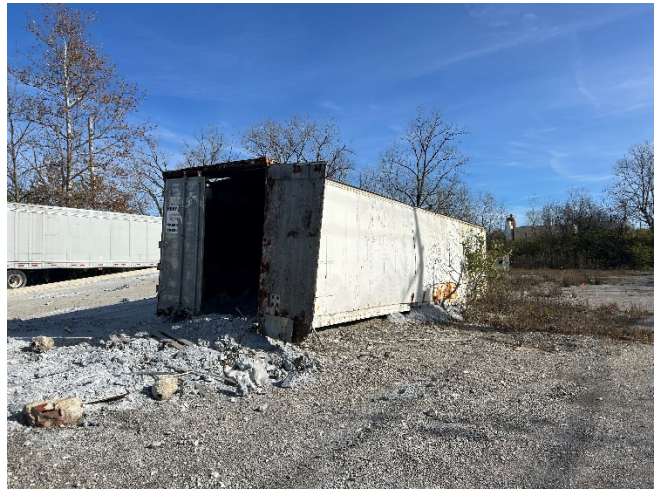
View of the southern side of the trailer and stockpiled material.

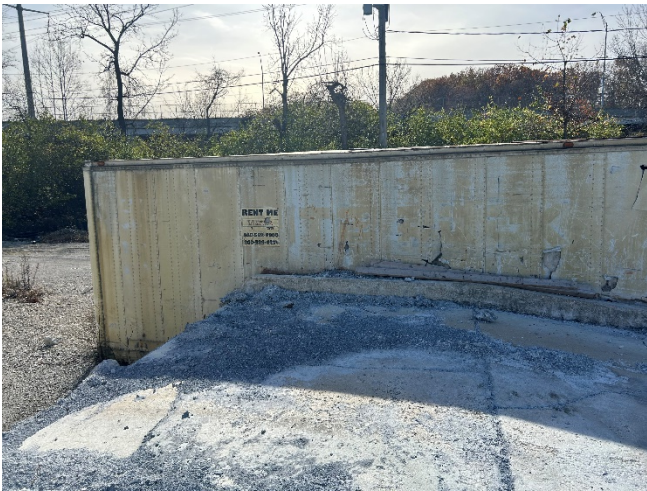
View of the northern side of the trailer.

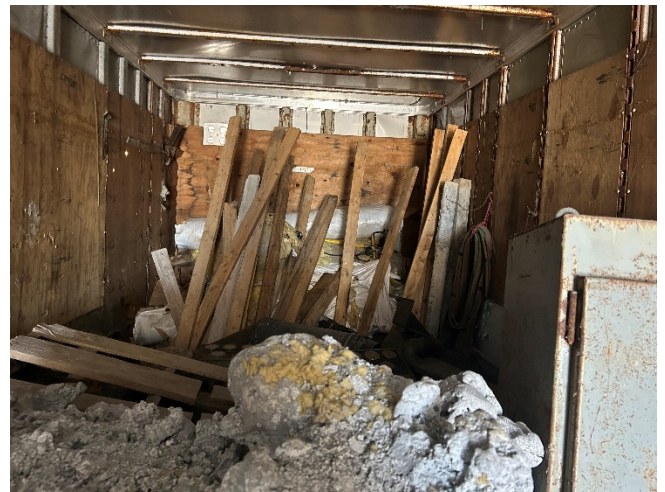
As noted, the Property contained a 49-foot by 10-foot metal trailer filled with debris including scrap wood, scrap metal, and fiberglass insulation. Based on the inspection, no asbestos was identified in or on the trailer.

View of the wood scrap, metal scrap, and fiberglass inside the trailer.
