## Asbestos Inspection Reporting Form

| County | Cuyahoga | Route | Granger Road over West Creek |
| Section | CUY-17-14.14 | PID | 117053 |

EnviroScience, Inc. was contracted by the Ohio Department of Transportation to provide an asbestos survey of the CUY-17-14.14 (SFN: 1802461) bridge structure located on Granger Road over West Creek. The location coordinates of the structure are 41.414392, -81.647431.

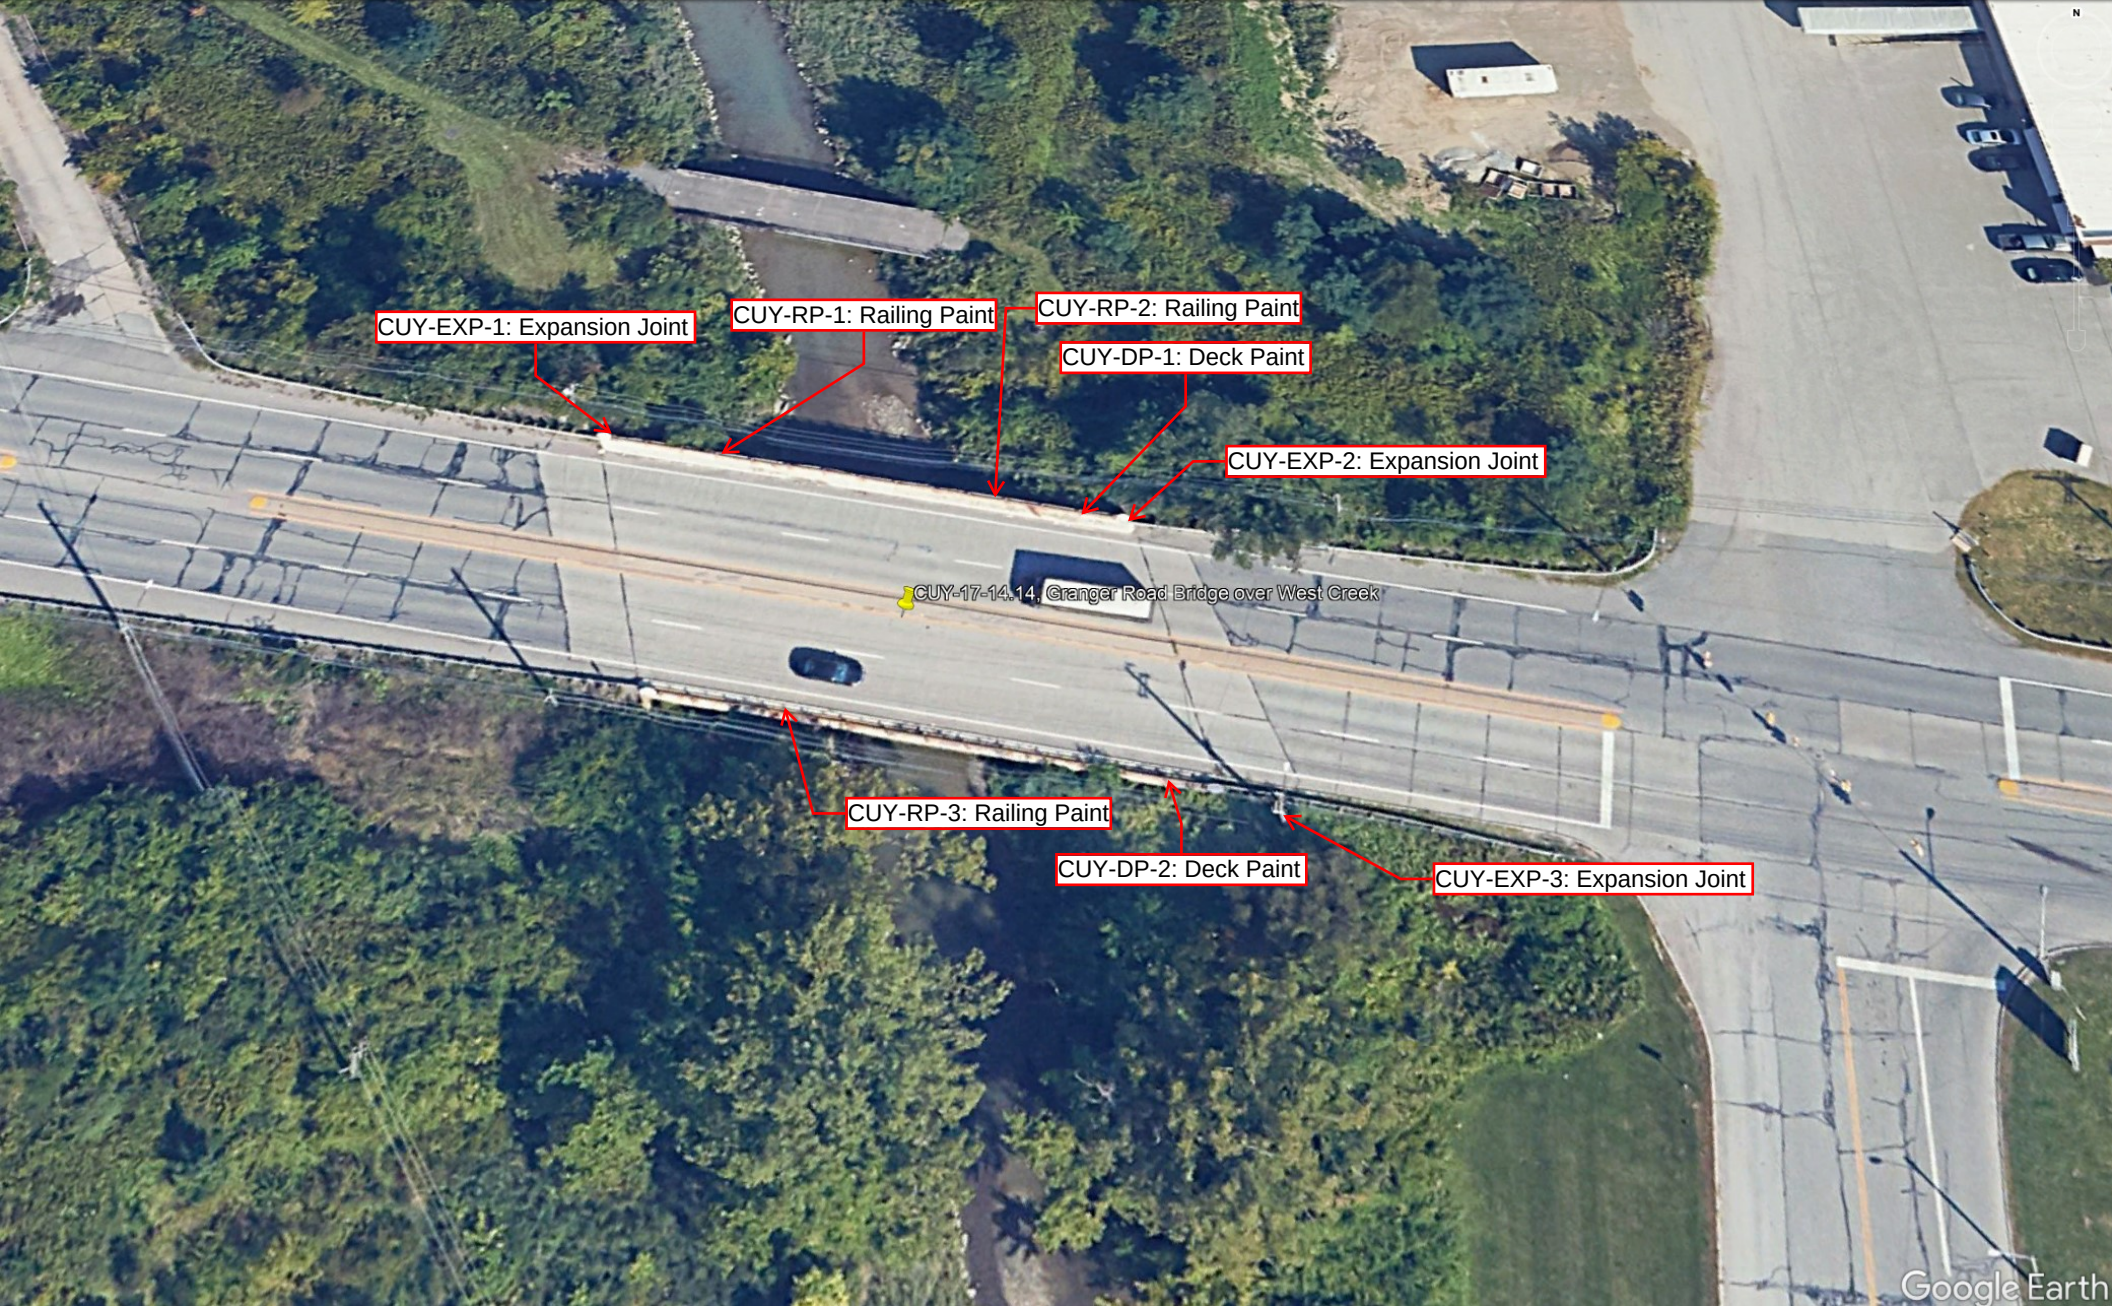
CUY-17-14.14, Granger Road Bridge over West Creek

CUY-EXP-1: Expansion Joint

CUY-RP-1: Railing Point

CUY-RP-2: Railing Point

CUY-DP-1: Deck Paint

CUY-EXP-2: Expansion Joint

CUY-RP-3: Railing Point

CUY-DP-2: Deck Paint

CUY-EXP-3: Expansion Joint

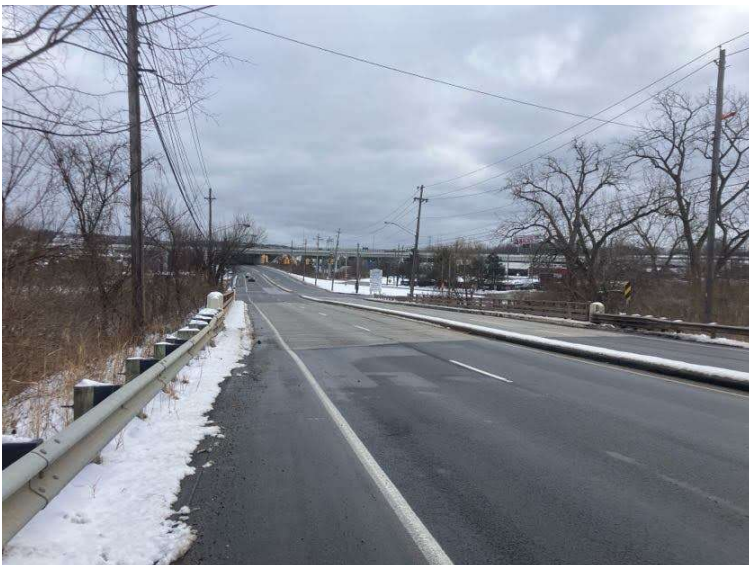
**PHOTO 1**  
View of bridge CUY-17-14.14,  
facing east.

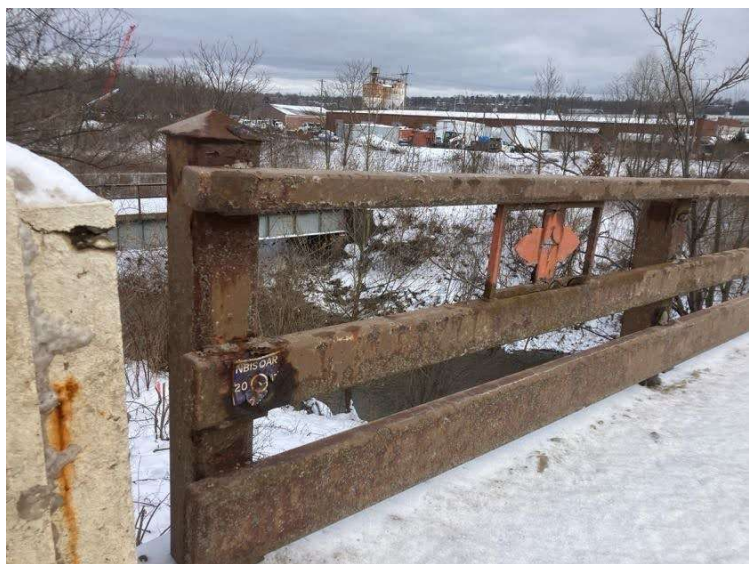
**PHOTO 2**  
View of the metal railing.  
Samples were collected for the  
flaking paint and found to not  
contain ACM.

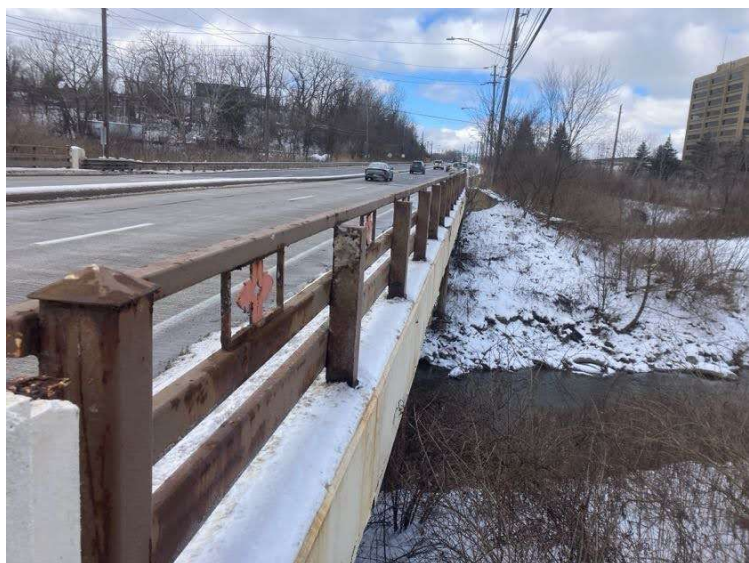
**PHOTO 3**  
View of the north side of the  
structure. No utilities were  
affixed to the structure.

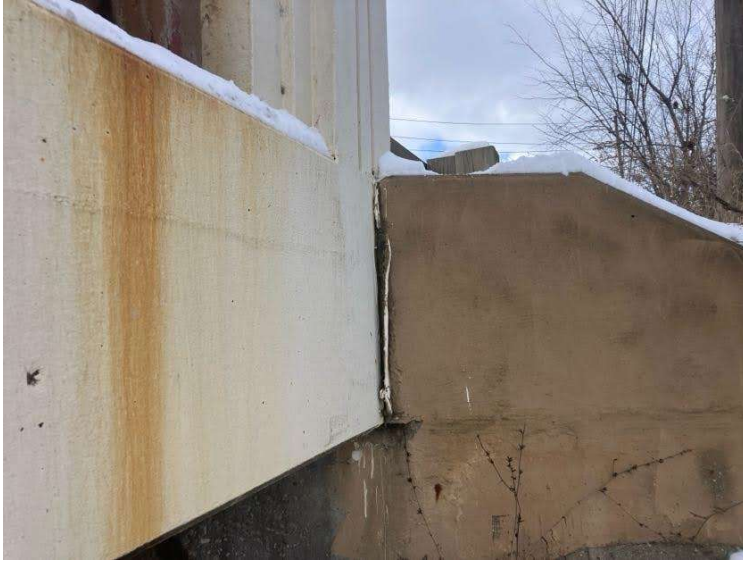
PHOTO 4

| Homogeneous Area | Category | Location of Sample | Positive Asbestos? | Quantity ACM (approximate) |
|---|---|---|---|---|
| Expansion Joint Material | Misc | Gap between wingwall and deck slab | Yes- 10% Chrysotile | 16 SF |

View of where the wingwall and deck slab meet. Expansion joint was found and sampled. The material collected was a fiber pressed particle board type. Results indicate it is positive for asbestos.

Lab analysis of bulk samples taken of the expansion joint material in the joint between the abutment wingwall and the deck slab indicates that the expansion joint material contains 10% chrysotile asbestos. The expansion joint material is the fiber particle board type and would be friable, if exposed and disturbed. Approximately 16 sq. ft. of expansion joint material is estimated to be present on the structure (Table 2). This is below the regulatory thresholds for abatement of 50 sq. ft. for friable material and 160 sq. ft. for non-friable material. However, OSHA still regulates the handling of friable ACMs less than 50 linear or 50 square feet under the Asbestos Construction Industry Standard (29 CFR 1926.1101). Therefore, renovation or demolition activities involving the disturbance of friable ACMs less than 50 linear or 50 square feet of ACMs must be performed in accordance with the requirements of 29 CFR 1926.1101.

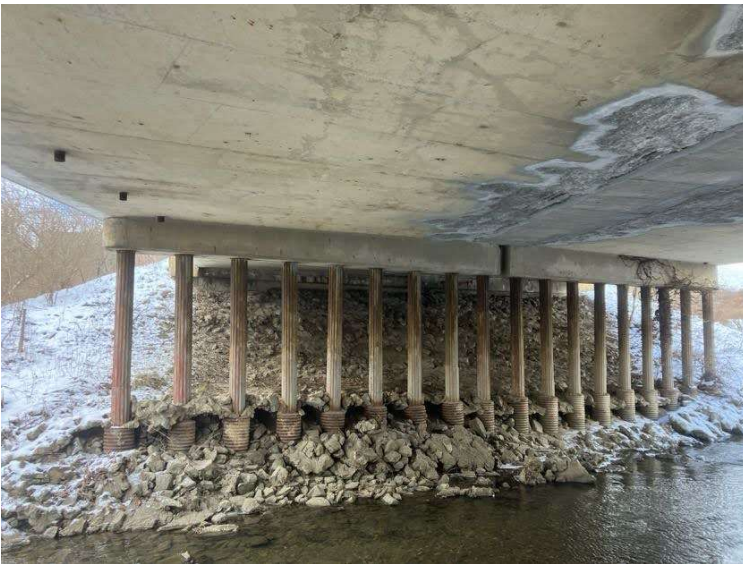
PHOTO 5

View of the underside of the structure looking at the concrete piles, pier caps, and rock armored slope protection. No utilities were affixed to the structure.

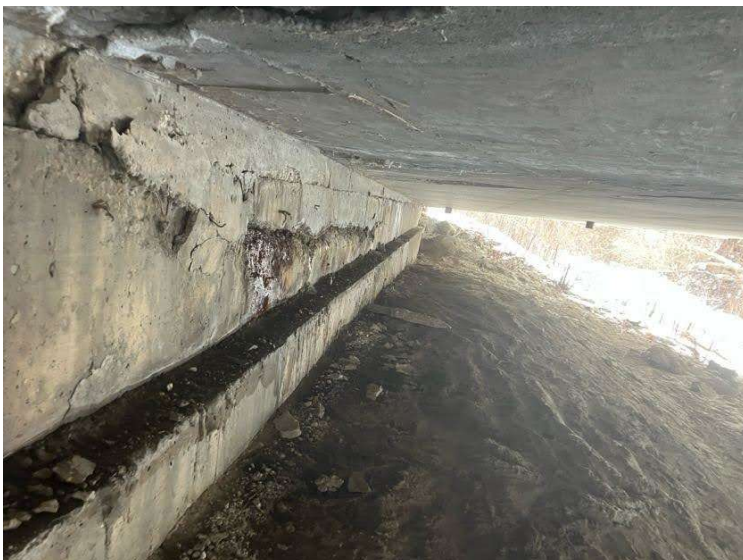
PHOTO 6

View of the concrete abutment and bottom of deck slab beneath the structure. No expansion joint, gasketing materials or other suspected ACM was observed.

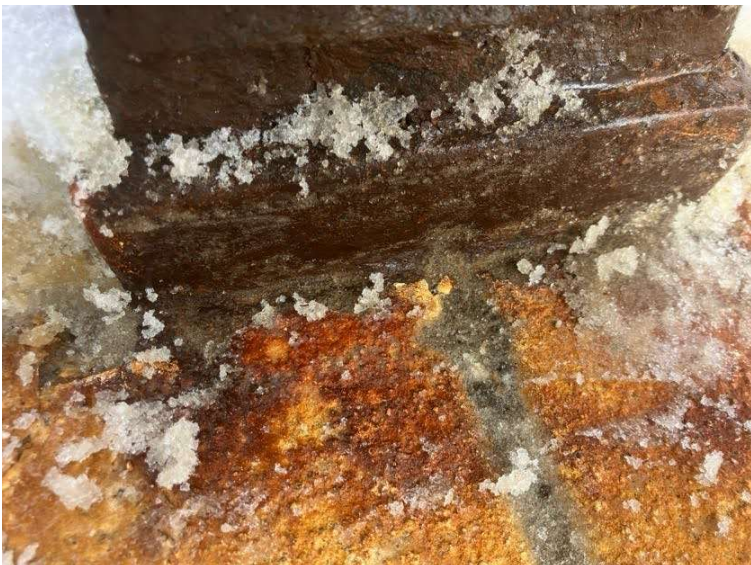
PHOTO 7

Close up view of where the railing and sidewalk meet. No expansion joint or gasketing materials were observed.

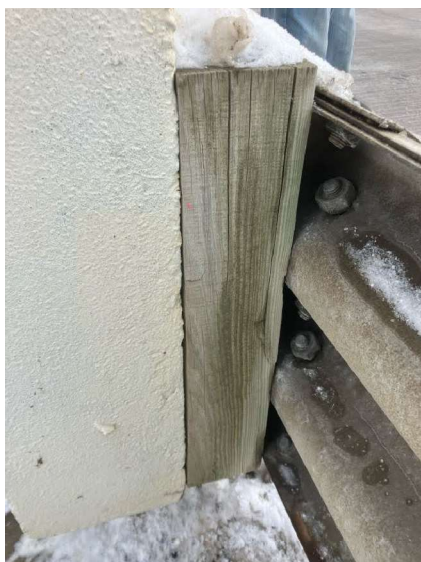
PHOTO 8

View of where steel guardrail is affixed to the bridge. No gasketing materials or other suspected ACM were observed.

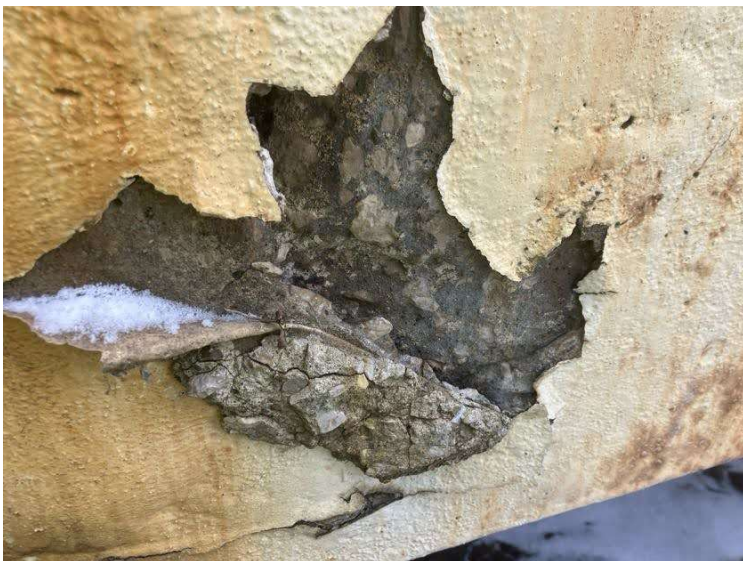
PHOTO 9

Close up view of the white curing sealer located on the side of the bridge deck.

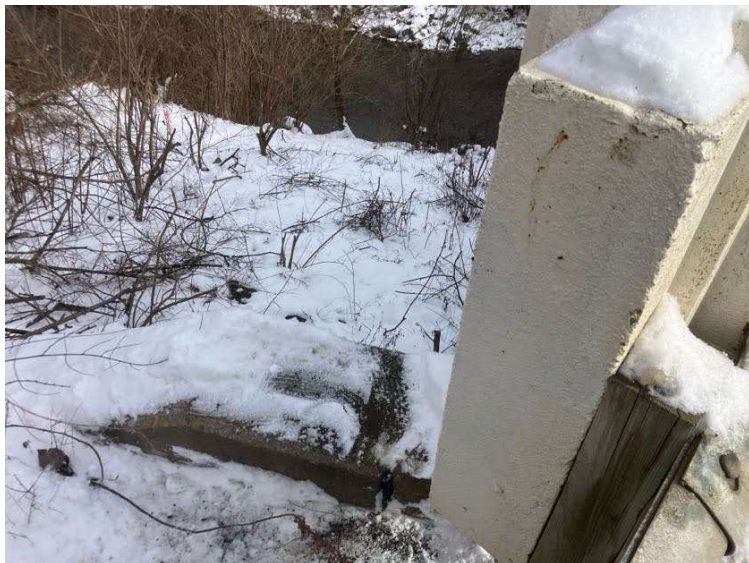
PHOTO 10  
View of the top of the wingwall  
where the expansion joint was  
sampled. Sample results indicate  
it was ACM.

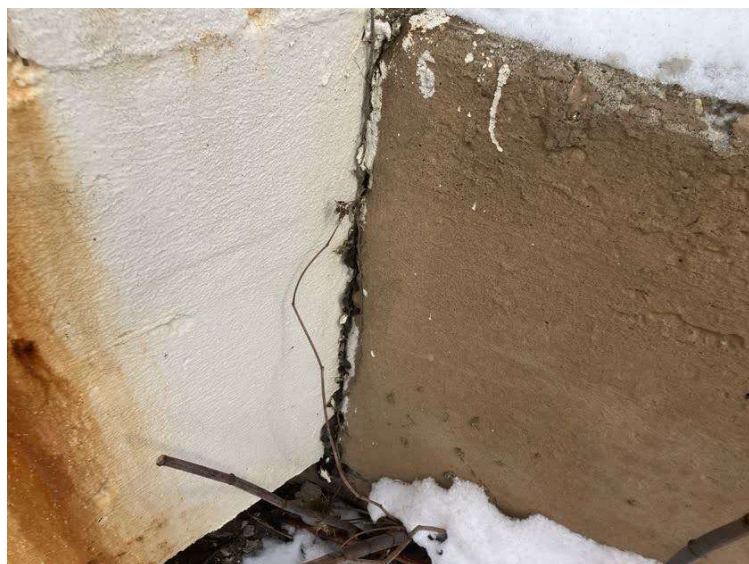
PHOTO 11  
View of the expansion joint  
material where the wingwall and  
deck slab meet. Samples  
collected were ACM.
