**FRA-270-9.3
BRIDGE REHABILITATION
ODOT DISTRICT 6
PID 105498
COLUMBUS, OHIO**

ASBESTOS SURVEY

Rii Project #W-20-145

January 2021

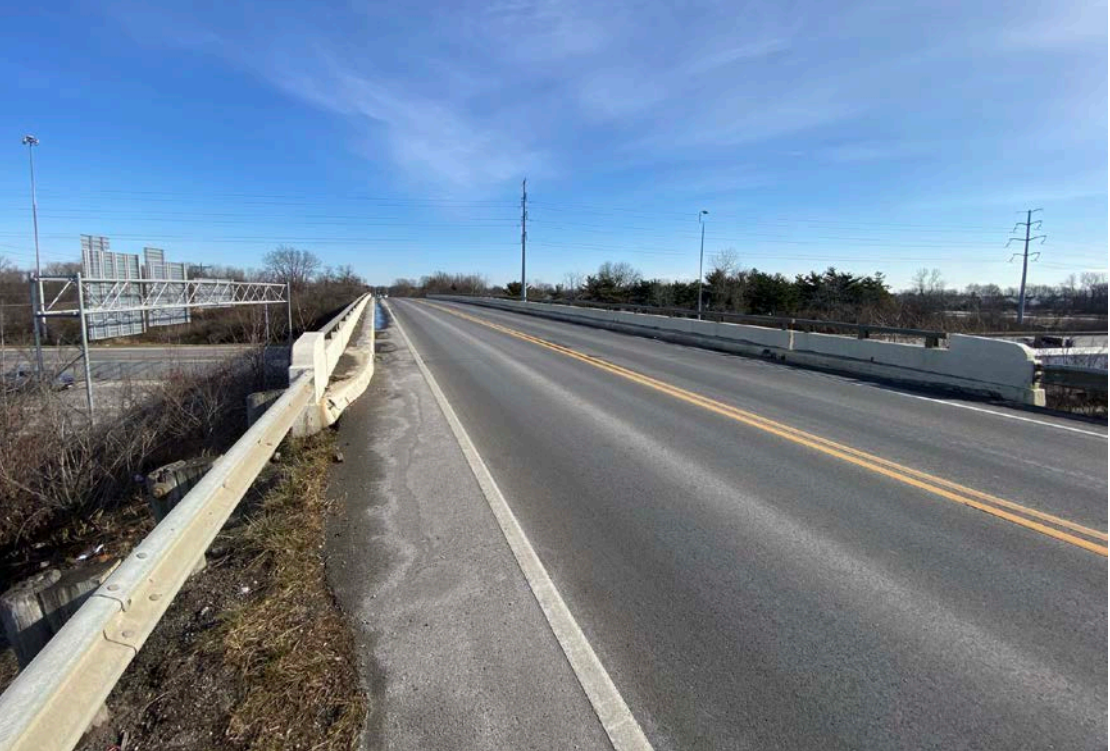
Project Name: FRA-270-9.3 Bridge Rehabilitation		Location: Trabue Road at I-270, Columbus, Ohio	Project No. W-20-145
Photo No. 1	Date: 12/29/2020

Description: View to the east from the west end of the bridge. No asbestos was detected in the white and yellow striping paint.

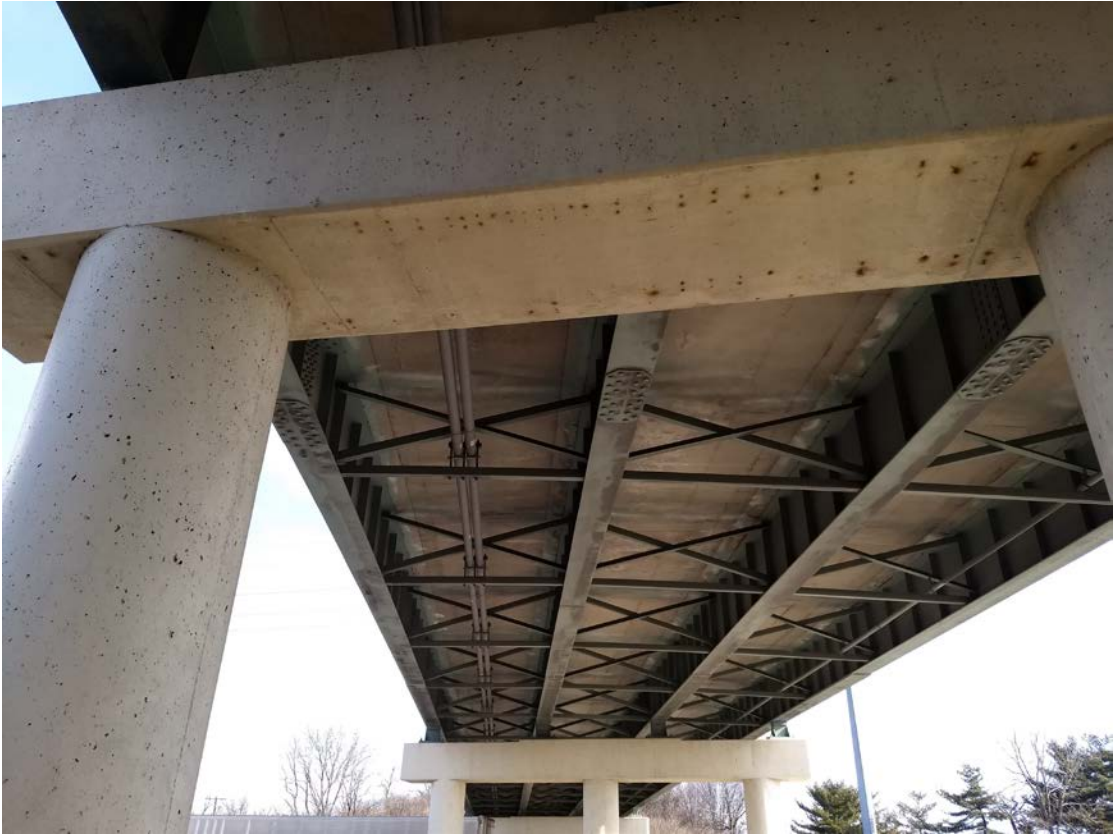
Project Name: FRA-270-9.3 Bridge Rehabilitation		Location: Trabue Road at I-270, Columbus, Ohio	Project No. W-20-145
Photo No. 3	Date: 12/29/2020

Description: View of the underside of the bridge. The conduits were fiberglass.
