**Reference: HAM-74-14.20**  
**Report of Landslide Exploration - FINAL**  
**PID No. 110174**

**HAM-74-14.20**  
**Report of Landslide Exploration**  
**(FINAL)**

PID No. 110174

Hamilton County, Ohio

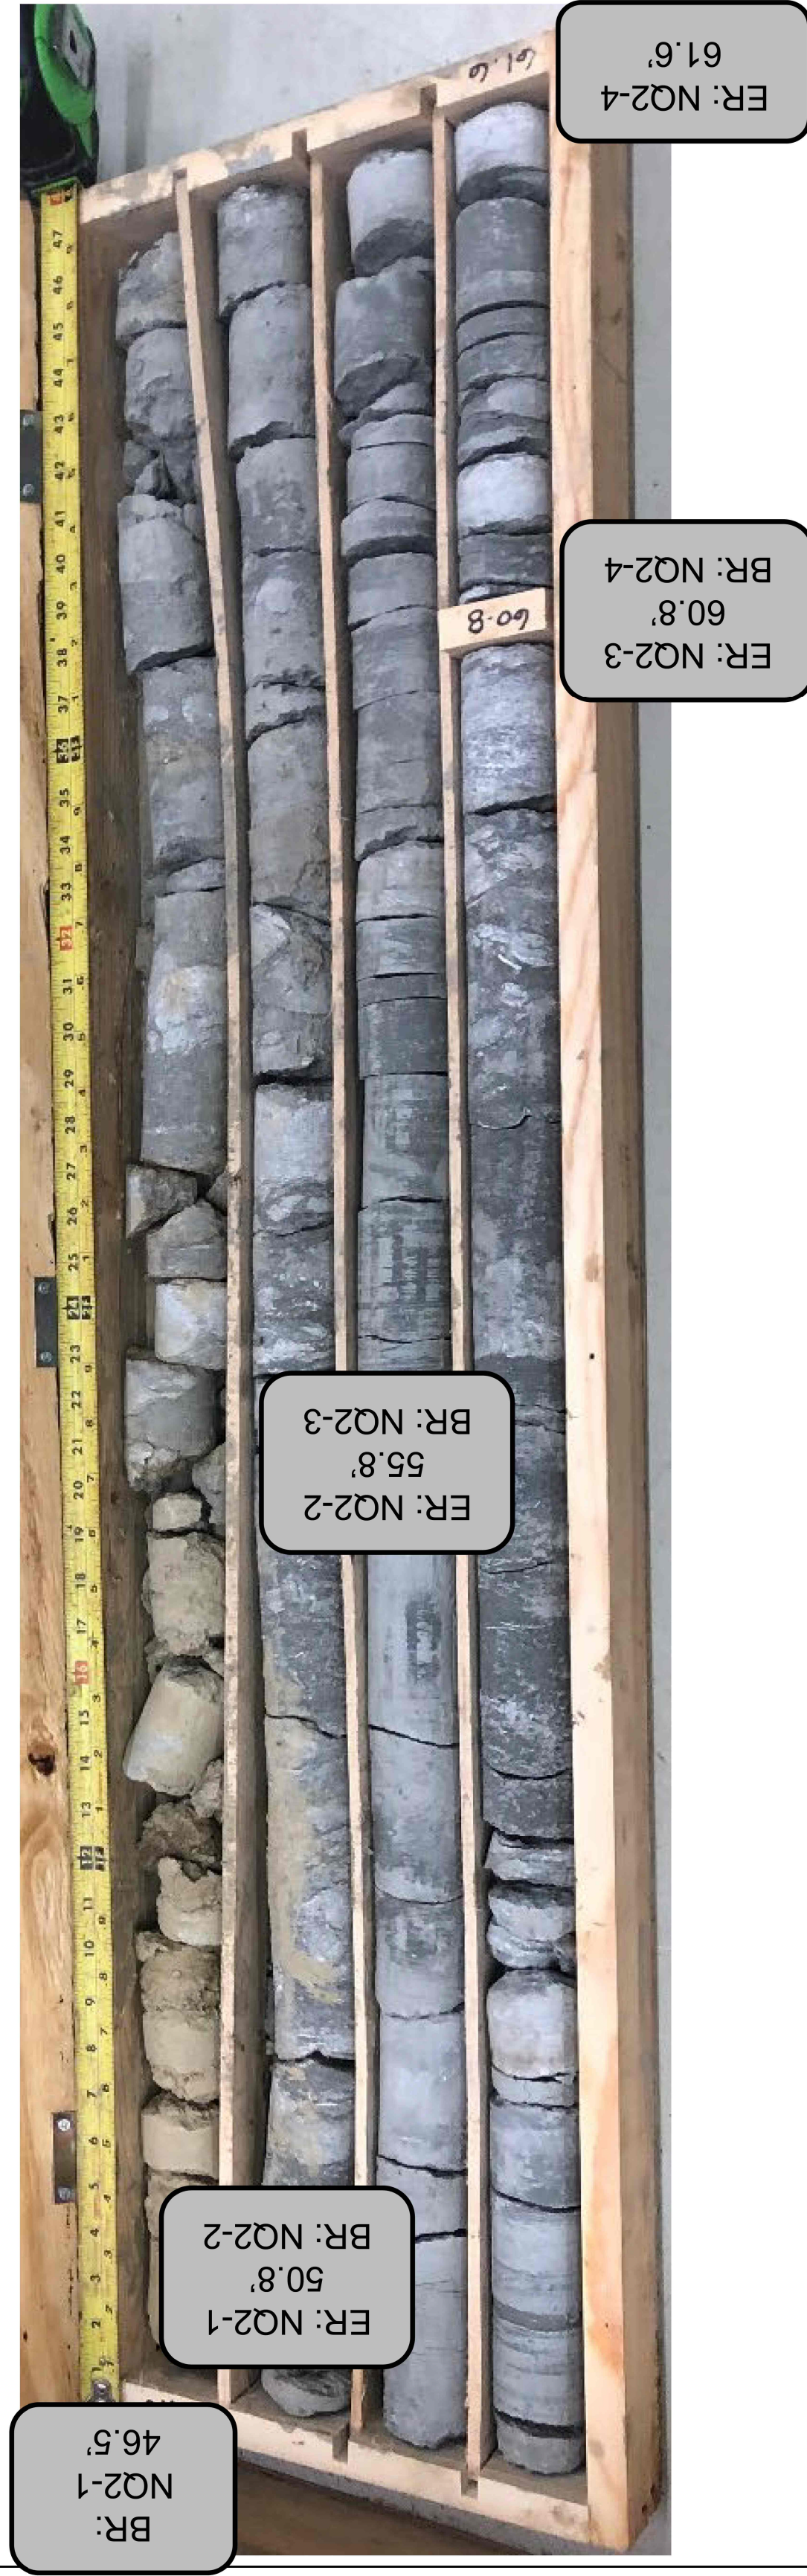
B-002-0-19

Run #:	Depth	Recovery	RQD
NQ2-1	46.5'	6/52	6/52 12%
NQ2-2	50.8'	60/60	35/60 58%
NQ2-3	55.8'	60/60	33.5/60 56%
NQ2-4	60.8'	10/10	5/10 50%

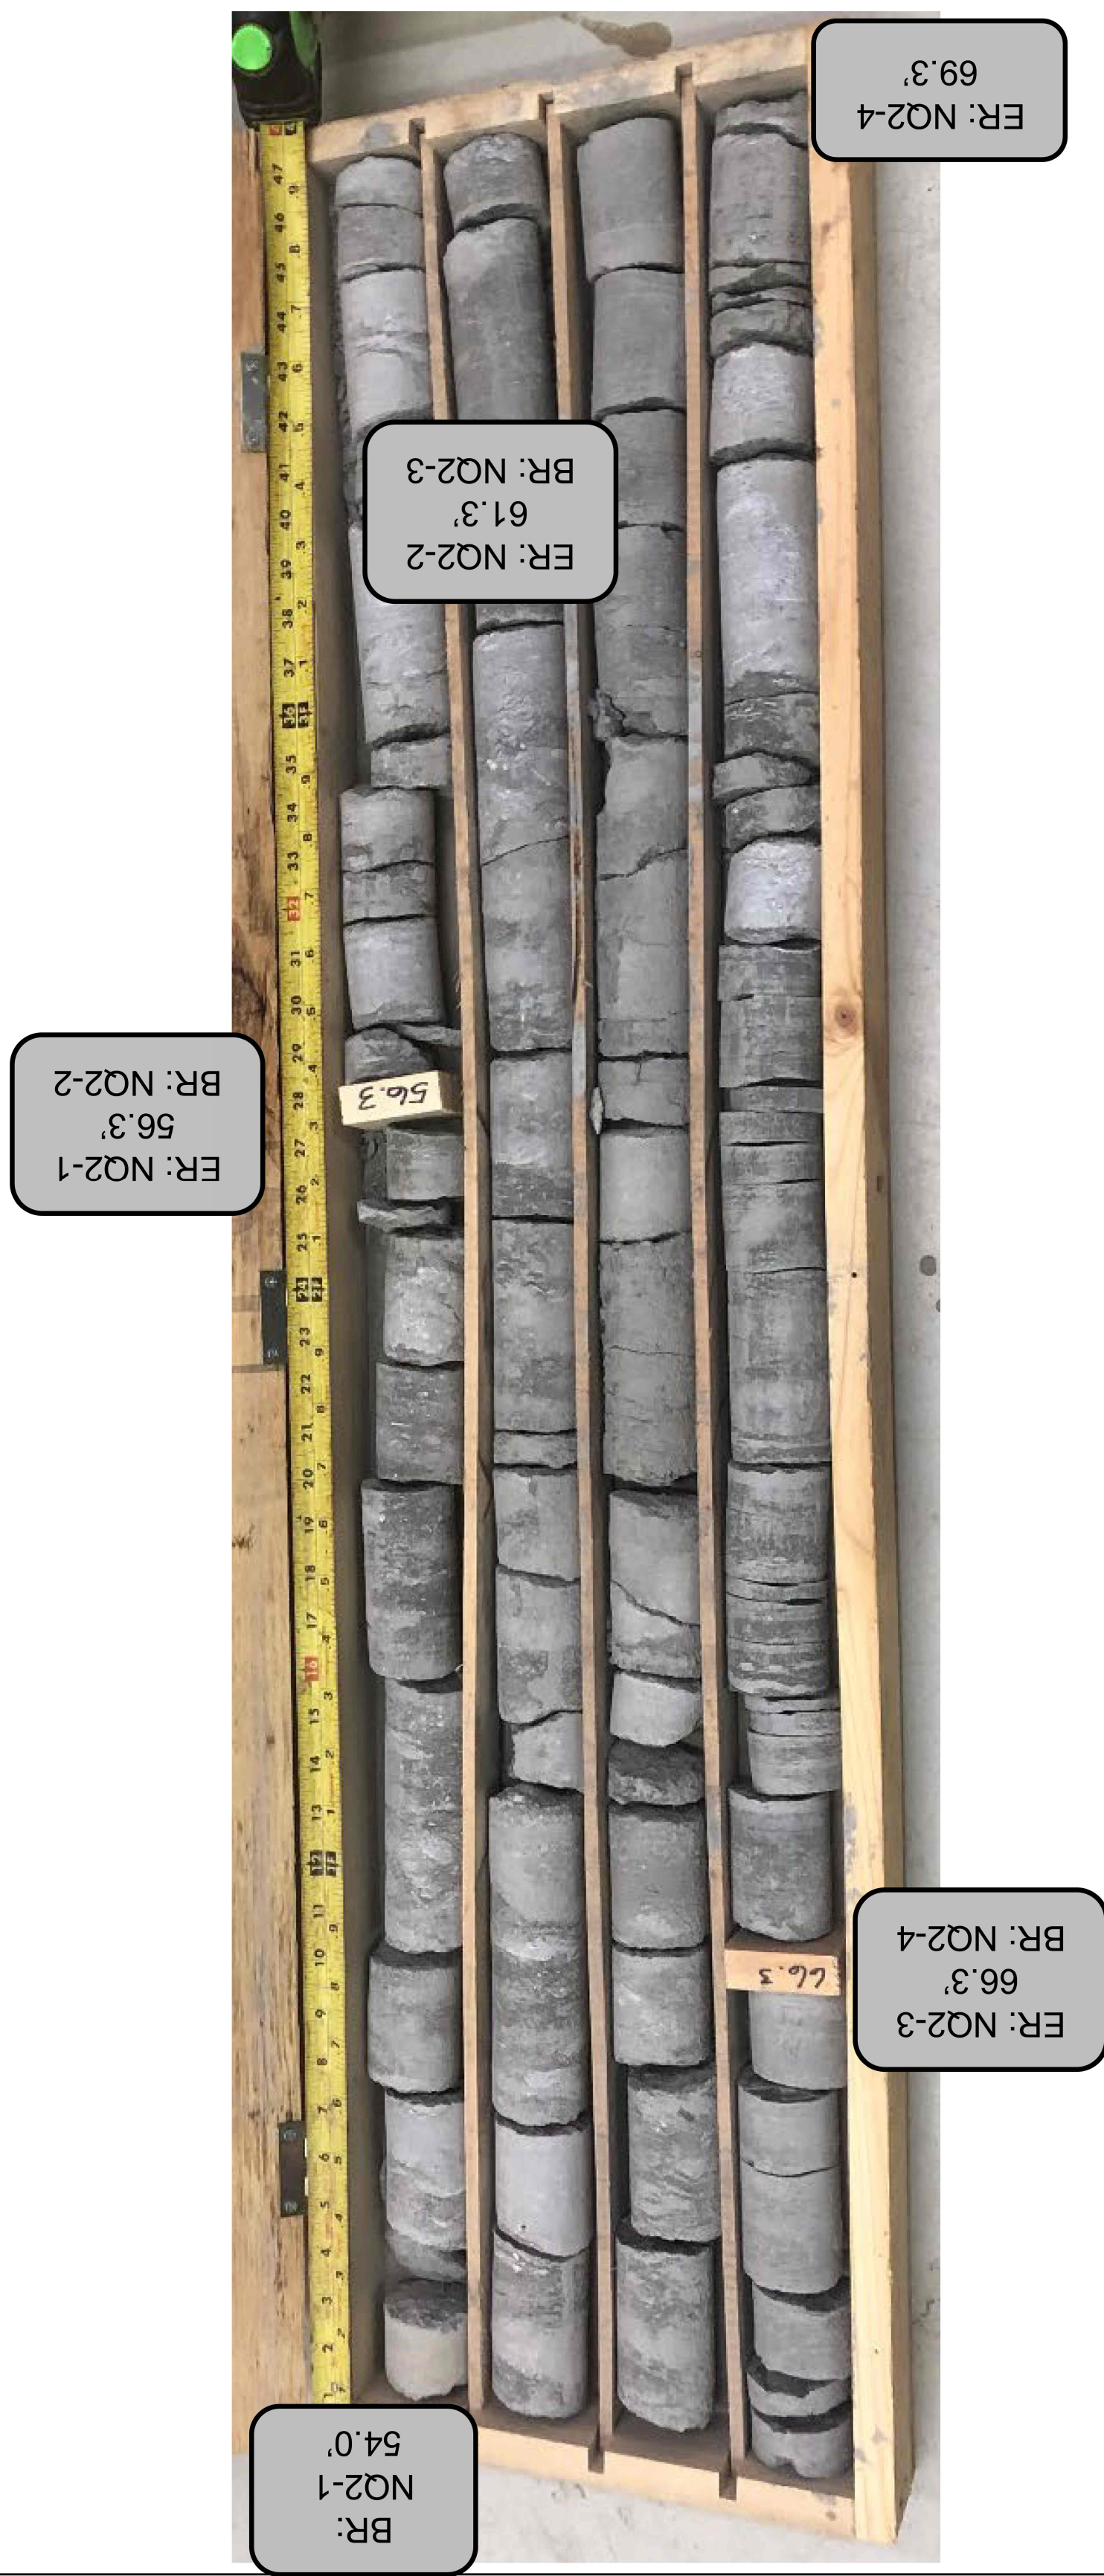
B-004-0-19

Run #:	Depth	Recovery	RQD
NQ2-1	54.0'	27/28	12/28
NQ2-2	56.3'	57.5/60	35/60
NQ2-3	61.3'	60/60	37/60
NQ2-4	66.3'	36/36	19/36

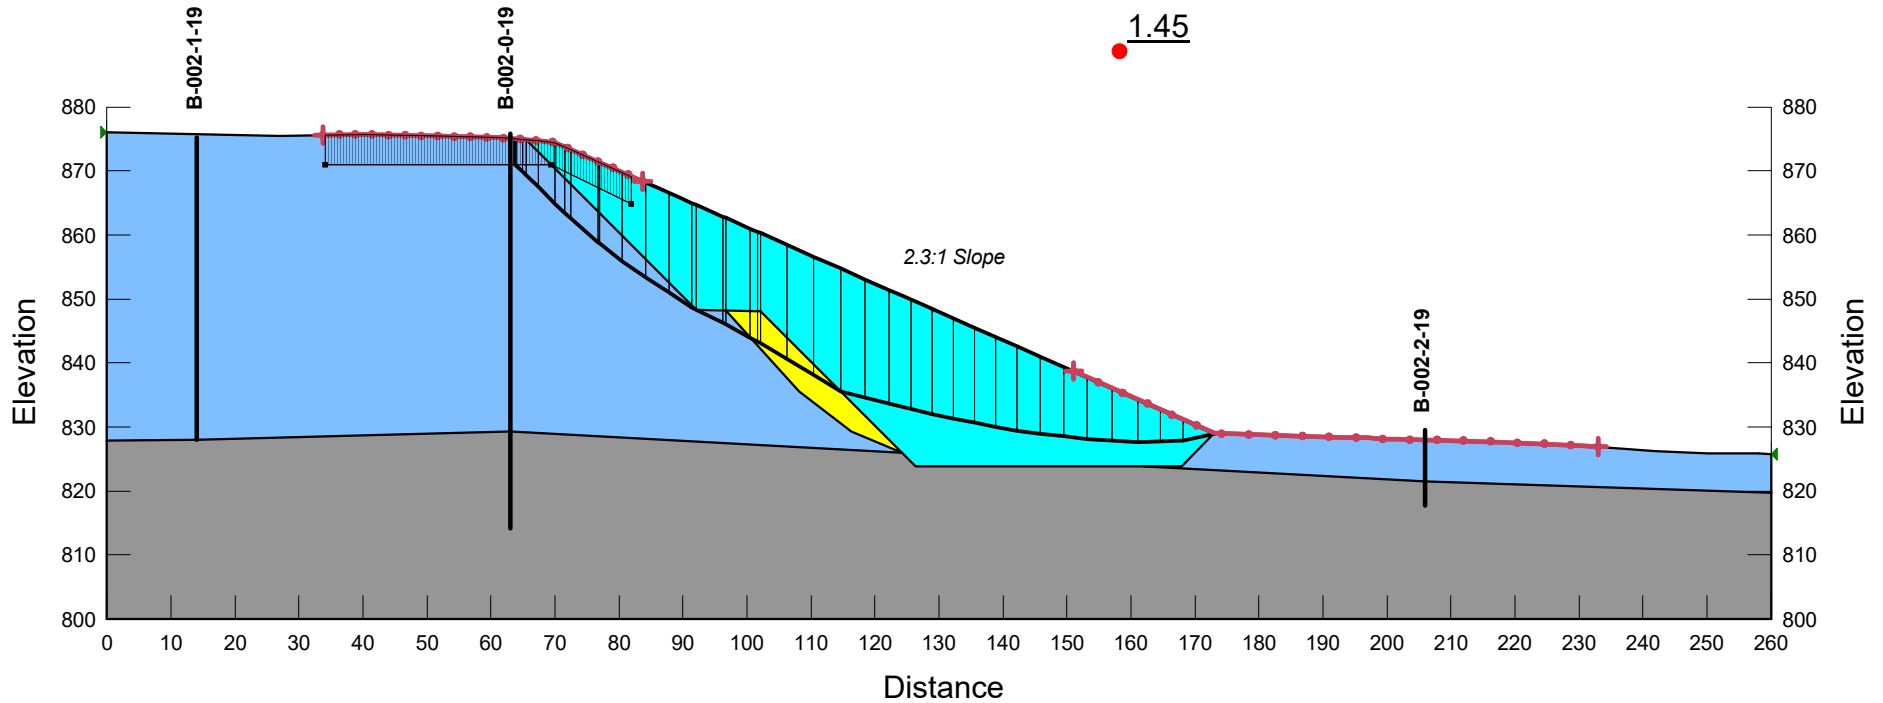
Slope Stability (cut/fill stability)_drained	
HAM-74_North Bend Slide_768+50.gsz	
06/24/2022	1:360

Color	Name	Model	Unit Weight (pcf)	Cohesion' (psf)	Phi' (°)
■	Bedrock	Bedrock (Impenetrable)			
■	Clay Soil (undrained)	Mohr-Coulomb	120	1,500	0
■	Clay Soil (weakened)	Mohr-Coulomb	120	0	14.5
■	Embankment Fill (undrained)	Mohr-Coulomb	125	2,000	0

Slope stability analyses were performed for the proposed bench and slope configurations at Station 768+50 and 770+50. The soil parameters estimated from the stability back analysis were used to analyze model the weakened soil near the existing failure surface. The existing embankment was modelled using an undrained cohesion of 1,500 psf, drained cohesion of 150 psf, and a drained friction angle of 24 degrees. The shear strength parameters used for the new embankment material were assumed to be a drained cohesion of 200 psf, a drained friction angle of 26 degrees, and an undrained cohesion of 2,000 psf based on Table 1 from GB 2 for an assumed borrow source of A-7-6 soil. The resulting factor or safety was 1.5 to 1.6 for drained conditions and 2.2 to 2.3 for undrained conditions. Graphical output showing the results of this stability analyses are shown in Appendix B.

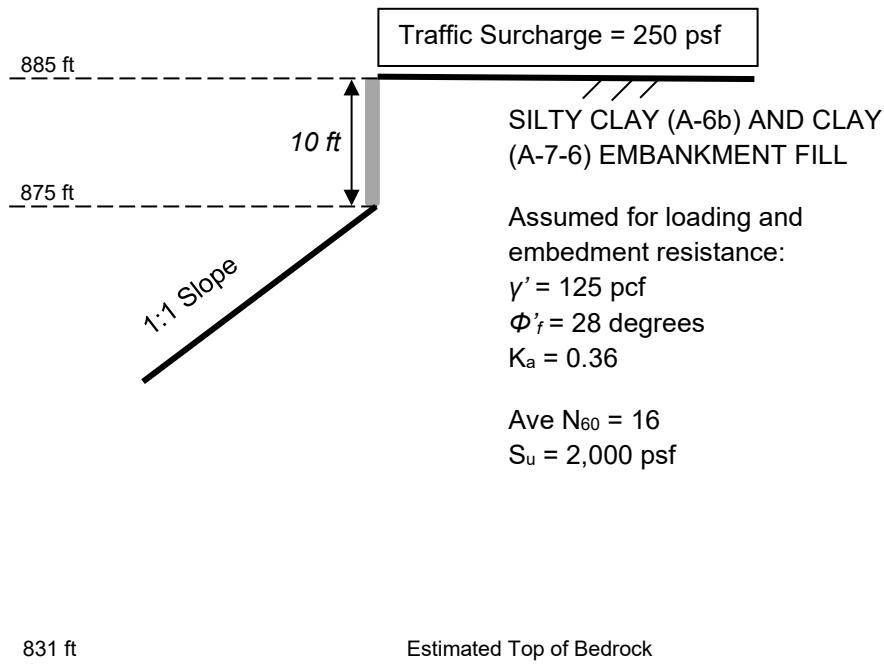
Base subsurface conditions on borings B-004-0-19.

Assume a flat backslope behind the shoring and 1:1 slope in front of wall.
