**Reference: Final Structure Foundation Exploration Report for HAN-75-14.39  
Bridge No. HAN-75-1477 over IR-75 Mainline and Norfolk Southern Railroad  
Findlay, Hancock County, Ohio  
PID No. 87005  
PGI Project No. G13011G**

**FINAL  
STRUCTION FOUNDATION EXPLORATION REPORT  
FOR HAN-75-14.39  
BRIDGE NO. HAN-75-1477 OVER IR-75 AND NORFOLK SOUTHERN RAILROAD**

**HANCOCK COUNTY, OHIO  
PGI PROJECT NO. G13011G  
PID NO. 87005**

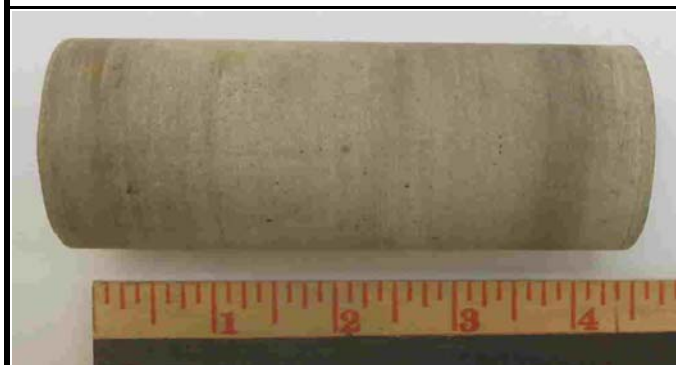
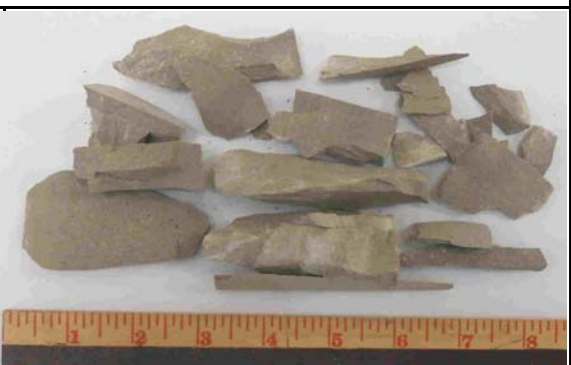
BEFORE TESTING

AFTER FAILURE

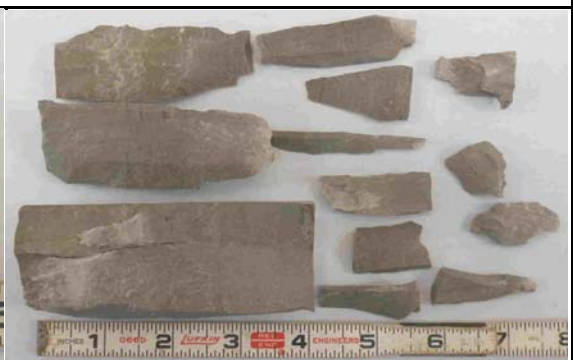
BEFORE TESTING

AFTER FAILURE

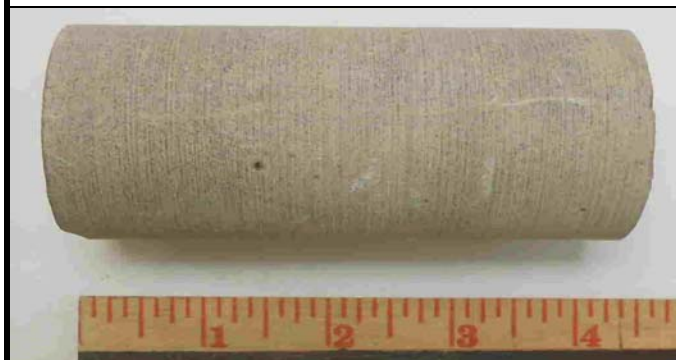
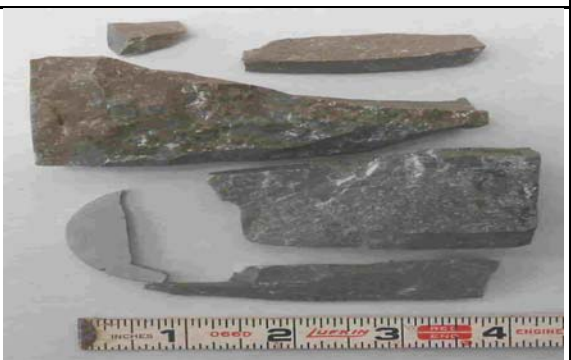
BEFORE TESTING

AFTER FAILURE

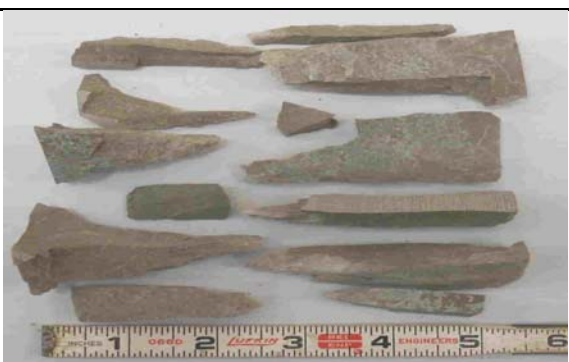
**BEFORE TESTING**

**AFTER FAILURE**

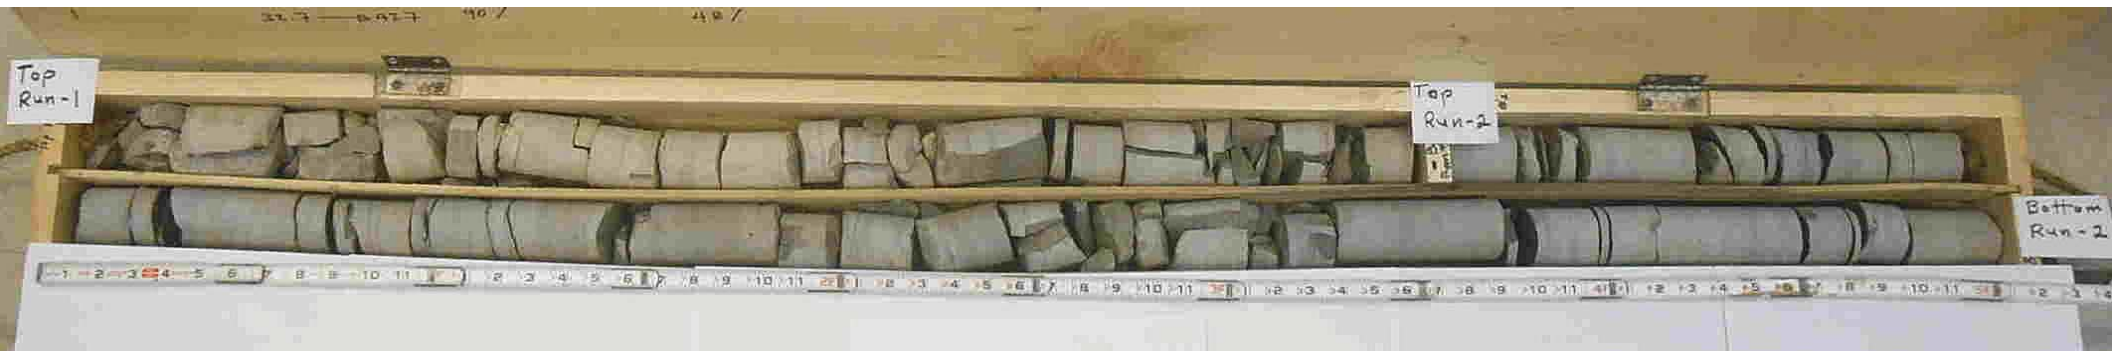
| RUN-2: 31.4' - 37.8' | REC: 100% RQD: 65% |

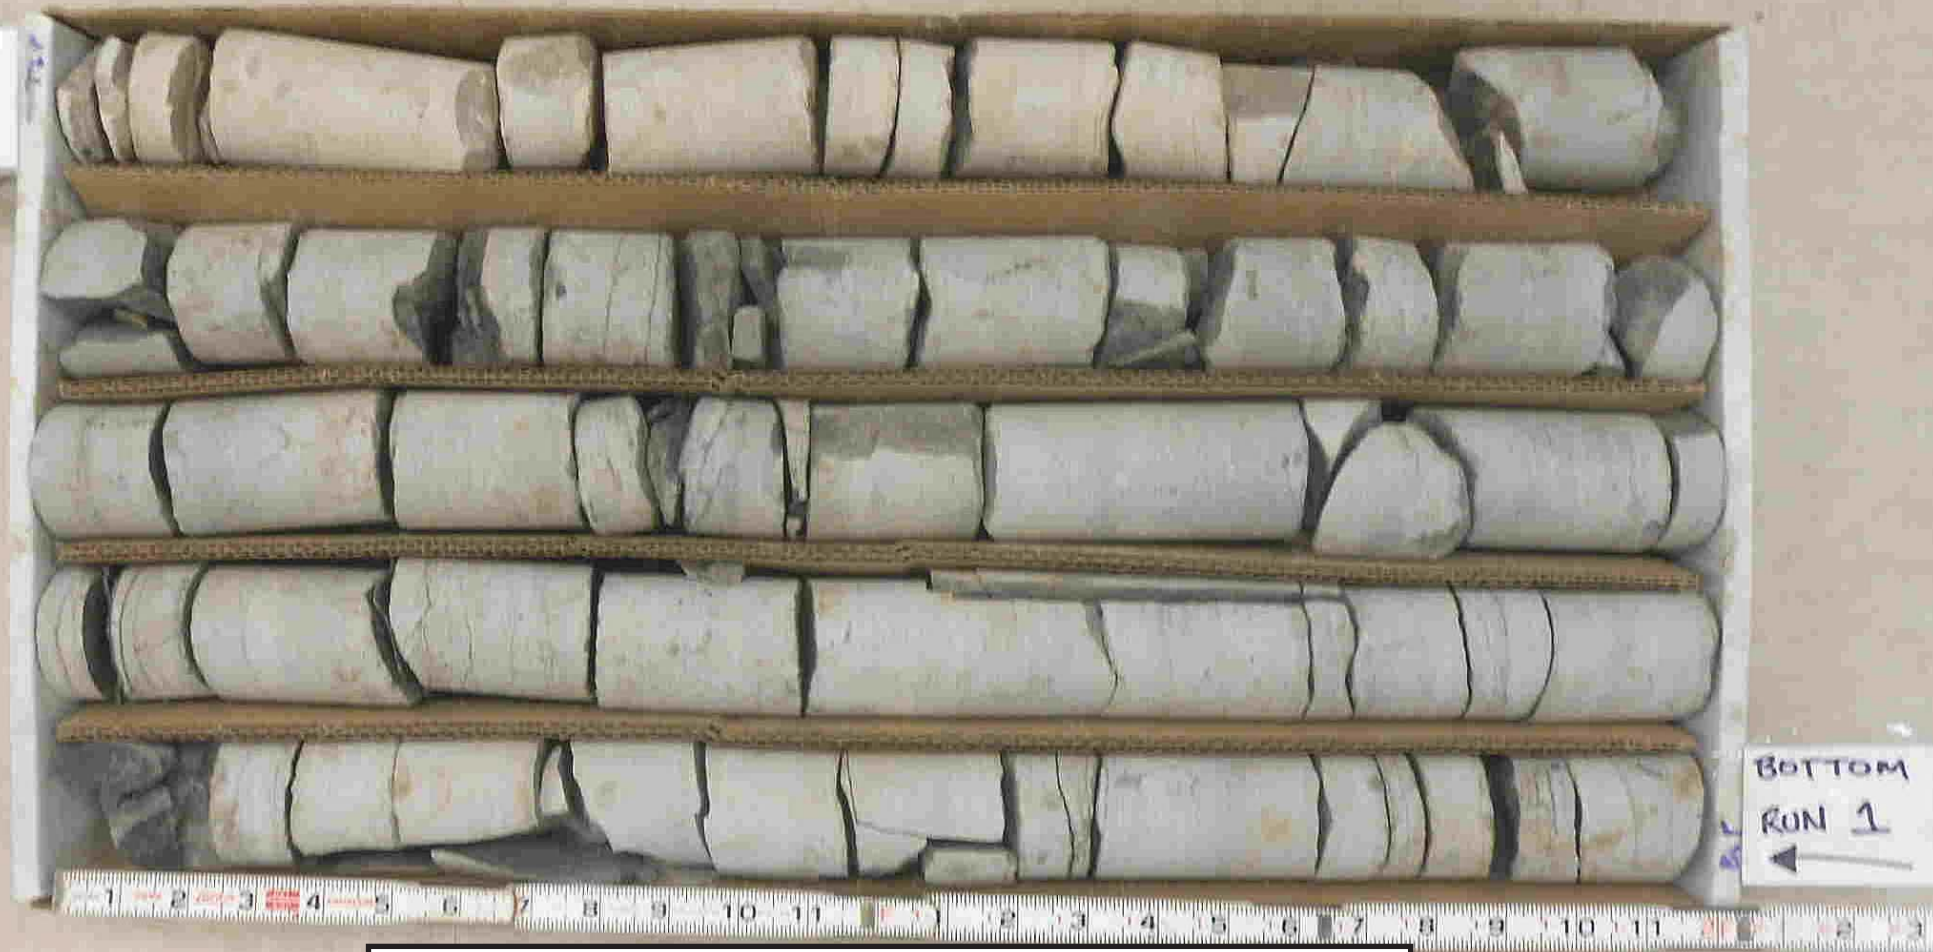
RUN-1: 4.3' - 14.3'

REC: 98% RQD: 42%

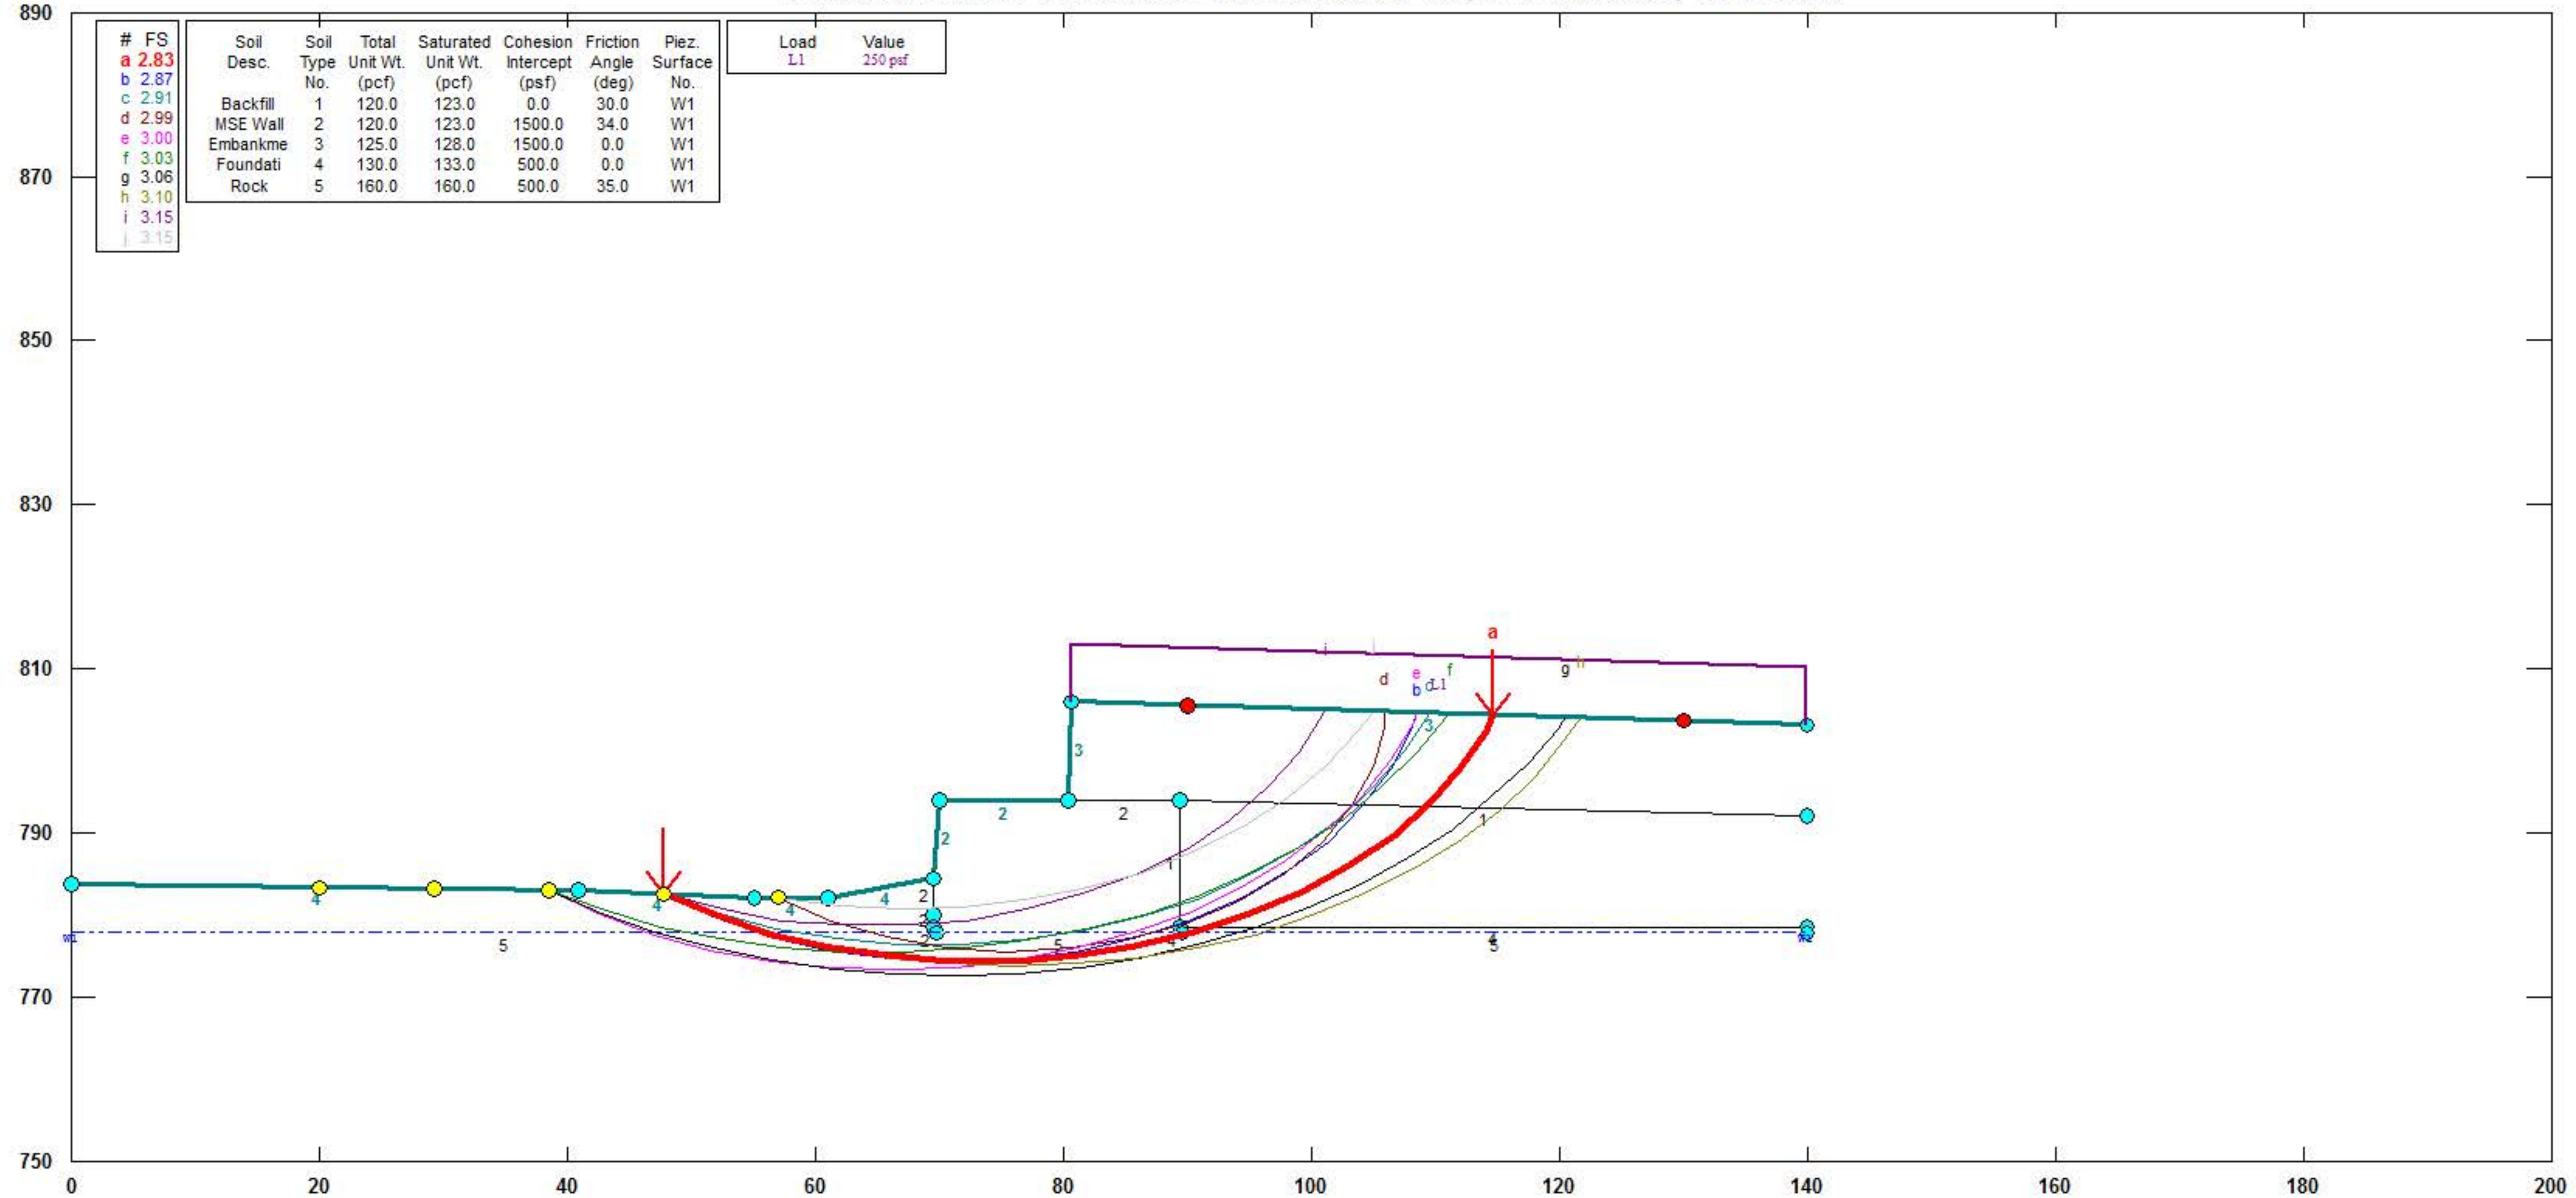
GSTABL7 v.2 FSmin=2.83  
 Safety Factors Are Calculated By The Modified Bishop Method

Global stability analyses were performed using the GSTABL7 with STEDwin, version 2.0 program that was developed by Mr. Garry H. Gregory, P.E. to estimate the Factor of Safety for the proposed MSE Walls. The foundation soil profiles below the proposed MSE Walls were estimated from information obtained from the test borings. The phreatic surface was assumed as top of bedrock. For slope stability analysis, shear strength soil parameters used in this analysis were obtained from the laboratory tests performed on the undisturbed soil samples obtained from the ramp test borings and from our experience with similar types of soils. Trial failure surfaces were generated using the method of slices for short term and long-term stability. The Modified Bishop Method of slices was used to generate circular trial failure surfaces. Table 6.2.2 summarizes the safety factors for the short term and long term stability of the proposed MSE Wall. Based on this slope stability analysis, the calculated Safety Factors for both short term and long term meet the required Safety Factors specified in the ODOT Embankment Checklist. Slope analyses critical failure circles are included in Appendix B.
