# ASBESTOS SURVEY REPORT

LAK-MR 1986-1.688 (PID 116955)

Bridge Structure (SFN 4304179) of Little Mountain Road over I-90  
Kirtland Hills, Lake County, Ohio 44060

Ohio Department of Transportation District 12  
September 11, 2026

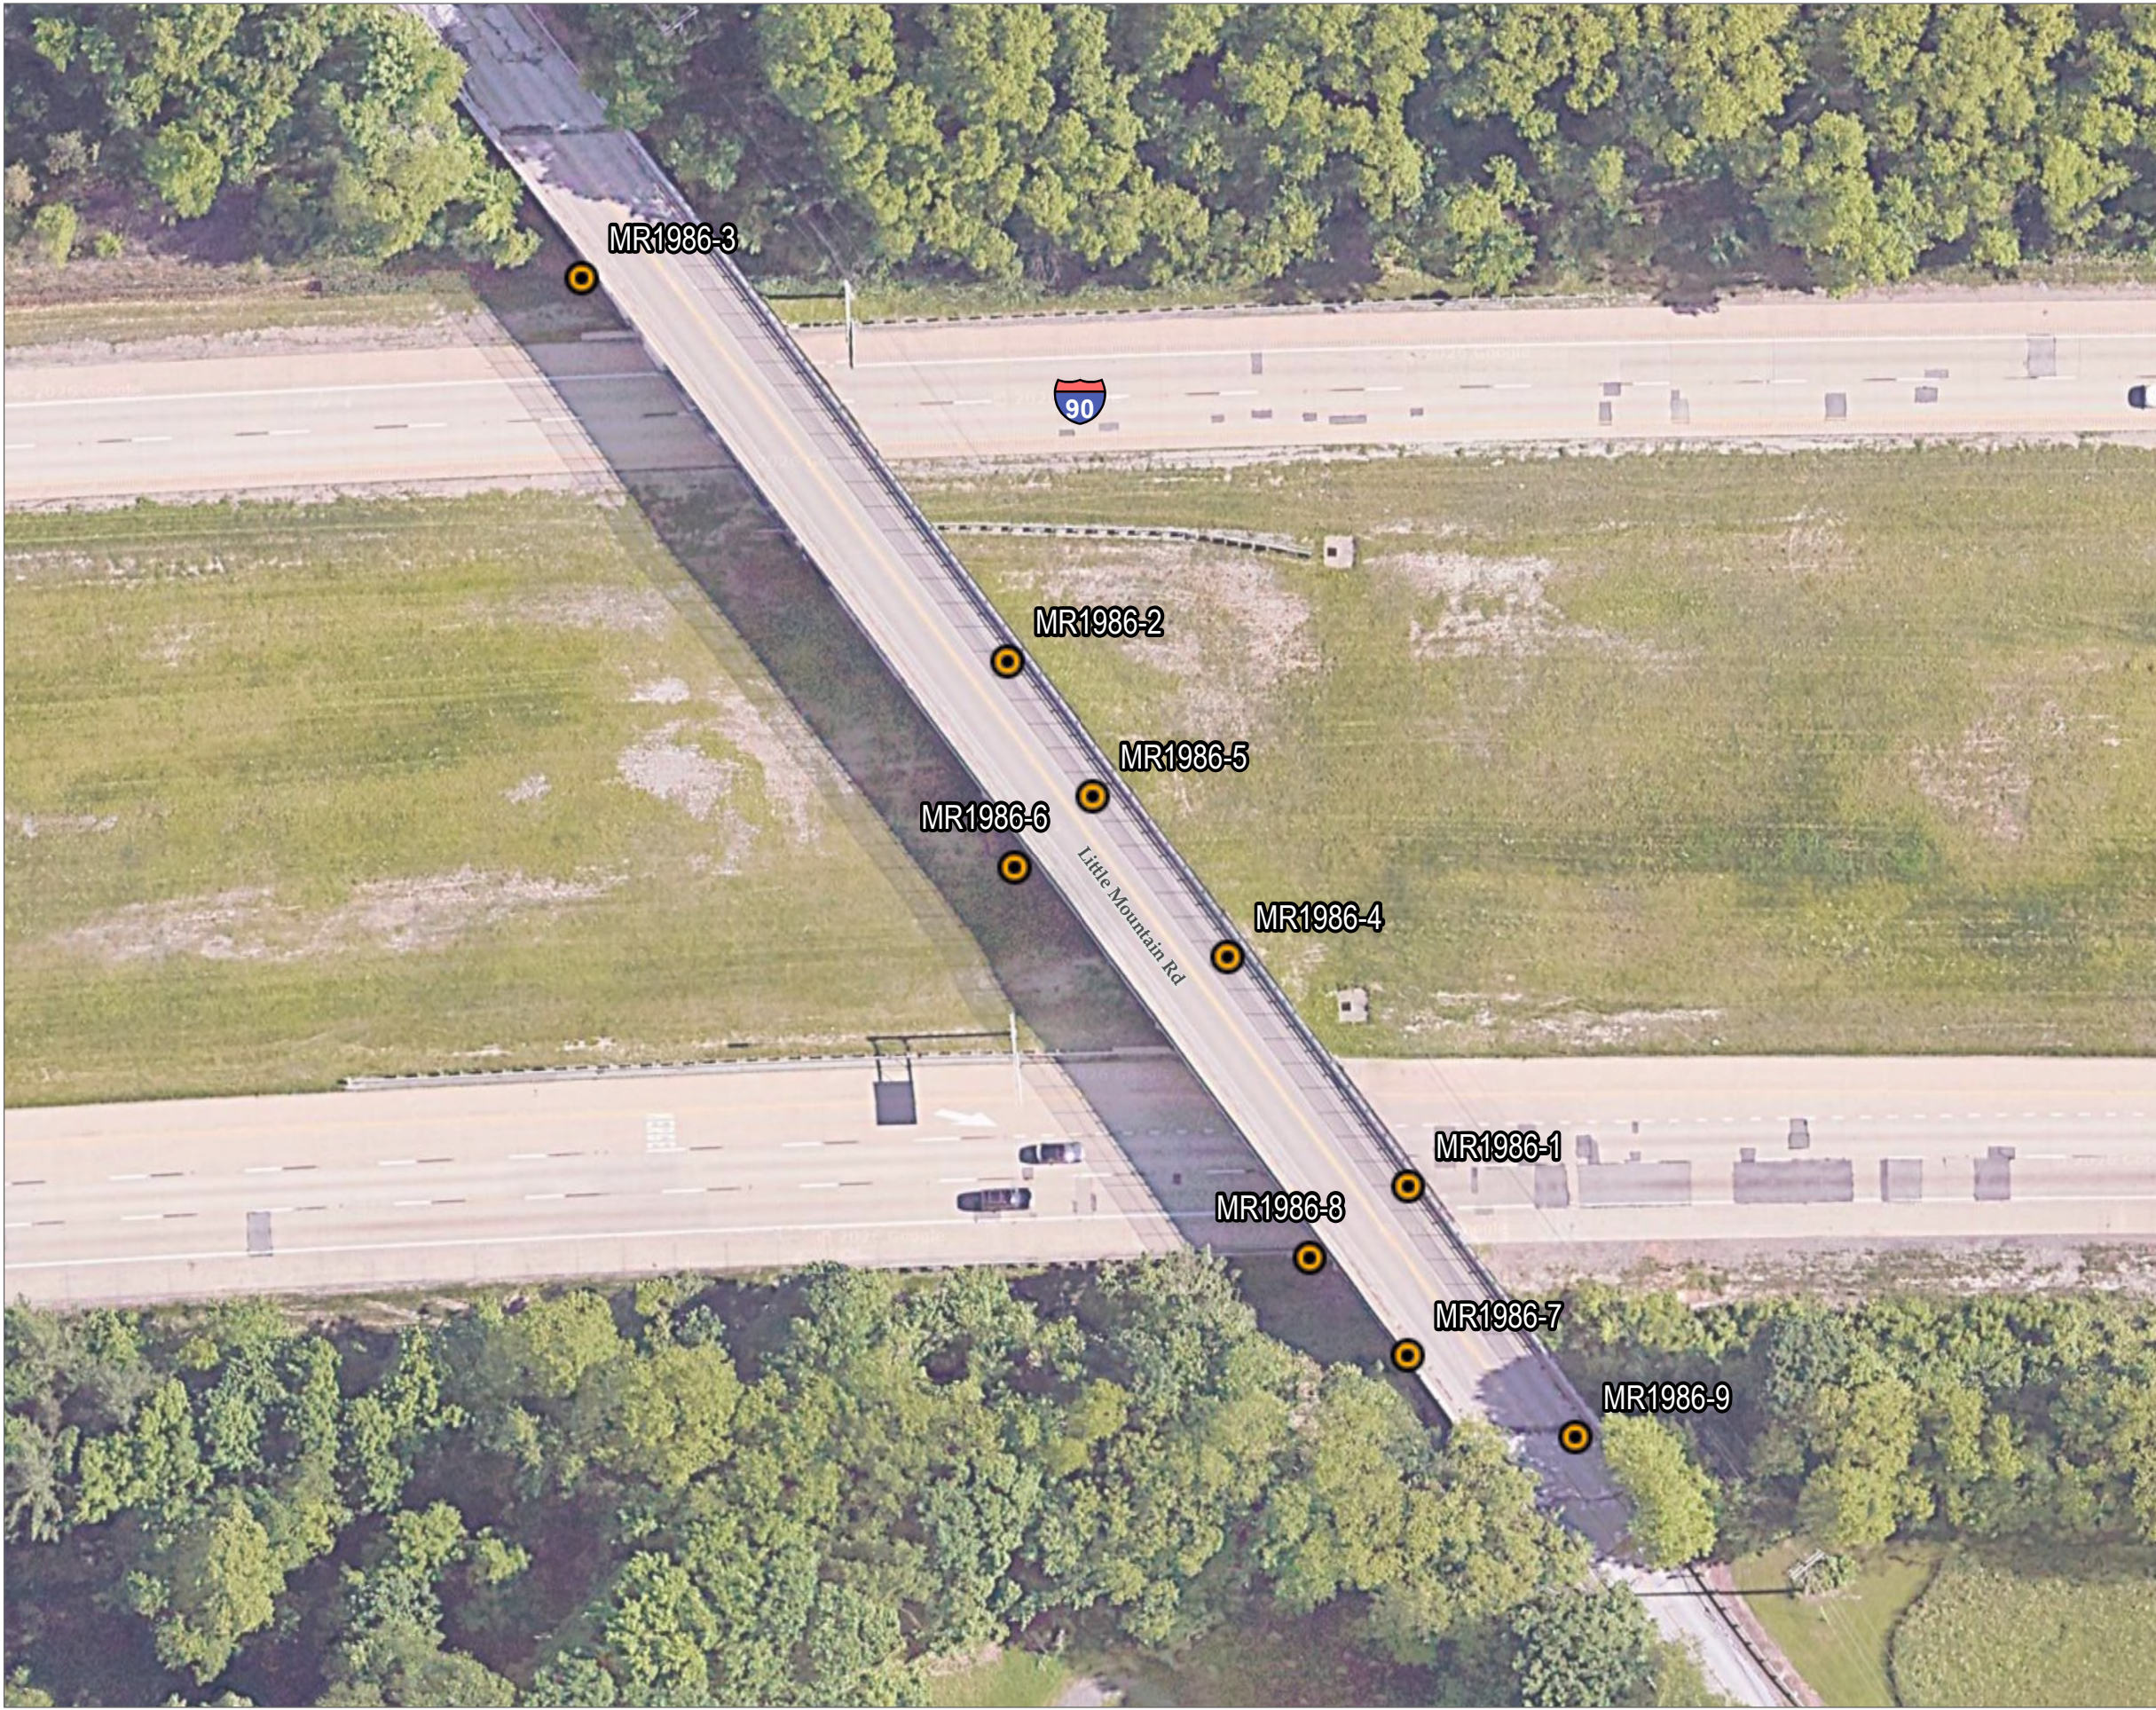
**SITE FIGURE**

ASBESTOSSAMPLELOCATION

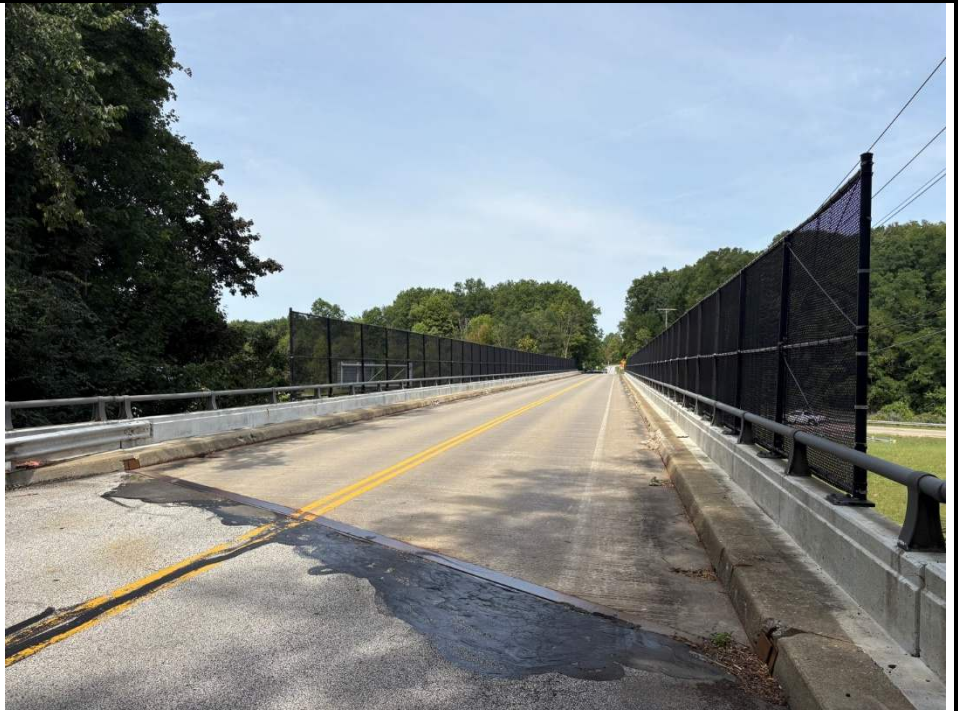
| <b>Photo No.</b><br>1 | <b>Date</b><br>September 8, 2026 | | |

| <b>Description:</b><br>View of LAK-MR 1986-1.688,<br>facing northwest. | | | |

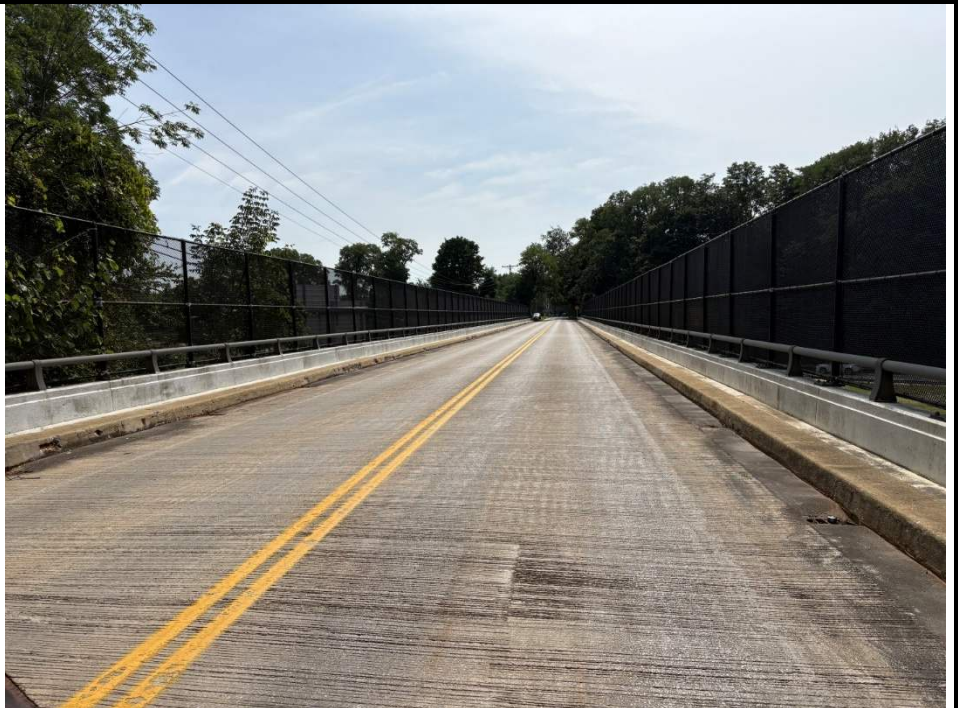
| <b>Photo No.</b><br>2 | <b>Date</b><br>September 8, 2026 | |

| <b>Description:</b><br>View of LAK-MR 1986-1.688,<br>facing southeast. | | |

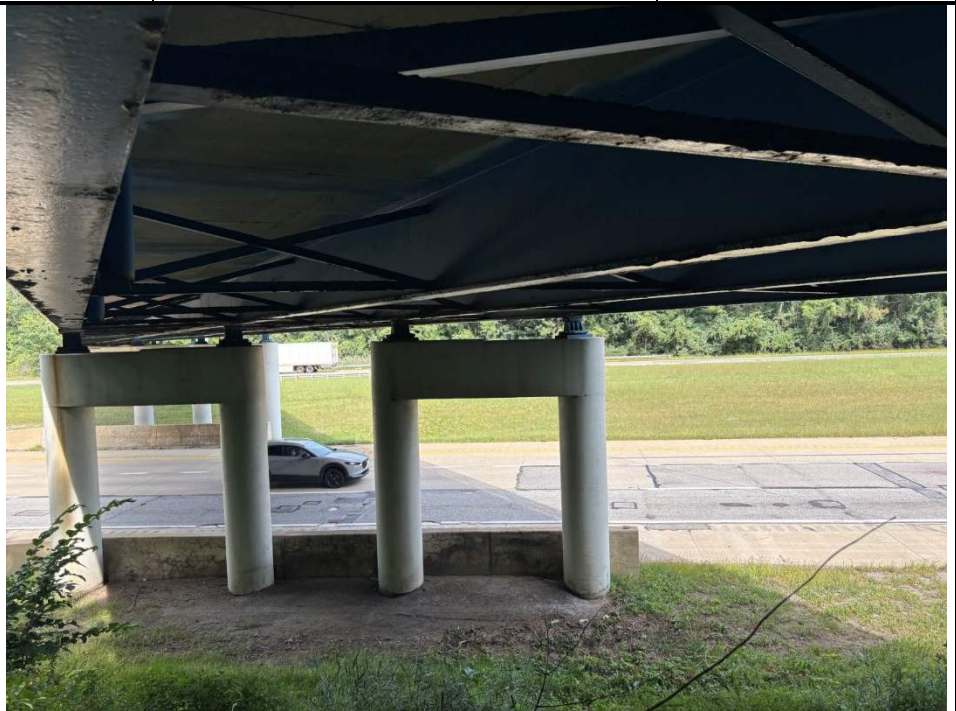
| <b>Photo No.</b><br>3 | <b>Date</b><br>September 8, 2026 | | |

| <b>Description:</b><br>Underneath view of LAK-MR 1986-1.688, facing north. | | | |

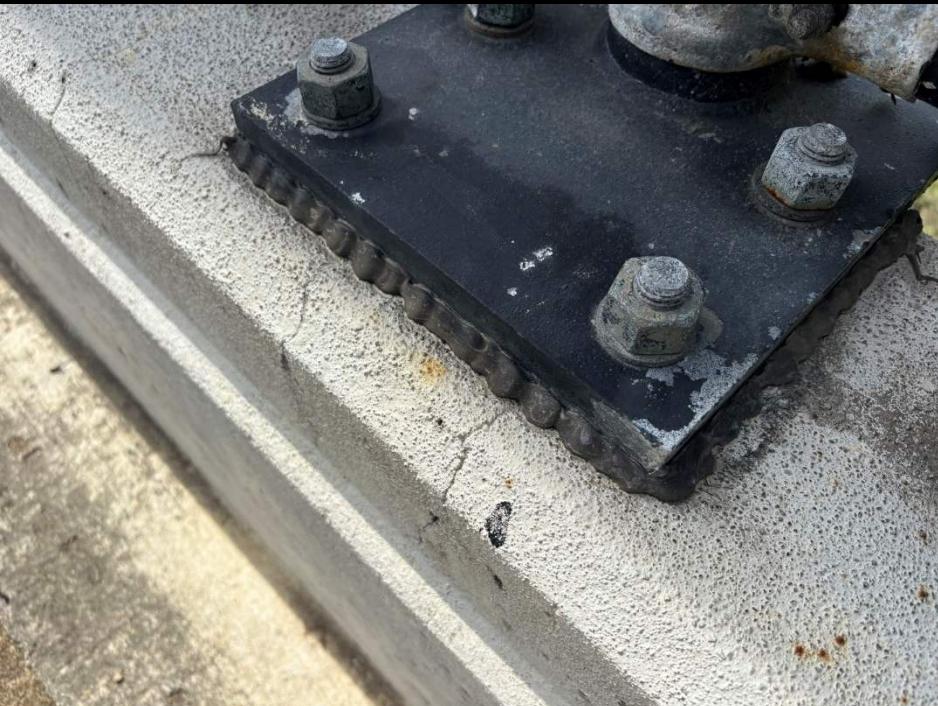
| Photo No. | Date | |
|---|---|---|
| 4 | September 8, 2026 | |

| Photo No. | Date | |
|---|---|---|
| <b>Description:</b><br>View of black caulking on fence post along bridge sidewalls (MR1986-1, MR1986-2, and MR1986-3), facing southwest. | | |

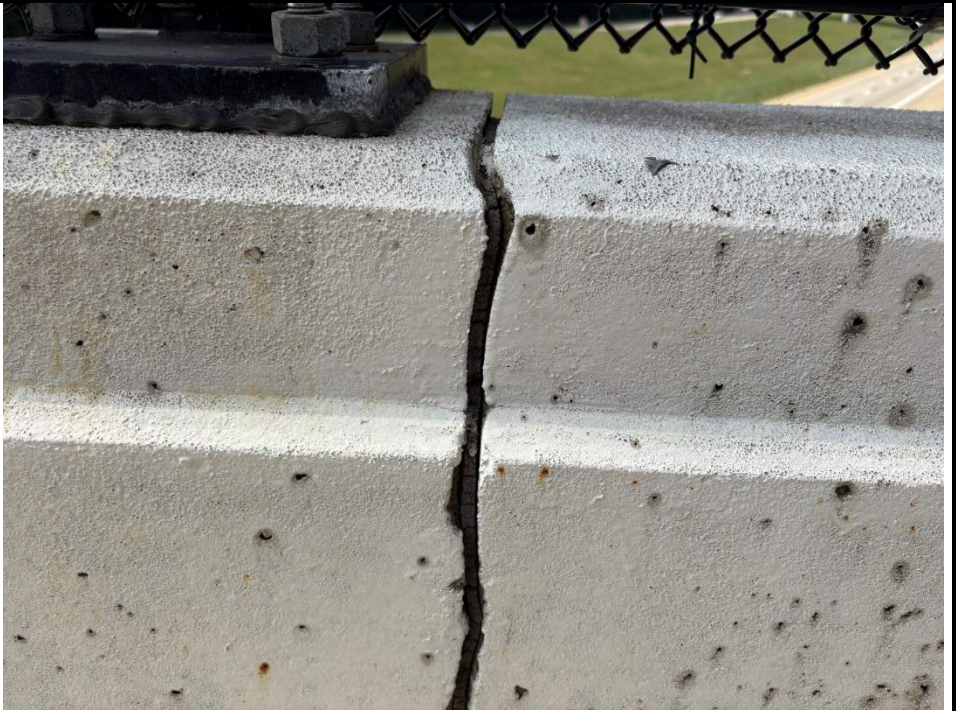
| <b>Photo No.</b><br>5 | <b>Date</b><br>September 8, 2026 | | |

| <b>Description:</b><br>View of tan/grey concrete spacing material located on sidewall barriers (MR1986-4, MR1986-5, and MR1986-6), facing west. | | | |

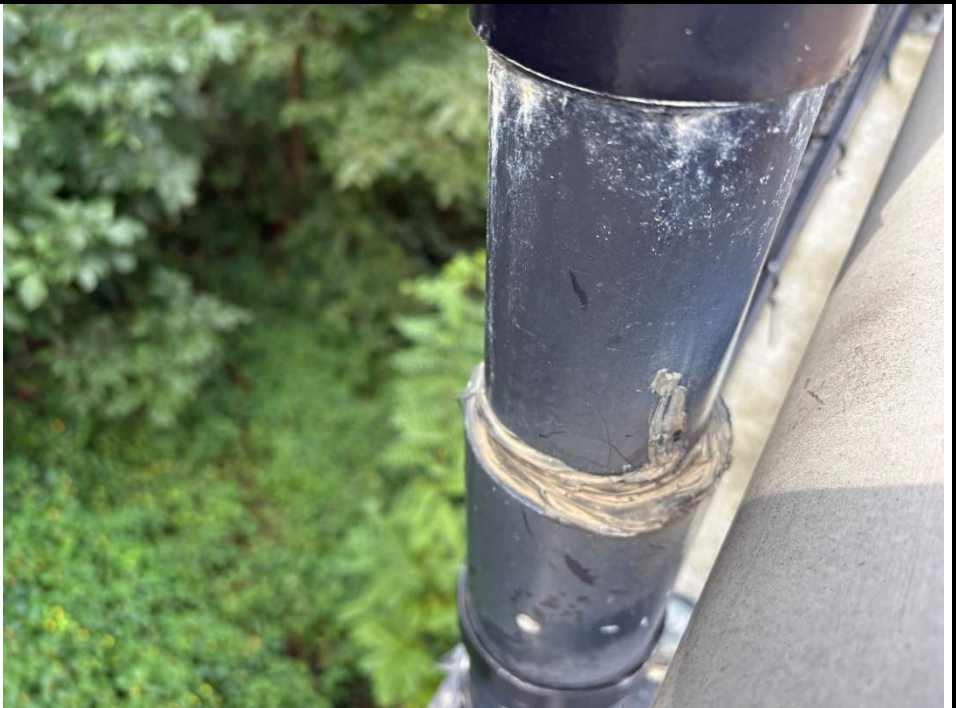
| <b>Photo No.</b><br>6 | <b>Date</b><br>September 8, 2026 | |

| <b>Description:</b><br>View of dark grey caulking on fence post joints (MR1986-7, MR1986-8, and MR1986-9), facing north. | | |

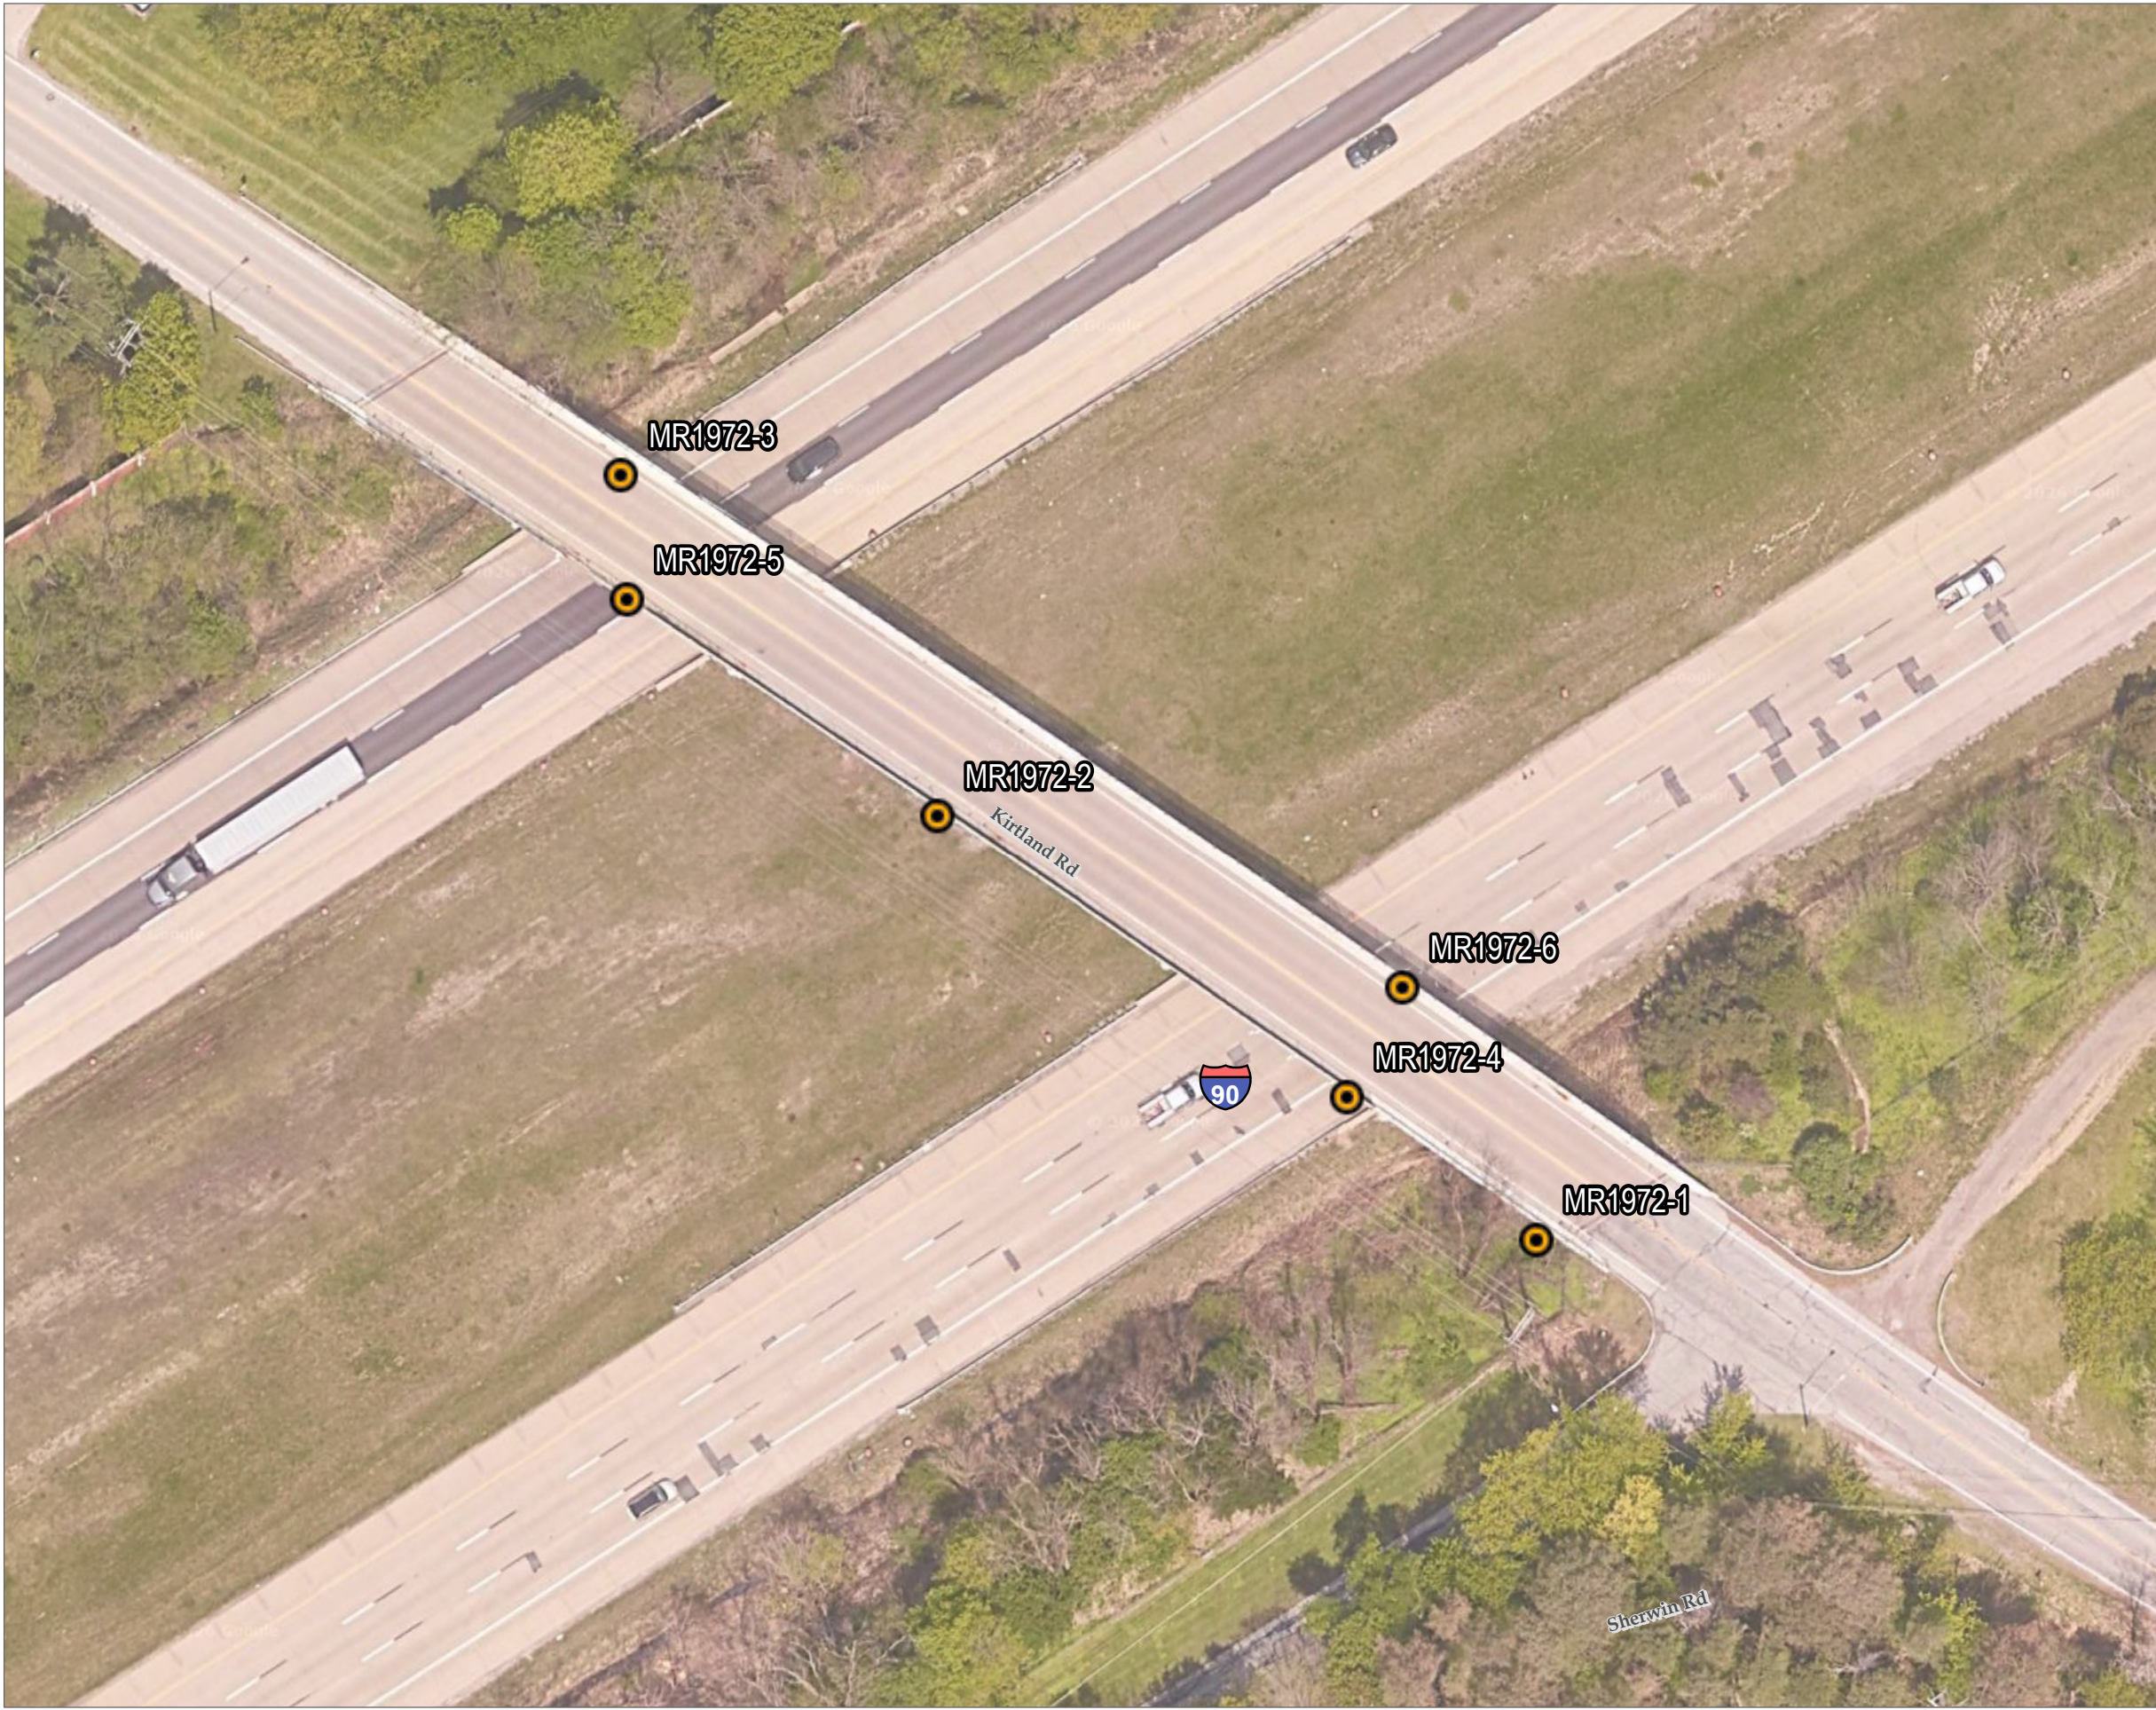
**SITE FIGURE**

● ASBESTOSSAMPLELOCATION

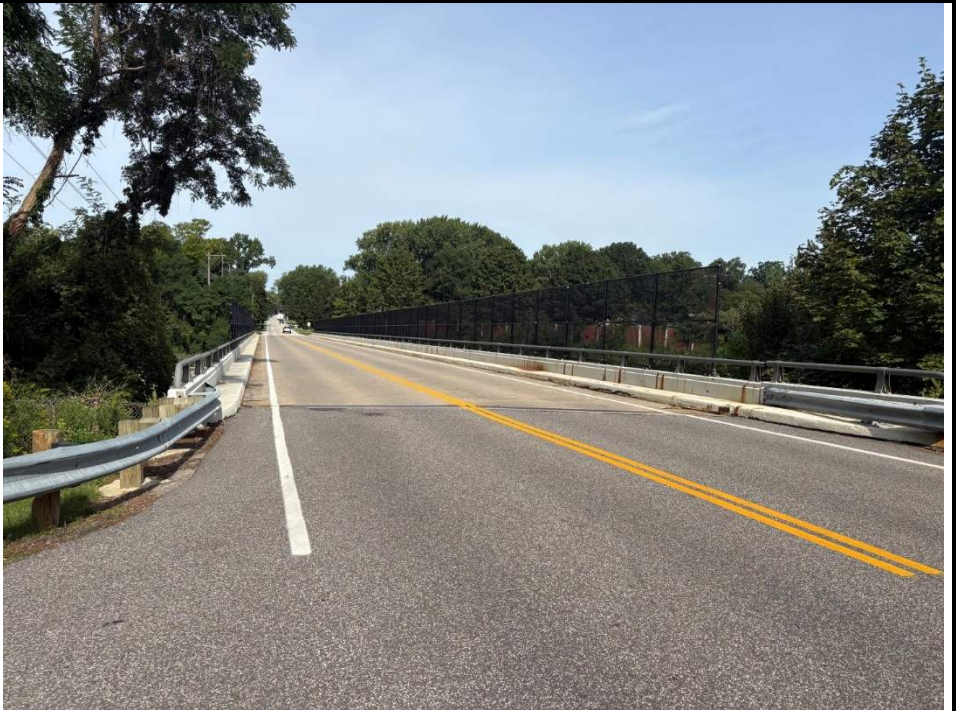
| <b>Photo No.</b><br>1 | <b>Date</b><br>September 8, 2026 | | |

| <b>Description:</b><br>View of LAK-MR 1972-0.879,<br>facing north. | | | |

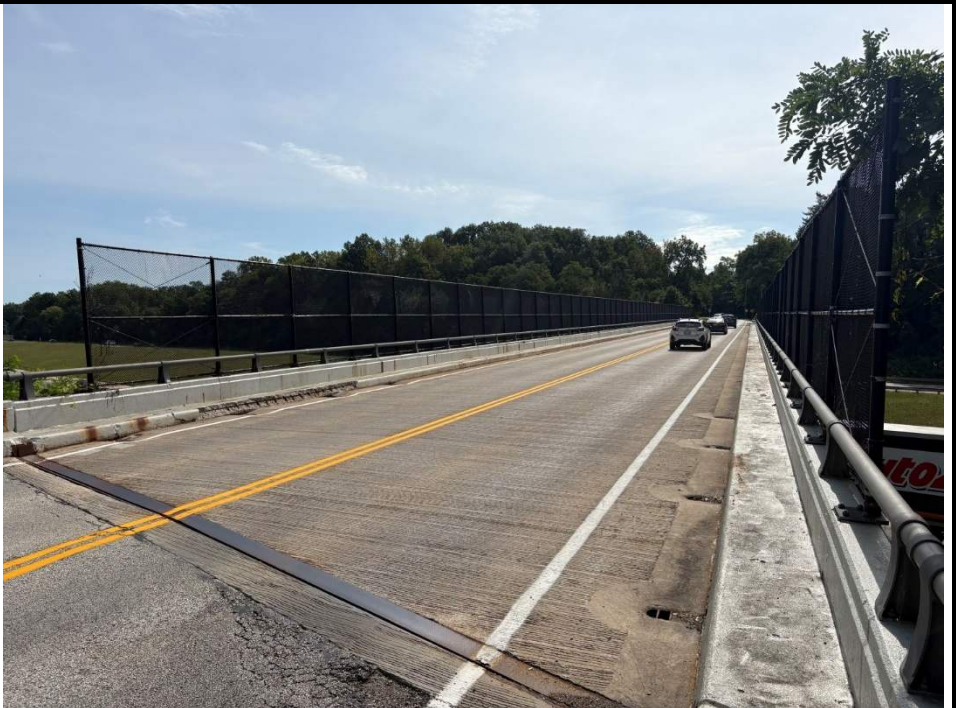
| <b>Photo No.</b><br>2 | <b>Date</b><br>September 8, 2026 | |

| <b>Description:</b><br>View of LAK-MR 1972-0.879,<br>facing south. | | |

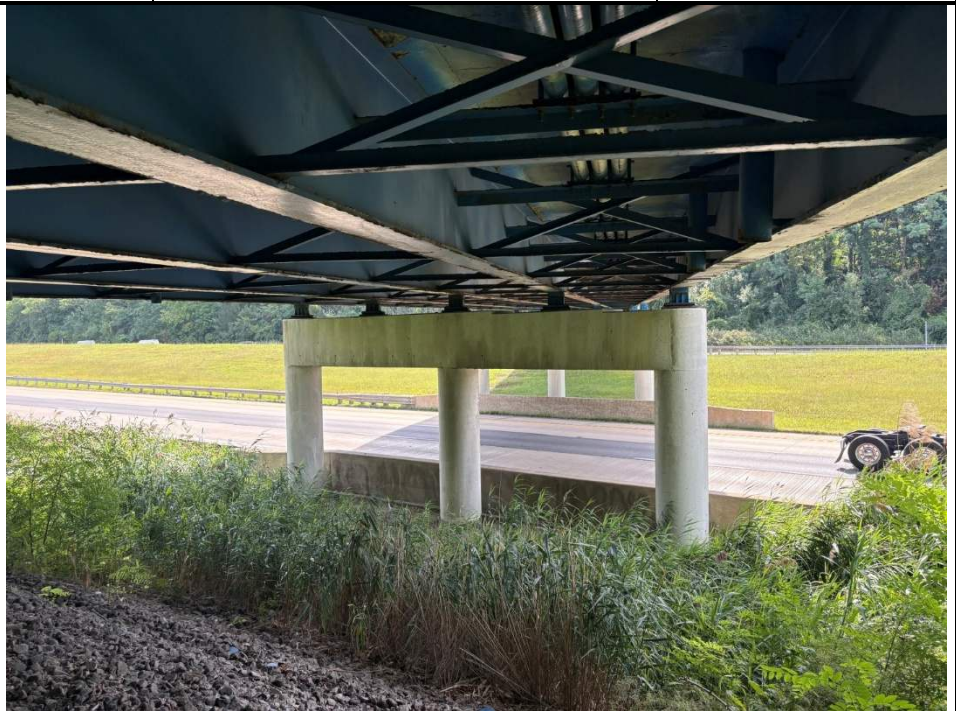
| <b>Photo No.</b><br>3 | <b>Date</b><br>September 8, 2026 | | |

| <b>Description:</b><br>Underneath view of LAK-MR 1972-0.879, facing southeast. | | | |

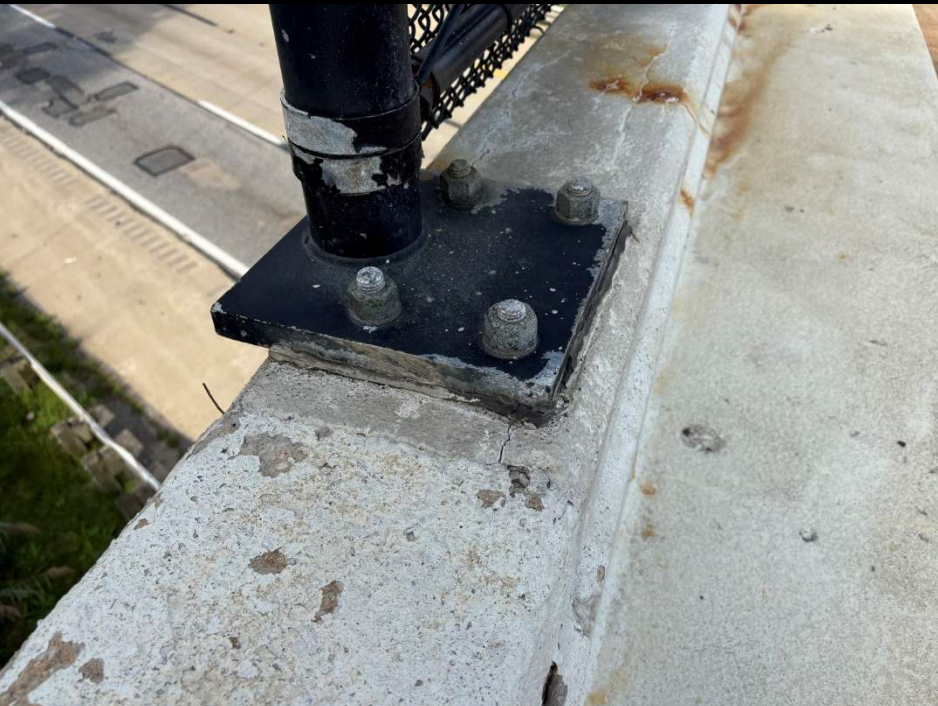
| 4 | September 8, 2026 | |

| <b>Description:</b><br>View of Black Caulking on fence post along bridge sidewalls (MR1972-1, MR1972-2, and MR1972-3), facing northwest. | | |

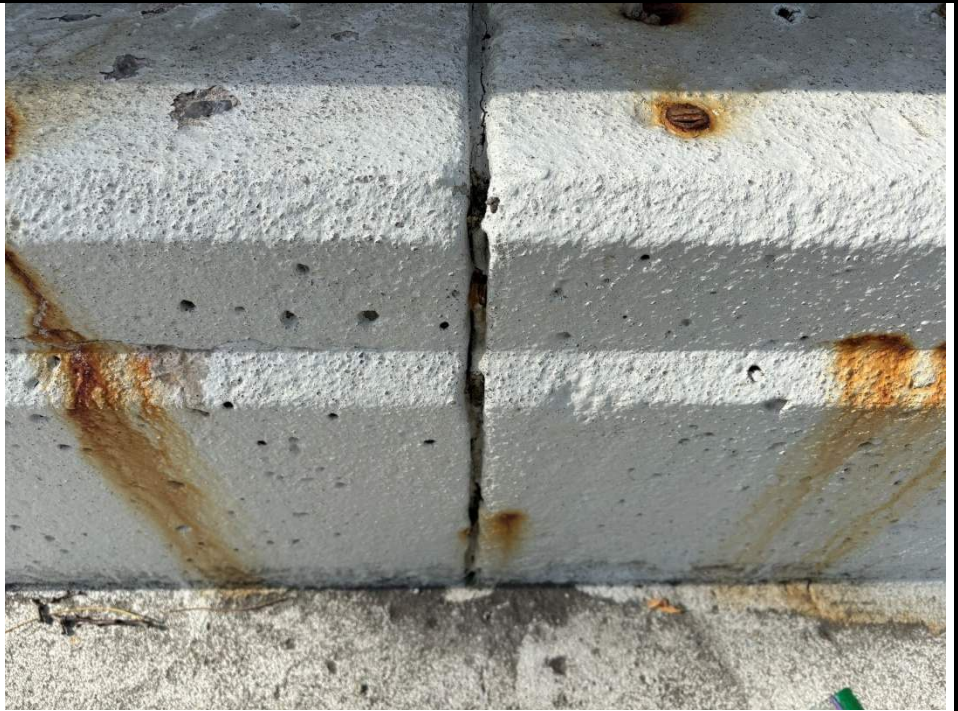
| <b>Photo No.</b><br>5 | <b>Date</b><br>September 8, 2026 | | |

| <b>Description:</b><br>View of tan/grey concrete spacing material located on sidewalk barriers (MR1972-4, MR1972-5, and MR1972-6), facing west. | | | |

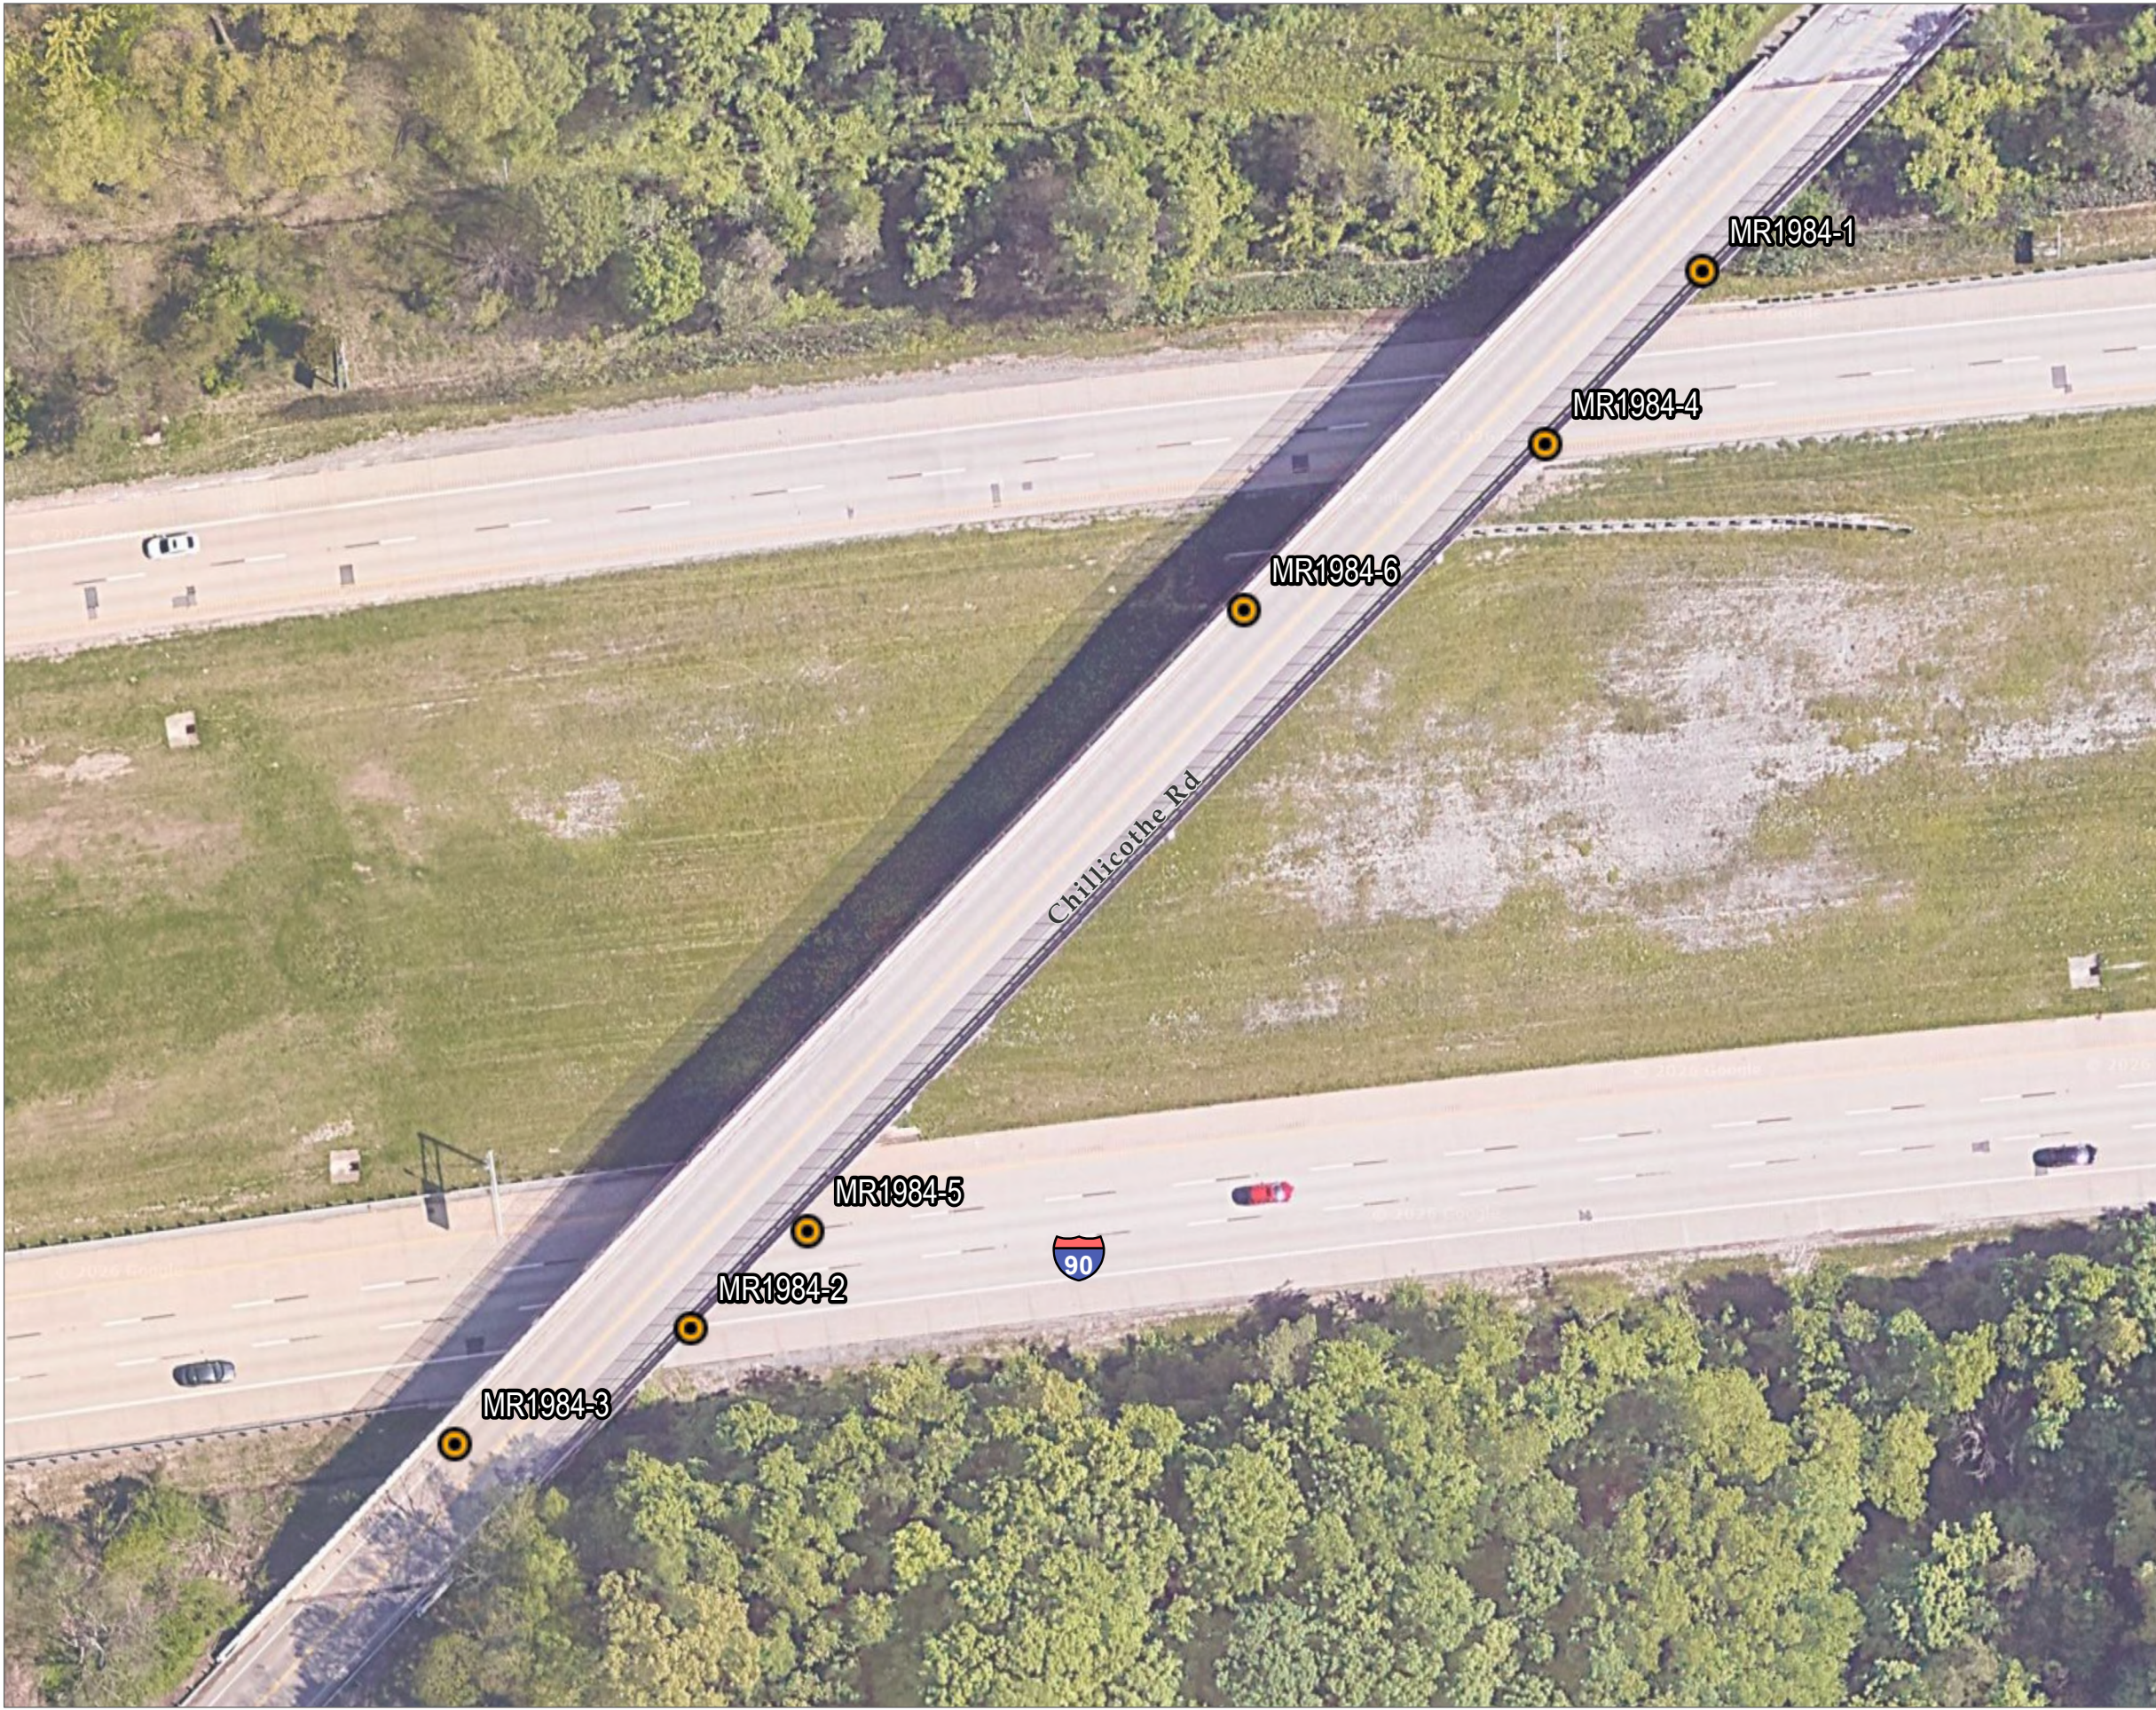
**SITE FIGURE**

● ASBESTOSSAMPLELOCATION

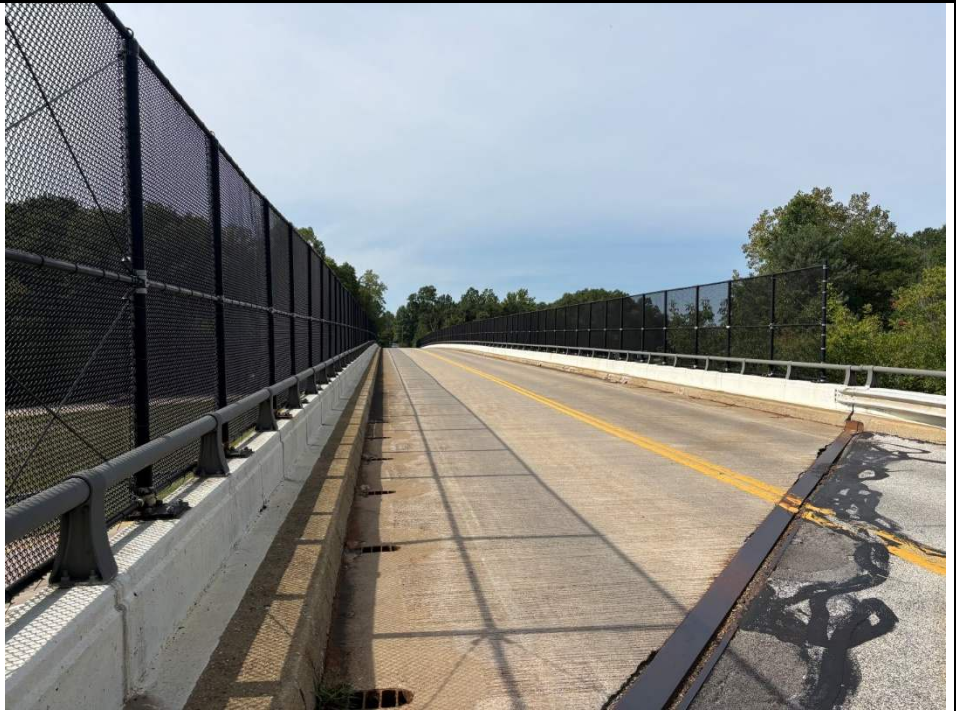
| <b>Photo No.</b><br>1 | <b>Date</b><br>September 8, 2026 | | |

| <b>Description:</b><br>View of LAK-MR 1984-0.941,<br>facing southwest. | | | |

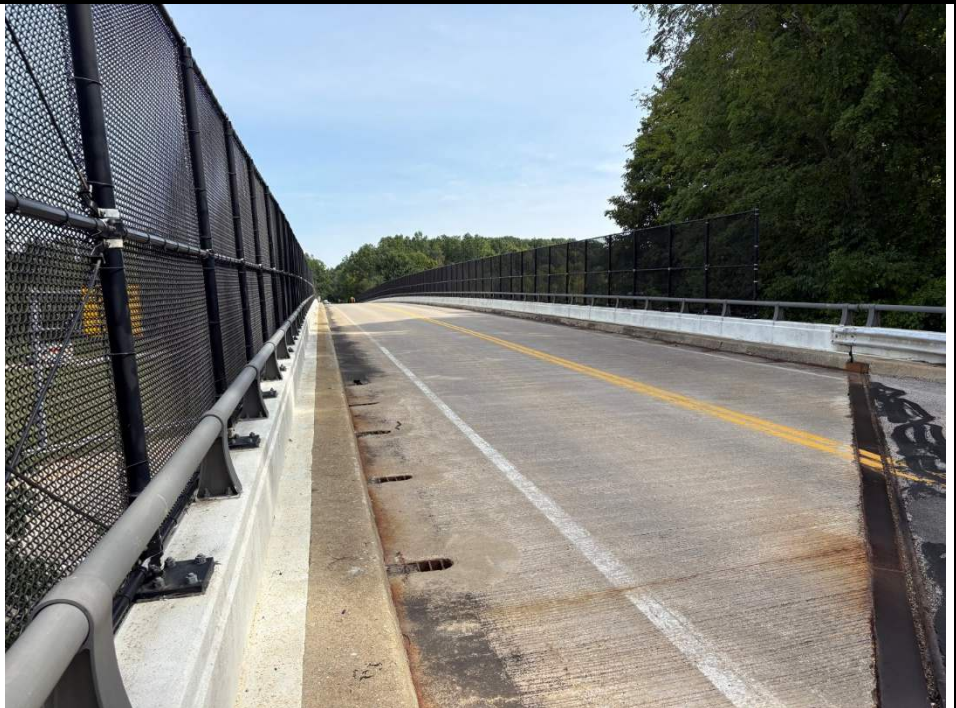
| <b>Photo No.</b><br>2 | <b>Date</b><br>September 8, 2026 | |

| <b>Description:</b><br>View of LAK-MR 1984-0.941,<br>facing northeast. | | |

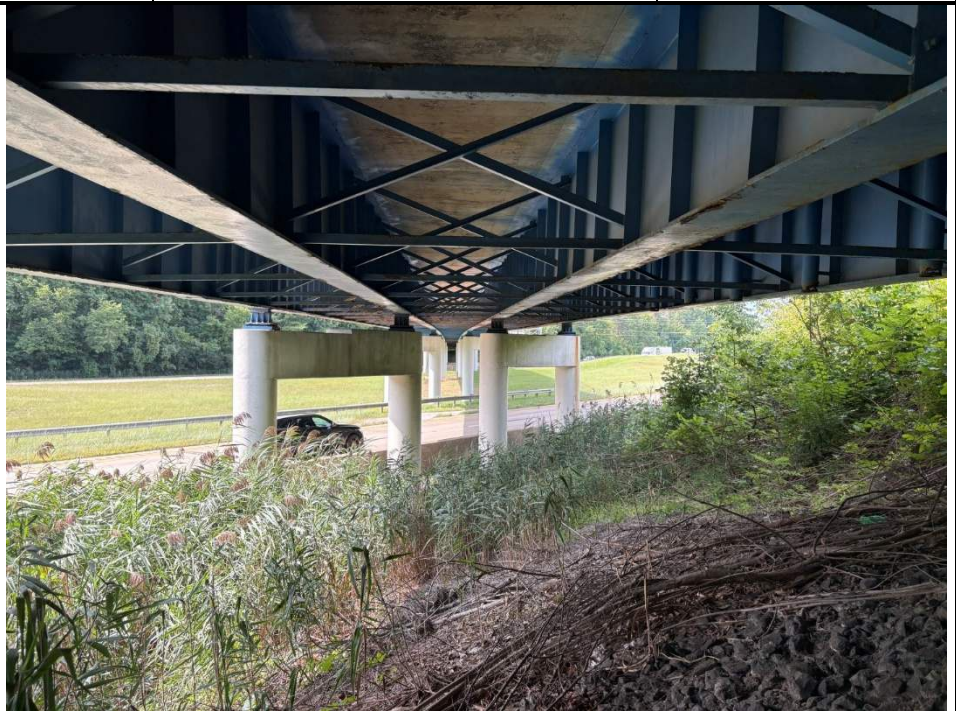
| <b>Photo No.</b><br>3 | <b>Date</b><br>September 8, 2026 | | |

| <b>Description:</b><br>Underneath view of LAK-MR 1984-0.941, facing southwest. | | | |

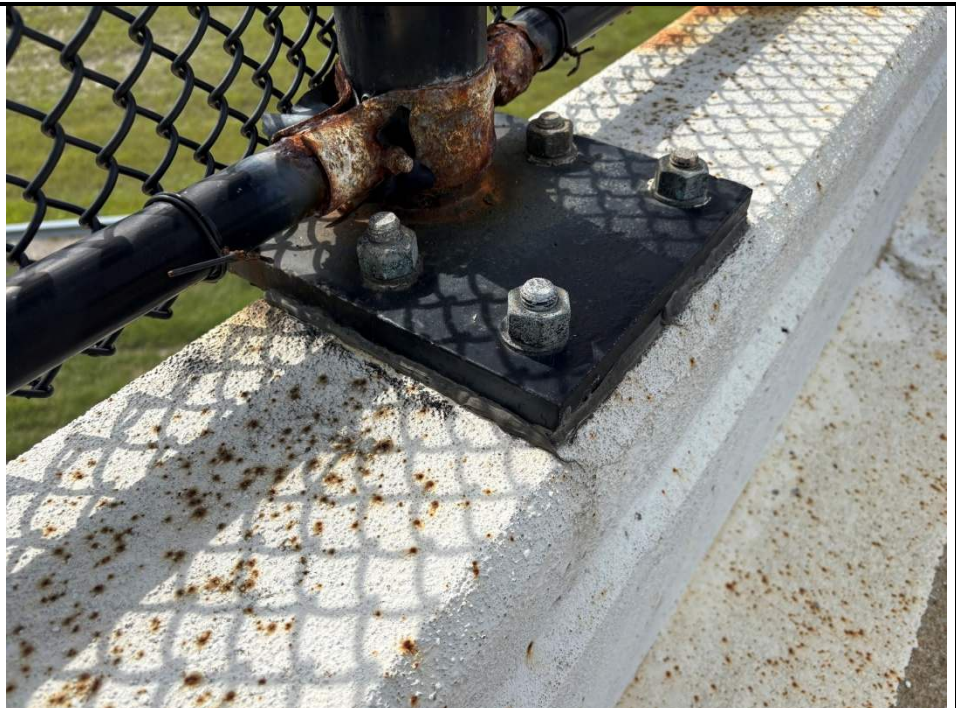
| 4 | September 8, 2026 | |

| <b>Description:</b><br>View of black caulking on fence post along bridge sidewalls (MR1984-1, MR1984-2, and MR1984-3), facing southwest. | | |

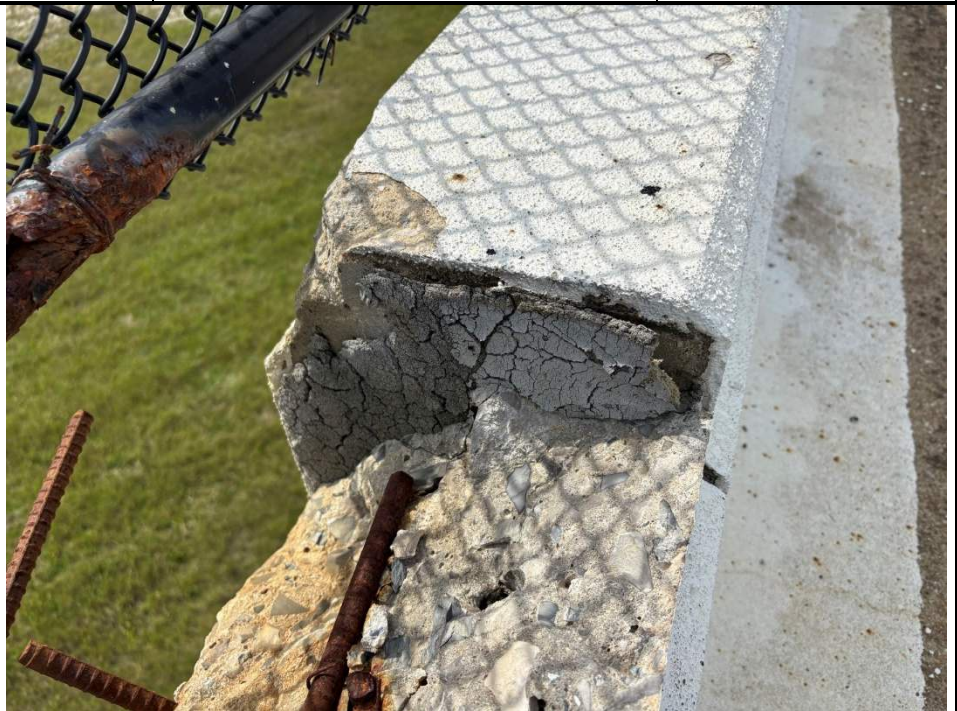
| <b>Photo No.</b><br>5 | <b>Date</b><br>September 8, 2026 | | |

| <b>Description:</b><br>View of tan/grey concrete<br>spacing material located on<br>sidewall barriers (MR1984-4,<br>MR1984-5, and MR1984-6),<br>facing southeast. | | | |
