# ASBESTOS SURVEY REPORT

LAK-MR 1986-1.688 (PID 116955)

Bridge Structure (SFN 4304179) of Little Mountain Road over I-90  
Kirtland Hills, Lake County, Ohio 44060

Ohio Department of Transportation District 12  
September 11, 2026

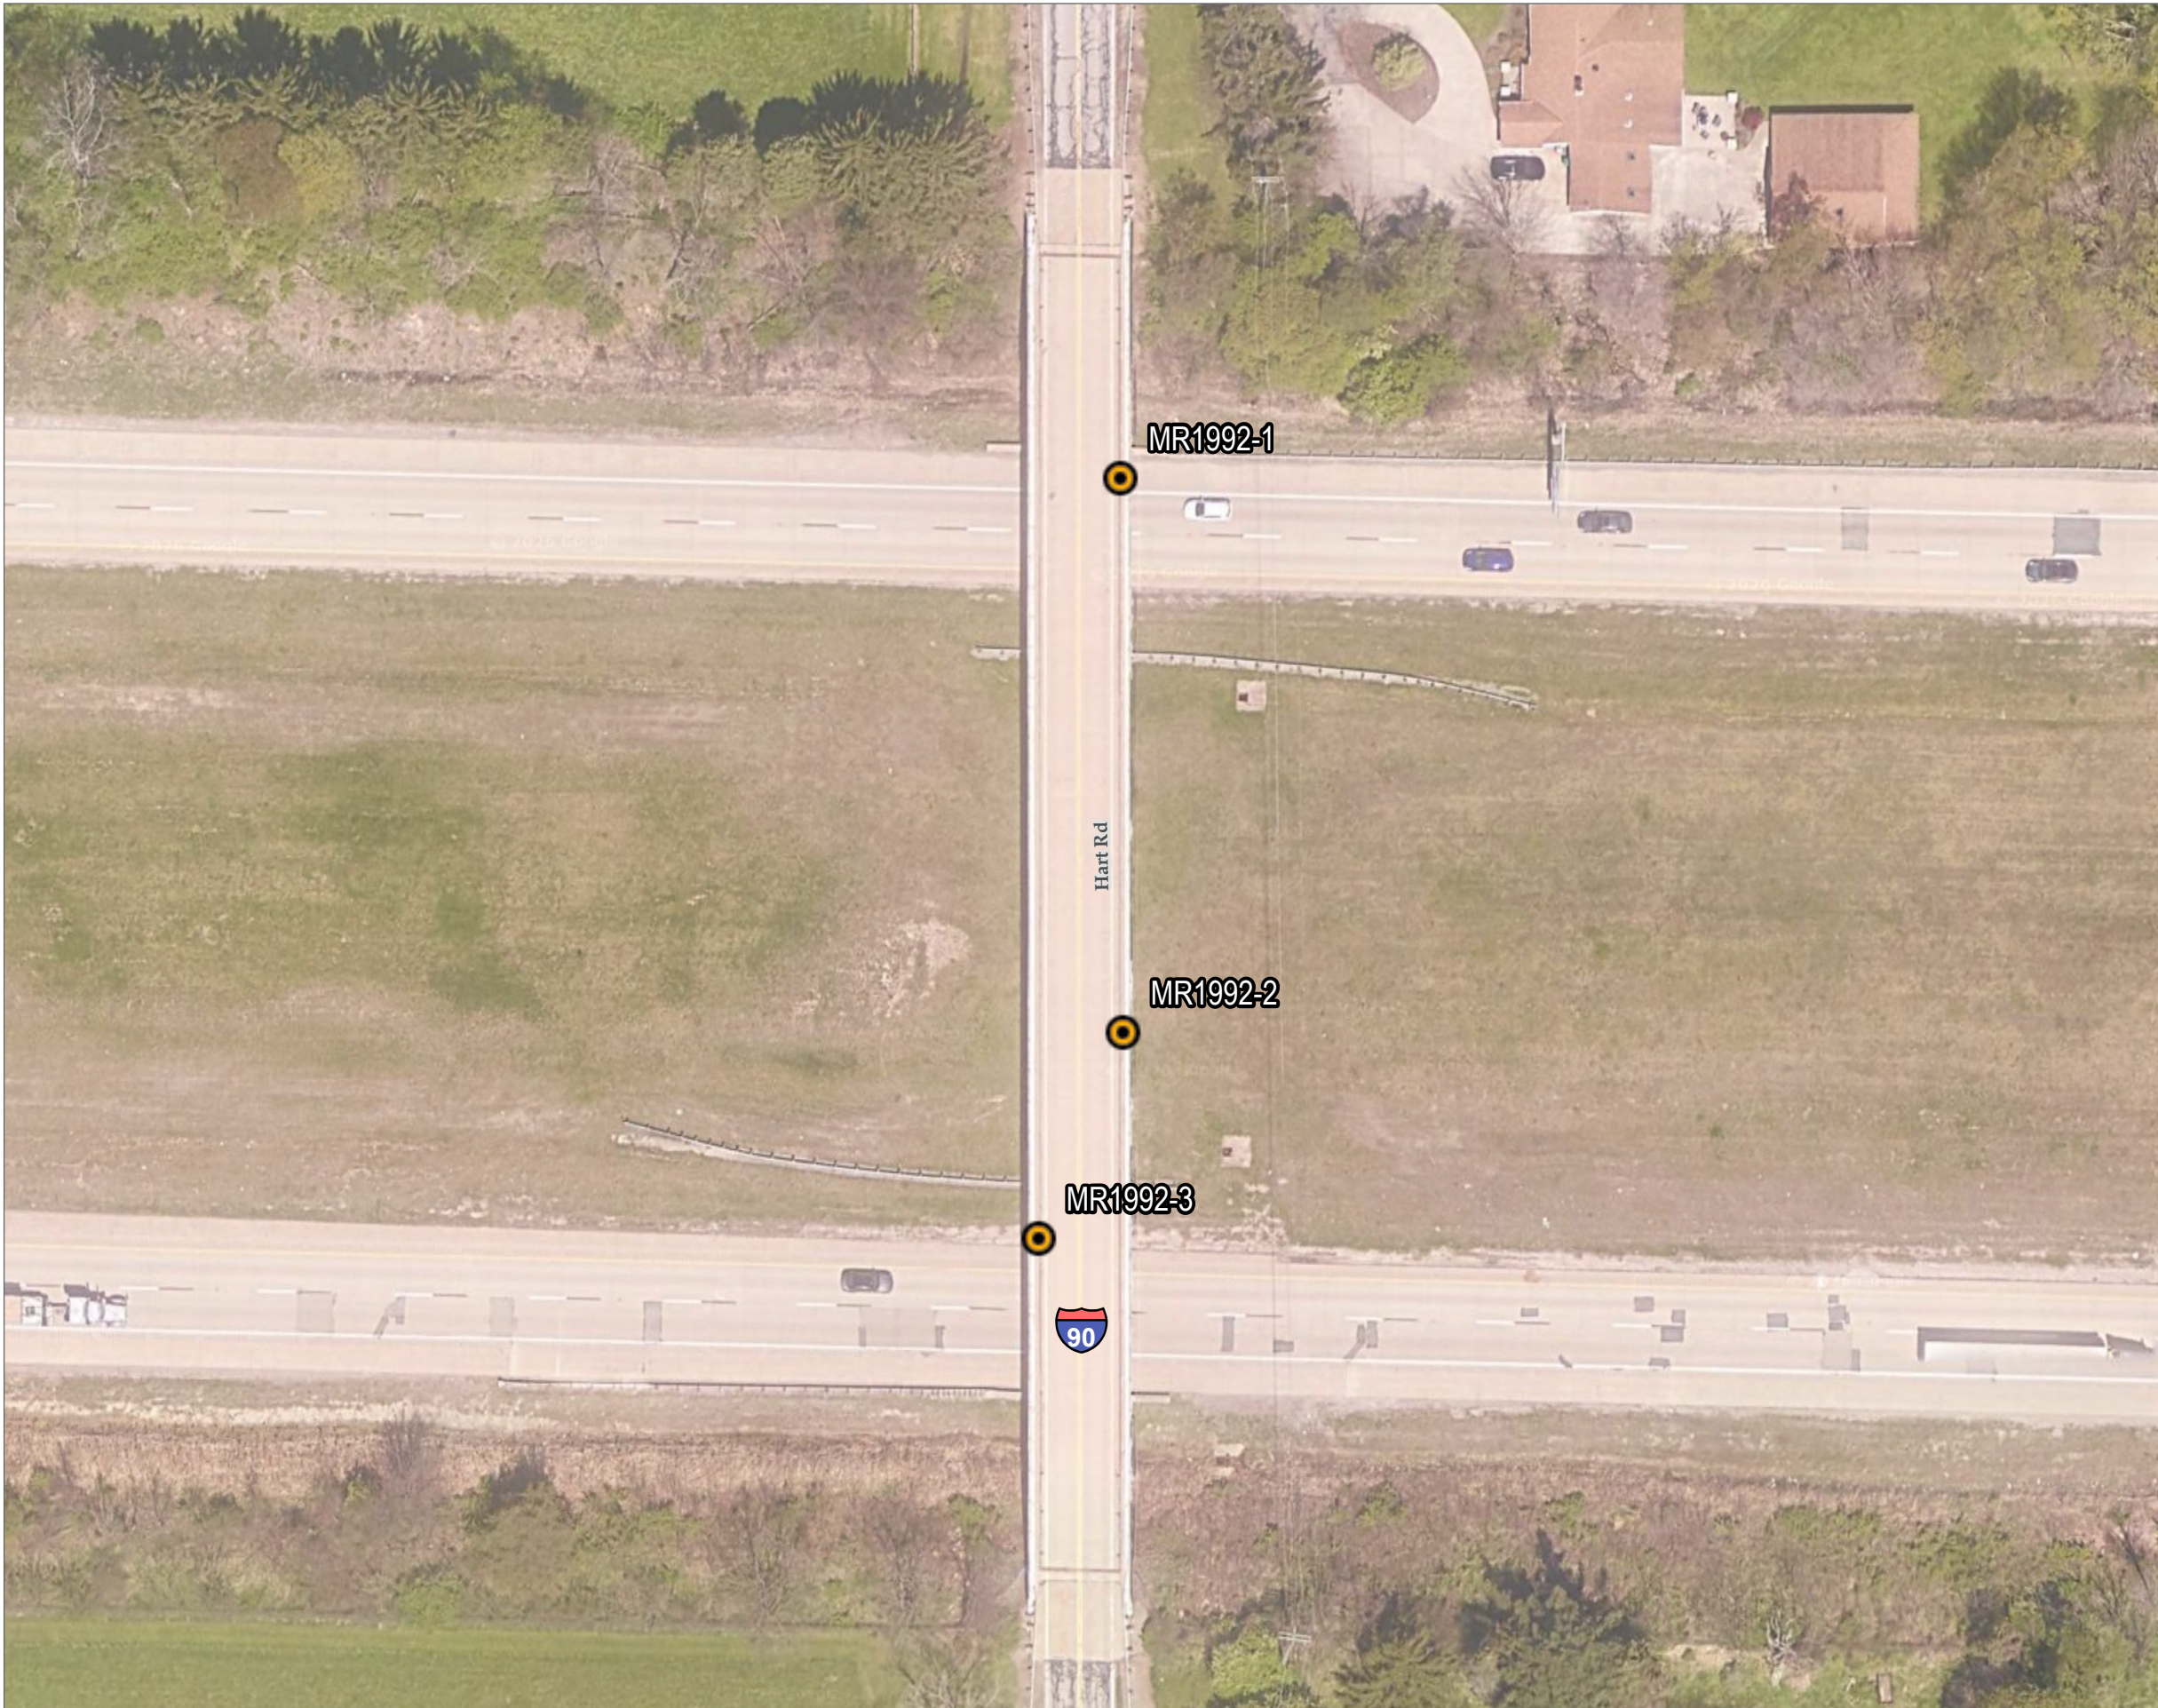
**SITE FIGURE**

● ASBESTOSSAMPLELOCATION

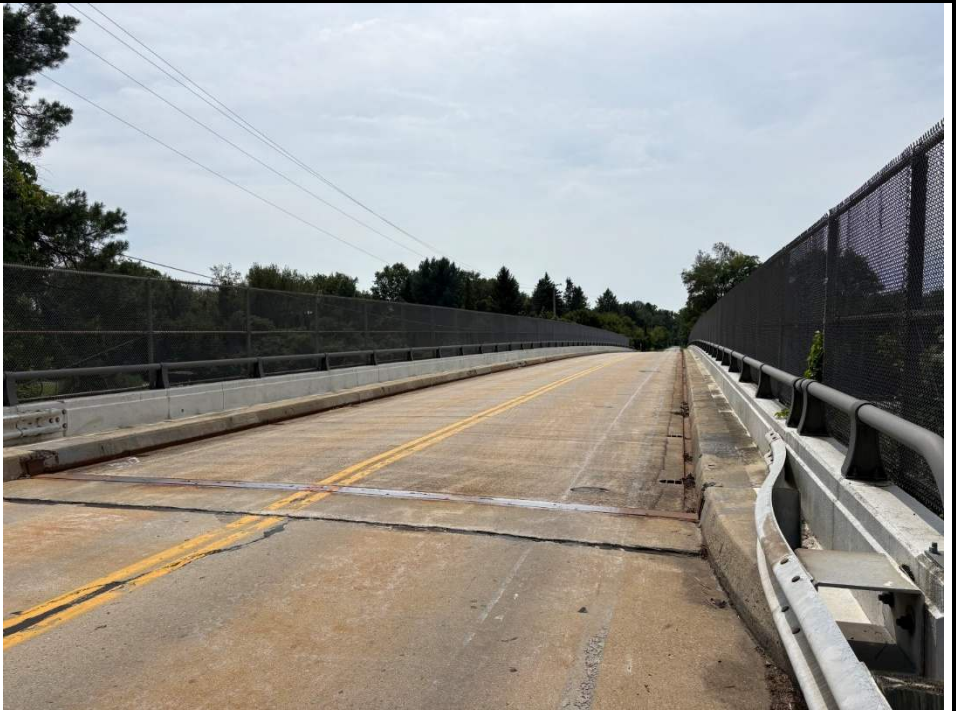
| <b>Photo No.</b><br>1 | <b>Date</b><br>September 8, 2026 | | |

| <b>Description:</b><br>View of LAK-MR 1992-0.951,<br>facing south. | | | |

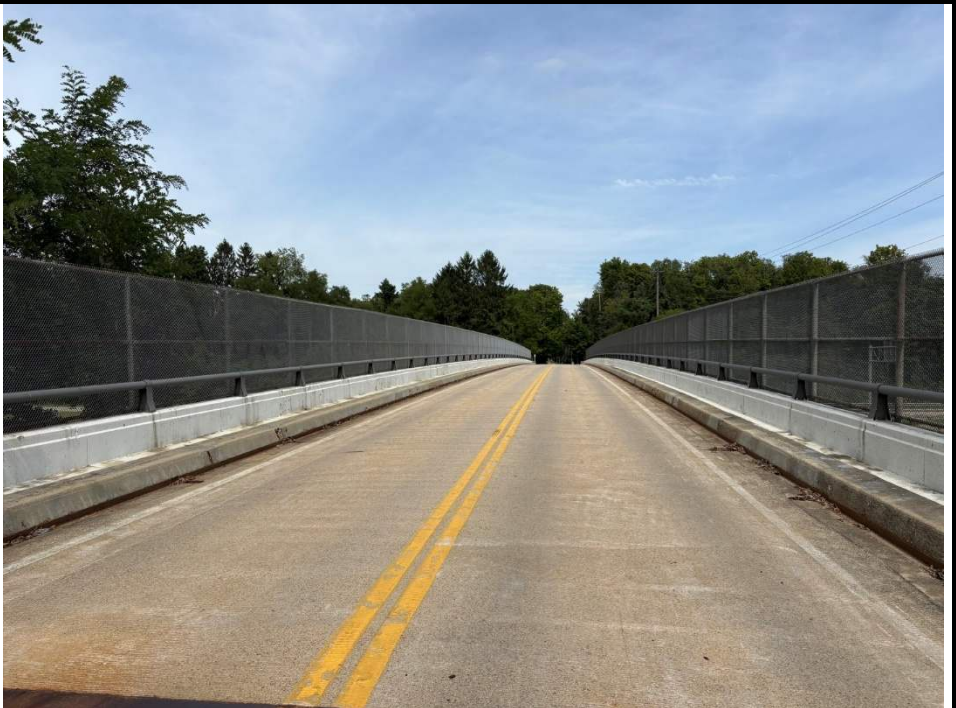
| <b>Photo No.</b><br>2 | <b>Date</b><br>September 8, 2026 | |

| <b>Description:</b><br>View of LAK-MR 1992-0.951,<br>facing north. | | |

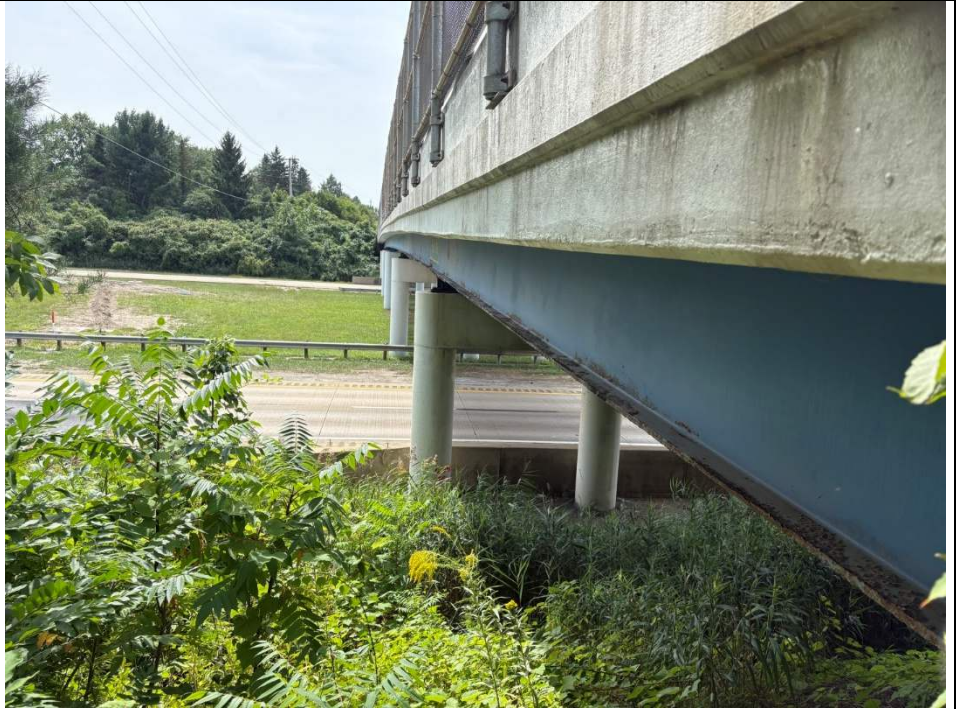
| Client Name: | | Subject Property Location: | Project No.: |
|---|---|---|---|
| 3 | September 8, 2026 | | |

| Client Name: | | Subject Property Location: | Project No.: |
|---|---|---|---|
| <b>Description:</b><br>Underneath view of LAK-MR 1992-0.951, facing south. | | | |

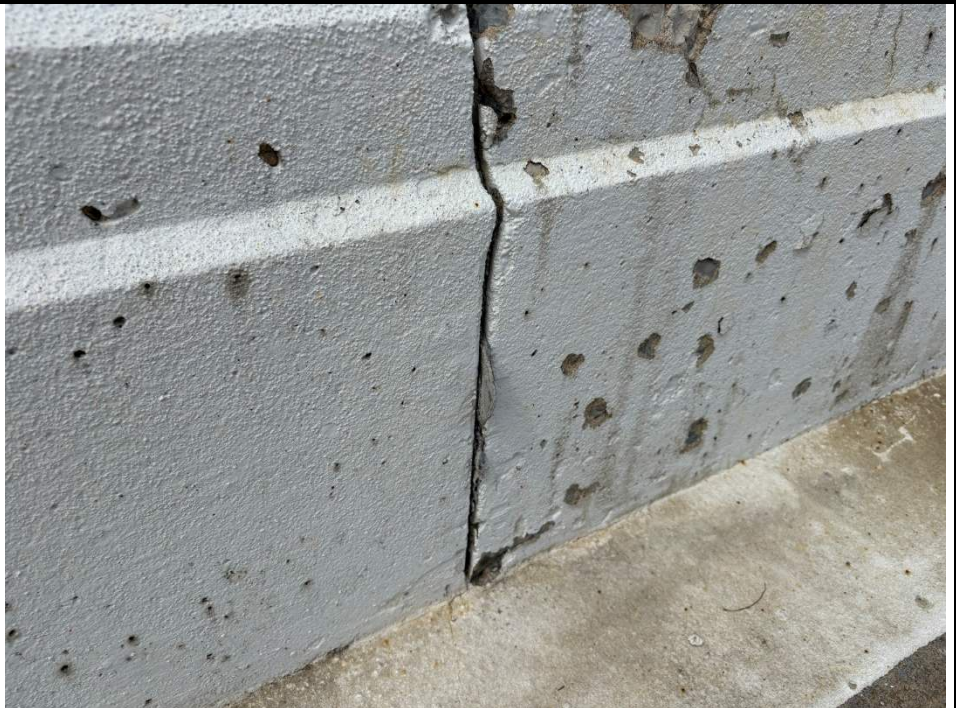
| Photo No. | Date | | |
|---|---|---|--|
| 4 | September 8, 2026 | | |

| Photo No. | Date | | |
|---|---|---|--|
| <b>Description:</b><br>View of concrete spacing material on side walls (MR1992-1, MR1992-2, and MR1992-3), facing west. | | | |
