PHASE I ENVIRONMENTAL SITE ASSESSMENT
For
STA-62-24.05 PROJECT
PID 100824

Prepared for:
Ohio Department of Transportation

September 25, 2017

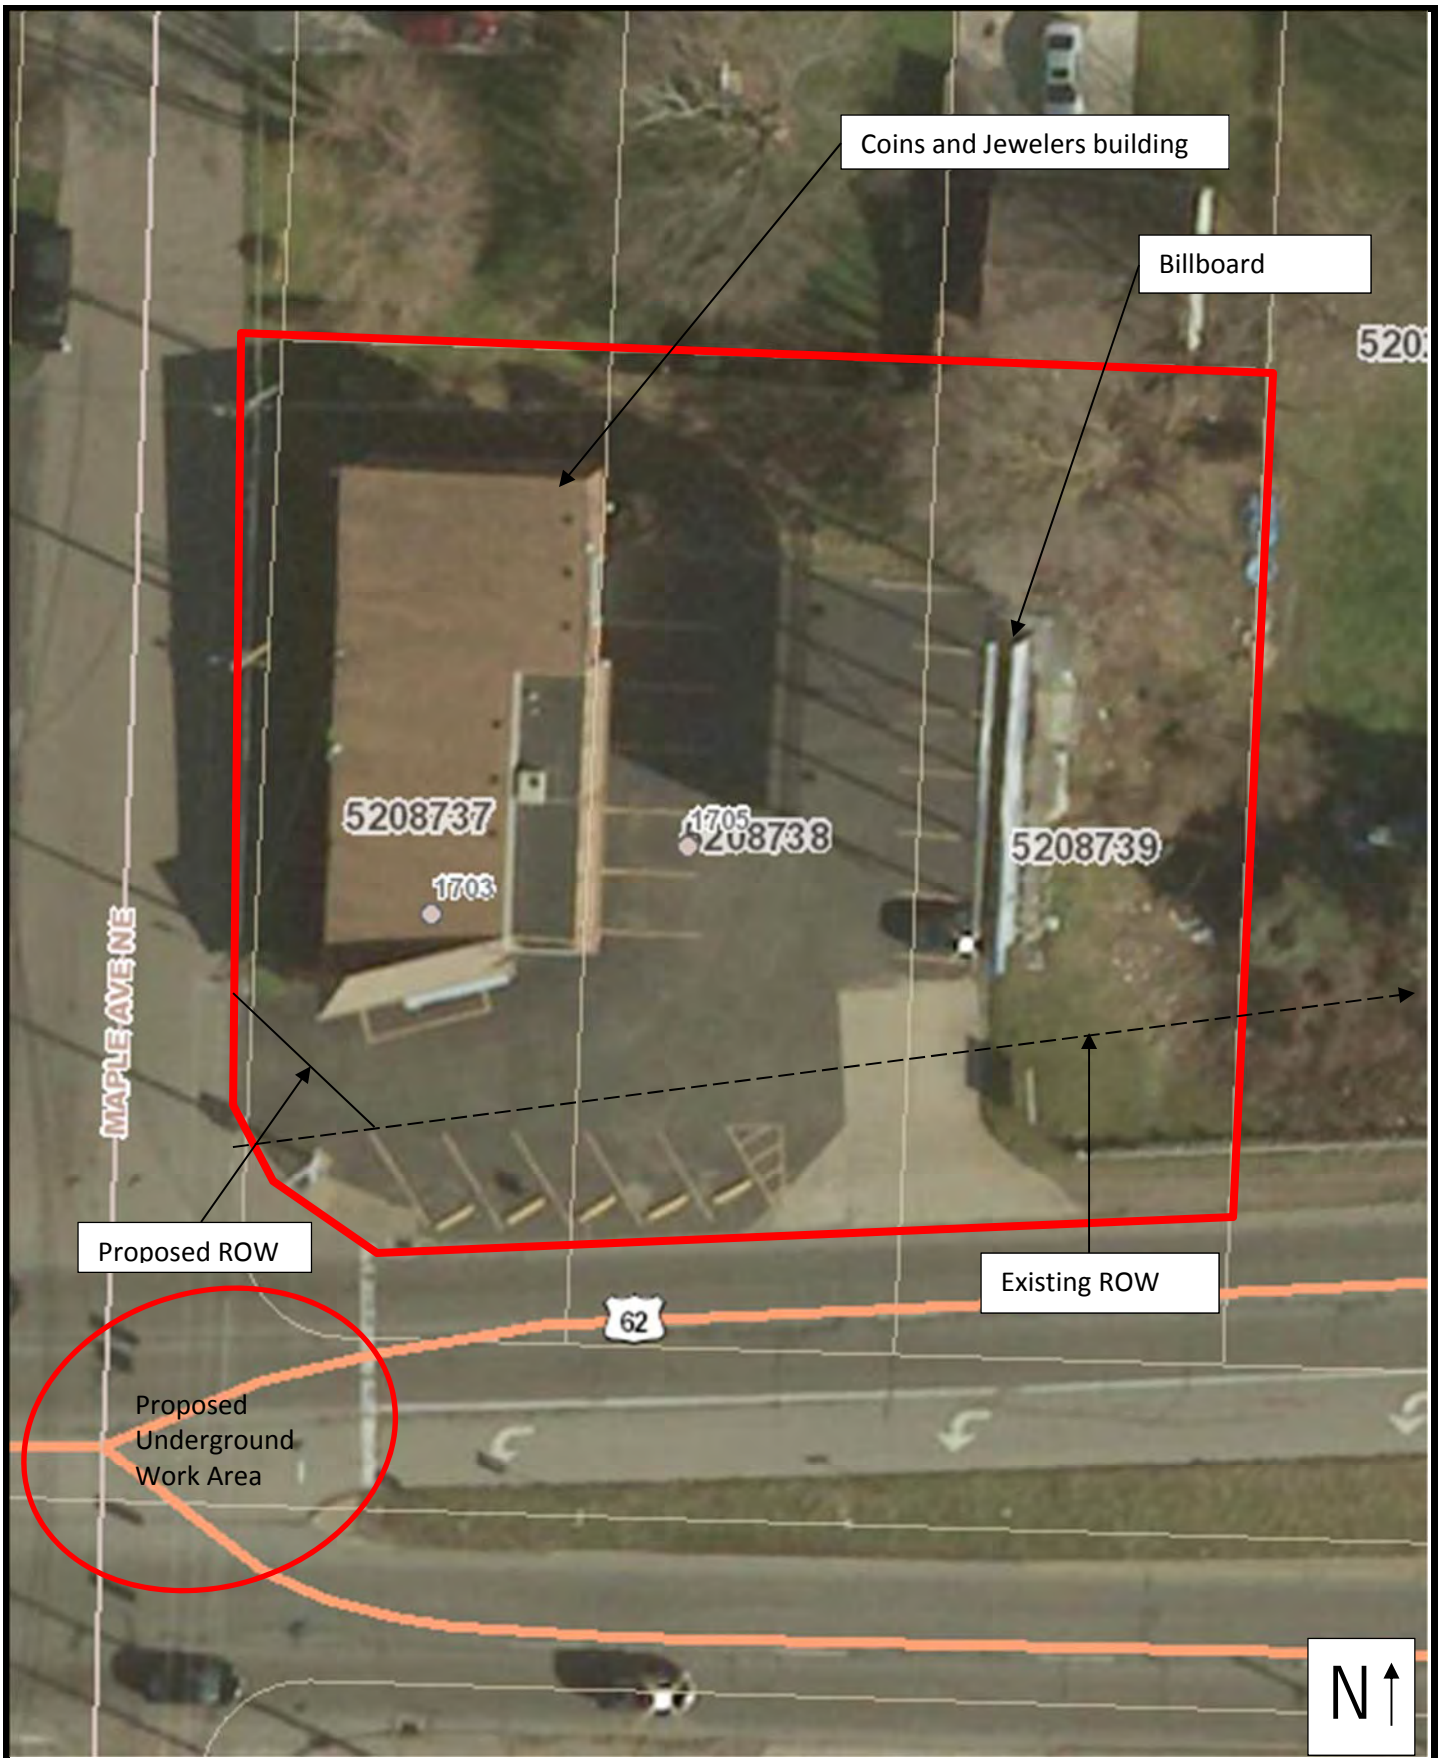
Site Plan
Sites M
STA-62-20.05 (PID 100824)
Canton, Stark County, Ohio

This site is located on the northeast corner of US 62 and Maple Avenue NE. This site was listed on the Historical Auto Station databases as Art S Generator Service at 1705 30th NE. Based on regulatory data, if right-of-way take or deep excavation is planned for this site additional ESA investigation was recommended. According to current right of way plans it appears that 20-feet of right of way is required from the southwest corner of this property, however, no access will be available and the owner will be displaced and the property will be an entire take. The Site Plan is presented in Appendix A.

The site has been a retail facility since at least the 1950s with minor generator repair for approximately two years (1959-1960). The site was occupied with a store and residential dwelling in 1956. No gasoline station was observed in the research performed. It appears that this site was used as retail and residential with generator repair between 1959 and 1960. Soils under this site consist of Chili-Urban land complex, which have high permeability. Construction will involve the removal of catch basins and storm sewers, and the installation of new roadway with curb and gutter in front of this site.

The site has been a retail facility since at least the 1950s with minor generator repair for approximately two years (1959-1960). No gasoline station was observed in the research performed. It appears that this site was used as retail and residential with generator repair between 1959 and 1960. Construction will involve the removal of catch basins and storm sewers, and the installation of new roadway with curb and gutter in front of this site. Based on the absence of a gasoline station and limited maintenance performed inside the building, no further investigation appears warranted for this site.

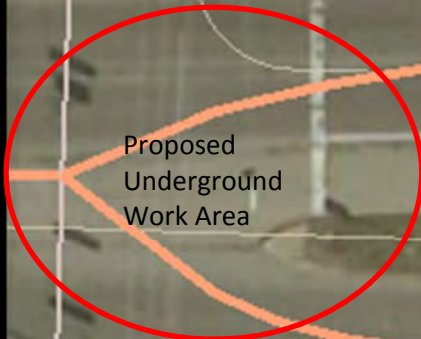
● = Proposed Phase II ESA Boring Locations

Proposed Underground Work Area

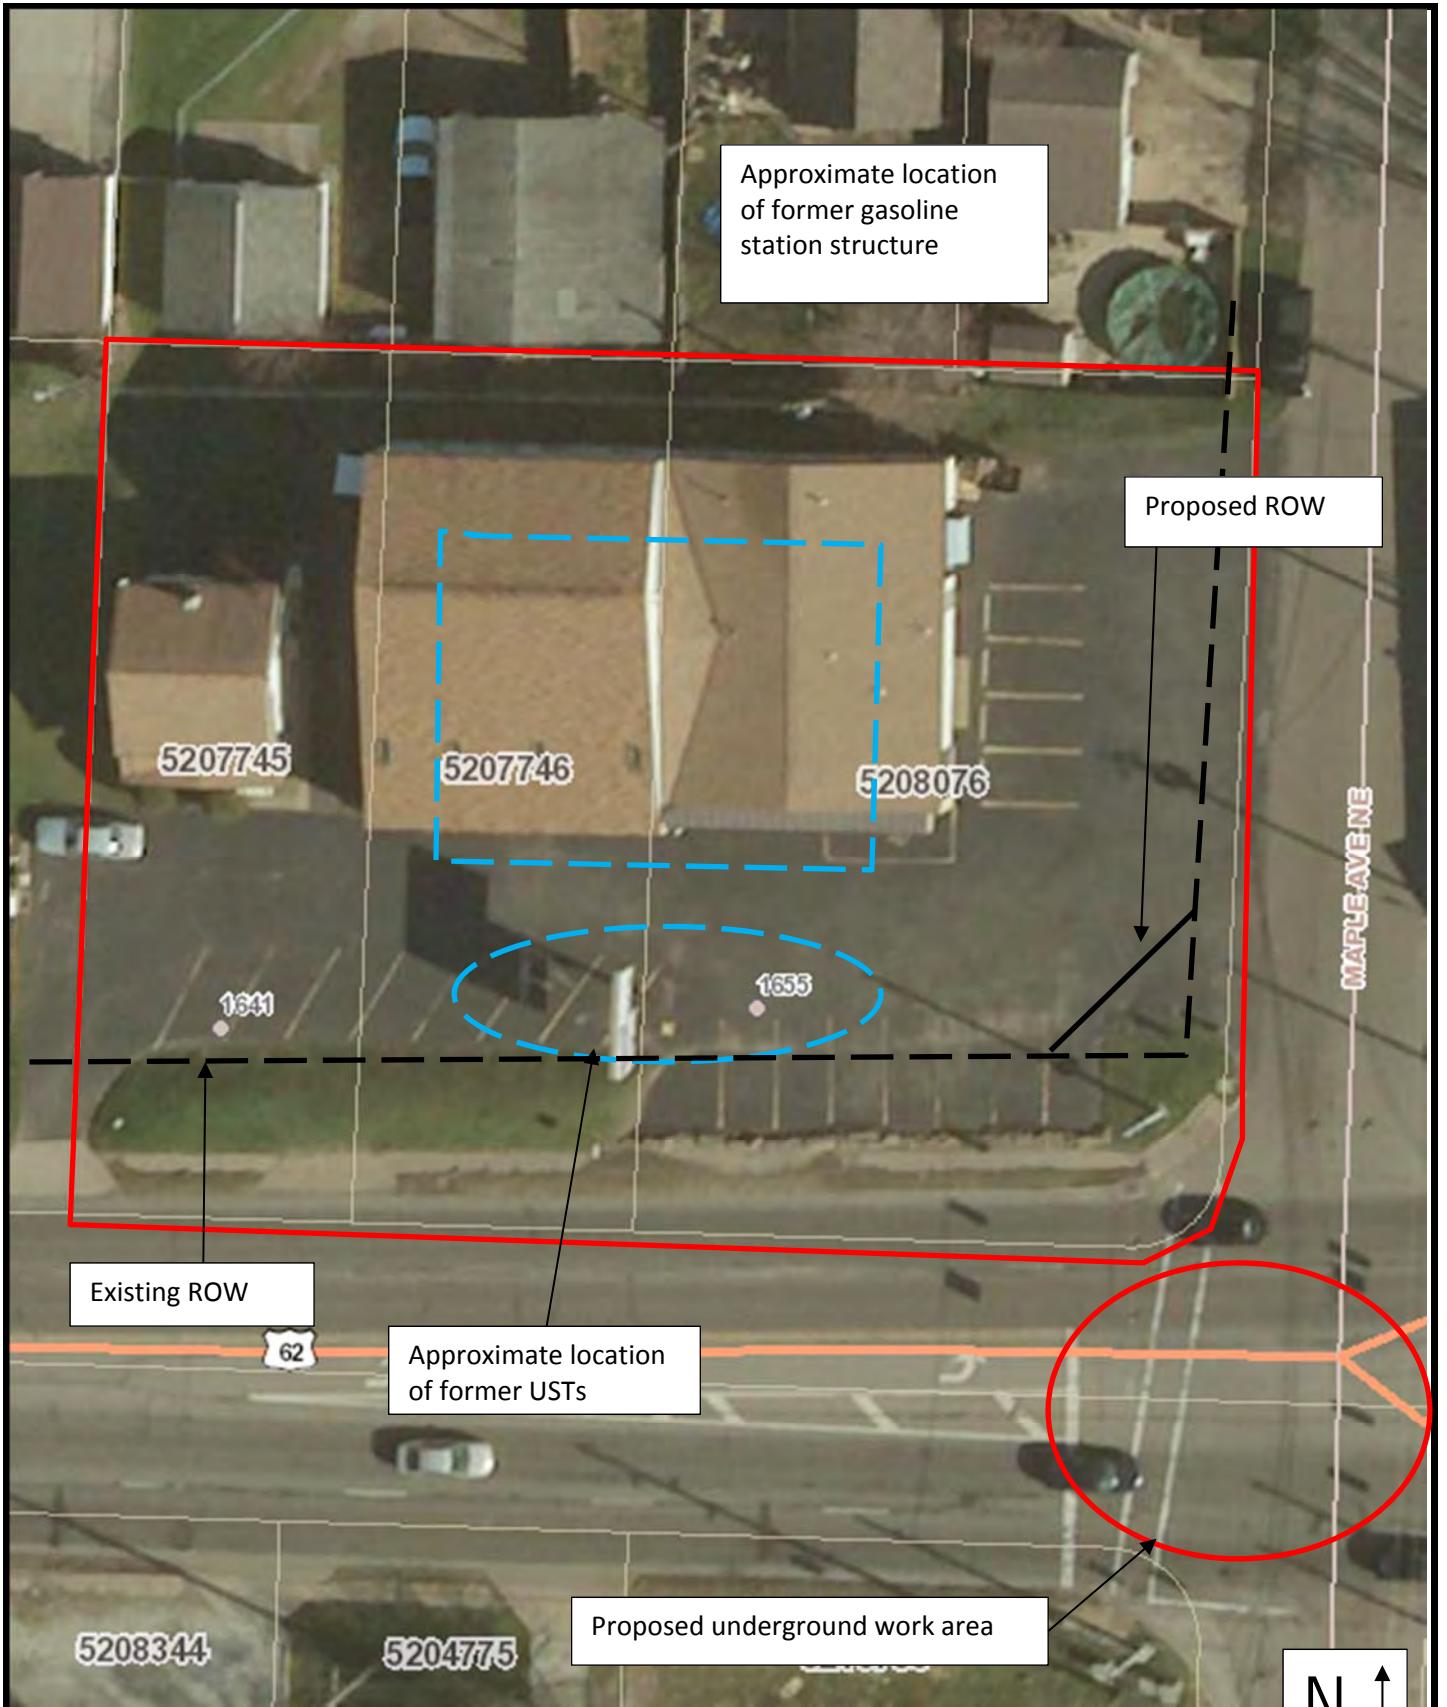
Site Plan
Site 2Y
STA-62-20.05 (PID 100824)
Canton, Stark County, Ohio

Approximate location of former gasoline station structure

Proposed ROW

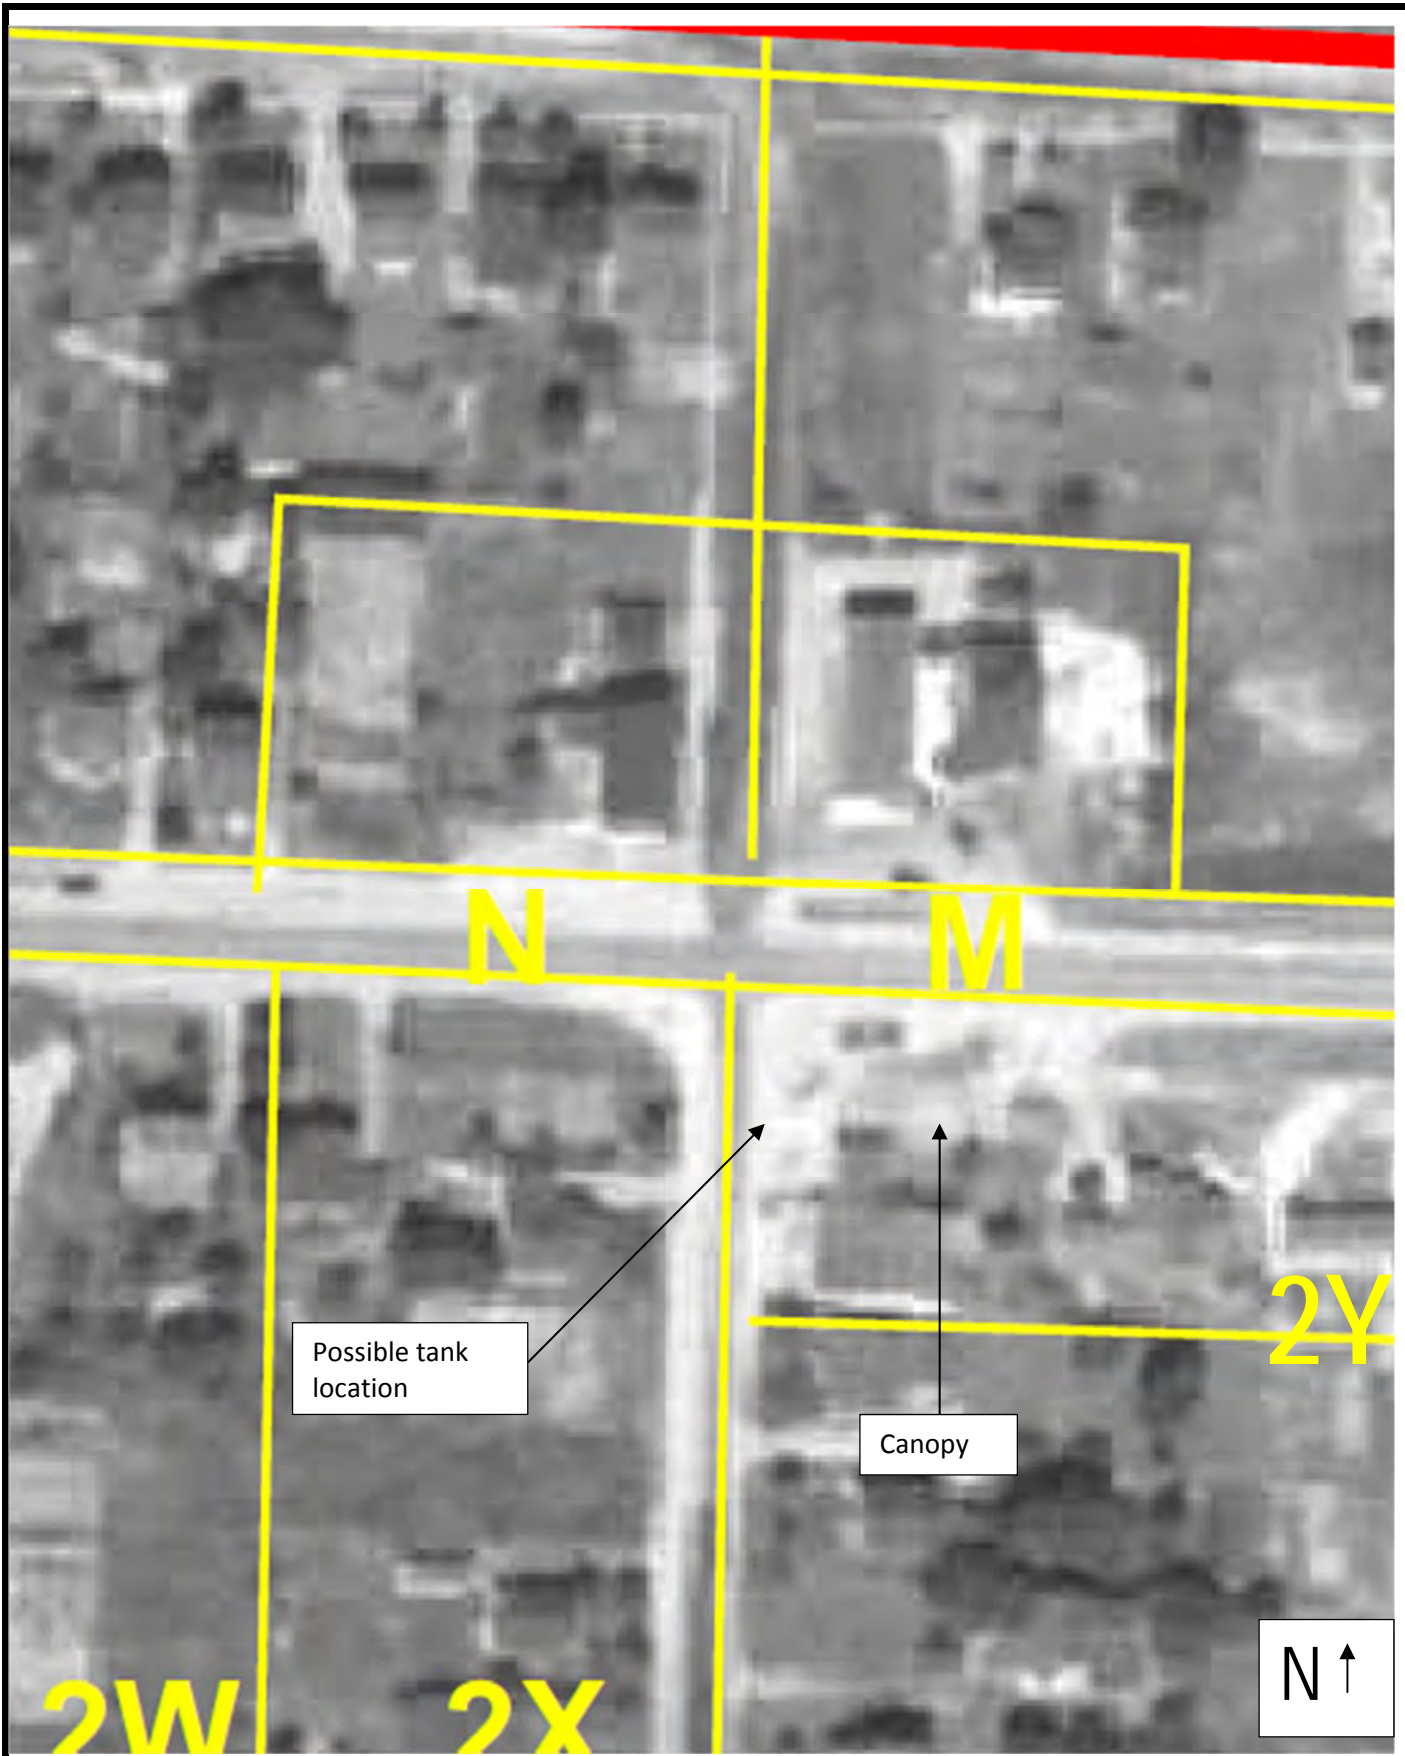
1957 Aerial Photograph
Sites N,M and 2Y
STA-62-20.05 (PID 100824)
Canton, Stark County, Ohio

Possible tank location

Canopy

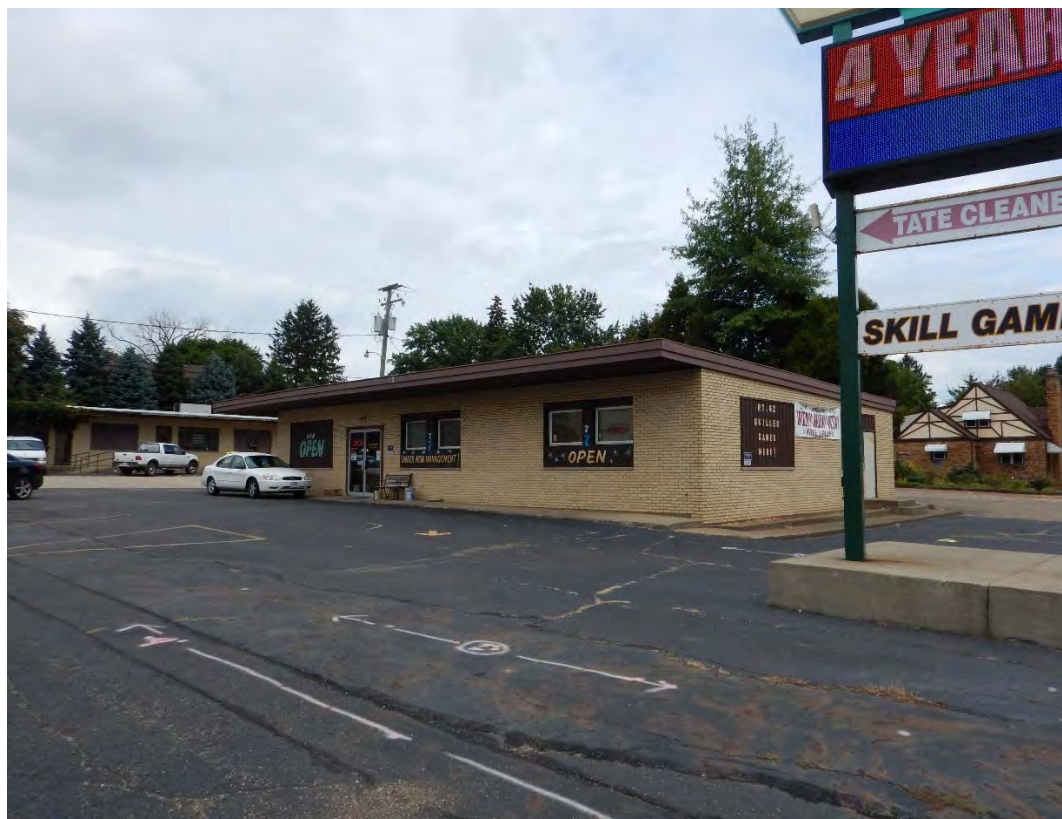
Photo 1

Standing in SW corner
of Skill Games parking
lot looking NE at Skill
Games building

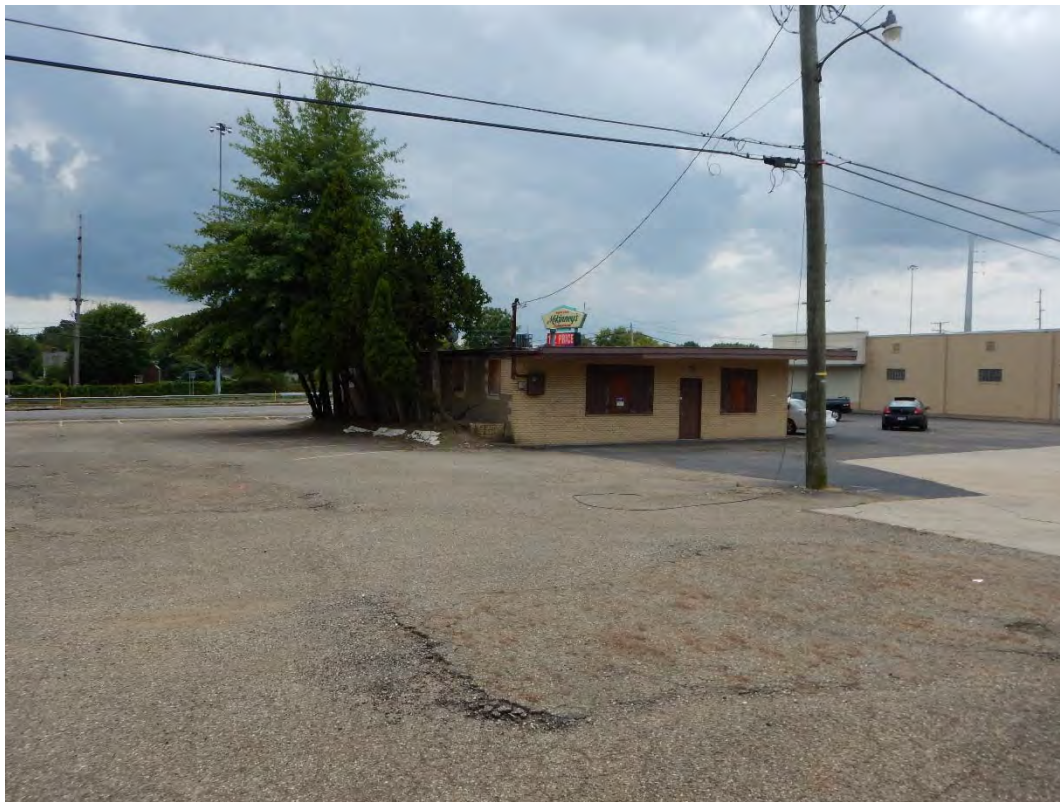
Photo 3

Standing in NE corner
of Skill Games parking
lot looking SW towards
Skill Games building

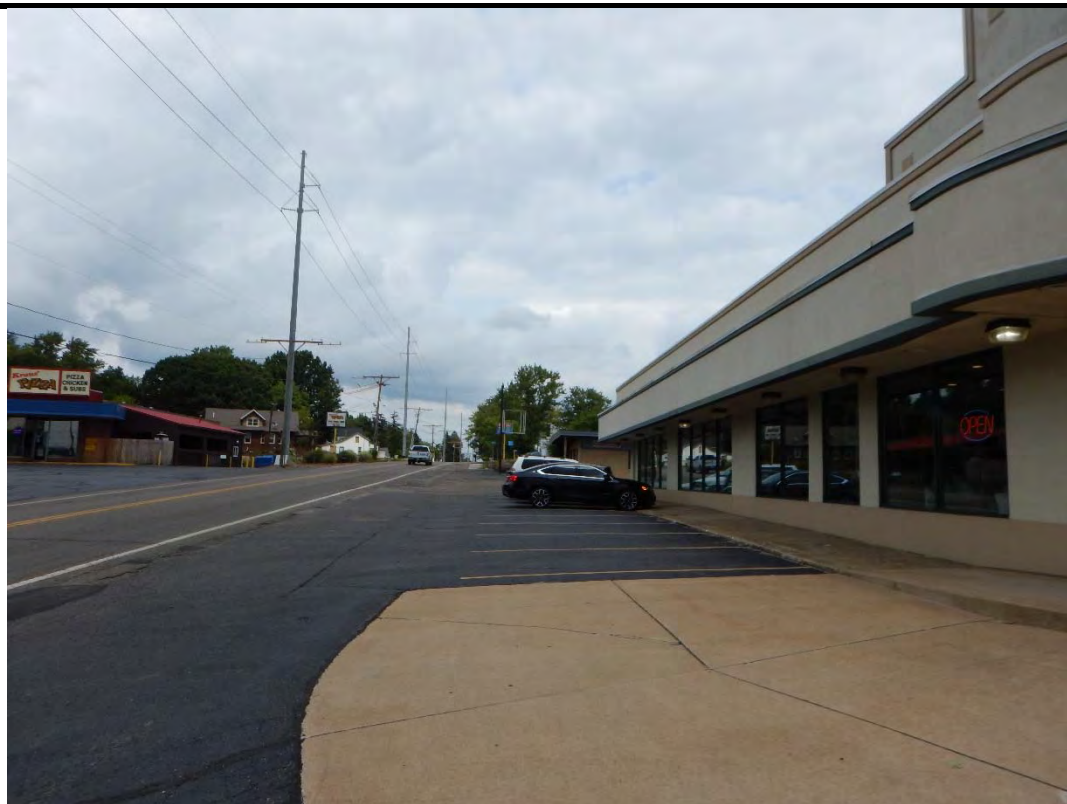
Photo 5
 Site W
 1001 30th Street NE
 Canton, OH 44714
 Standing at corner of
 30th Street and
 Martindale Road
 looking N along the
 West side of
 McKinney's Outlet
 building

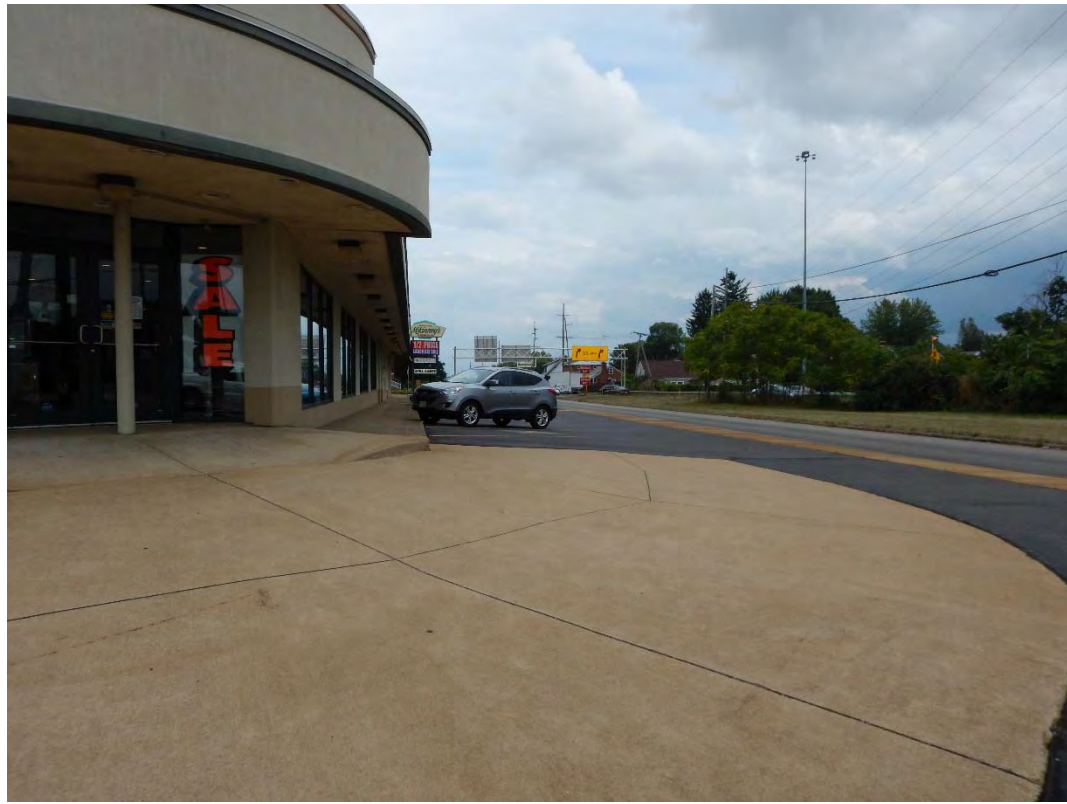
Photo 6
 Site W
 1001 30th Street NE
 Canton, OH 44714
 Standing at corner of
 30th Street and
 Martindale Road
 looking E along the
 South side of
 McKinney's Outlet
 building

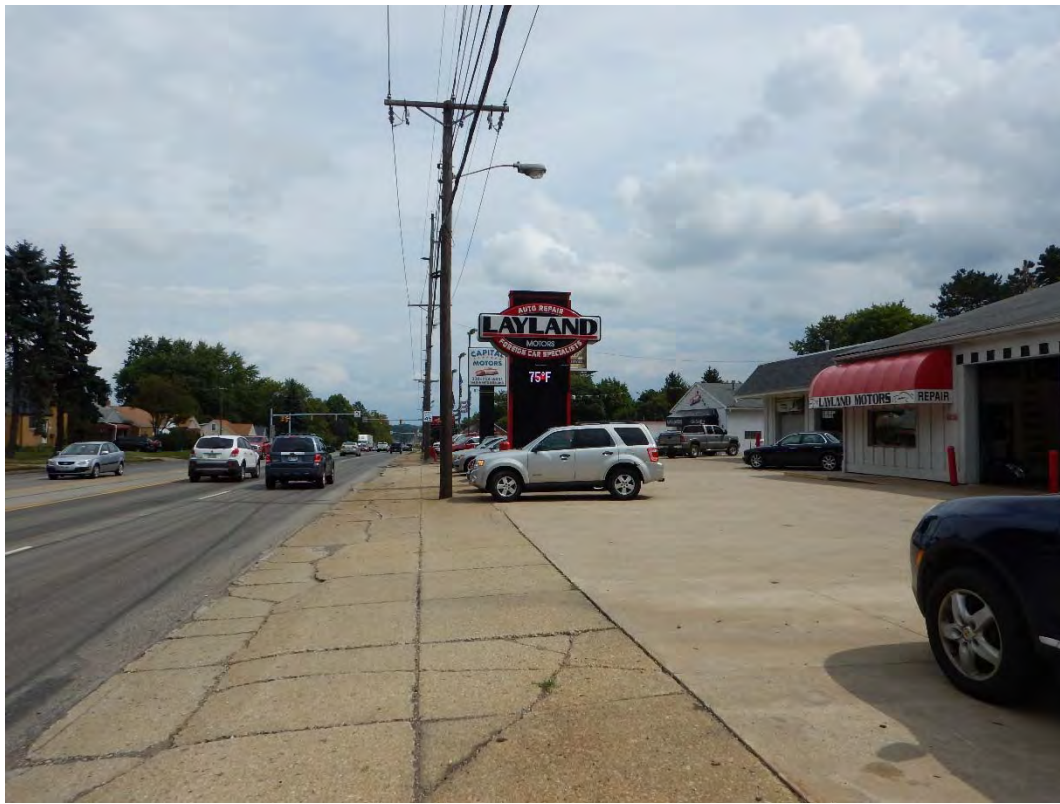
Photo 7

Standing in NW corner of Layland Motors' parking lot looking E along 30th Street, viewing Layland's parking lot and front of shop

Based on the potential location of the former pumps adjacent or within the ROW, a Phase II ESA is recommended for this site in the location of the assumed dispensers on 1132 and 1220. A total of four (2 on 1132 30th property and 2 on 1220 30th Street property) borings should be installed to 10-feet below ground surface near the sidewalk based on the results of the geophysical survey. Samples should be collected continuously and each two foot interval should be screened with an organic vapor analyzer. The interval with the highest reading from each boring should be analyzed for SW 846-8260 BTEX, SW 846-8270 PAHs, SW 846-6010 lead and SW-846 8015M TPH GRO and DRO.

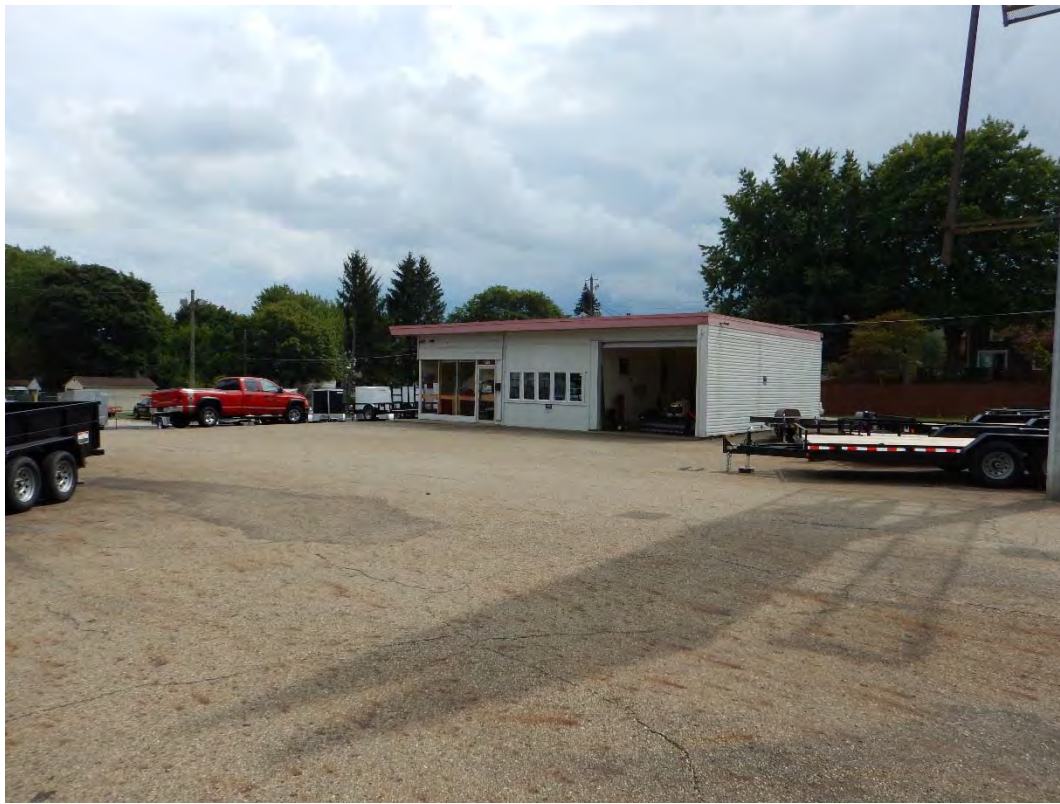
Photo 11

Standing in the NW corner of the old gas station parking lot looking SE towards the building and parking lot of the old gas station

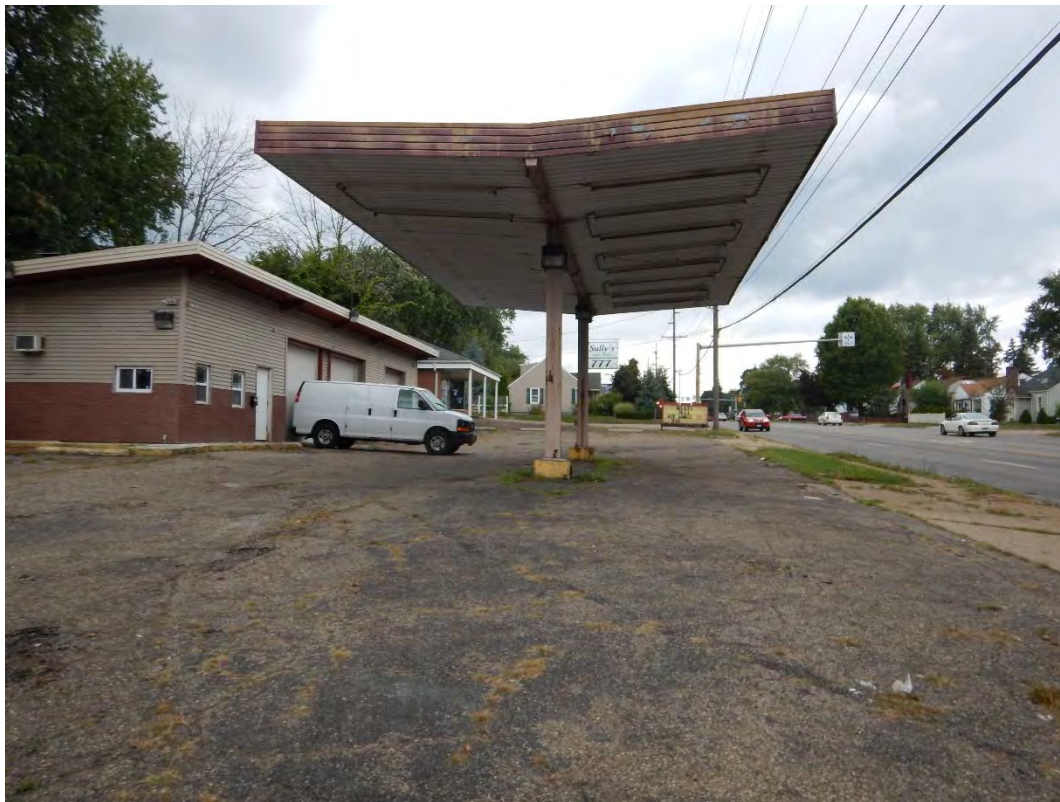
Photo 13

Standing at corner of
30th Street and St
Elmo Ave looking W
towards the old pump
station and building

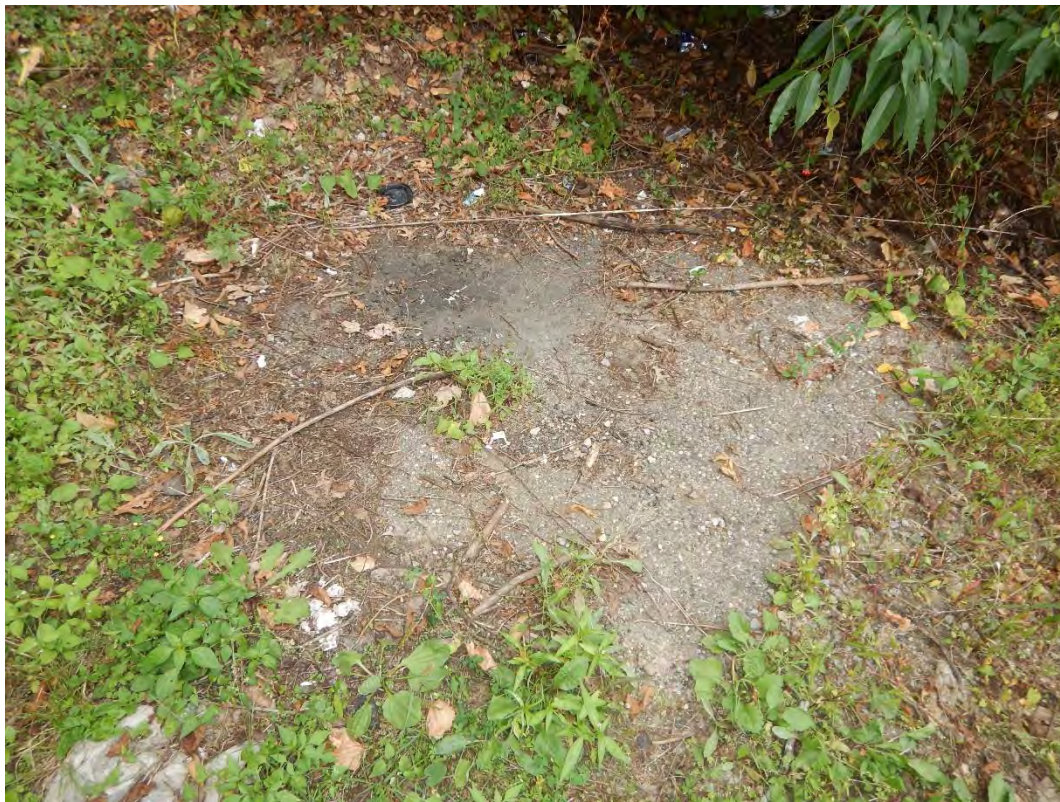
Photo 15

Standing in the SW corner of the gas station lot, on the W side of the building looking down at the possible location of old fuel tanks that have been removed

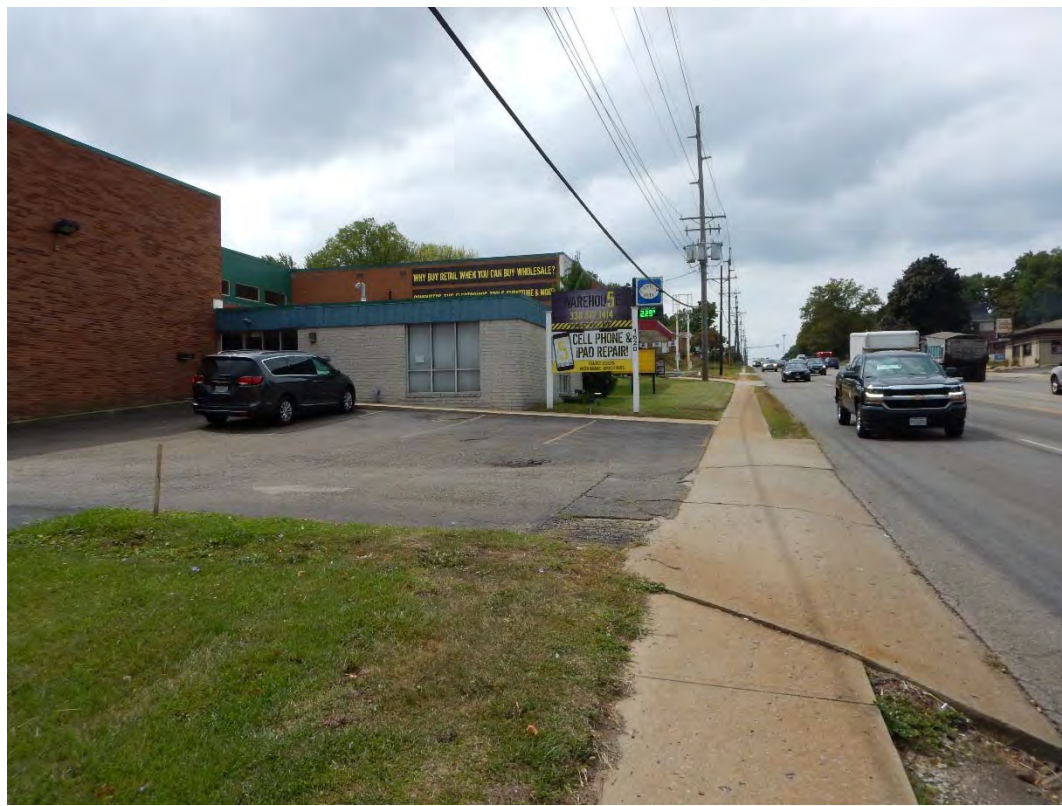
Photo 17

Standing in NE corner
of the Warehouse5e lot
looking W along the
North front of the
Warehouse5e building
complex

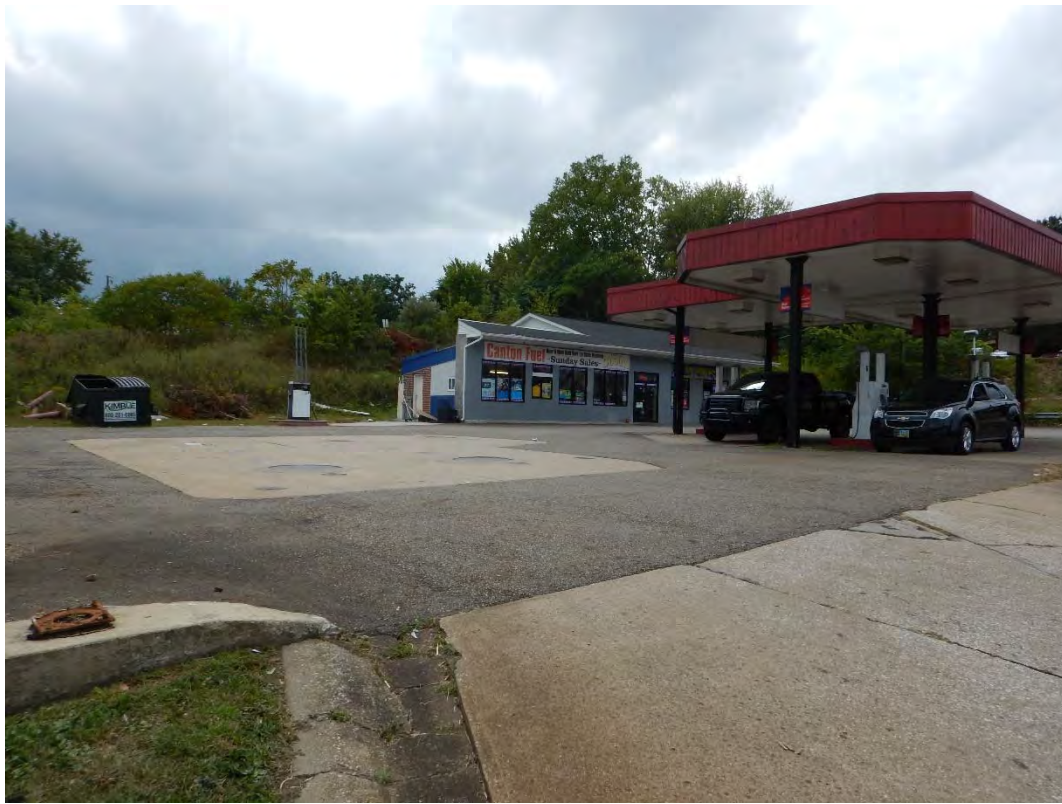
Photo 19

Standing in the NE
corner of the Canton
Fuel parking lot
looking SW towards
the Canton Fuel gas
station

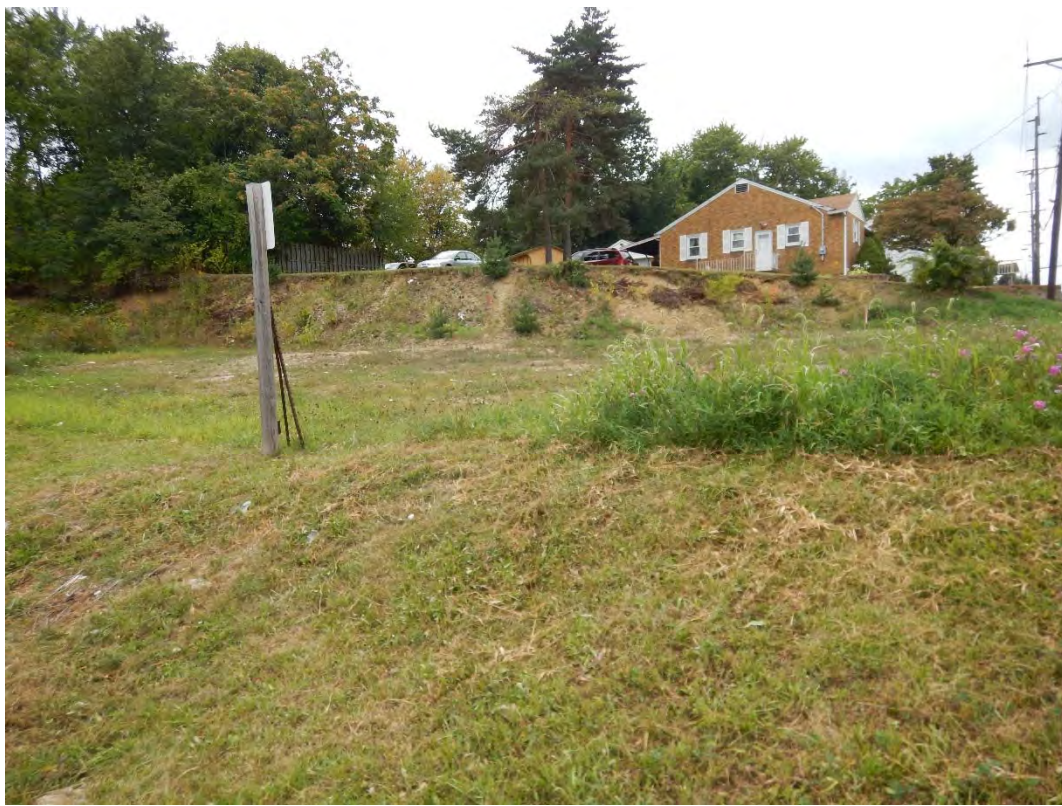
Photo 21

Standing in the NW
corner of the Canton
Fuel parking lot
looking SW towards
the vacant lot
neighboring the gas
station

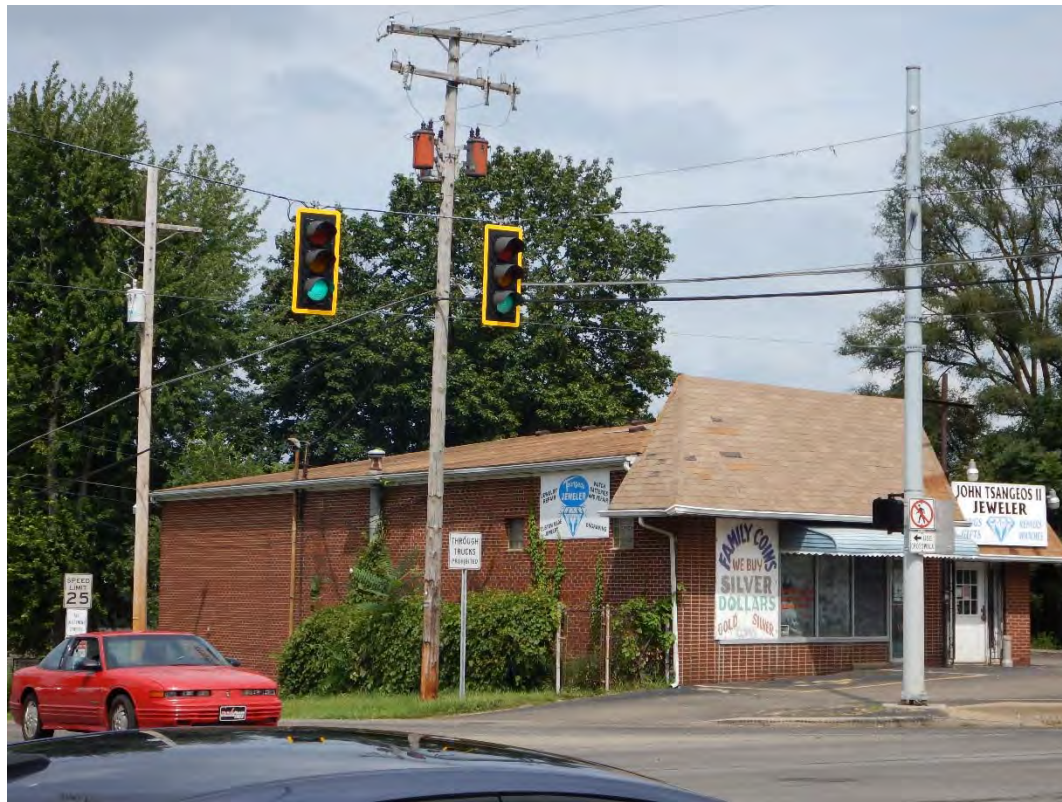
Photo 23

Standing at the SW corner of 30th Street and Maple Ave looking NE across 30th Street towards Tsangeos Jeweler

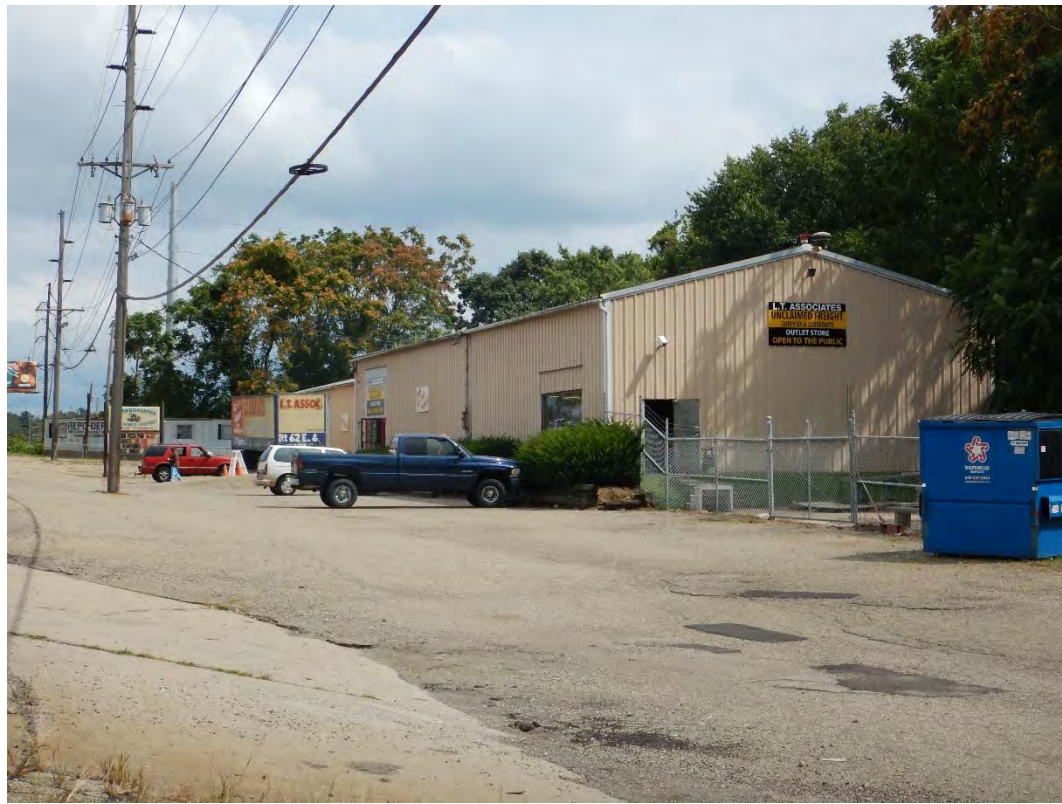
Photo 25

Standing in the NW corner of the L.T. Associates' parking lot looking SE towards the L.T. Associates' building complex

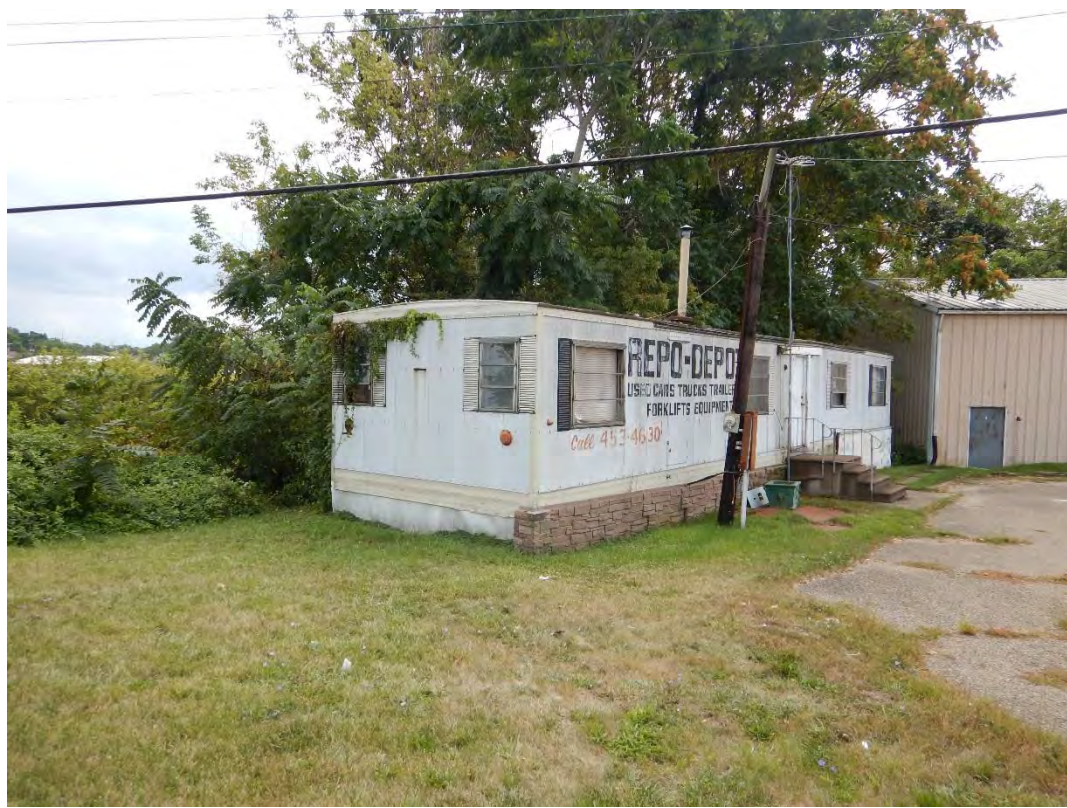
Photo 27

Standing in the NE corner of the L.T. Associates' parking lot looking S towards the N side of the Repo-Depot trailer

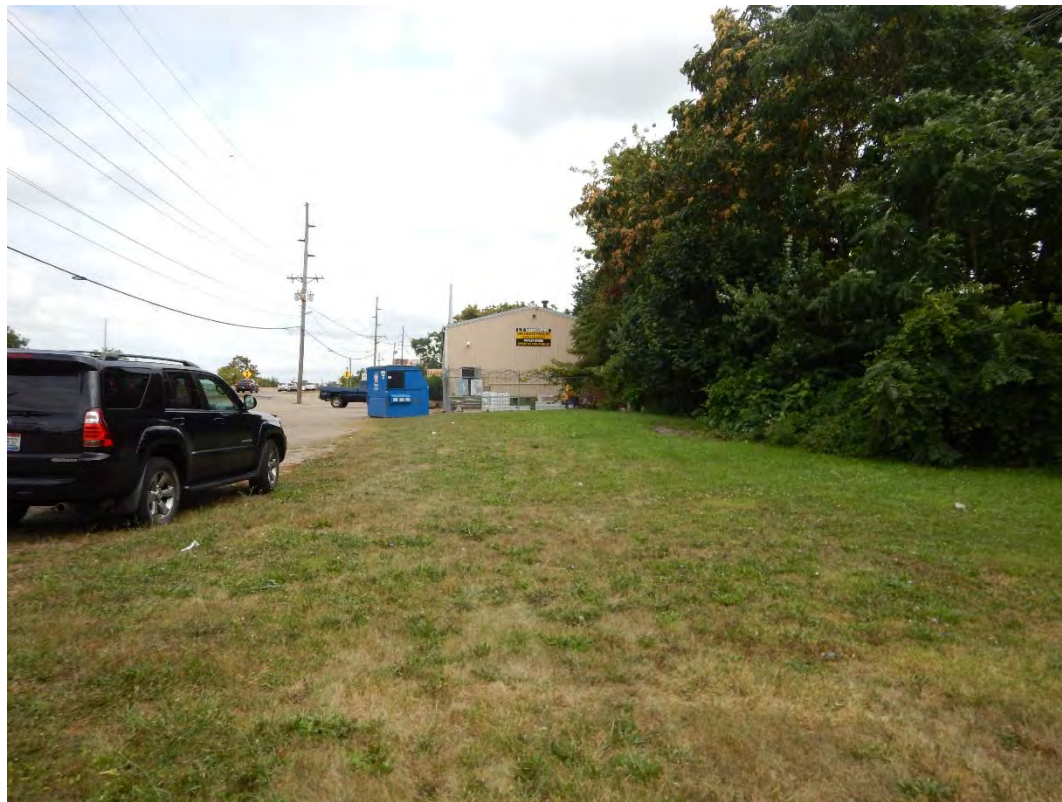
Photo 29

Standing in the SW corner of the L.T. Associates' lot looking E towards the L.T. Associate's building, viewing the open land in the SW corner of the lot

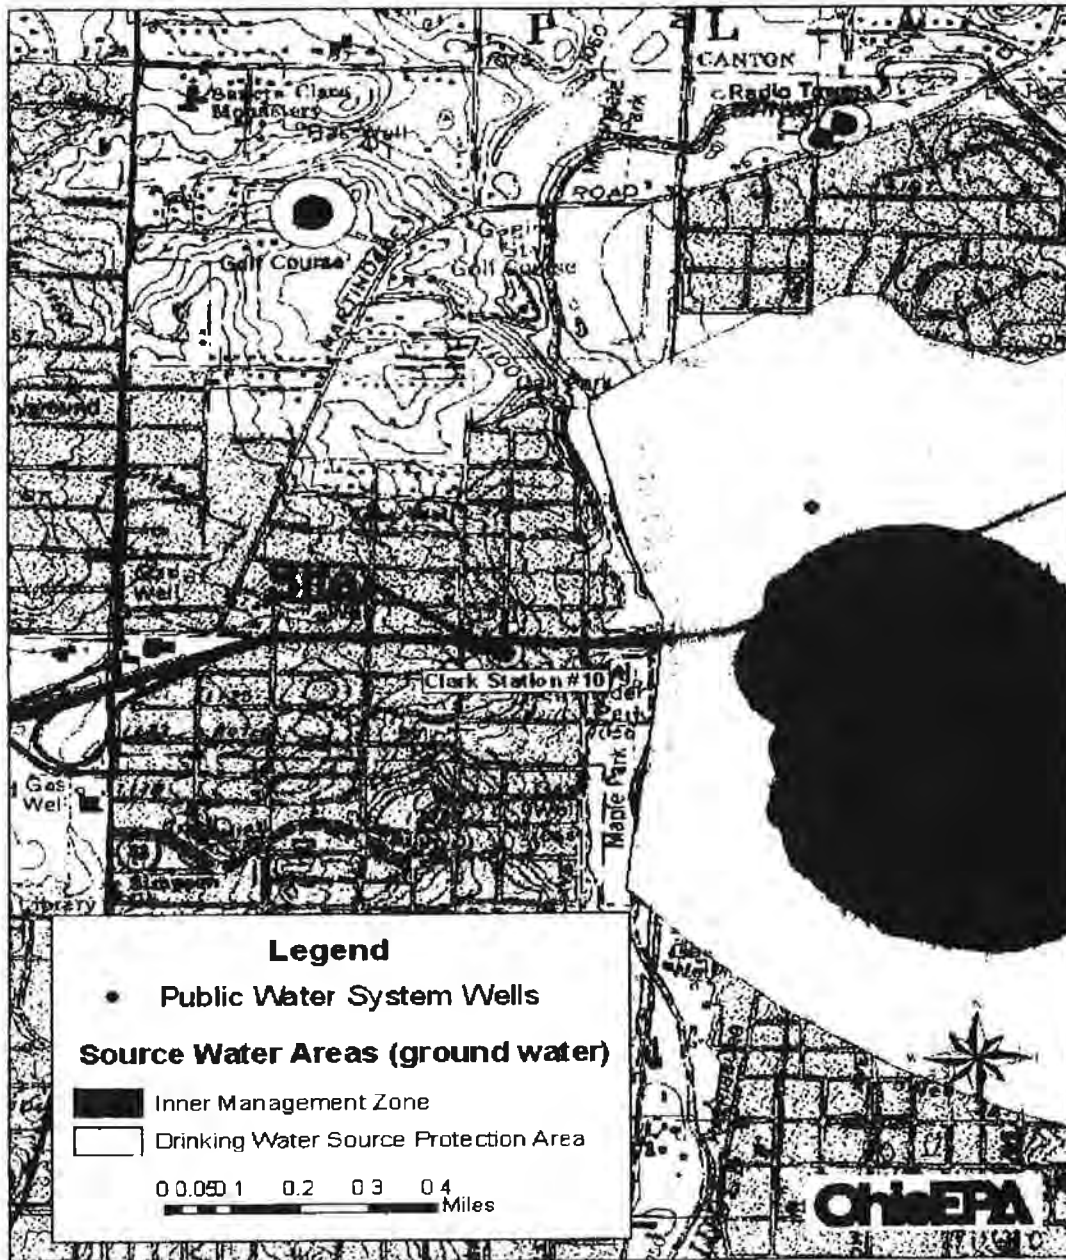
Figure A-10: Well Head Protection Plan Map

Drinking Water Source Protection Areas Near BUSTR Evaluation 1600 30th Street, Canton, Ohio
