Reference: **Geotechnical Desktop Study**
TP 26 NE Ohio Site 12 – SUM-77 Vacant Rest Area (PID 122880)
Summit County, Ohio
S&ME Project No. 24170232

Based on information provided by ms and ODOT, S&ME understands that ODOT is proposing to construct multiple truck parking areas across the state of Ohio to meet the parking needs. Each site will be designed to facilitate the largest quantity of truck parking spots while addressing impacts to environmentally sensitive areas, geometric alignments and the cost of construction. This site is part of the TP 26 NE Ohio grouping of six (6) general locations and includes ten (10) total parking areas.

Site 12 consists of one proposed parking area in the currently vacant rest area for the northbound travel direction of Interstate 77 near Uniontown, Ohio, and between the Wise Road and Graybill Road overpass structures.

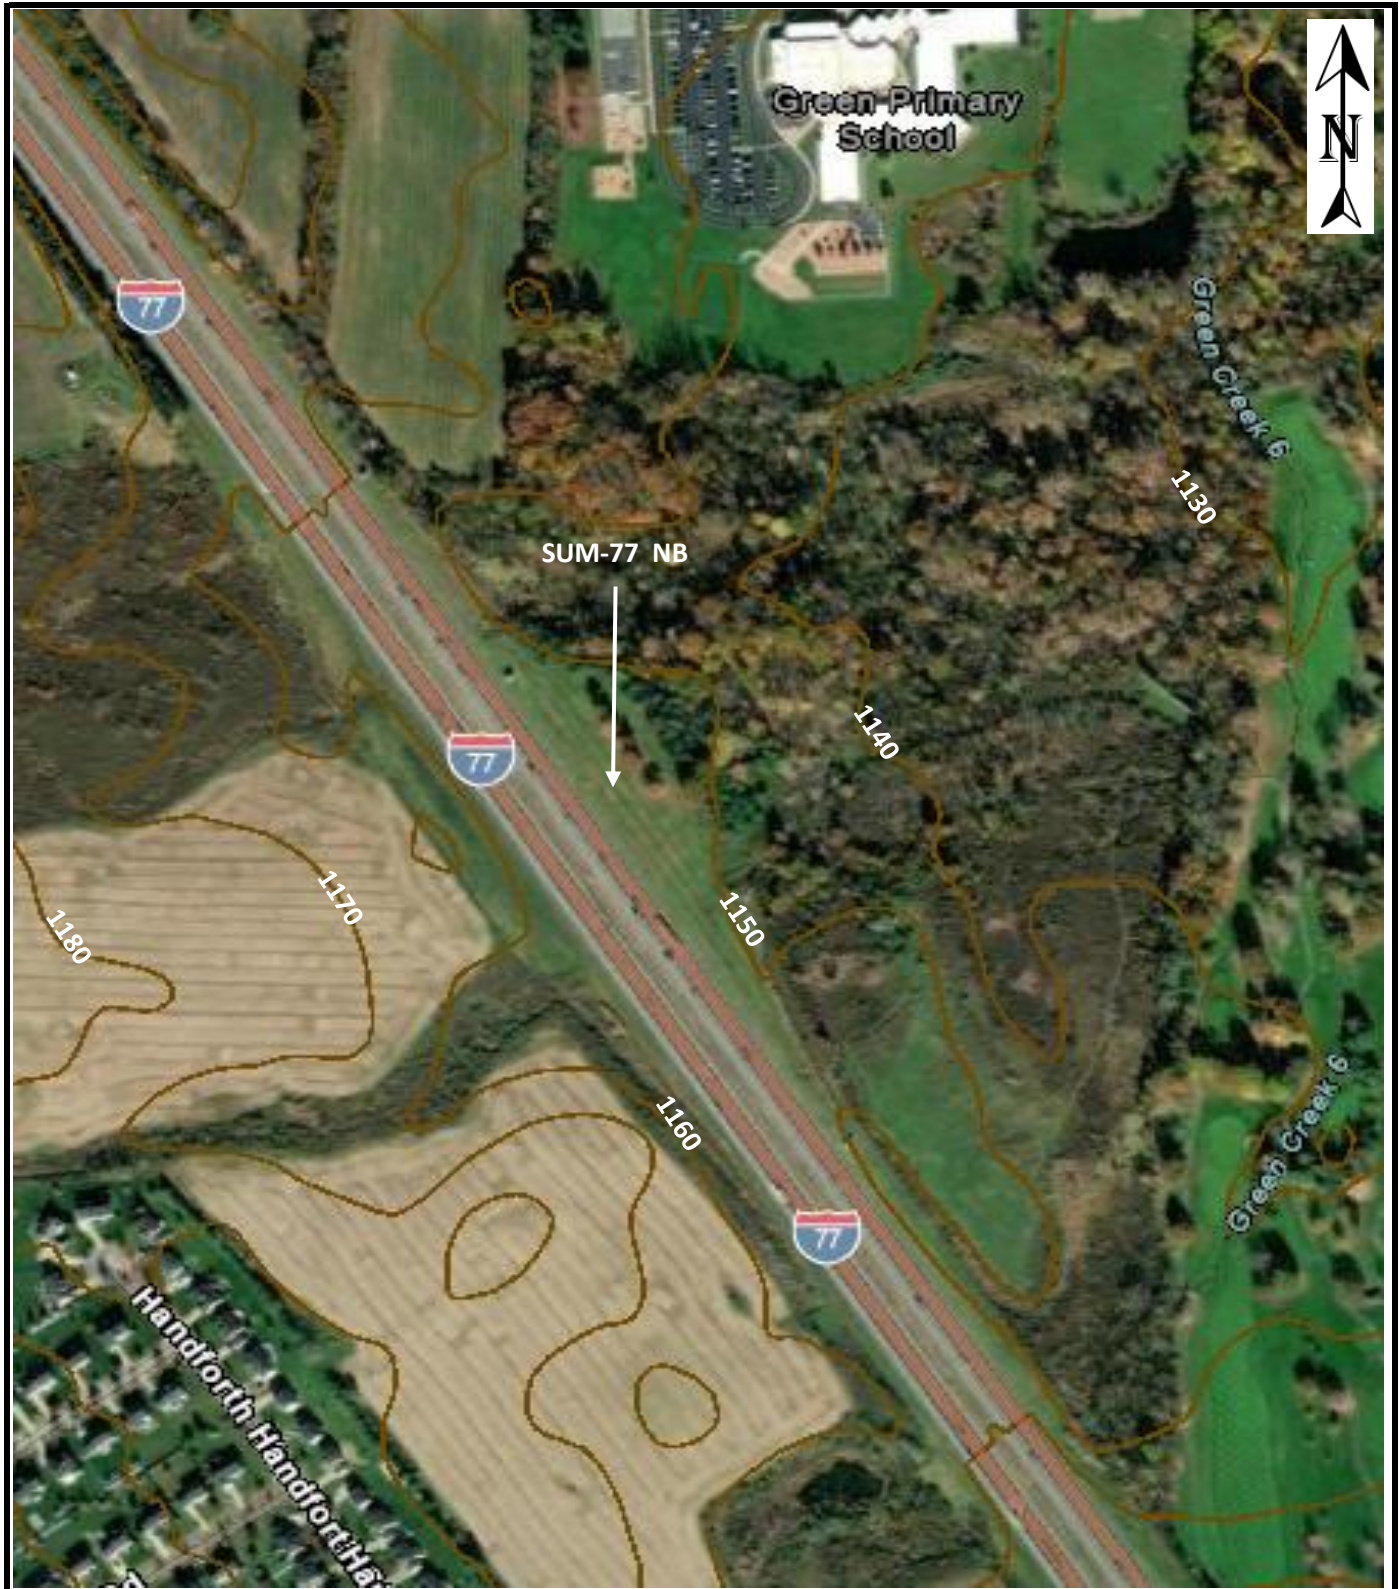
Figure Desc.: Site location and ground surface contour mapping

Topic	Resource(s)	Summary of Findings
Surface Topography	Ground Surface Topography Mapping (Summit County GIS & Google Earth)	The ground surface elevation (El.) at Site 12 ranges between approximate El. 1150 and El. 1160.
Soil Overburden	Physiographic Regions of Ohio Map (ODNR) Drift Thickness Mapping (ODNR) Quaternary Geology Mapping (ODNR) Surficial Geology Mapping (ODNR) Groundwater Pollution Potential Mapping (ODNR) Groundwater Resource Potential Mapping (ODNR) Water Well Logs (ODNR) Soil Web Survey (NRCS)	<p>Site 12 is within the Glaciated Allegheny Plateau section of Ohio which is located within the Akron-Canton Interlobate Plateau Physiographic Region. Overburden soil is composed of sandy Wisconsinan-age and older glacial drift. Kames, eskers and peat kettles are common within this physiographic region. The soil overburden at this site is anticipated to range from approximately 10 to 20 feet deep.</p> <p>Water well logs indicate the glacial deposits are anticipated to consist of predominantly granular soils with discontinuous layers of clay.</p>

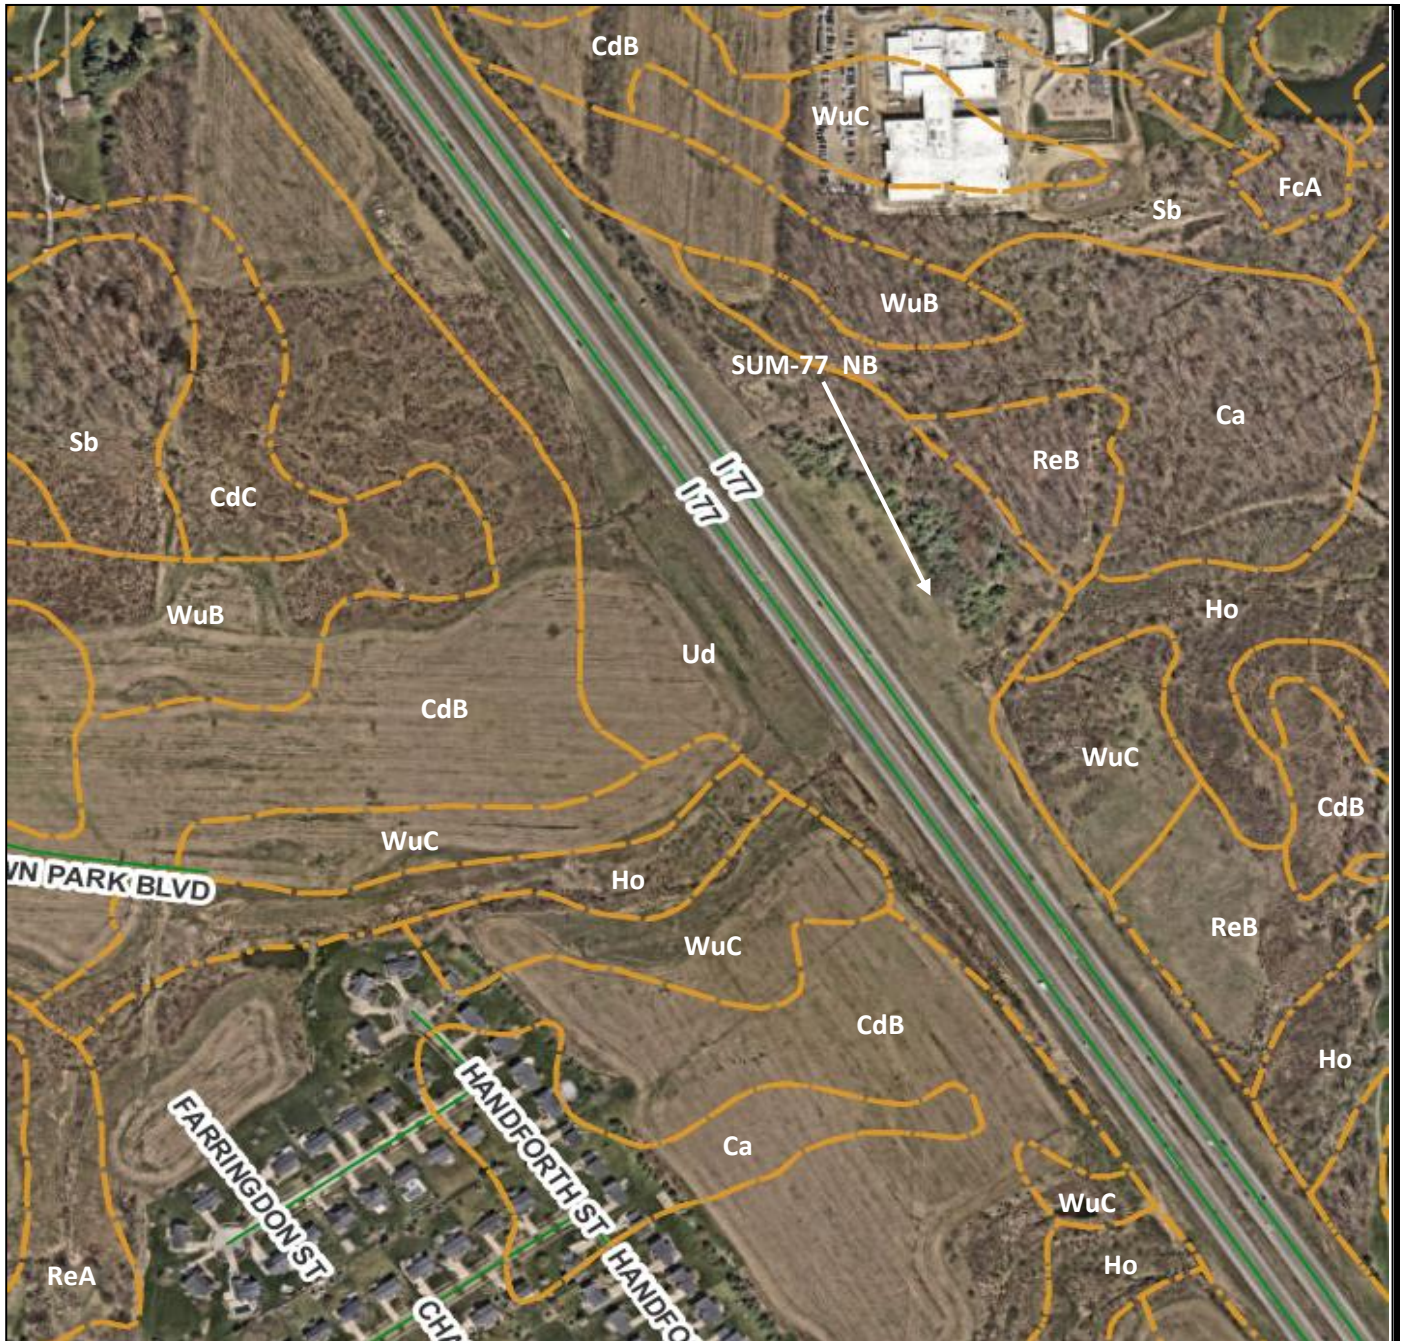
Figure Desc.: Site location and surficial geology mapping

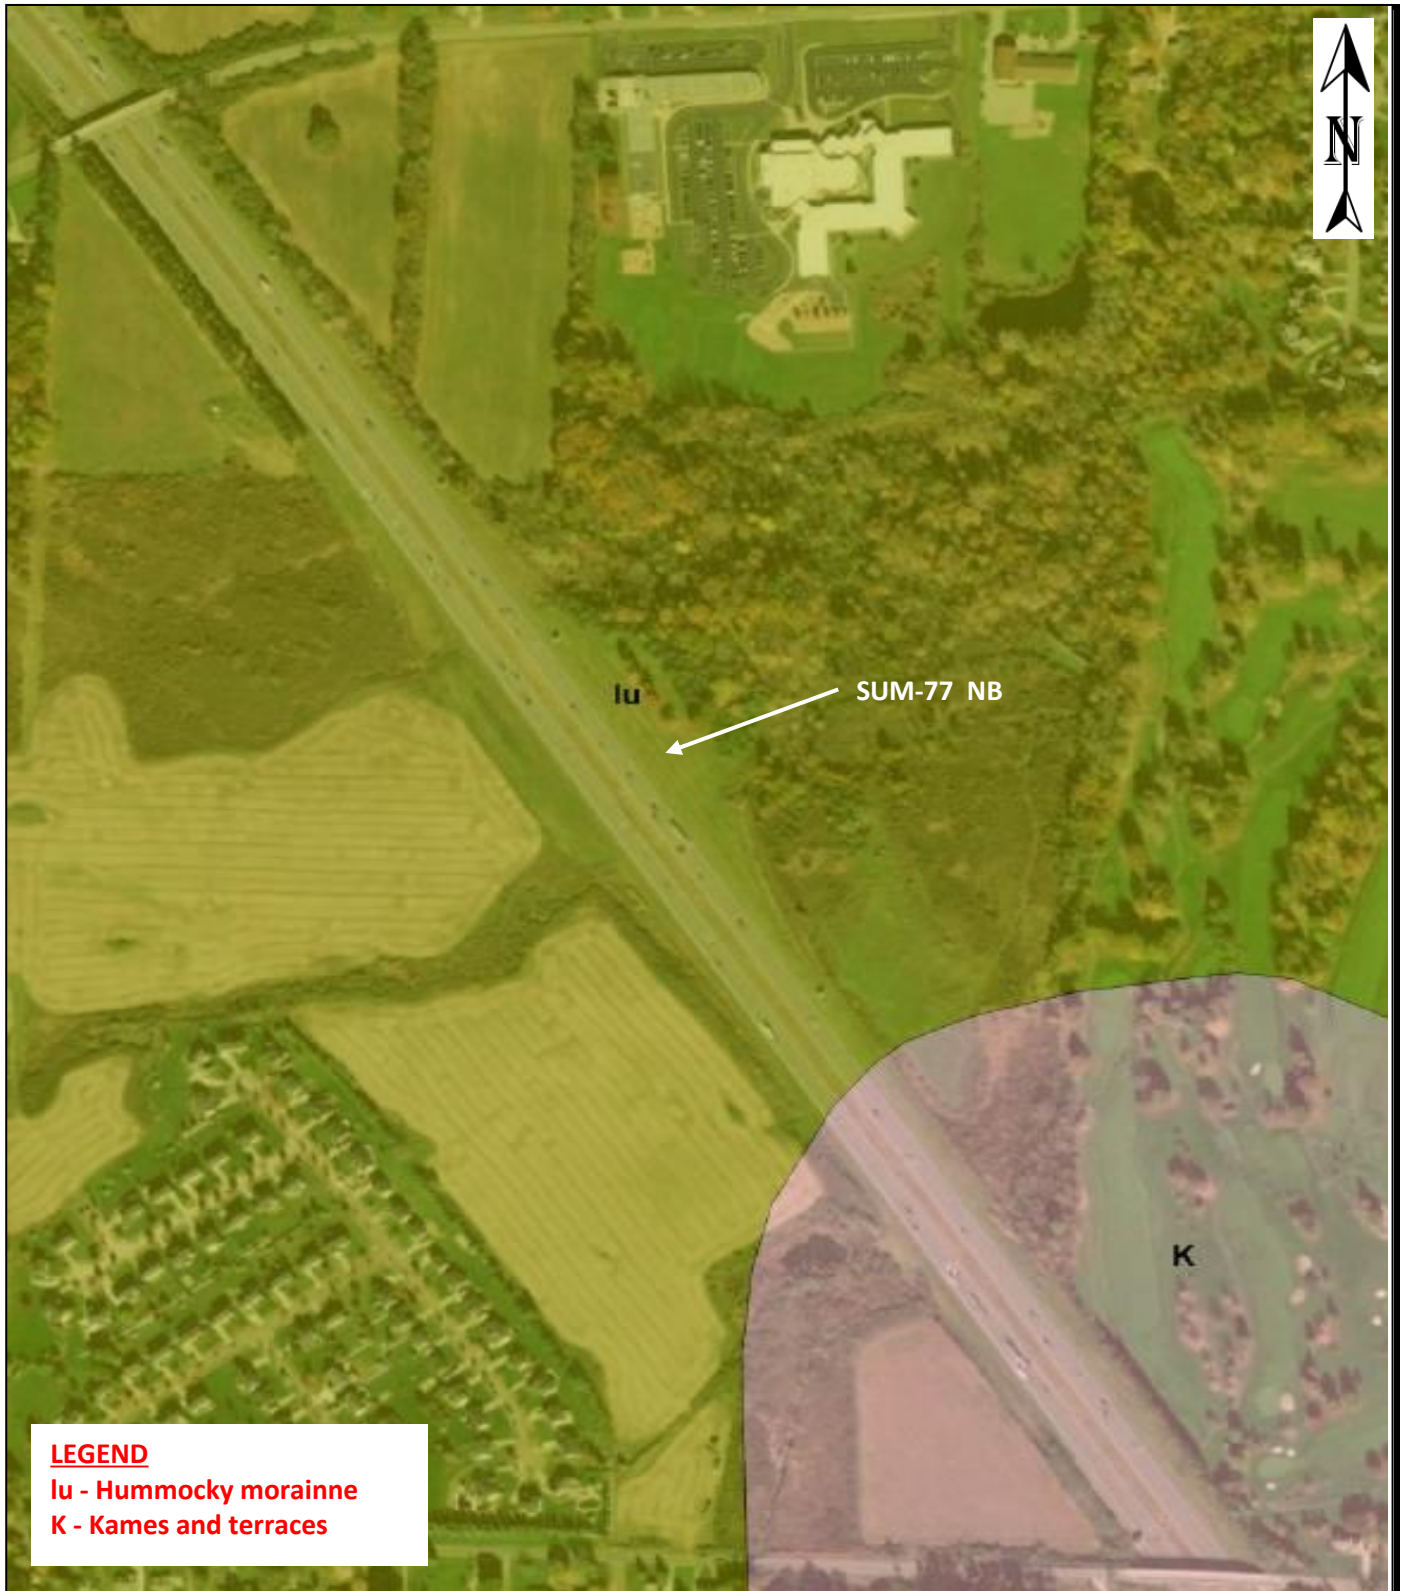
Figure Desc.: Site location and quaternary geology mapping

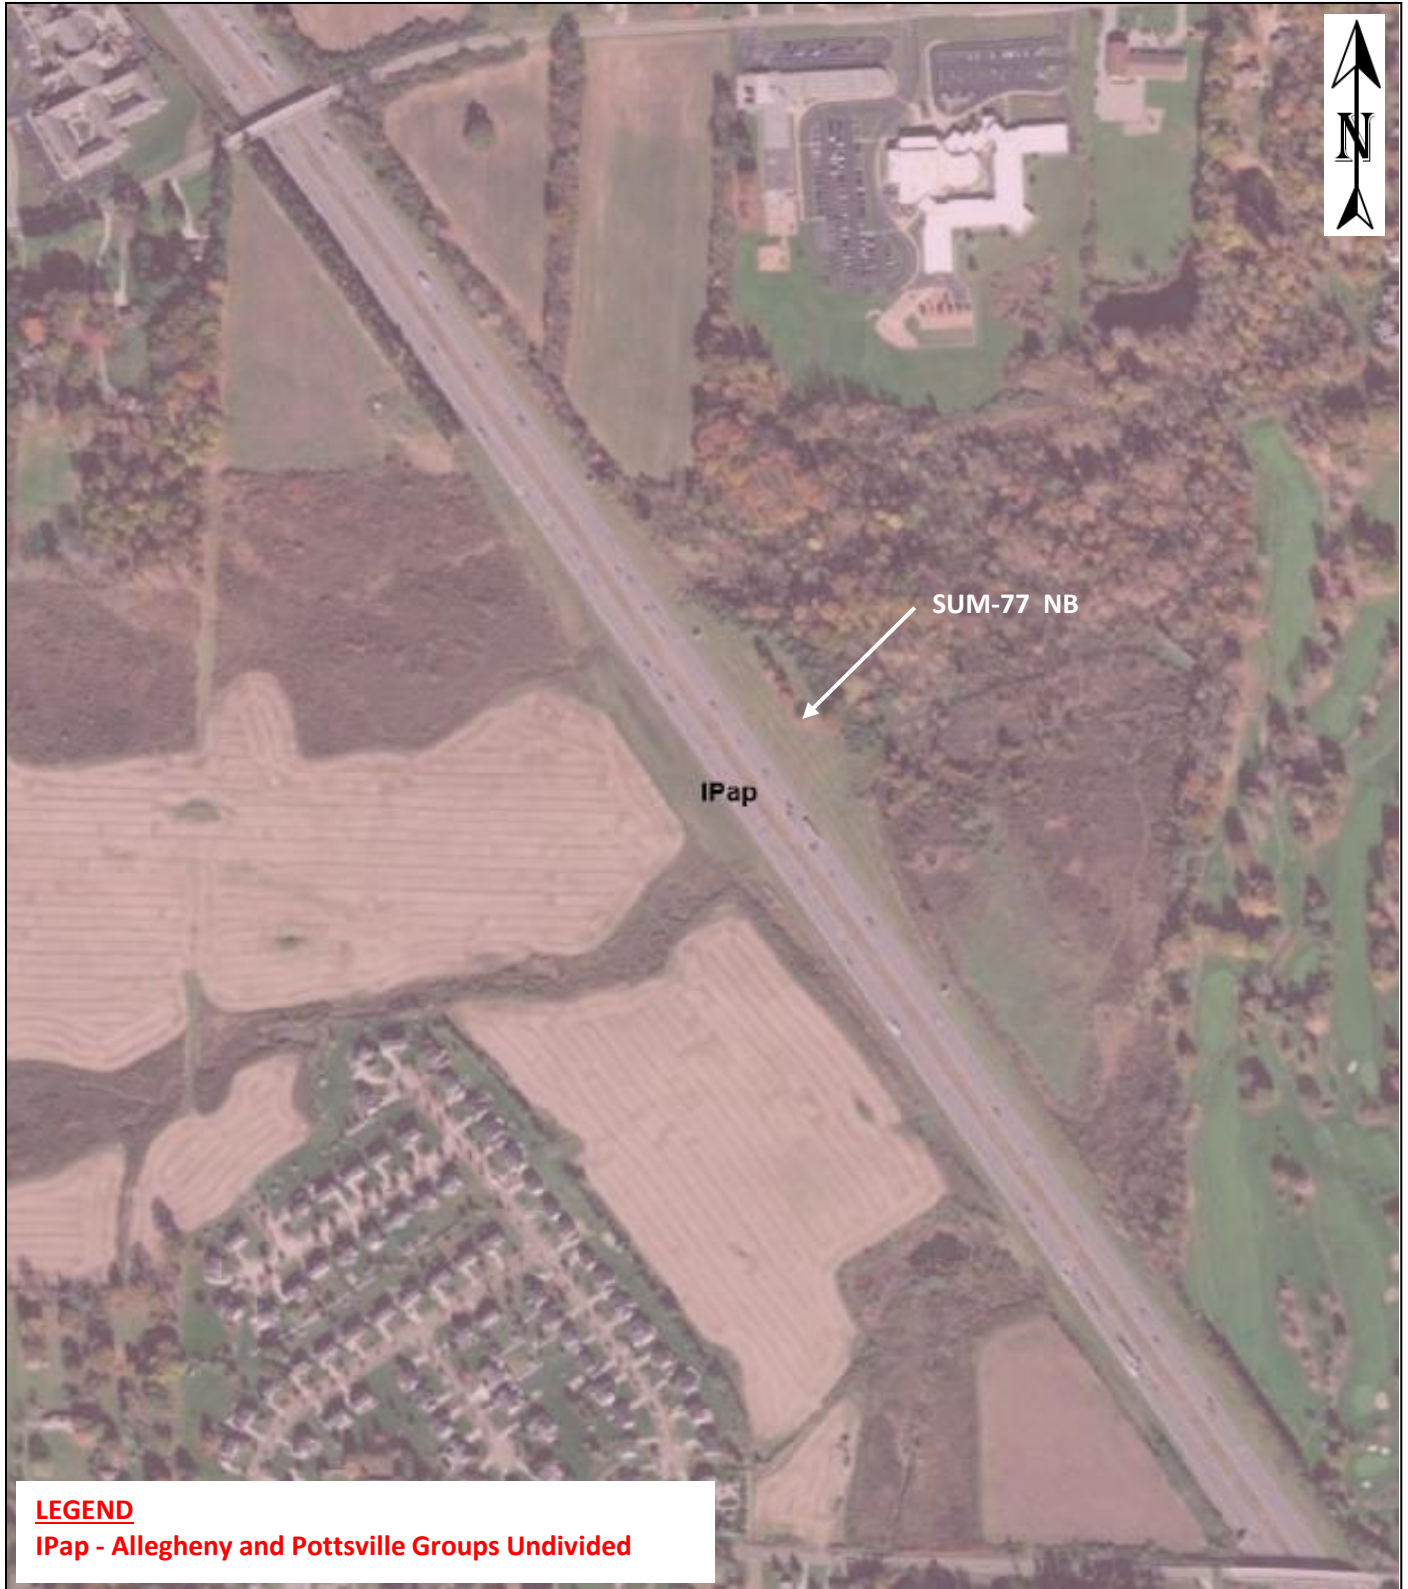
Figure Desc.: Site location and bedrock geology mapping

Bedrock	Physiographic Regions of Ohio Map (ODNR) Bedrock Topography Mapping (ODNR) Water Well Logs (ODNR)	Shale, siltstone, and sandstone bedrock, along with conglomerate and coal of the Allegheny and Pottsville Groups Undivided is anticipated at Site 12. Bedrock topography mapping indicates the uppermost bedrock at this site is near El. 1140.

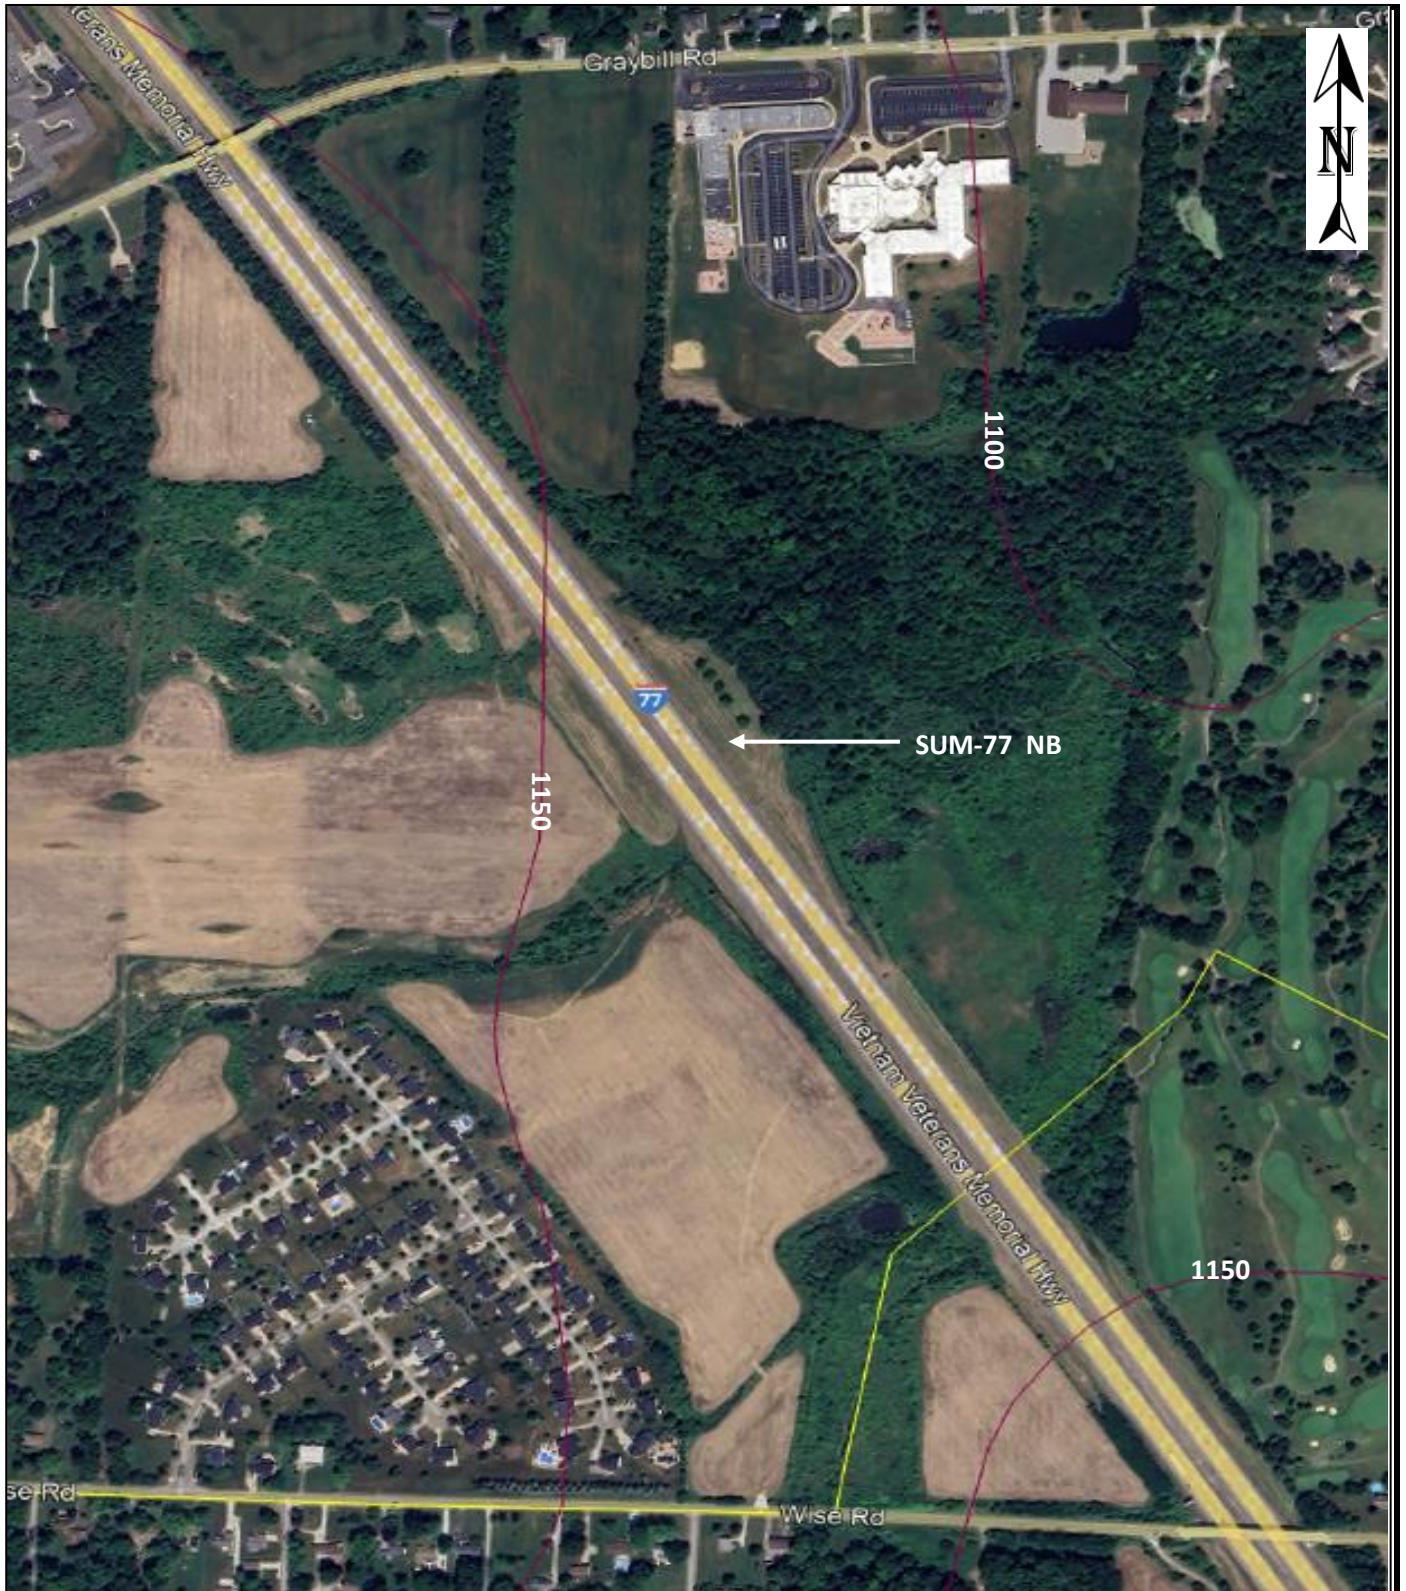
Figure Desc.: Site locations and top of bedrock contour mapping

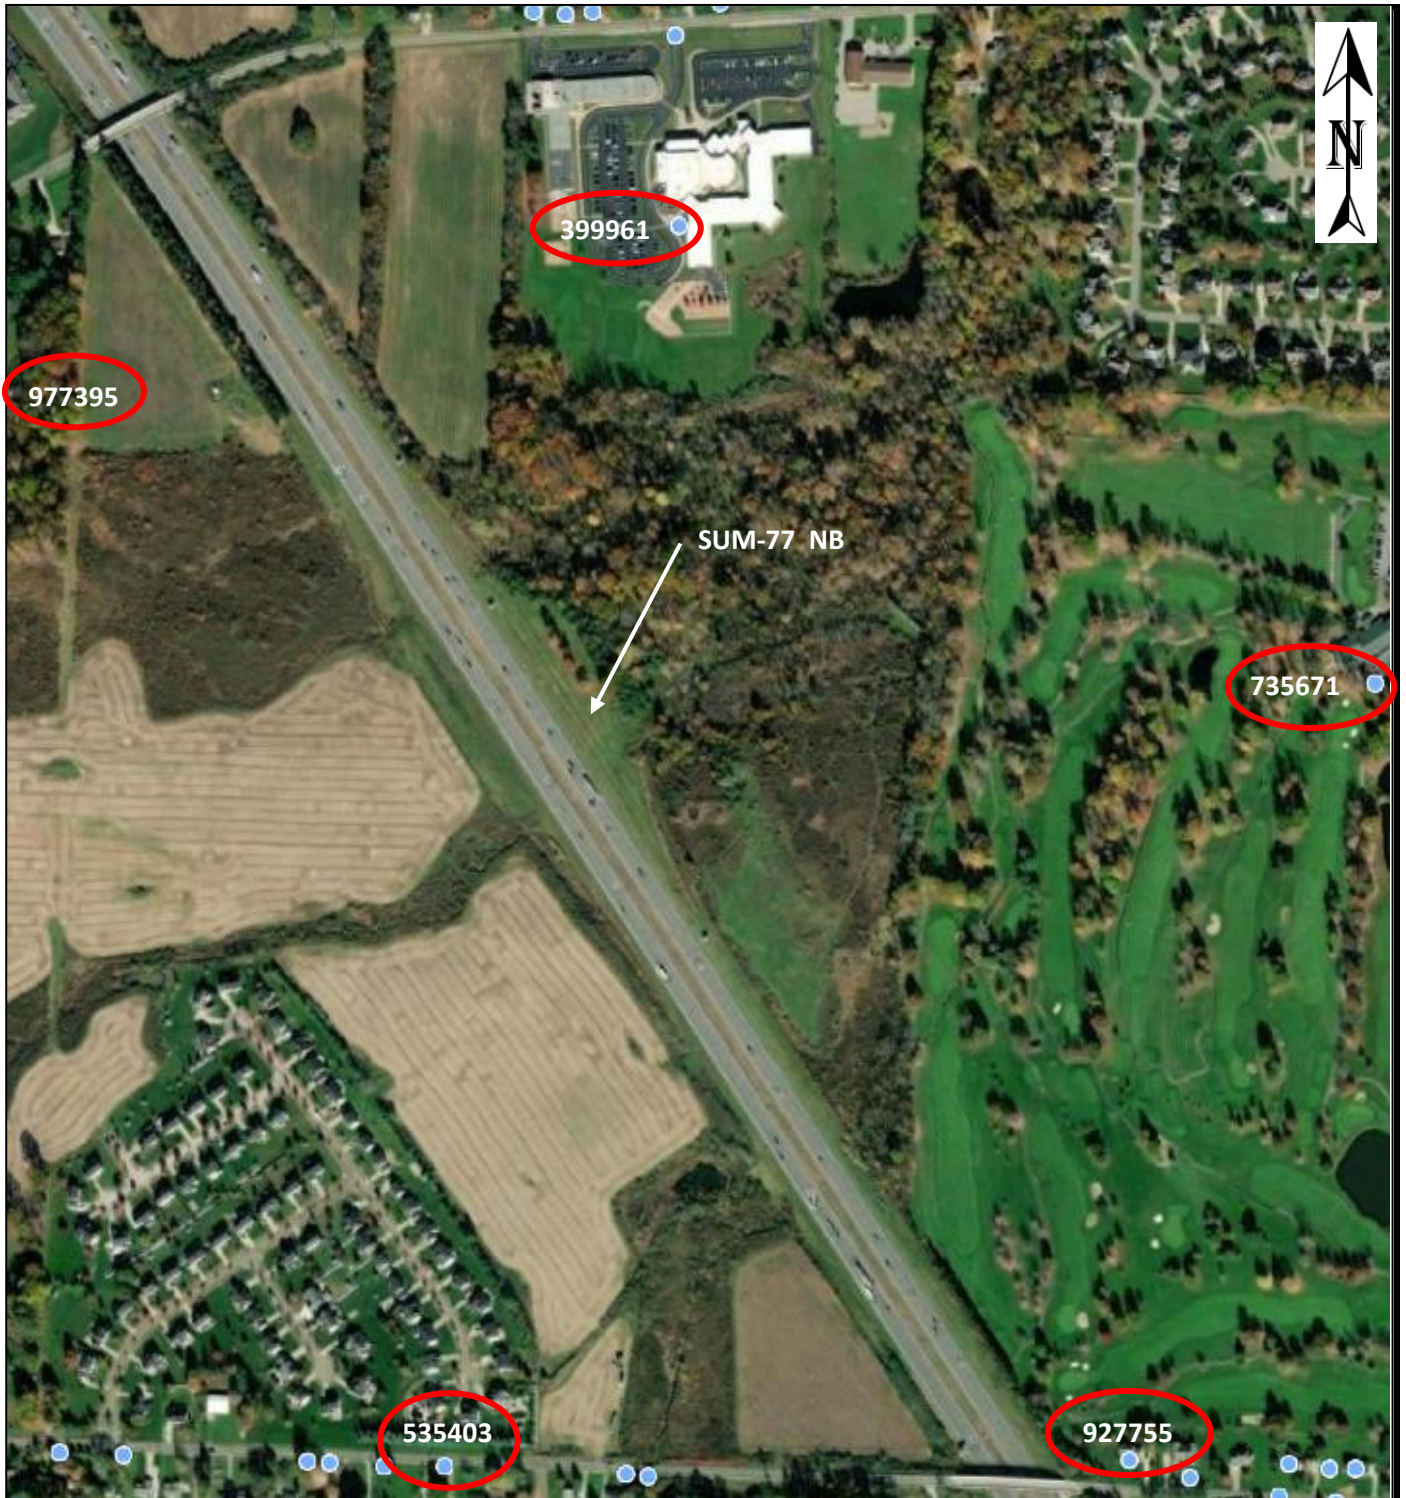
Figure Desc.: Site location and water well mapping

Topic	Resource(s)	Summary of Findings
Groundwater	Groundwater Resource Potential Mapping (ODNR) Groundwater Vulnerability Mapping (ODNR) Water Well Logs (ODNR)	<p>The primary groundwater aquifer is anticipated to be within the Pennsylvanian-age interbedded sedimentary (shale, sandstone, siltstone) bedrock, developing yields from 10 to 25 gallons per minute (gpm). A secondary aquifer appears to be present within lower Pennsylvanian-age coarse grained sandstone or conglomerate bedrock, with yields from 25 to 50 gpm.</p> <p>Groundwater vulnerability mapping* indicates that groundwater at the parking area may be encountered approximately 15 to 30 feet below the existing ground surface, with a groundwater vulnerability index of 99.</p> <p>Water well logs indicate that nearly all permanent production water wells for households near Site 12 are extended into bedrock. Test pumping rates for household wells in the area ranged from 20 to 50 gpm.</p>

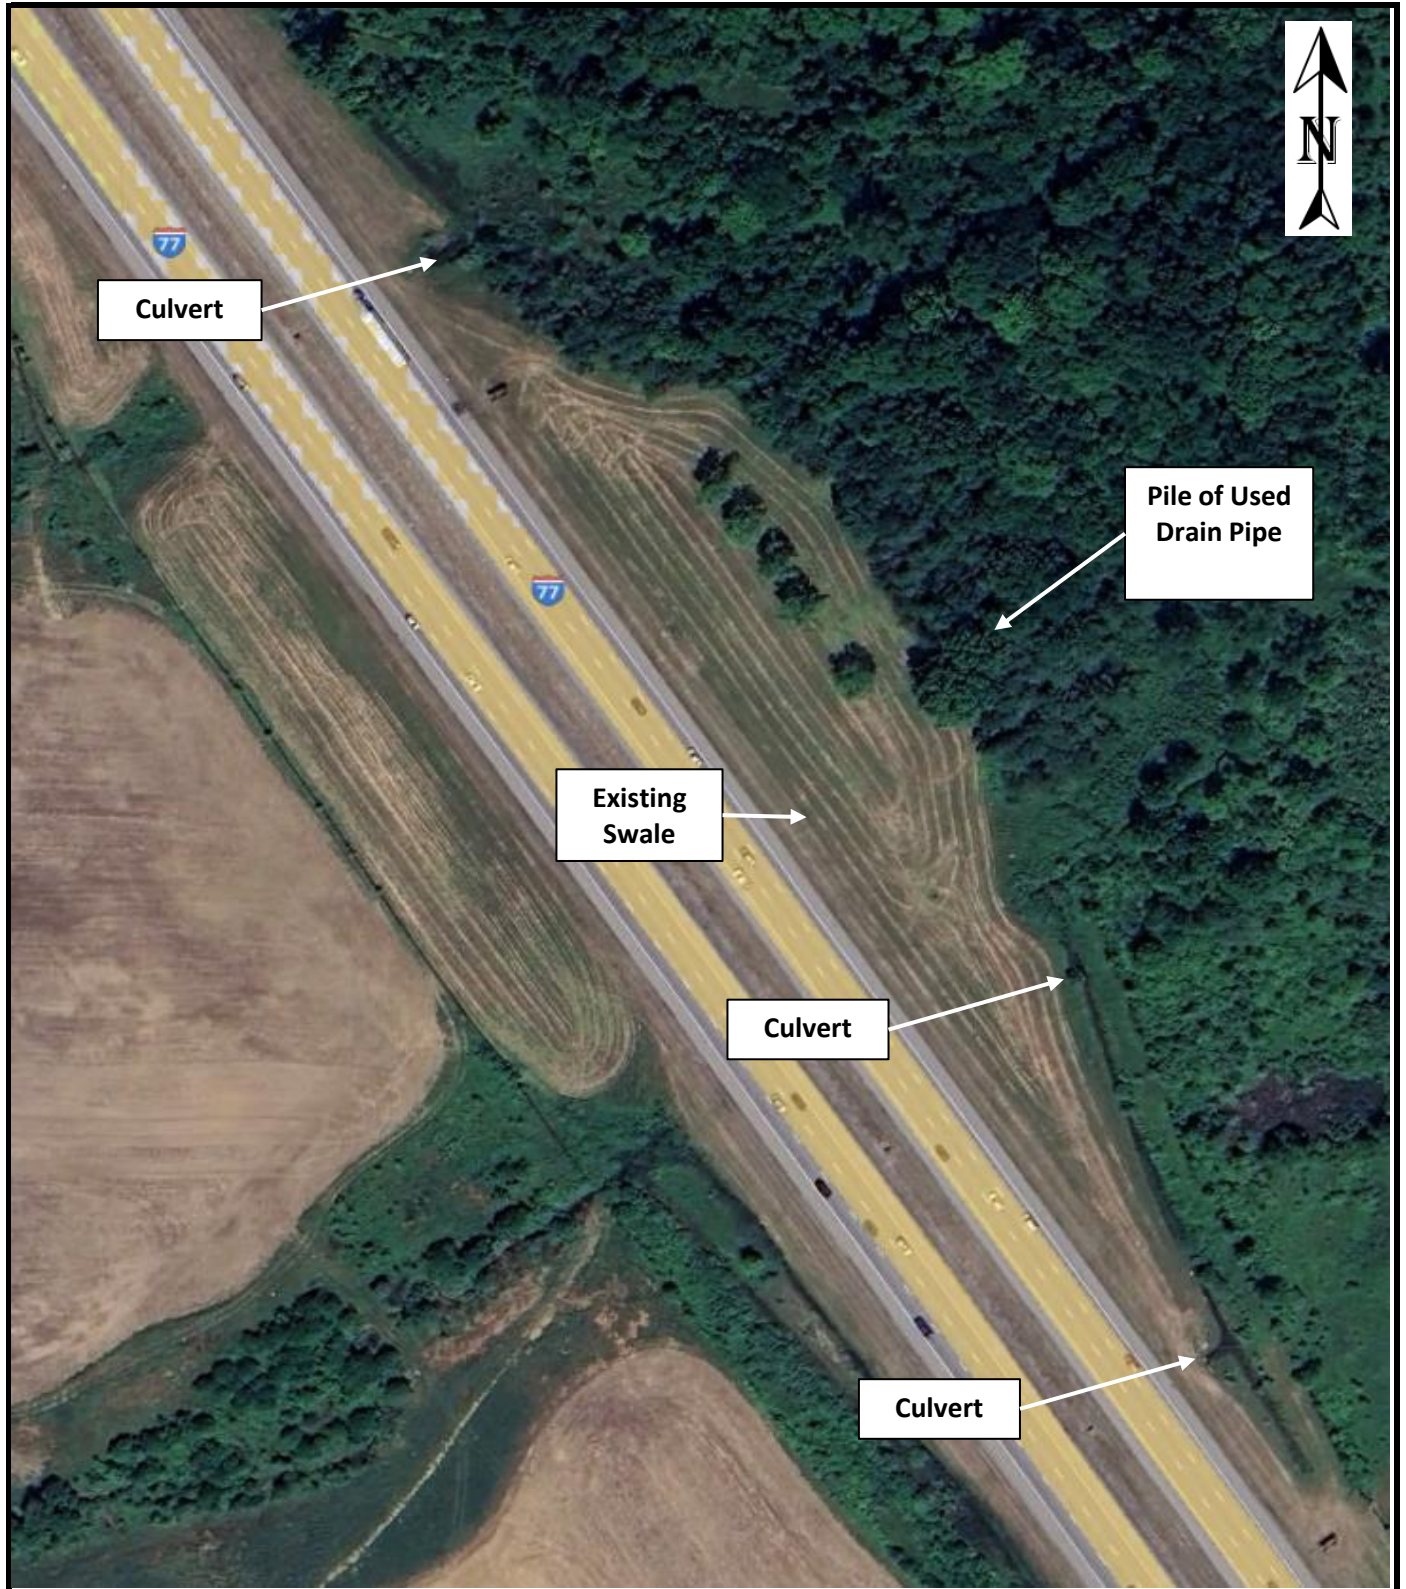
Figure Desc.: Site Aerial with Reconnaissance Notes

S&ME, accompanied by a representative from Stone Environmental, visited Site 12 on May 12, 2025. Select site photos taken by S&ME during the site reconnaissance visit are included as Plates 2 and 3 of Appendix C. The following items were noted during our site visit and also annotated on Figure 1 of Appendix C:

- The existing drainage swale adjacent to the NB outside shoulder of IR 77 was roughly 2 feet deep.
- Existing grass areas are relatively flat.
- An approximate 18-inch diameter circular concrete culvert (without a headwall) was noted on the south end of the Site 12 entrance ramp, slightly north of the “FOOD – EXIT 118” roadway sign.

- Approximately 350 feet north of the 18-inch culvert, the inlet to a double barrel elliptical culvert (approximate dimensions of 3.5 to 4 feet high and 4.5 to 5 feet wide) was noted. This double culvert carries an existing stream beneath IR 77.

- A pile of used drainage pipe was found just inside (east of) the tree line at the eastern end of the Site 12 parking area.
- An approximate 42-inch diameter circular concrete culvert running beneath IR 77 was located north of the parking area and near the beginning of the on-ramp to NB IR 77.

- Areas of possible wetlands were observed adjacent to and within the tree line bordering the east side of the parking area and near the two culverts on the southern portion of the site.
