**Regulated Materials Investigation for
PPN 004-08-007,-008,-009,-017,-046,-054,-056
(Contract Document)**

**Innerbelt Bridge
Construction Contract Group 1 (CCG1)**

Subject: Report of Findings of a Regulated Materials Investigation Conducted at The Wendell Collins Building Located at 2177 West 15th Street, Cleveland, Cuyahoga County, Ohio (H10002-12)

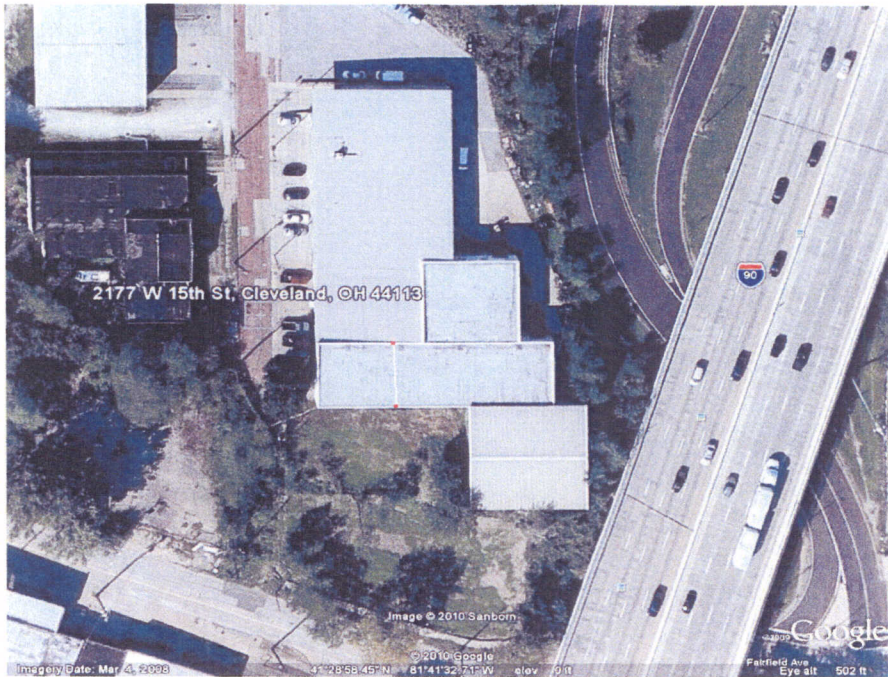
Photograph 01

Aerial View of The Wendell Collins Building
2177 West 15th Street, Cleveland, Ohio (CCG1 Design PID 77332)

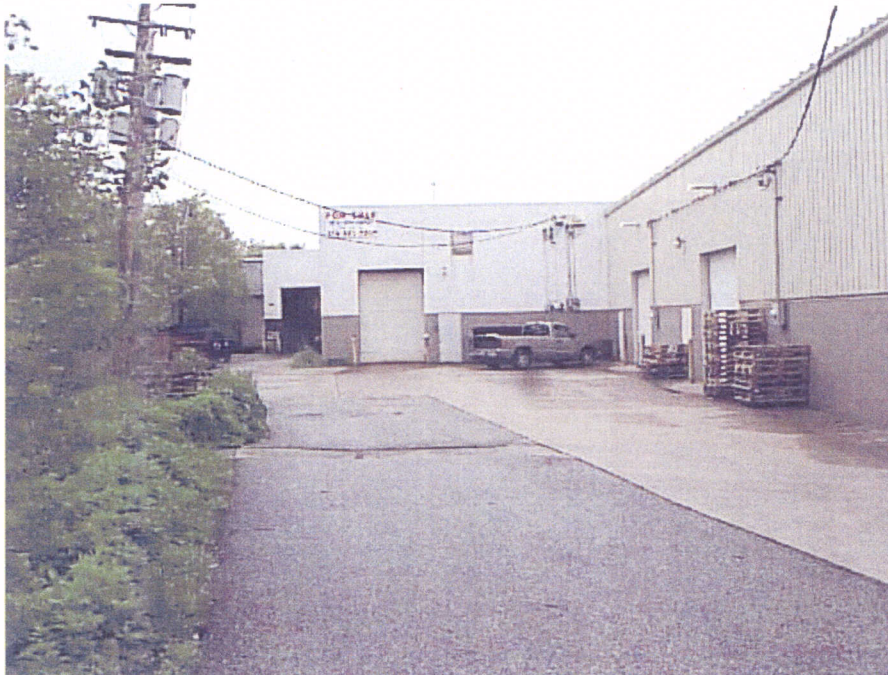
Photograph 02

View Looking South at the East Side of The Wendell Collins Building
2177 West 15th Street, Cleveland, Ohio (CCG1 Design PID 77332)

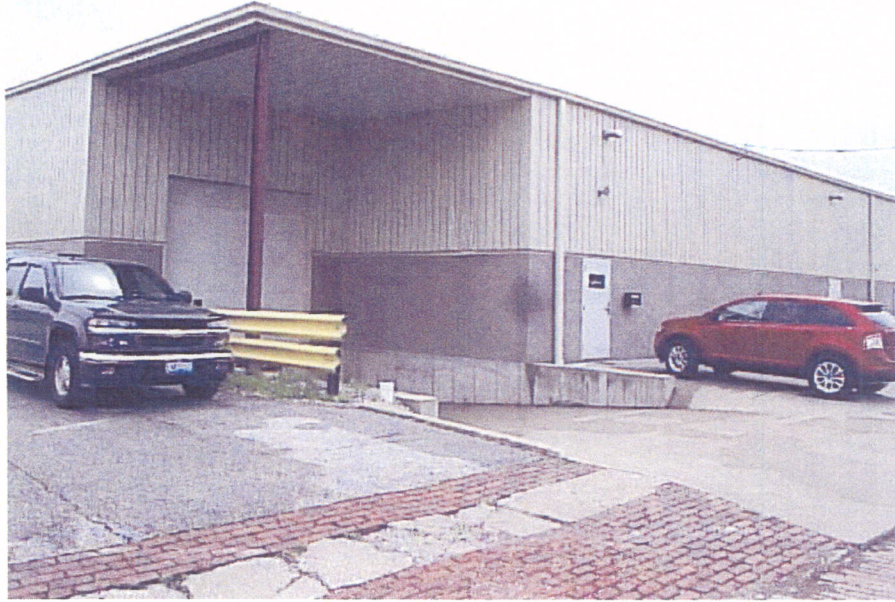
Photograph 03

View Looking Southeast at the Northeast Truck Dock of The Wendell Collins Building
2177 West 15th Street, Cleveland, Ohio (CCG1 Design PID 77332)

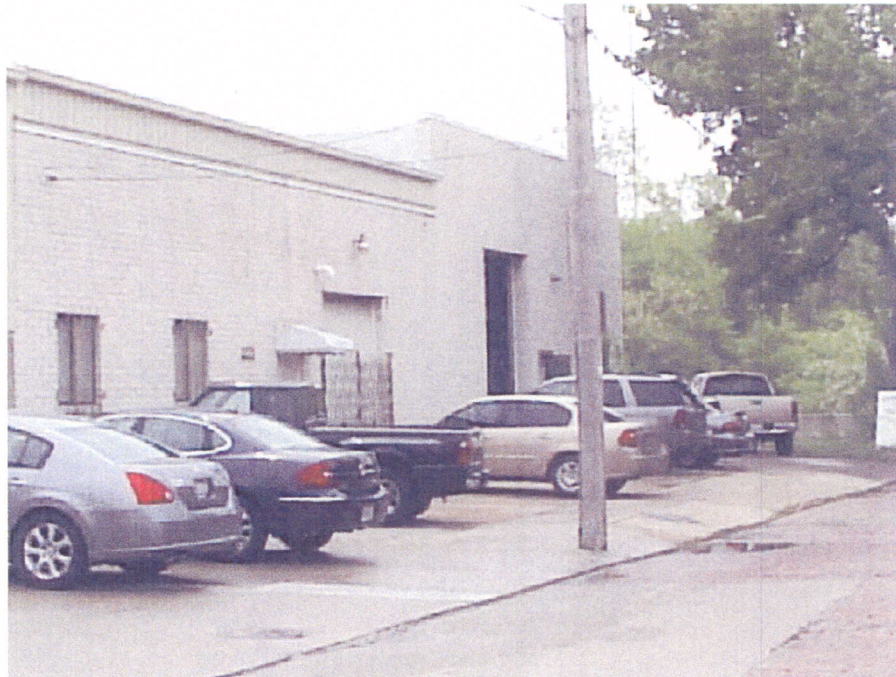
Photograph 04

View Looking Southeast at the Southwest Side of The Wendell Collins Building
2177 West 15th Street, Cleveland, Ohio (CCG1 Design PID 77332)
