**Regulated Materials Investigation for
PPN 004-27-003
(Contract Document)**

**Innerbelt Bridge
Construction Contract Group 1 (CCG1)**

Subject: Report of Findings of a Regulated Materials Investigation Conducted at The Distribution Terminal Warehouse Buildings Located at 2000 West 14th Street, Cleveland, Cuyahoga County, Ohio (H10002-05)

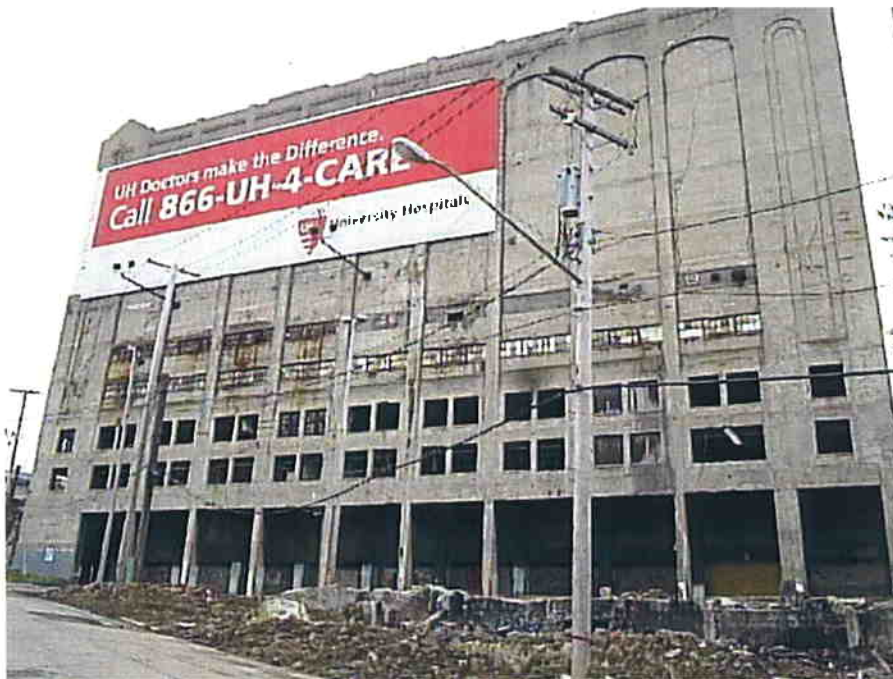
Photograph 02

View Looking South at the North Side of the Cold Storage Building,
2000 West 14th Street, Cleveland, Ohio (CCG1 Design PID 77332)

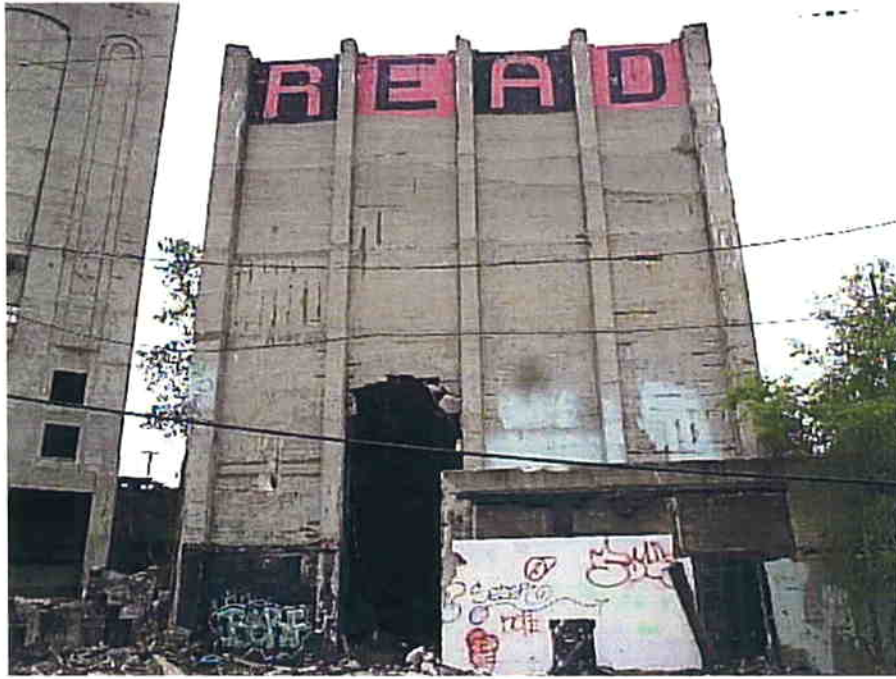
Photograph 03

View Looking South at the North Side of the Ice House Building,
2000 West 14th Street, Cleveland, Ohio (CCG1 Design PID 77332)

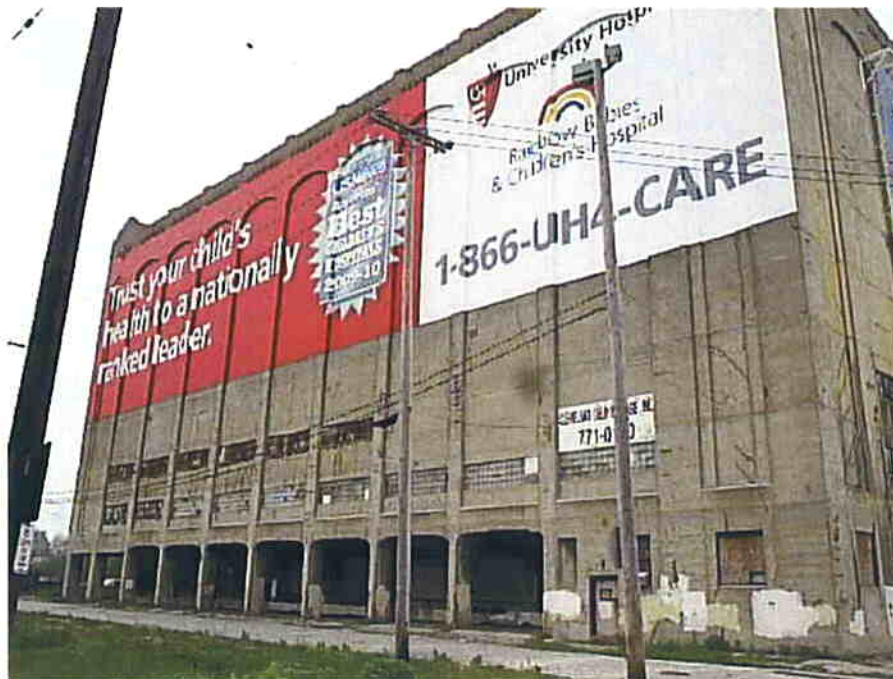
Photograph 04

View Looking North at the South Side of the Cold Storage Building
2000 West 14th Street, Cleveland, Ohio (CCG1 Design PID 77332)

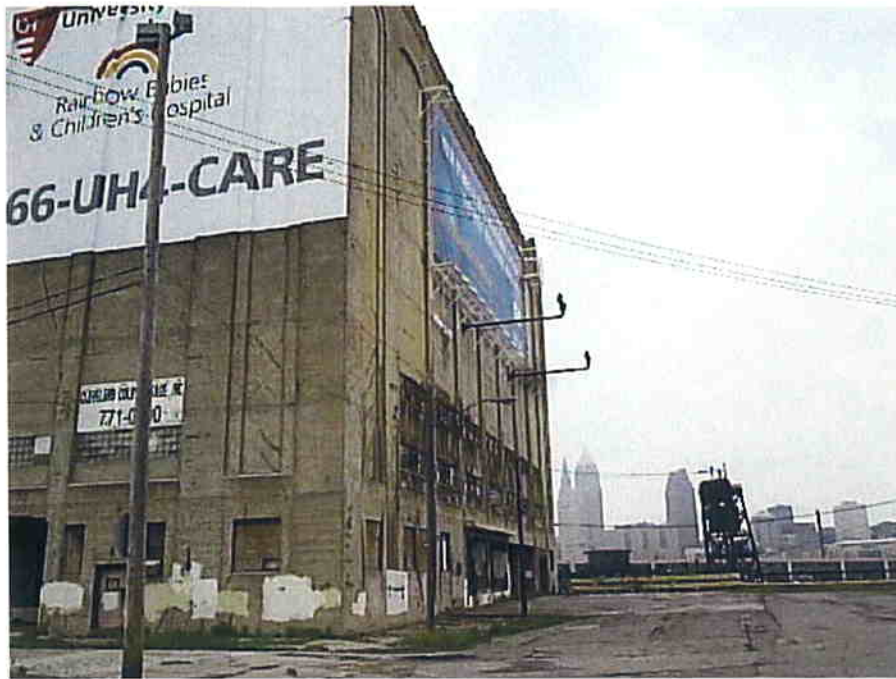
Photograph 05

View Looking North at the East Side of the Cold Storage Building
2000 West 14th Street, Cleveland, Ohio (CCG1 Design PID 77332)

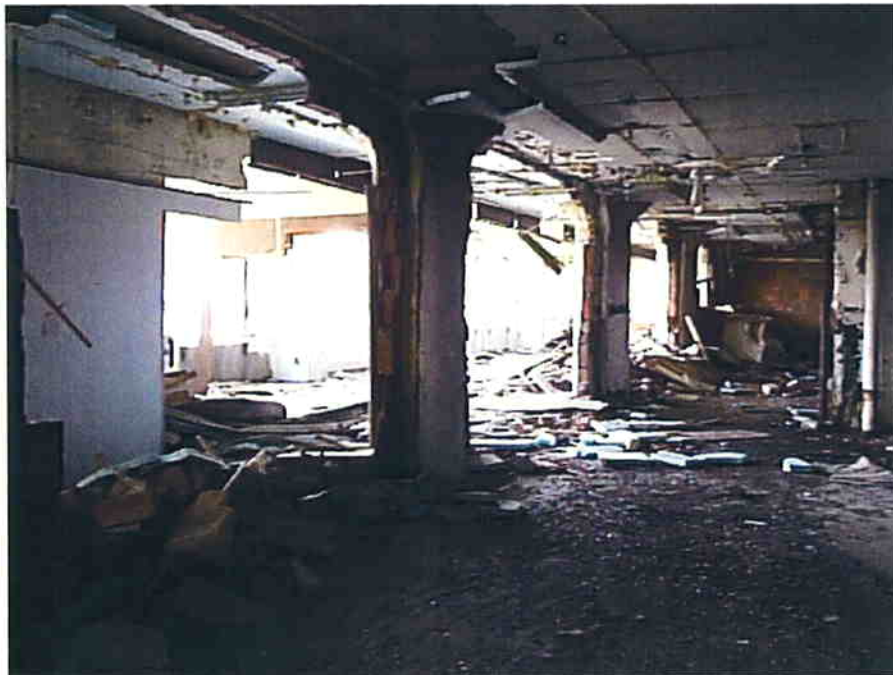
Photograph 06

View Looking at the North end of the 3rd Floor of the Cold Storage Building
2000 West 14th Street, Cleveland, Ohio (CCG1 Design PID 77332)

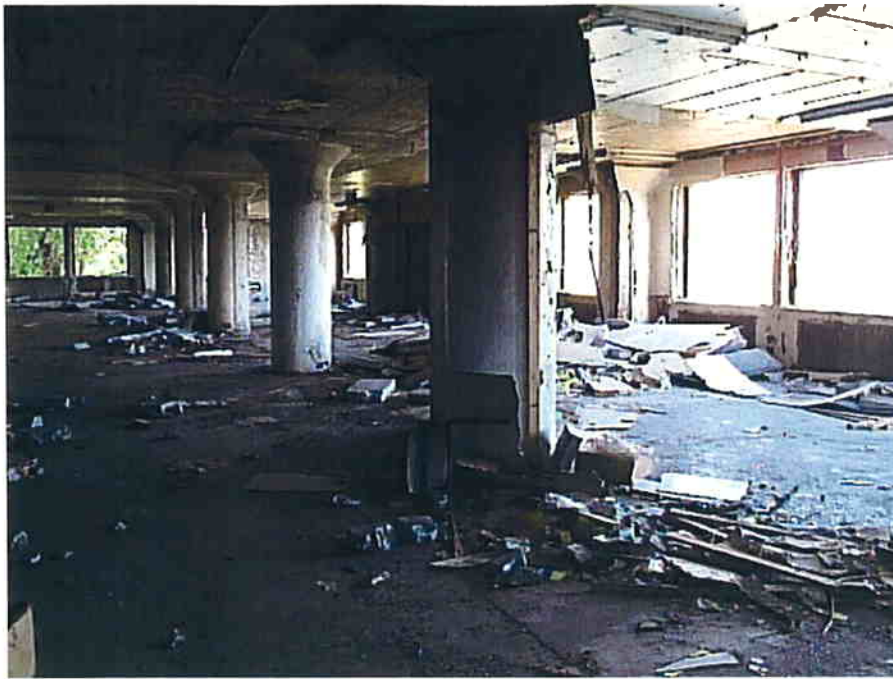
Photograph 07

View Looking at the North end of the 3rd^h Floor of the Cold Storage Building
2000 West 14th Street, Cleveland, Ohio (CCG1 Design PID 77332)

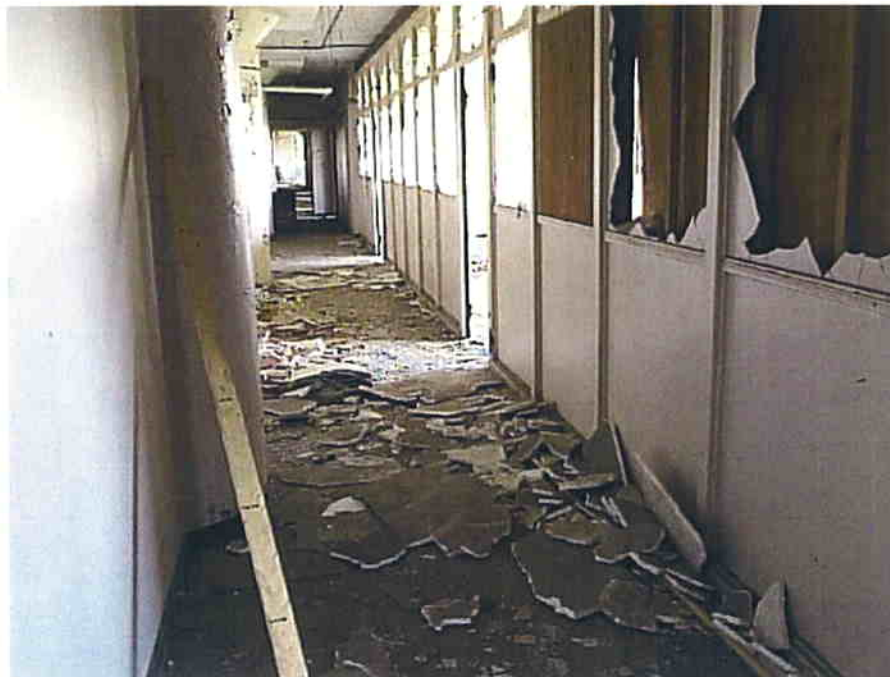
Photograph 08

View Looking West at the North end of the 4th Floor of the Cold Storage Building
2000 West 14th Street, Cleveland, Ohio (CCG1 Design PID 77332)

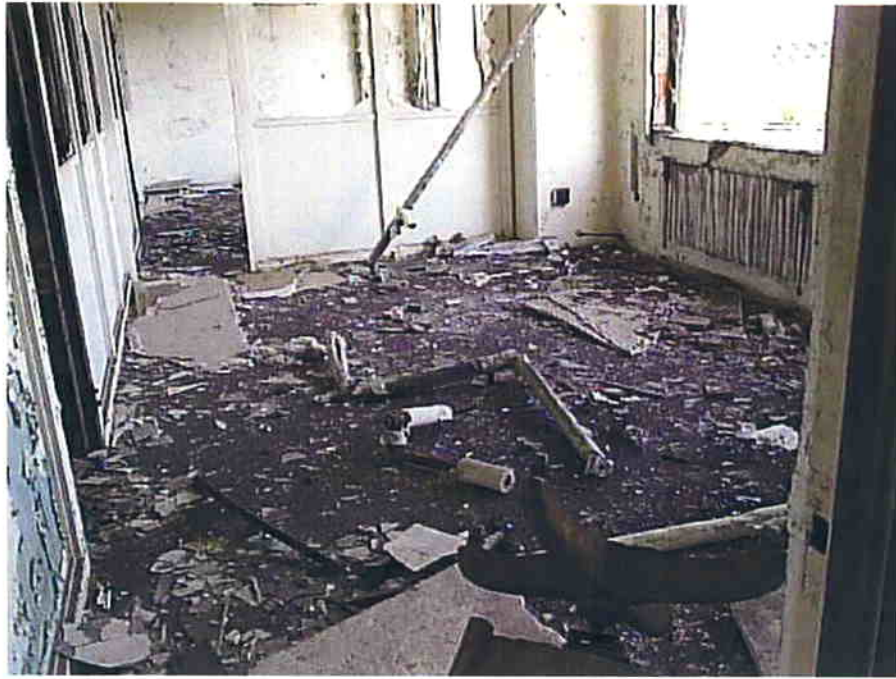
Photograph 09

View Looking West at a North end Office on the 4th Floor of the Cold Storage Building
2000 West 14th Street, Cleveland, Ohio (CCG1 Design PID 77332)
