**Regulated Materials Investigation for
PPN 004-25-012, 122-19-008 & 012, and 122-20-012
(Contract Document)**

**Innerbelt Bridge
Construction Contract Group 1 (CCG1)**

FINDINGS FROM A REGULATED MATERIALS INVESTIGATION

***Stripmatic Products, Inc. & TIG Welding (Parcel 700)
River Dock Inc. (Parcel 619) and
Allied Corporation, Inc. (Parcel 621)
Cleveland, Cuyahoga County, Ohio
CUY – Cleveland Innerbelt [PID 77332]***

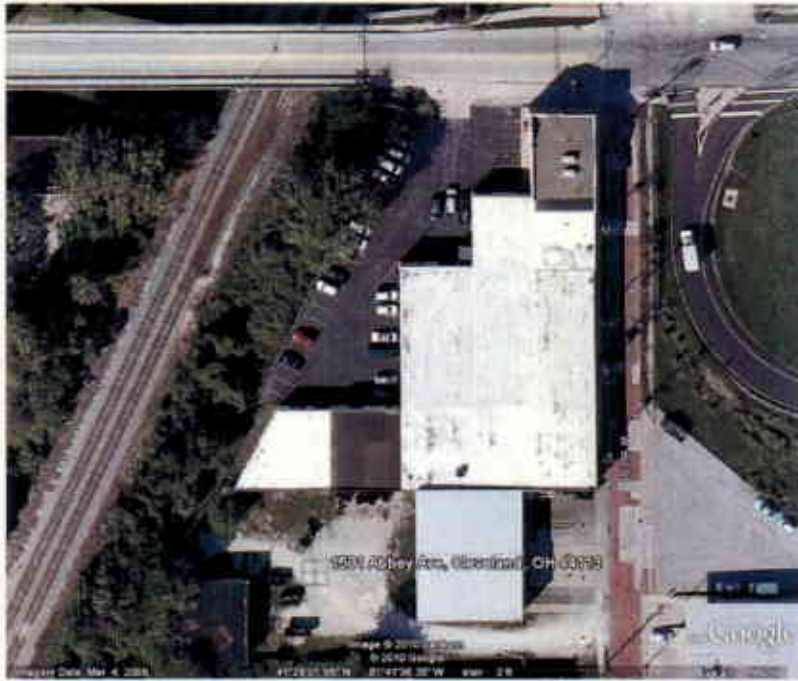
Photograph 01

Aerial View of the Stripmatic Products Inc. Property
located at 1501 Abbey Road, Cleveland, Ohio

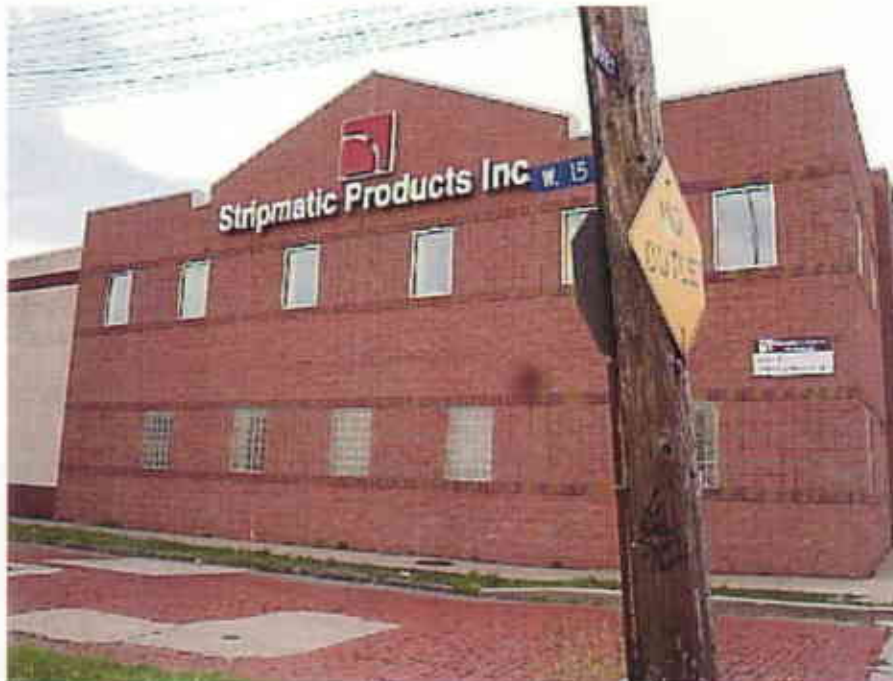
Photograph 02

View Looking West at the East Side of the Stripmatic Products Inc. Building
located at 1501 Abbey Road, Cleveland, Ohio

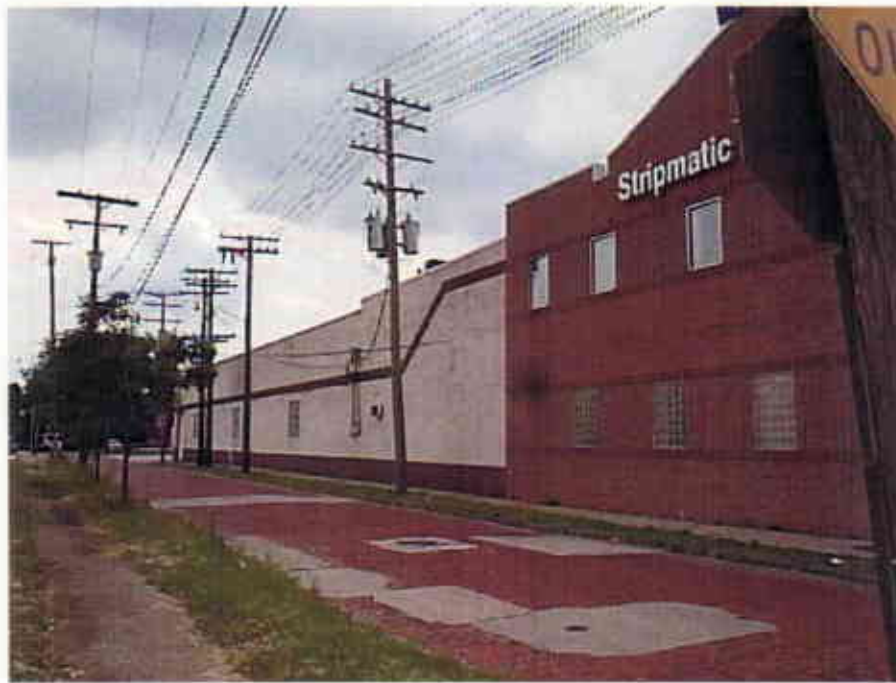
Photograph 03

View Looking South at the East Side of the Stripmatic Products Inc. Building
located at 1501 Abbey Road, Cleveland, Ohio

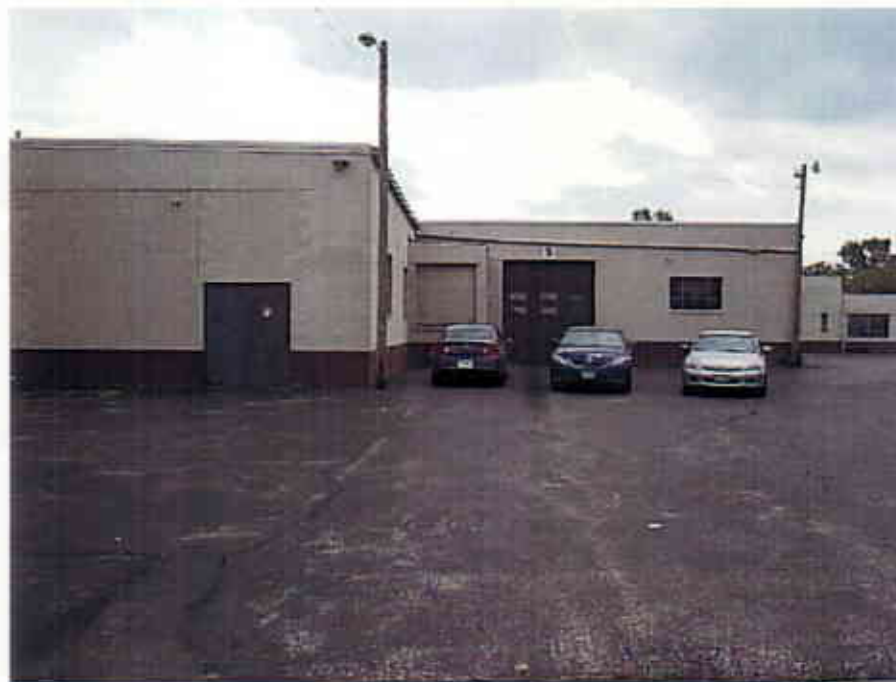
Photograph 04

View Looking South at the North Side of the Stripmatic Products Inc. Building
located at 1501 Abbey Road, Cleveland, Ohio

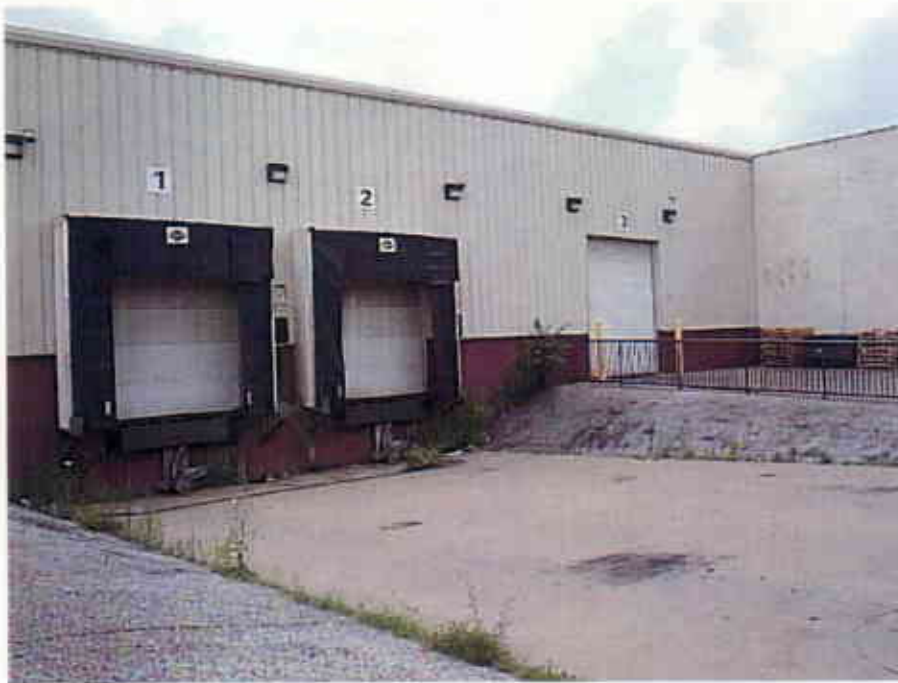
Photograph 05

View Looking West at the East Side of the Stripmatic Products Inc. Building
located at 1501 Abbey Road, Cleveland, Ohio

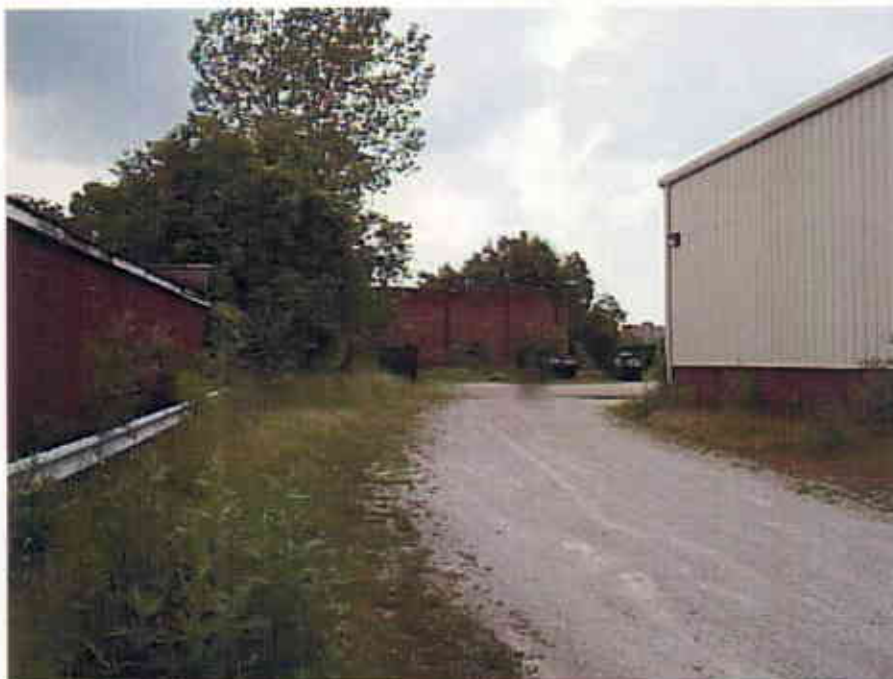
Photograph 06

View Looking West at the Detached Building Associated with the Stripmatic Products Inc. Property
located at 1501 Abbey Road, Cleveland, Ohio

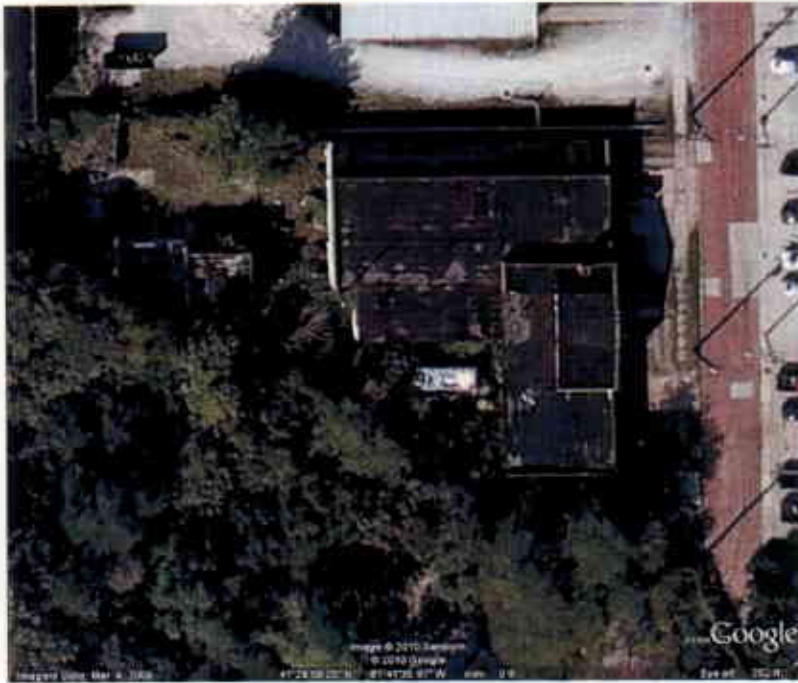
Photograph 07

Aerial View of the TIG Welding Property
Located at 2150 West 15th Street, Cleveland, Ohio

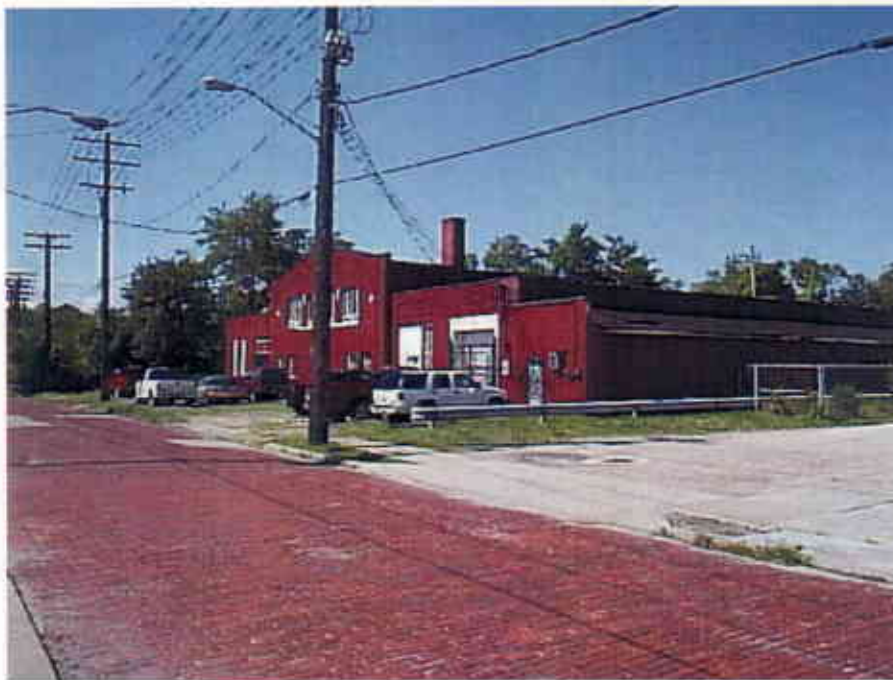
Photograph 08

View Looking South at the North and East Sides of the TIG Welding Building
Located at 2150 West 15th Street, Cleveland, Ohio

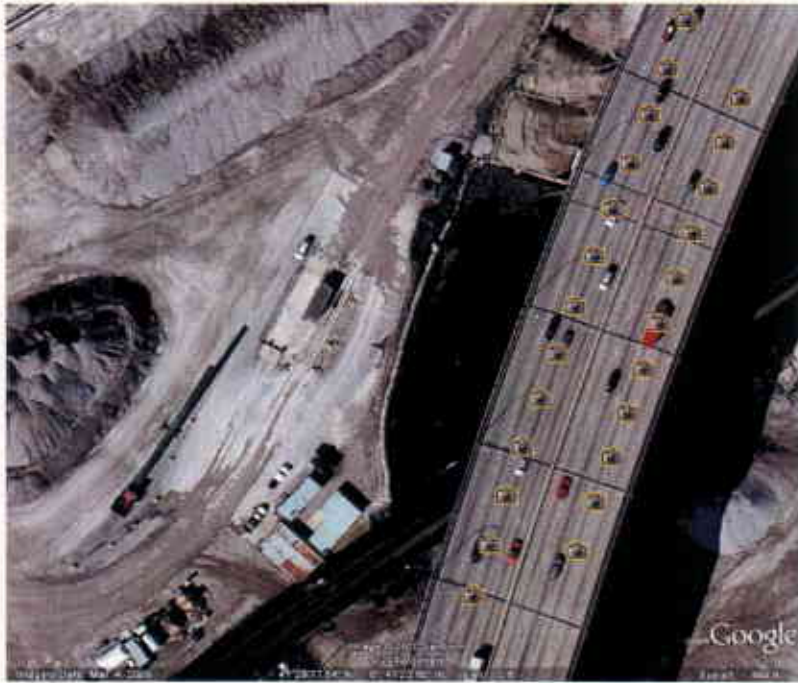
Photograph 09

Aerial View of the River Dock, Inc. Property
Located on Harrison Street, Cleveland, Ohio

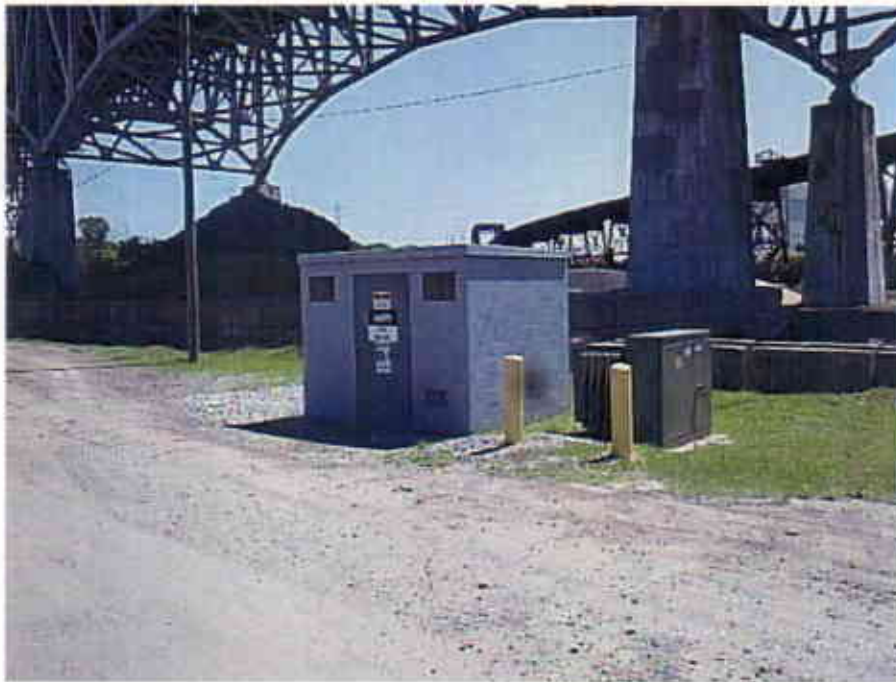
Photograph 10

View of the Electrical Building Associated with the River Dock, Inc. Property
Located on Harrison Street, Cleveland, Ohio

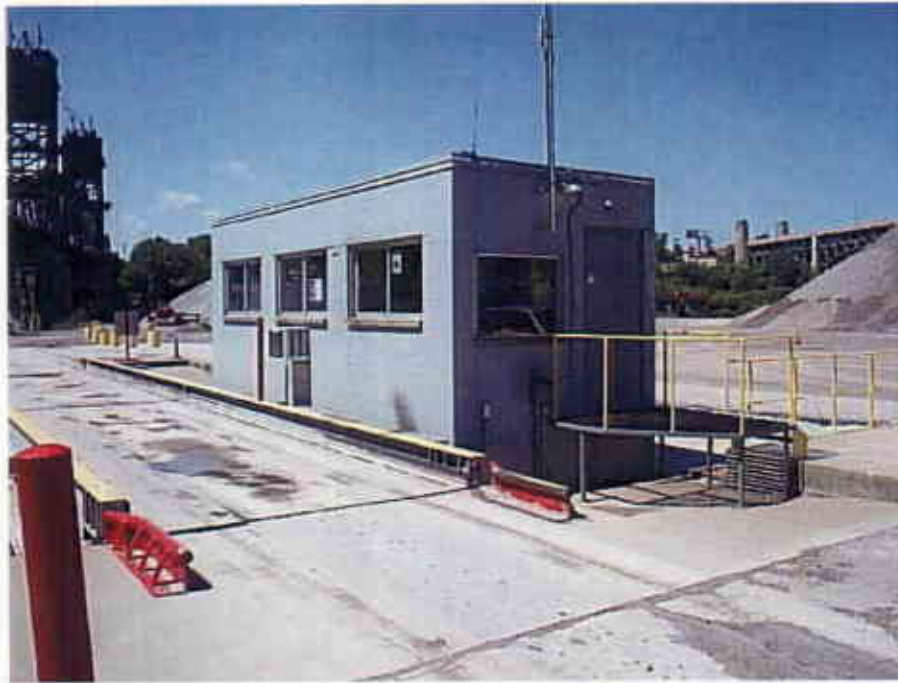
Photograph 11

View of the Scale House Building Associated with the River Dock, Inc. Property
Located on Harrison Street, Cleveland, Ohio

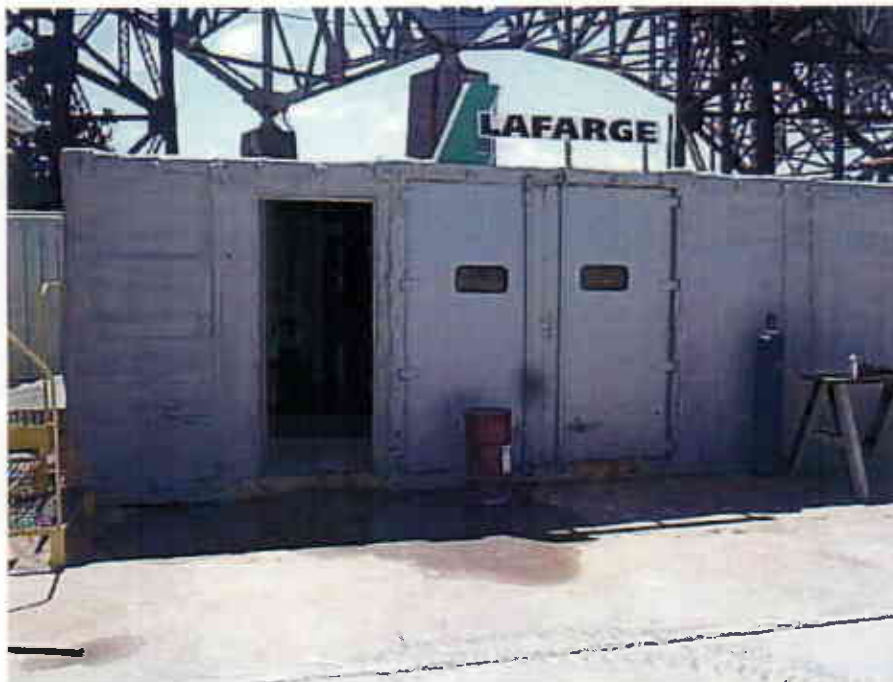
Photograph 12

View of a Storage Building Associated with the River Dock, Inc. Property
Located on Harrison Street, Cleveland, Ohio

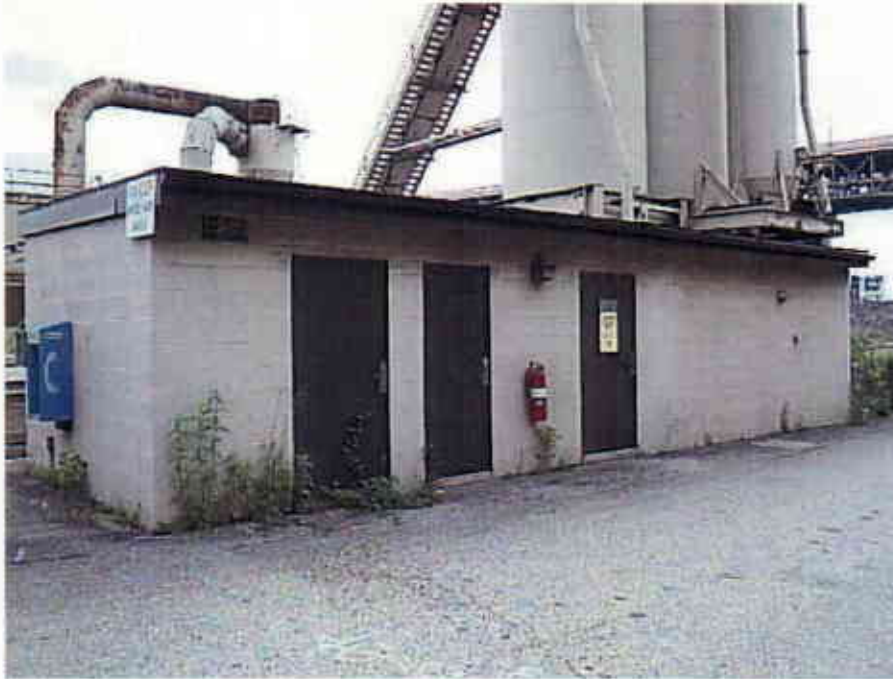
Photograph 13

View Looking West at the Allied Corporation, Inc. Building
Located on Harrison Street, Cleveland, Ohio
