**CUY-90-14.90**

**PID 77332/85531**

**APPENDIX ST-04**

**Bulkhead Reference Information  
(Reference Document)**

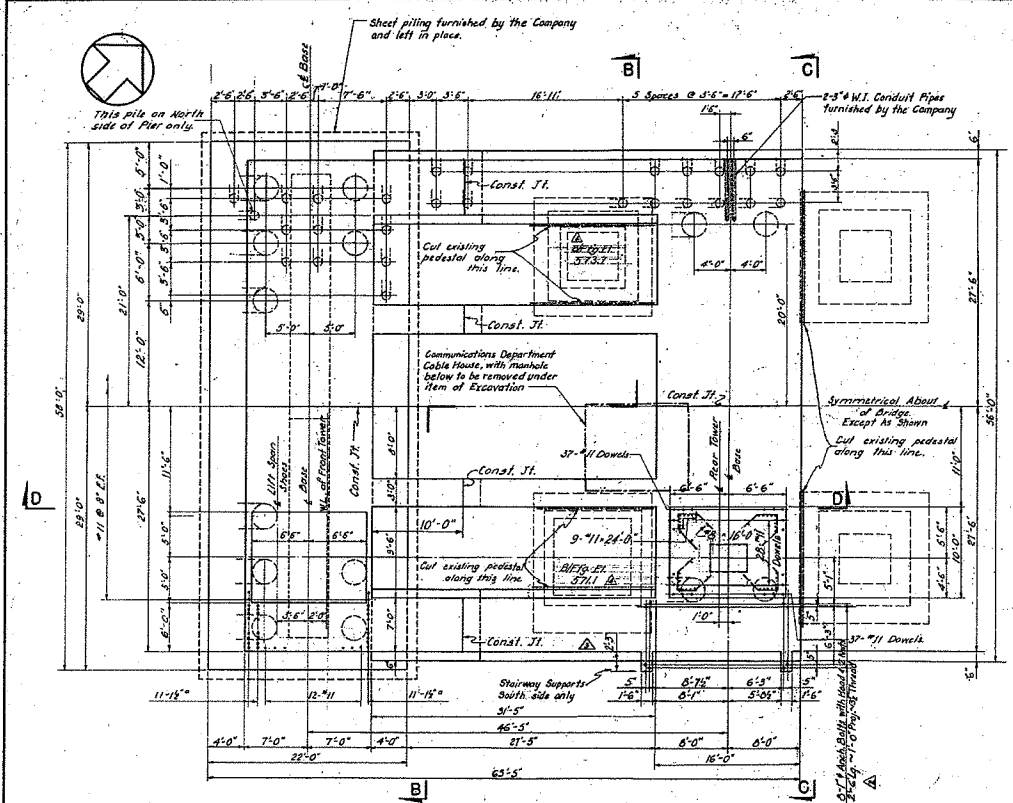
**SECTION A-A**  
 23-10" Pipe Piles  
 14-30" Cylinders  
 10-16" W 211 Cores - Front Base  
 4-14" W 136 Cores - Rear Base

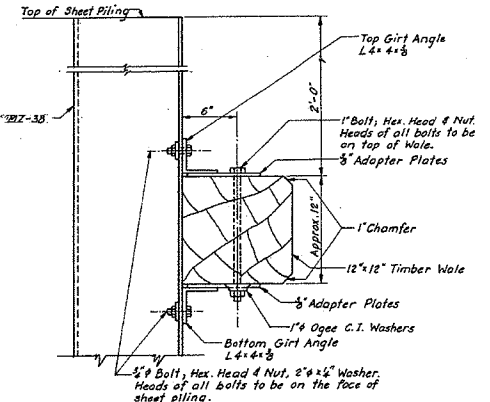
SECTION - TIMBER WALE  
Scale: 1/2" = 1'-0"

NOTE: The line of the timber wale shall be approximately straight. Any space between the face of the steel sheet piling and the back of the wale angles shall be filled at each bolt with a 4" x 4" x 4" steel plate washers.

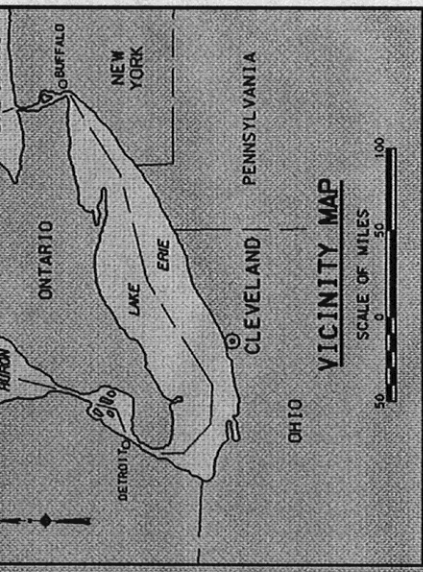
- INDEX TO UNDERWATER SITES**  
SHOWN THUS **8**
- 1 EAST SHORE, PARKS 1 & 3, NEAR FOOT OF ST. CLAIR
  - 2 EAST SHORE, GLAZER 4/CITY OF CLEVELAND 31 & 32, APPROXIMATELY 400 FEET SOUTH OF SITE 1
  - 3 EAST SHORE, CEREAL 1 & 2 OR CEREAL FOOD PROCESSORS
  - 4 EAST SHORE, MID-CONTINENTAL COAL/COKE
  - 5 WEST SHORE, ERIE RAILROAD 10/ST. REALTY, INC.
  - 6 EAST SHORE, CARTER PENINSULA, BY THE CONSOLIDATED RAILROAD BRIDGE
  - 7 EAST SHORE, B&O RAILROAD, BETWEEN TOWER CITY AND F.C. SOUTHRIDGE CORP.
  - 8 EAST SHORE, B&O RAILROAD, MID-CONTINENTAL COAL/COKE
  - 9 EAST SHORE, REPUBLIC STEEL/CITY STEEL
  - 10 EAST SHORE, SOUTH SHORE, ERIE RAILROAD/ONTARIO STONE
  - 11 OLD RIVER, SOUTH SHORE, ERIE RAILROAD/ONTARIO STONE
  - 12 OLD RIVER, SOUTH SHORE, ERIE RAILROAD/ONTARIO STONE

**CUYAHOGA RIVER BULKHEAD STUDY**  
**CLEVELAND, OHIO**  
**PHASE 2**  
**UNDERWATER SITES**  
U.S. ARMY ENGINEER DISTRICT BUFFALO  
APRIL 1999

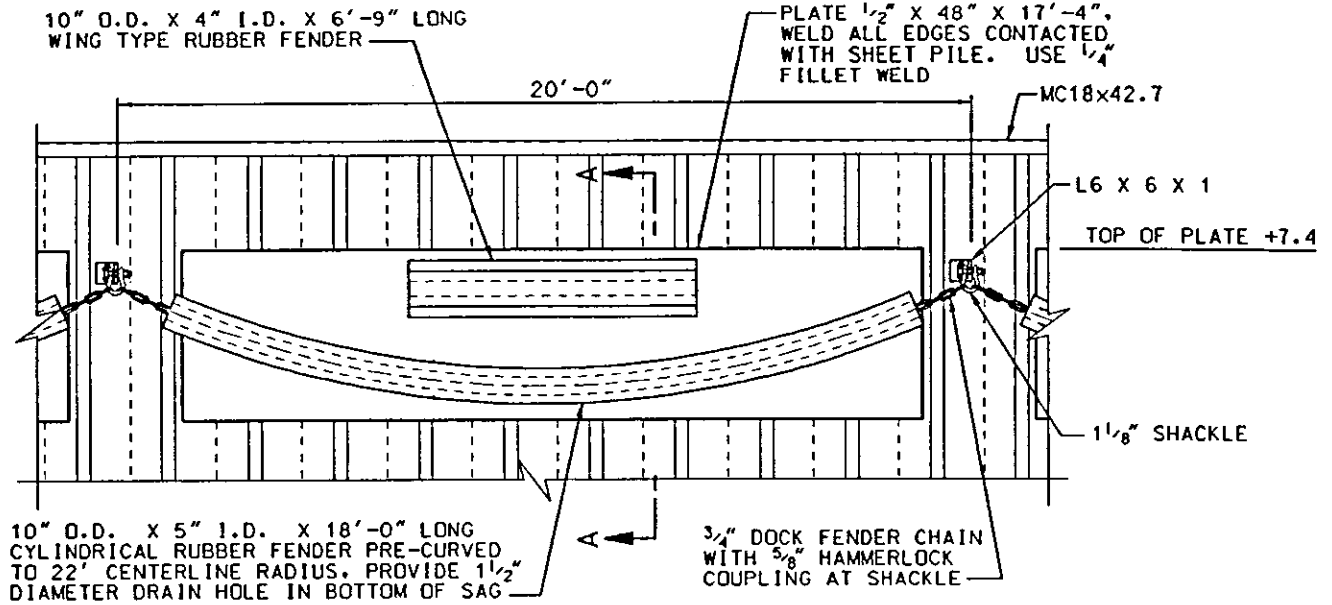
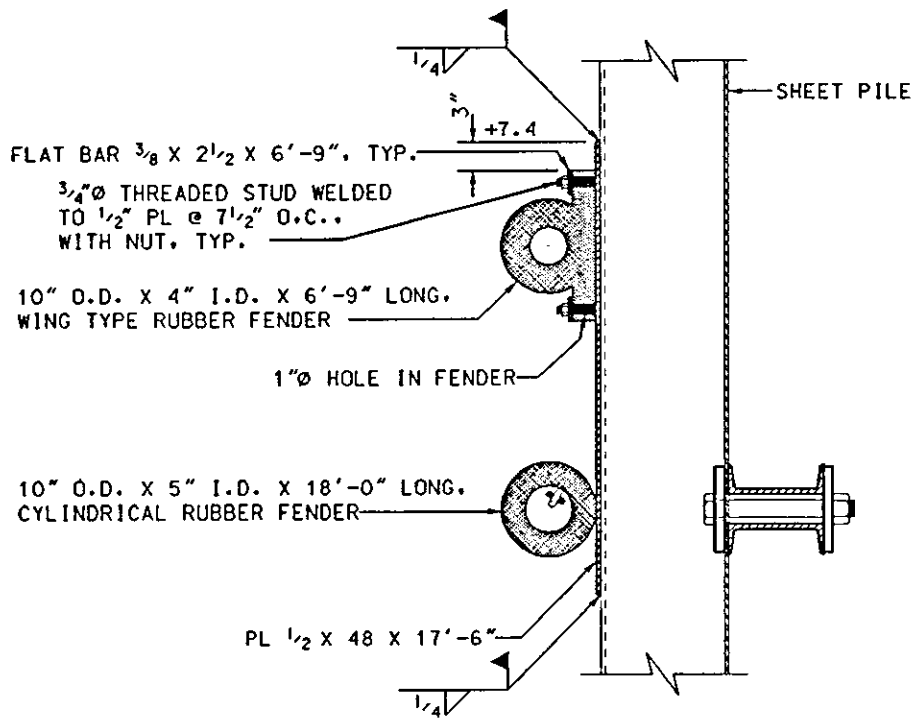
TYPE A  
FENDERING SYSTEM

**FENDER ASSEMBLY DETAIL**

Many of the bulkheads along the Cuyahoga River do not have fendering or have timber fendering in various stages of deterioration. The lack of fendering or ineffective fendering makes the bulkheads susceptible to damage from vessel impact. It is recommended, where applicable, that bulkhead owners assess the need for new fendering along their bulkheads. Rubber fendering, either horizontal, vertical, or a combination is recommended where needed. Fendering can be rigidly attached to the bulkhead or hung by chains or wire rope, depending on the fendering type. Details of fendering used by the Port Authority (Type A) and USACE (Type B) at the mouth of the Cuyahoga River are shown on Plates 3 and 4, respectively. These are only two of the various types of fendering systems that are available. Details and costs are provided for planning purposes. Based on the actual bids received for the Corps of Engineers' Dock 20 and West Pier repair project at the mouth of the Cuyahoga River, the installed costs for fendering (March 1999 price level) are \$3,060 for each complete Type A assembly and \$150 per linear foot for Type B.

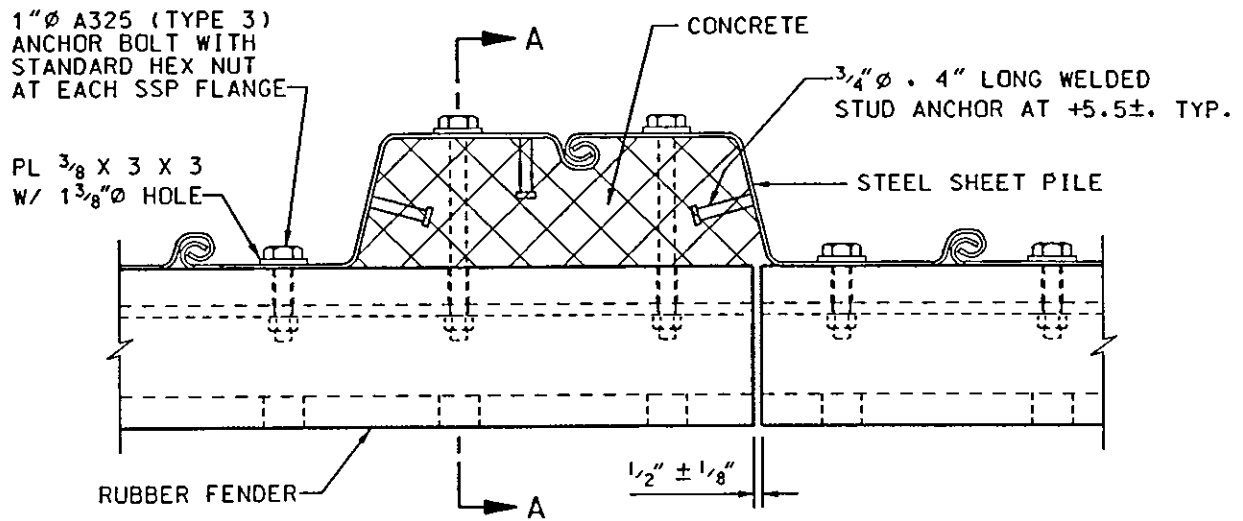
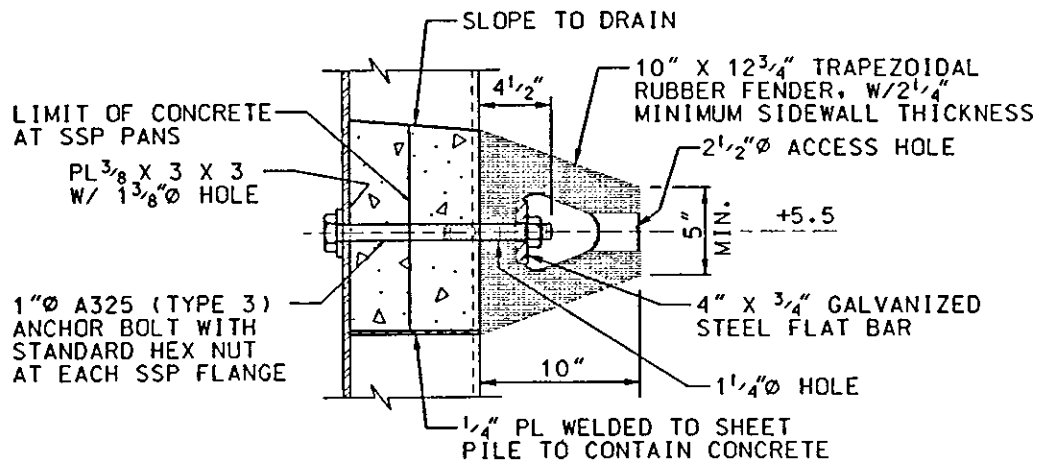
TYPICAL TRAPIZOIDAL RUBBER FENDER ASSEMBLY

TYPICAL PLAN
