APPENDIX EC-27

**Regulated Materials Investigation for
PPN 004-25-020, 021, 022 & 023, and 122-18-004
(Contract Document)**

**Innerbelt Bridge
Construction Contract Group 1 (CCG1)**

Subject: Report of Findings of a Regulated Materials Investigation Conducted at the Scranton-Averill and Canal Road Buildings Located in Cleveland, Cuyahoga County, Ohio (H10002-13)

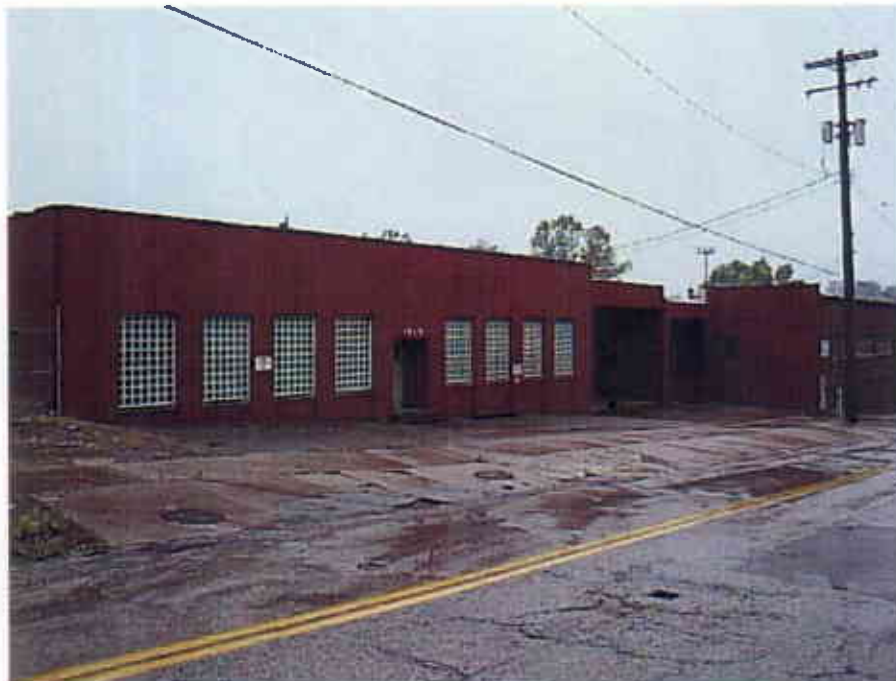
Photograph 02

View Looking Southwest at the North Side of the Scranton-Averill Building
Located at 1515 Fairfield Road, Cleveland, Ohio

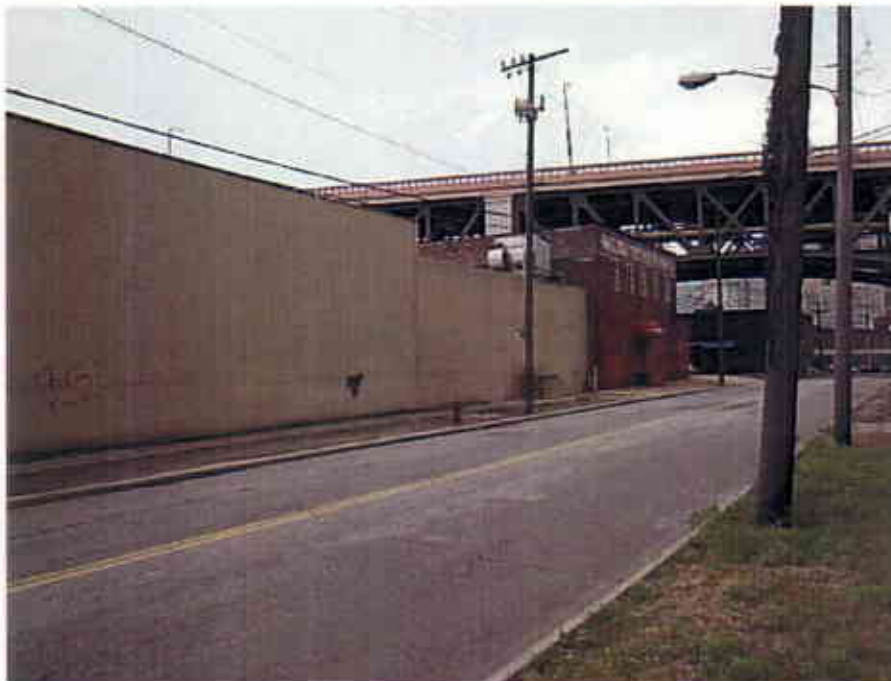
Photograph 04

View Looking Northwest at the North Side of the Canal Road Property
Located at 2394 Canal Road, Cleveland, Ohio

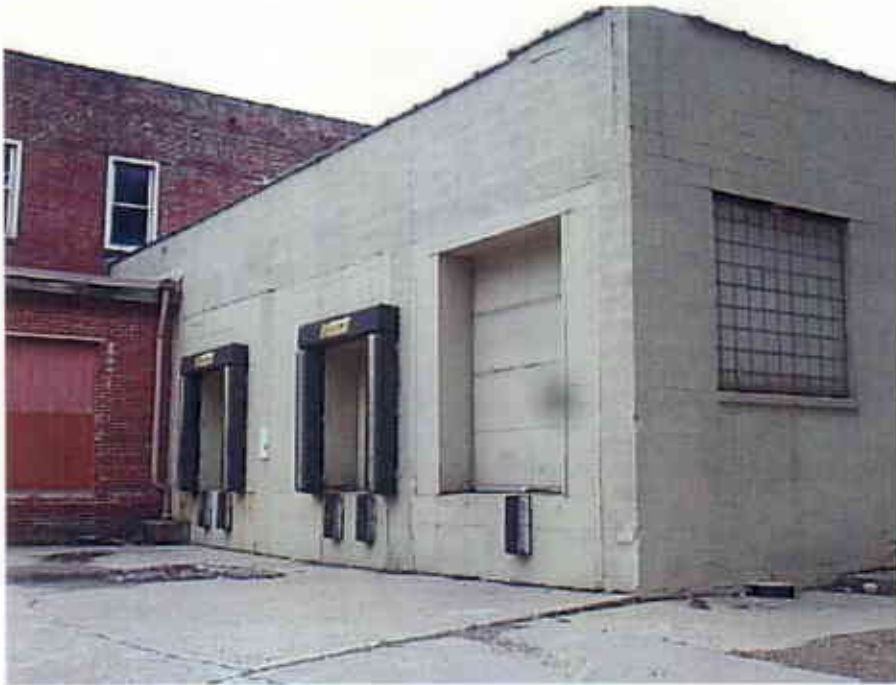
Photograph 05

View Looking East at the Northwest Side of the Canal Road Property
Located at 2394 Canal Road, Cleveland, Ohio

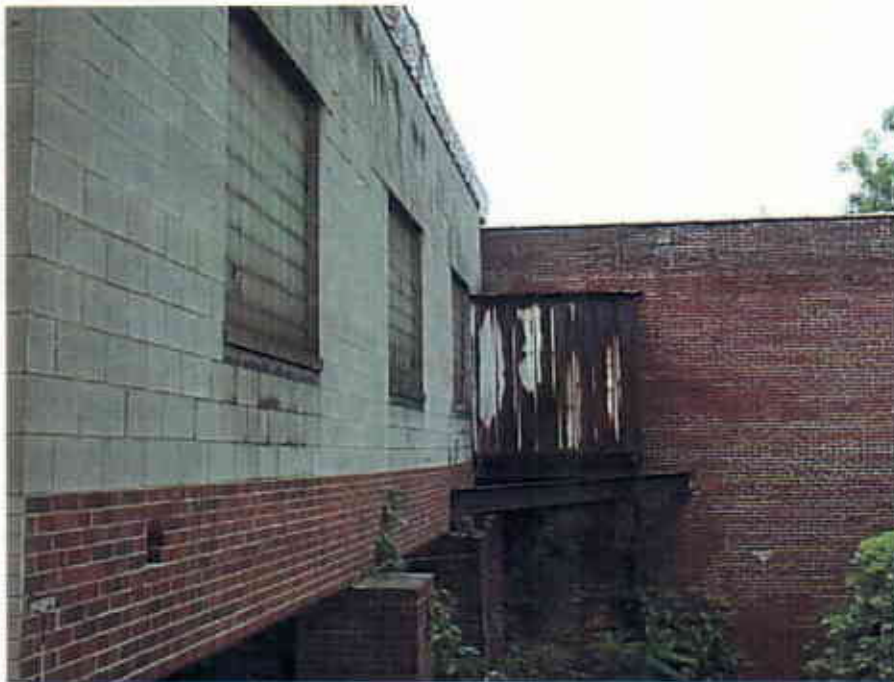
Photograph 06

View Looking West at the South and West Side of the Canal Road Property
Located at 2394 Canal Road, Cleveland, Ohio

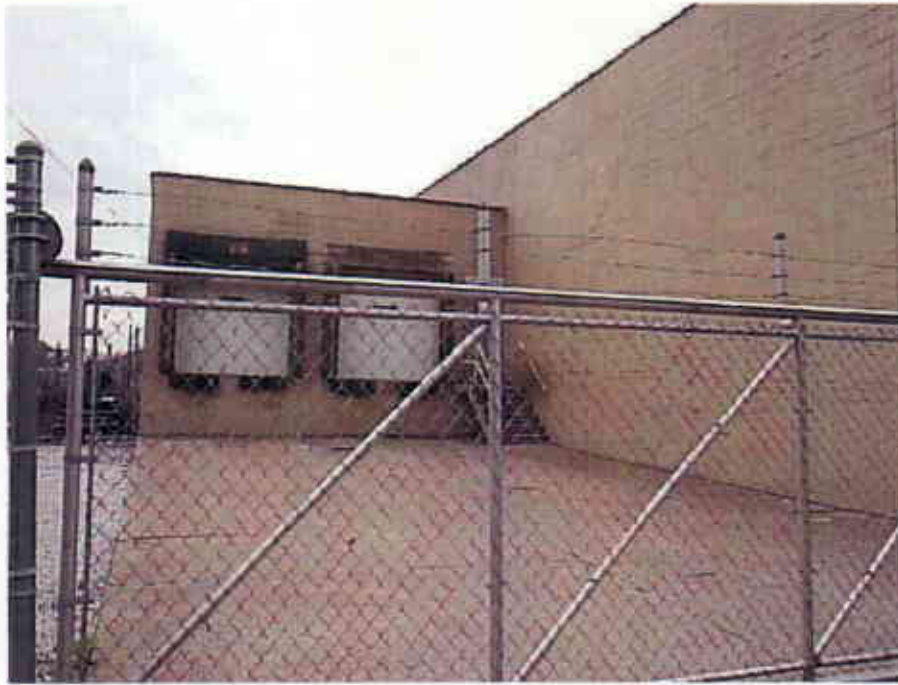
Photograph 07

View Looking South at the North Side of the Canal Road Property
Located at 2394 Canal Road, Cleveland, Ohio

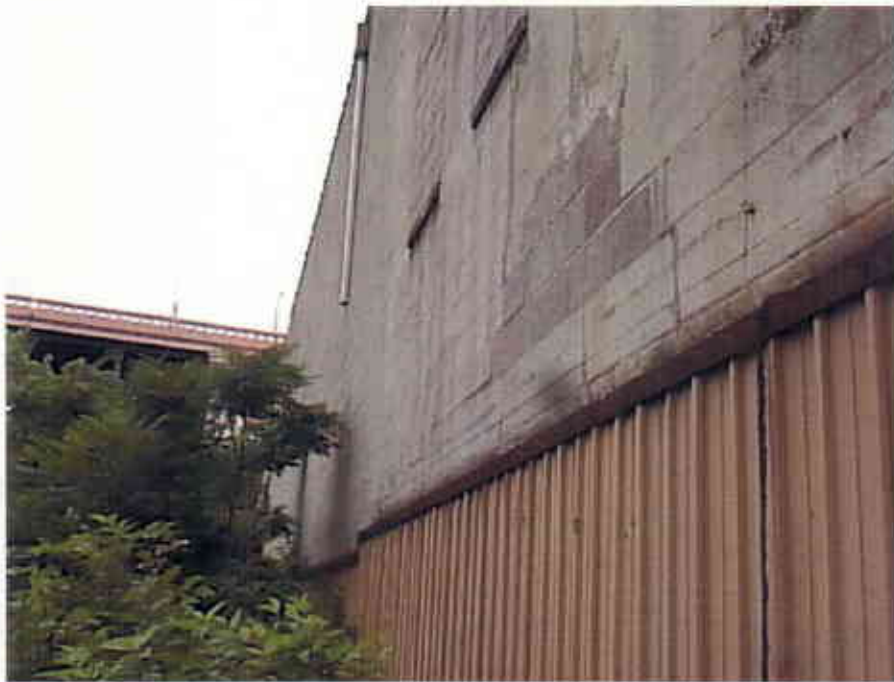
Photograph 08

View Looking Northwest at the South Side of the Canal Road Property
Located at 2394 Canal Road, Cleveland, Ohio

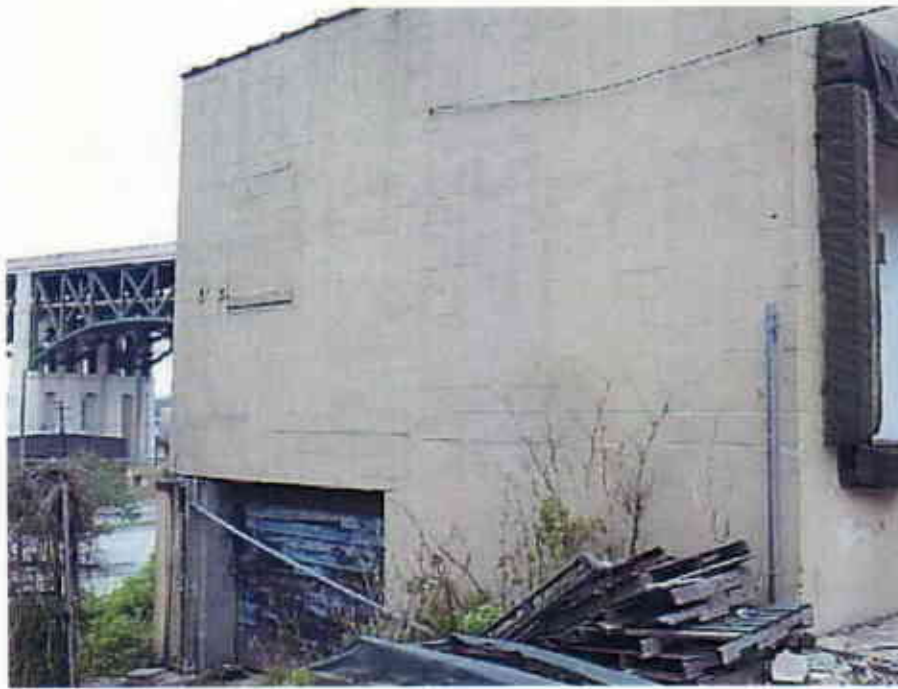
Photograph 9

View Looking West at the East Side of the Canal Road Property
Located at 2394 Canal Road, Cleveland, Ohio

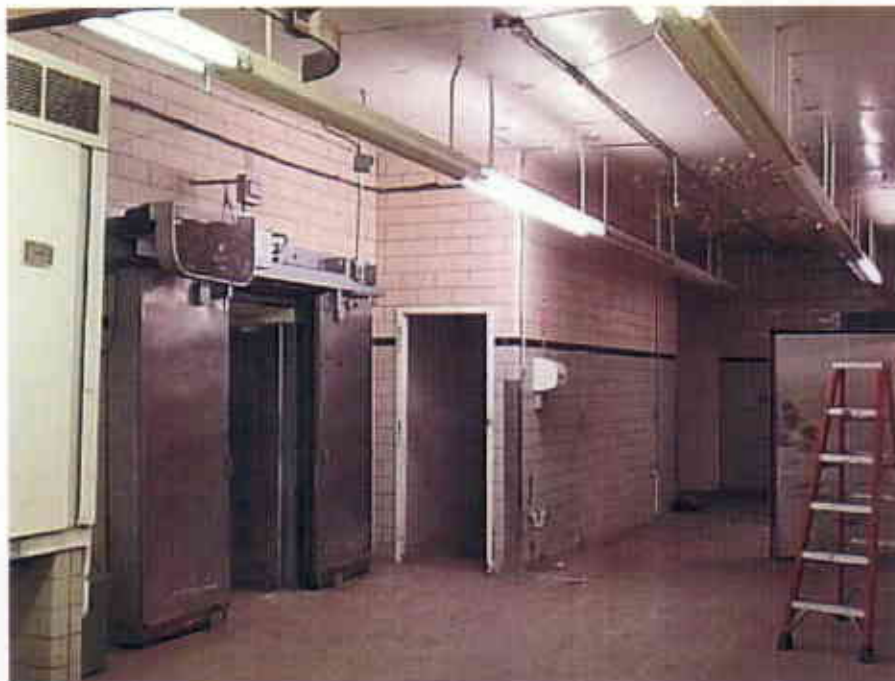
Photograph 10

Interior View of the First Floor of the Original Building Construction of the Canal Road Property
Located at 2394 Canal Road, Cleveland, Ohio

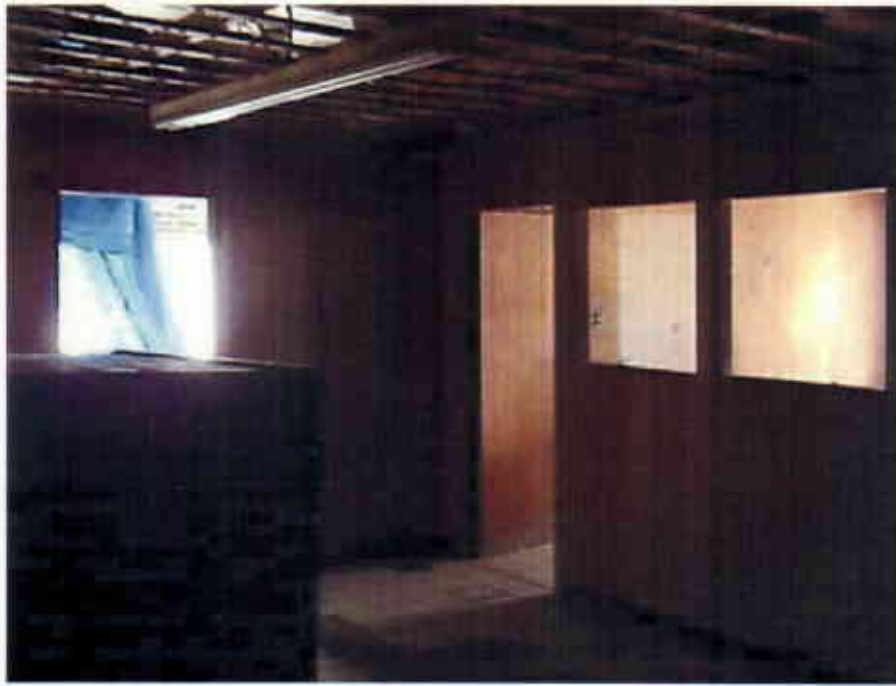
Photograph 11

Interior View of the Second Floor of the Original Building Construction of the Canal Road Property
Located at 2394 Canal Road, Cleveland, Ohio
