**CUY-90-14.90**

**Innerbelt Bridge  
Construction Contract Group 1 (CCG1)**

# ***FINDINGS FROM AN ASBESTOS SURVEY***

## ***Eleven (11) Bridges Associated with the CUY-Innerbelt CCGI Design ODOT PID 77332***

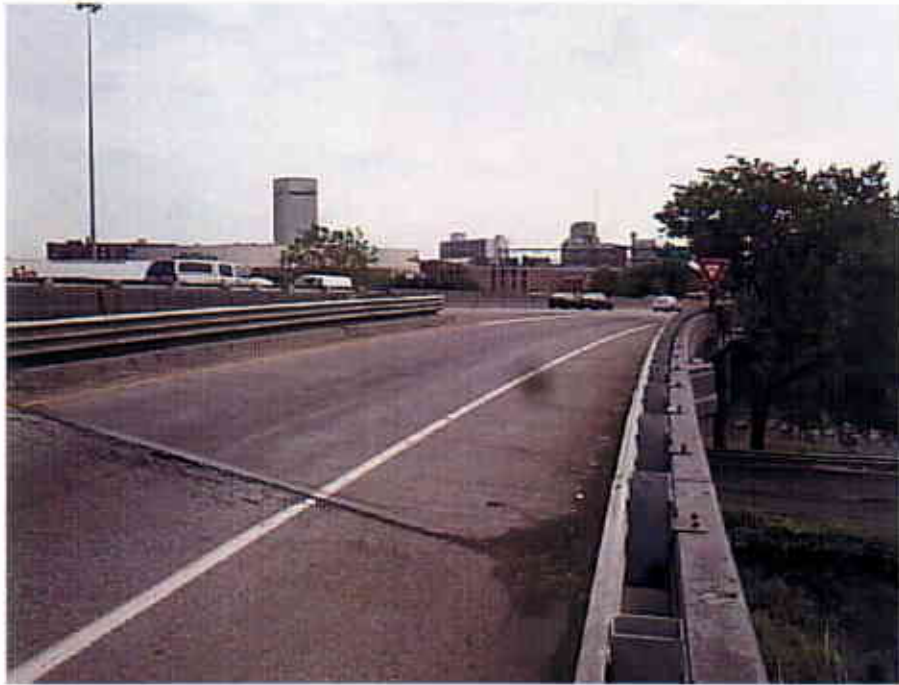
Photograph 01  
View Looking East at the Top of the East Bound Lanes of the  
Interstate 90 Bridge over East 14<sup>th</sup> Street (CUY-90-1651R)

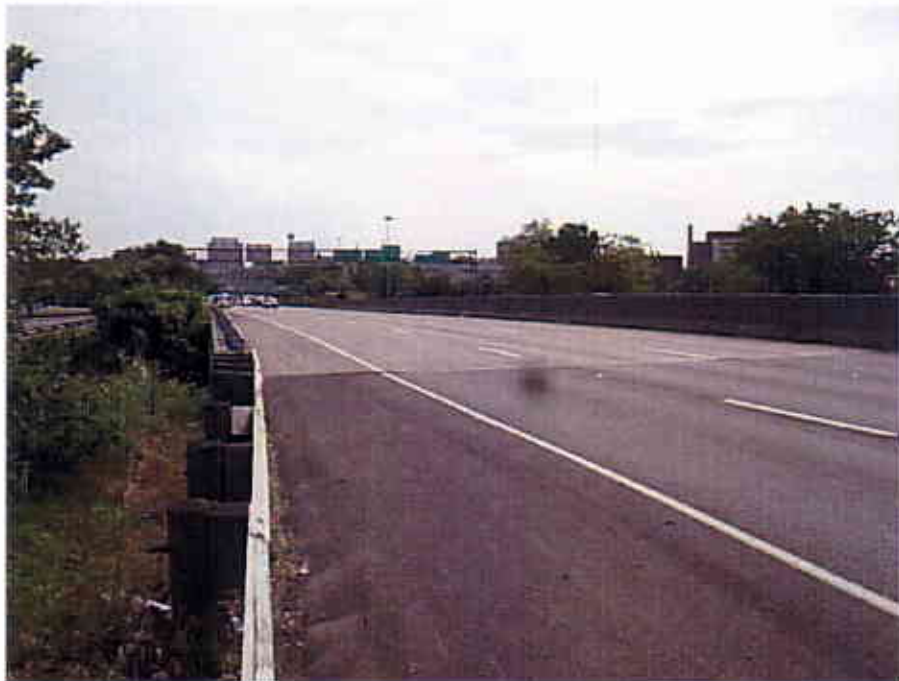
Photograph 02  
View Looking East at the Top of the West Bound Lanes of the  
Interstate 90 Bridge over East 14<sup>th</sup> Street (CUY-90-1651L)

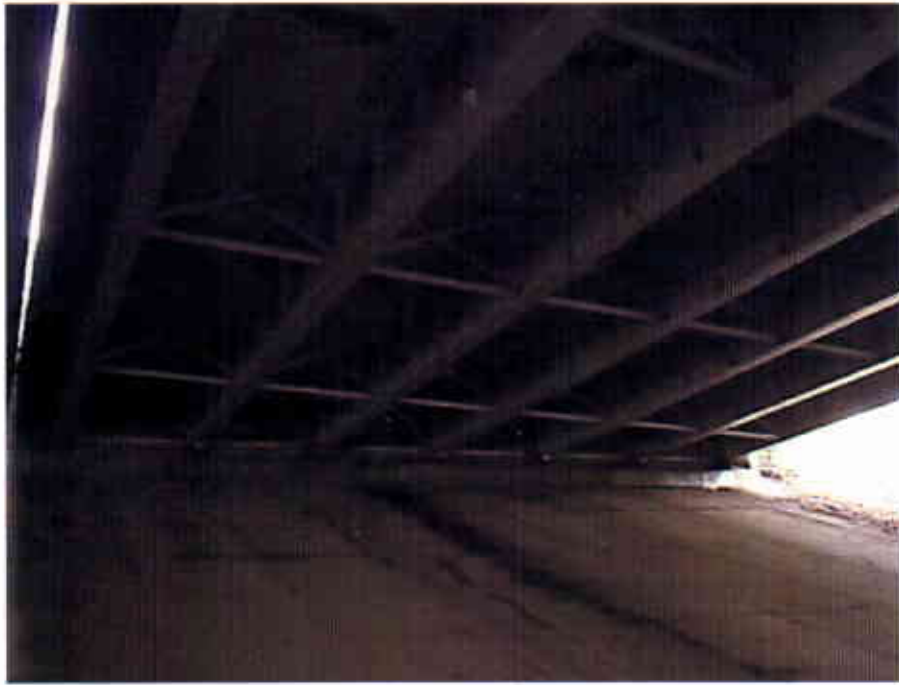
Photograph 03  
View Looking West at the Underside of the West Bound Lanes of the  
Interstate 90 Bridge over East 14<sup>th</sup> Street (CUY-90-1651L)

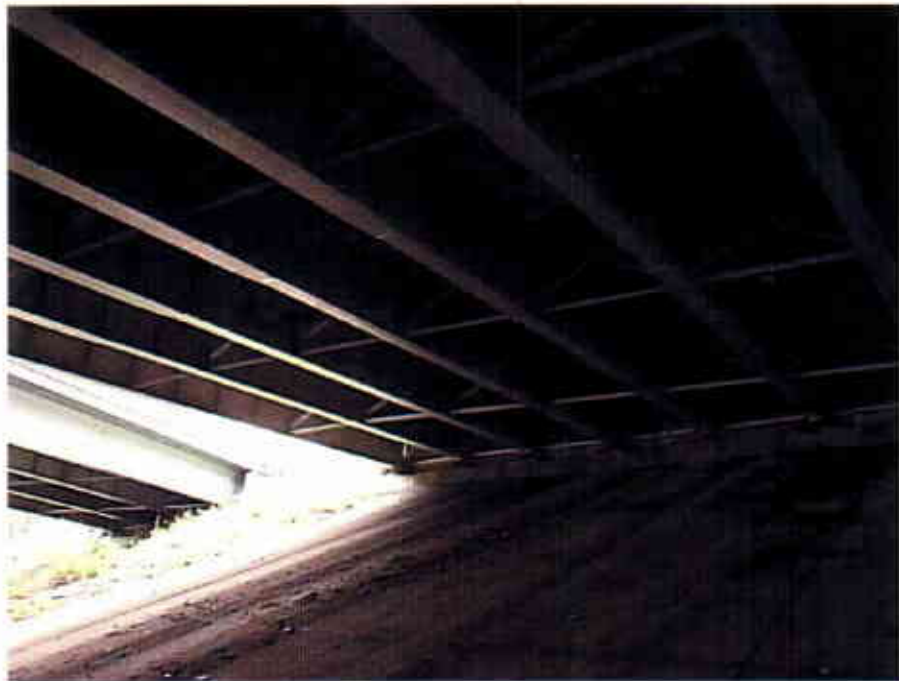
Photograph 04  
View Looking West at the Underside of the East Bound Lanes of the  
Interstate 90 Bridge over East 14<sup>th</sup> Street (CUY-90-1651R)

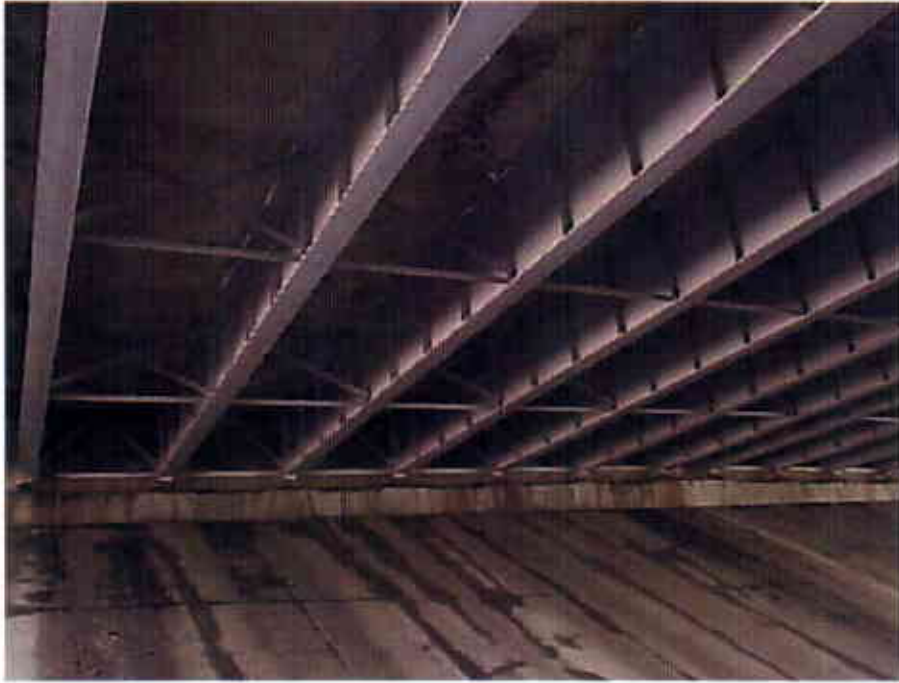
Photograph 05  
View Looking East at the Underside of the West Bound Lanes of the  
Interstate 90 Bridge over East 14<sup>th</sup> Street (CUY-90-1651L)

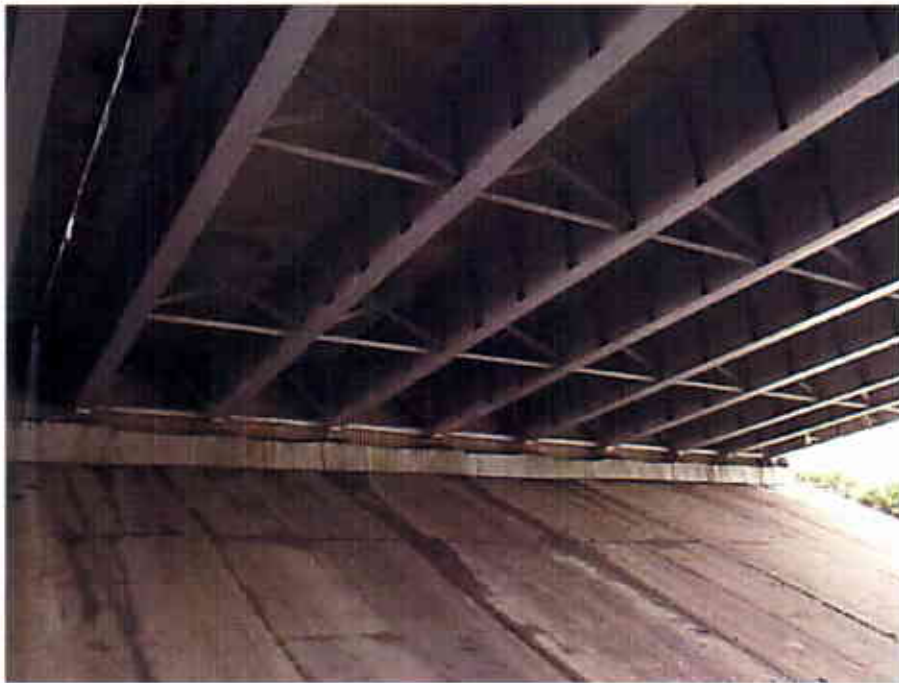
Photograph 06  
View Looking East at the Underside of the East Bound Lanes of the  
Interstate 90 Bridge over East 14<sup>th</sup> Street (CUY-90-1651R)

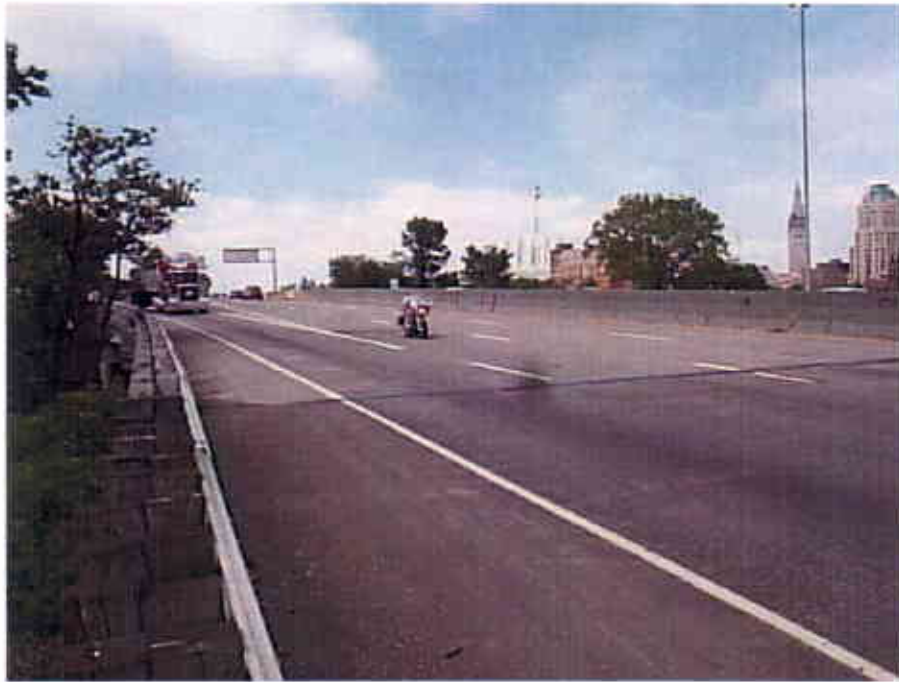
Photograph 07  
View Looking West at the Top of the East Bound Lanes of the  
Interstate 90 Bridge over East 14<sup>th</sup> Street (CUY-90-1651R)

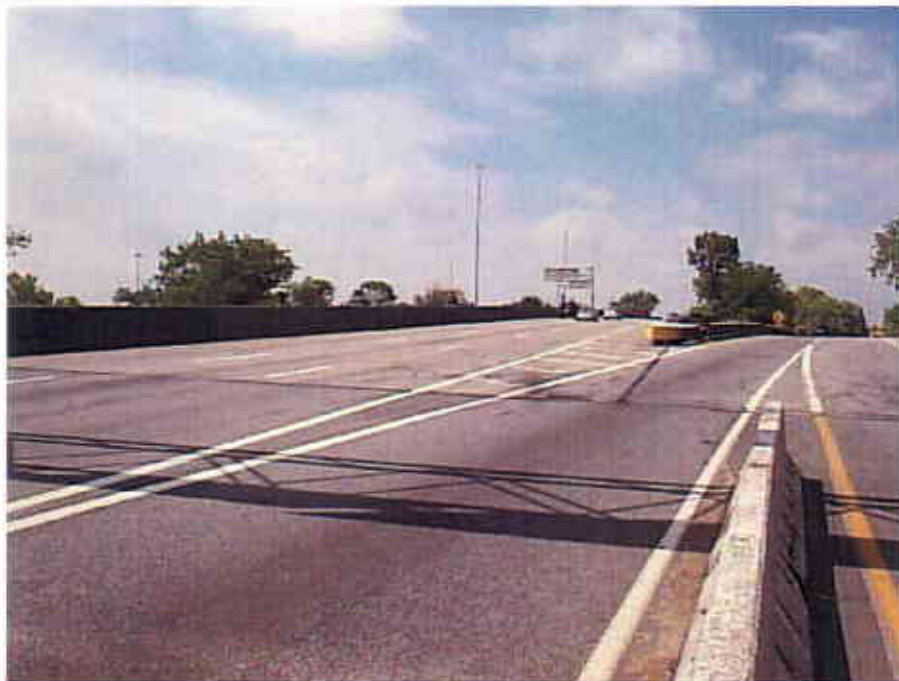
Photograph 08  
View Looking West at the Top of the West Bound Lanes of the  
Interstate 90 Bridge over East 14<sup>th</sup> Street (CUY-90-1651L)

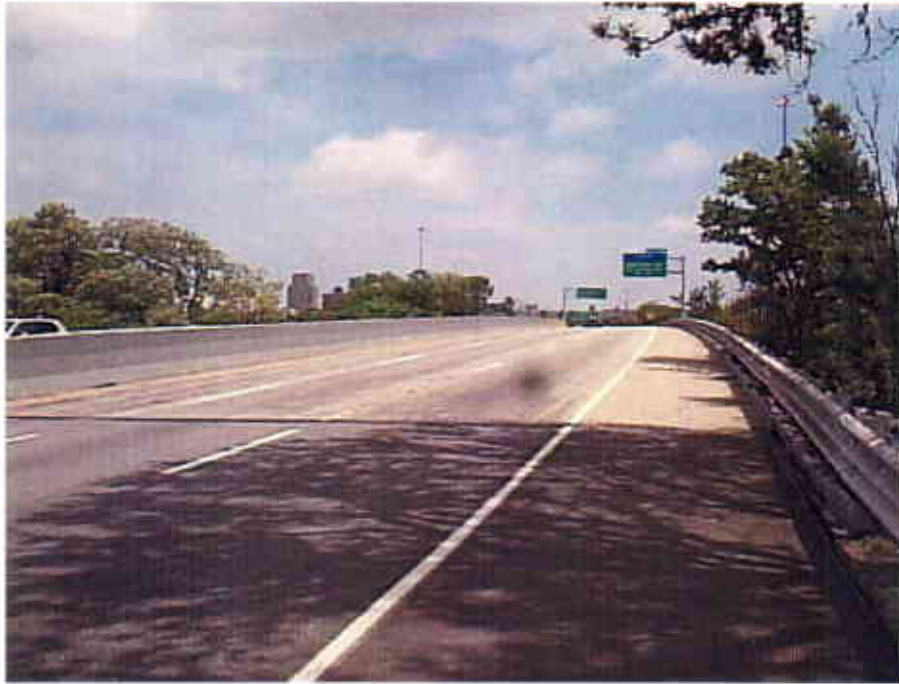
Photograph 09  
View Looking East at the Top of the East Bound Lanes of the  
Interstate 90 Bridge over Ramps E-10 and E-8 (CUY-90-1640)

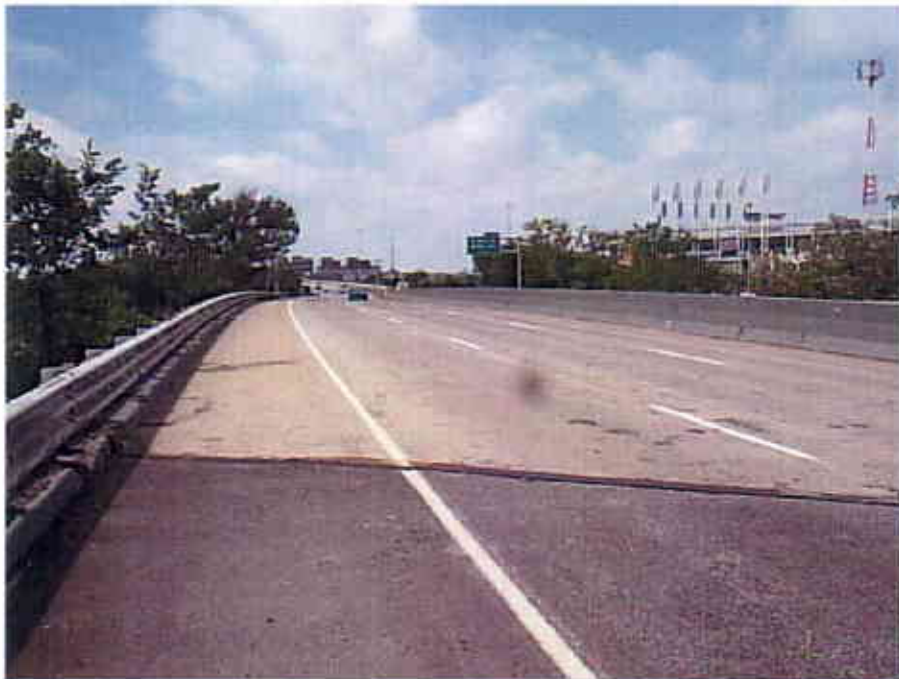
Photograph 10  
View Looking West at the Top of the East Bound Lanes of the  
Interstate 90 Bridge over Ramps E-10 and E-8 (CUY-90-1640)

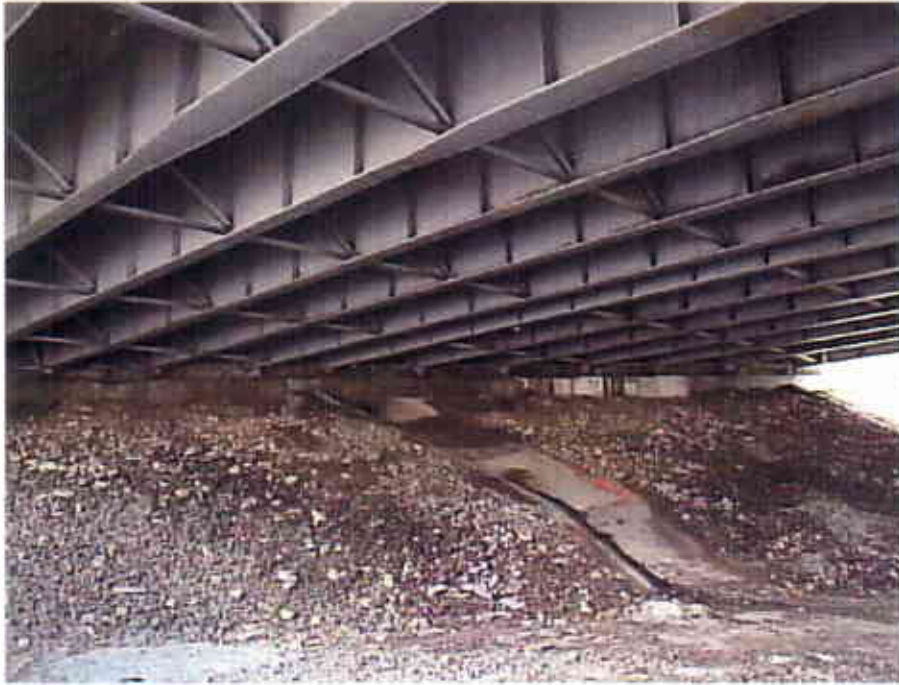
**Photograph 11**  
View Looking East at the Underside of the East and West Bound Lanes of the Interstate 90 Bridge over Ramps E-10 and E-8 (CUY-90-1640)

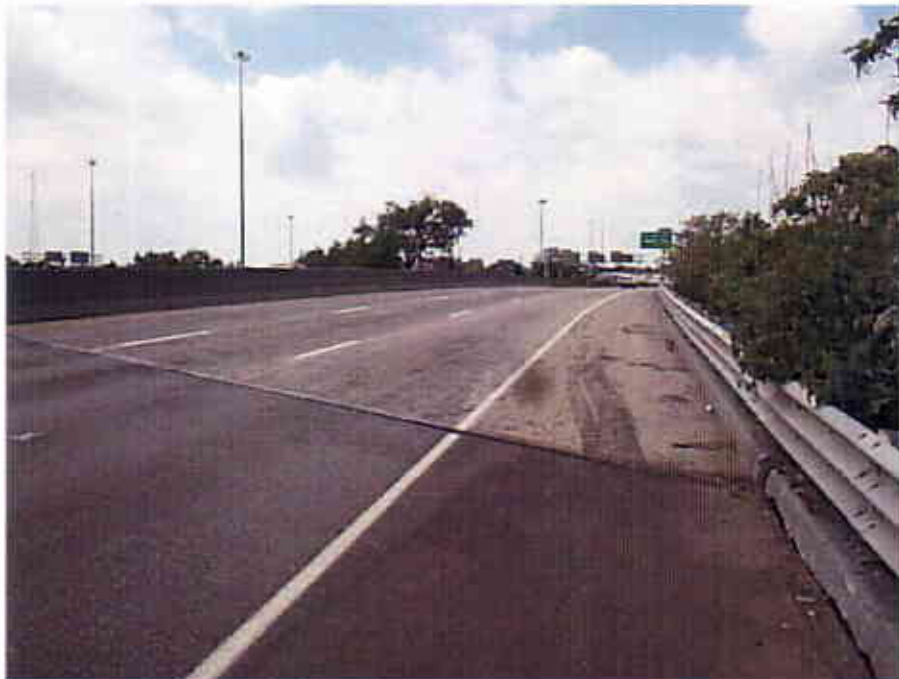
**Photograph 12**  
View Looking West at the Top of the West Bound Lanes of the Interstate 90 Bridge over Ramps E-10 and E-8 (CUY-90-1640)

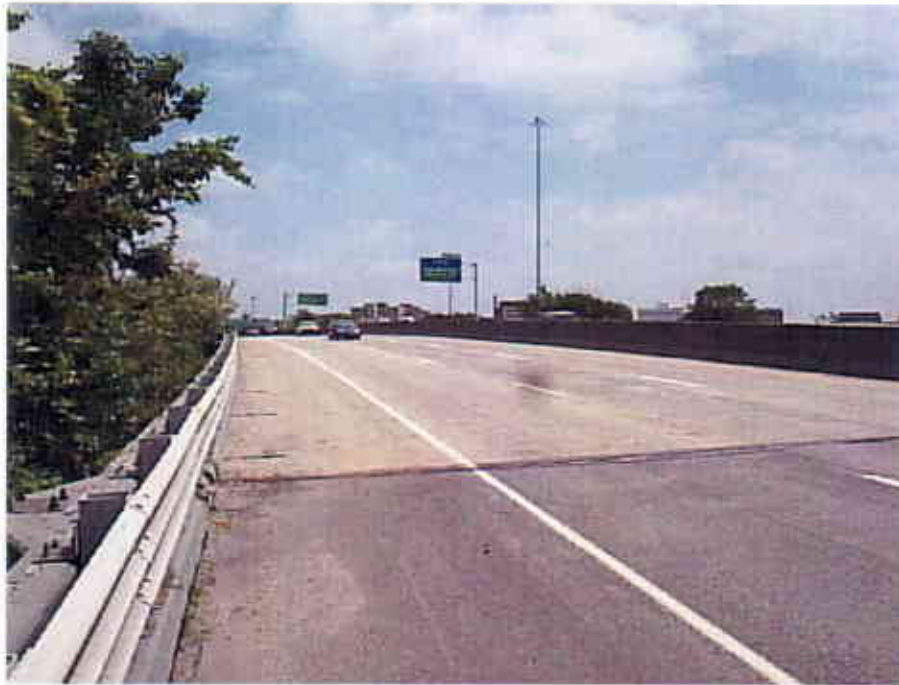
Photograph 13  
View Looking East at the Top of the West Bound Lanes of the  
Interstate 90 Bridge over Ramps E-10 and E-8 (CUY-90-1640)

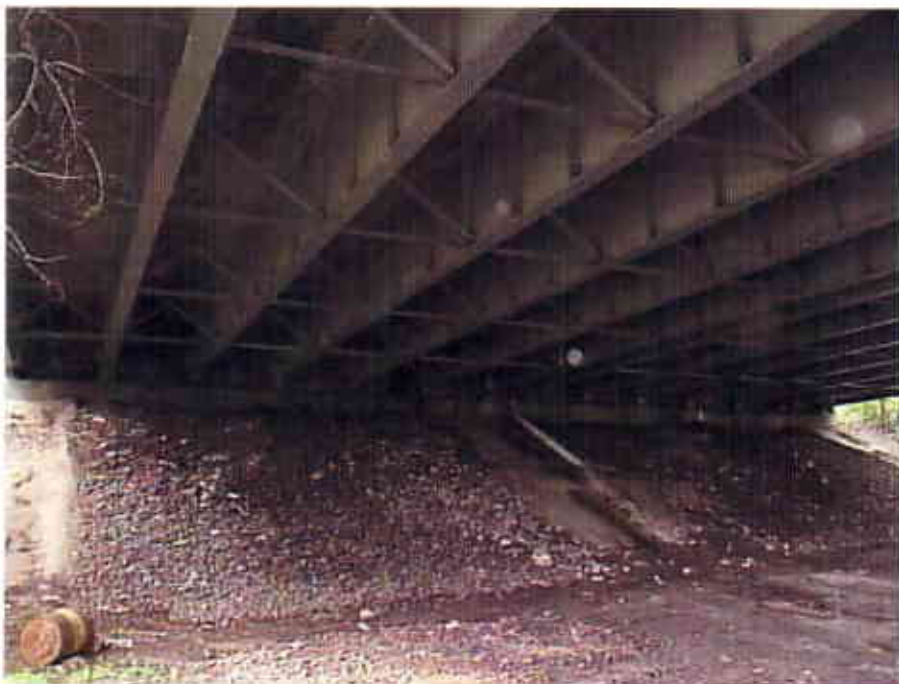
Photograph 14  
View Looking West at the Underside of the East and West Bound Lanes of the  
Interstate 90 Bridge over Ramps E-10 and E-8 (CUY-90-1640)

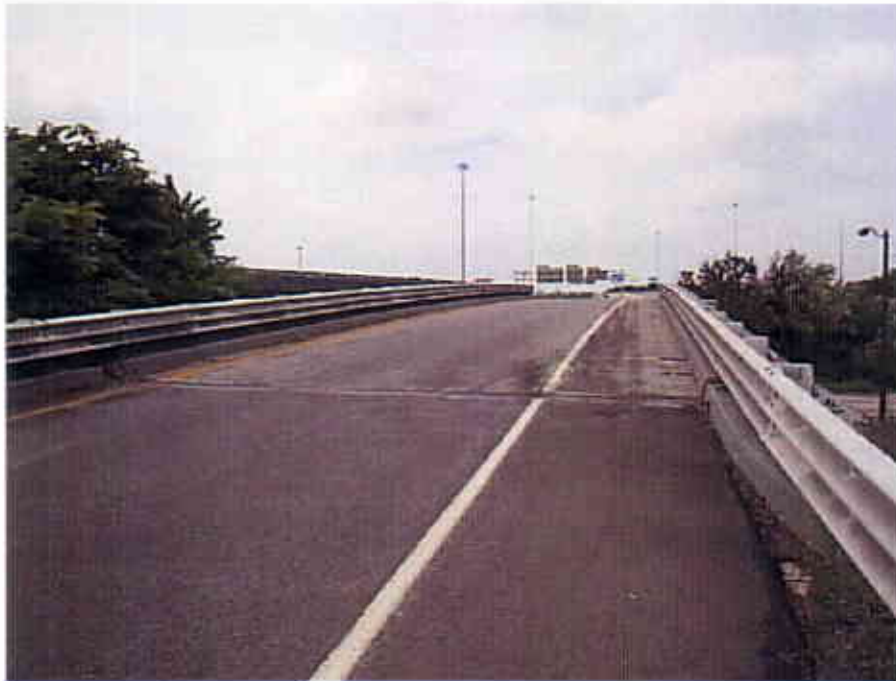
Photograph 15  
View Looking West at the Top of the West Bound On Ramp of the  
Interstate 90 Bridge over East 9<sup>th</sup> Street (CUY-90-1628EW)

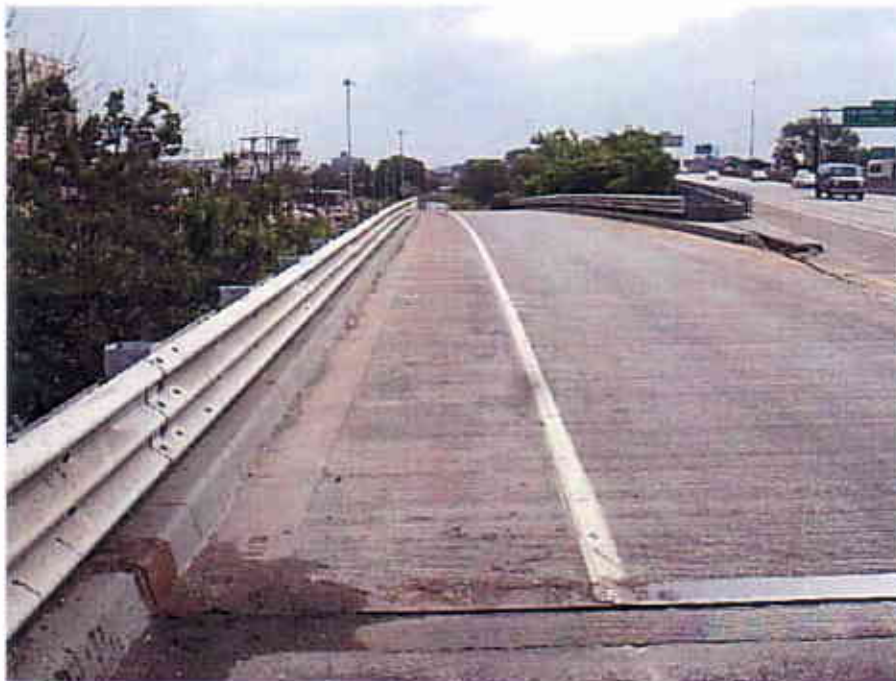
Photograph 16  
View Looking East at the Top of the West Bound On Ramp of the  
Interstate 90 Bridge over East 9<sup>th</sup> Street (CUY-90-1628EW)

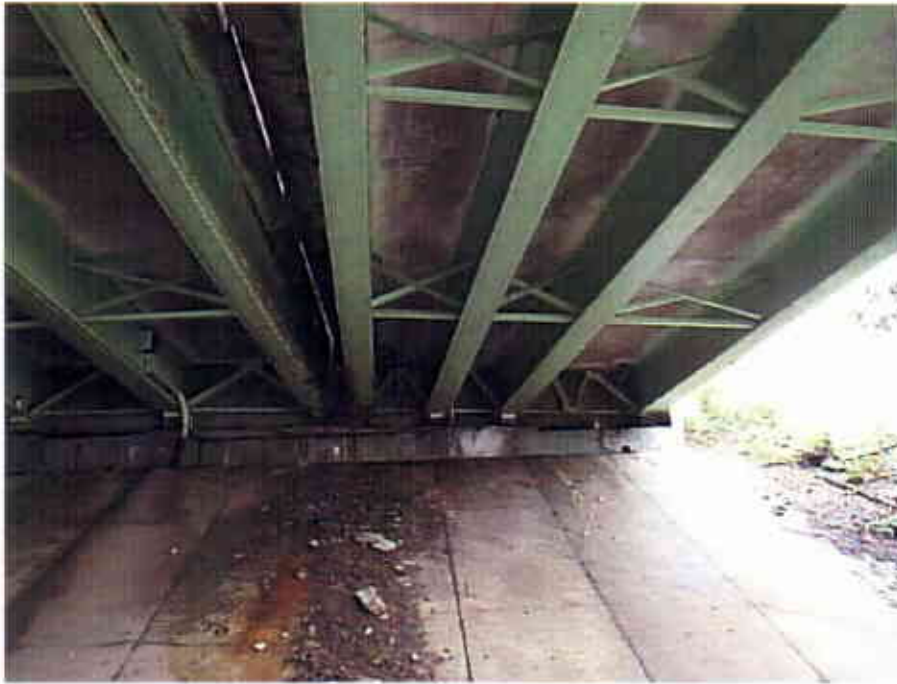
Photograph 17  
View Looking West at the Underside of the West Bound On Ramp of the  
Interstate 90 Bridge over East 9<sup>th</sup> Street (CUY-90-1628EW)

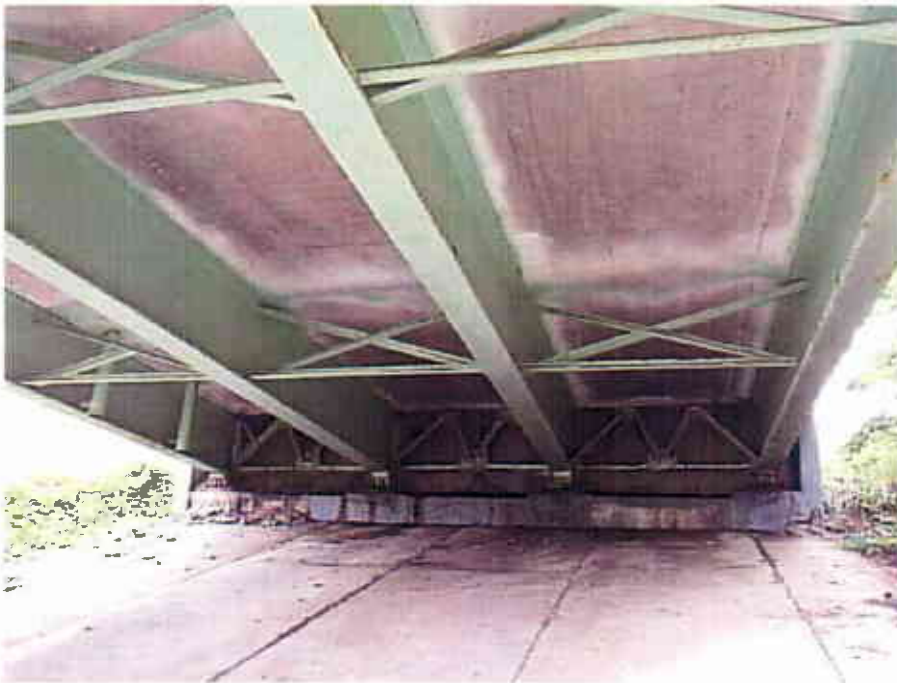
Photograph 18  
View Looking East at the Underside of the West Bound On Ramp of the  
Interstate 90 Bridge over East 9<sup>th</sup> Street (CUY-90-1628EW)

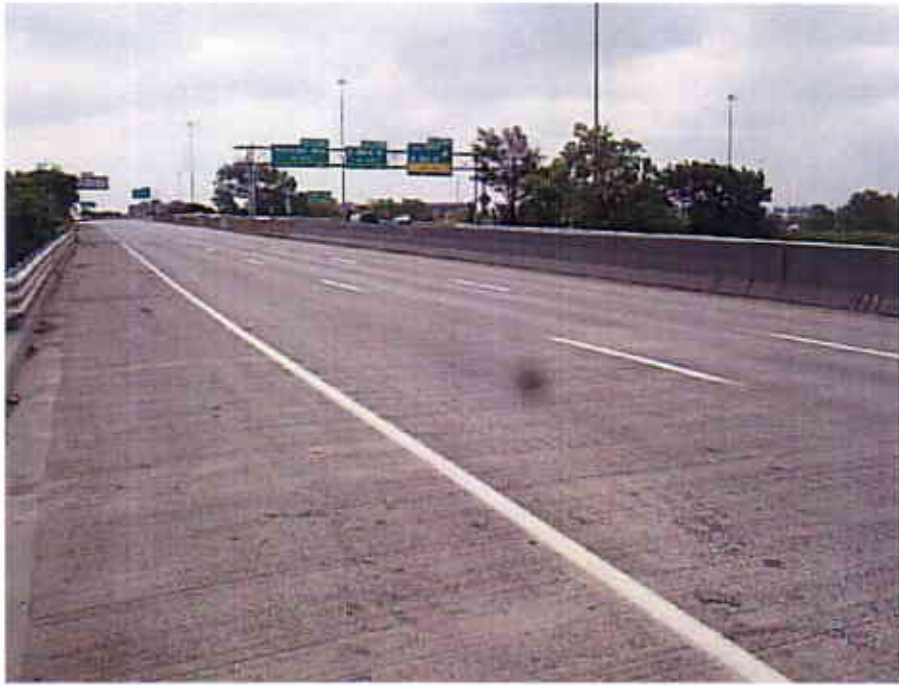
Photograph 19  
View Looking West at the Top of the West Bound Lanes of the  
Interstate 90 Bridge over East 9<sup>th</sup> Street (CUY-90-1628L)

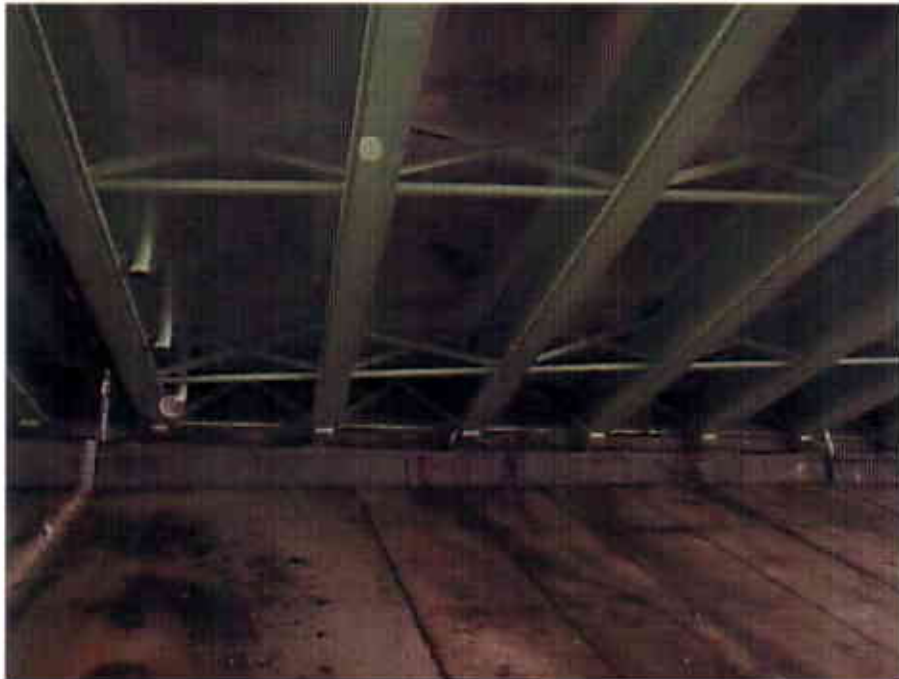
Photograph 20  
View Looking West at the Underside of the West Bound Lanes of the  
Interstate 90 Bridge over East 9<sup>th</sup> Street (CUY-90-1628L)

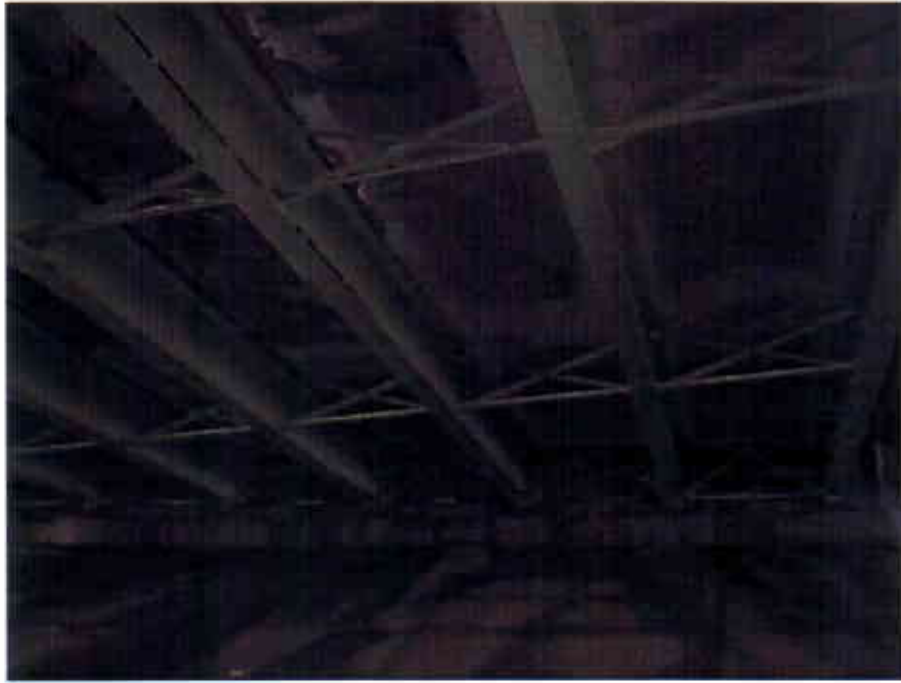
Photograph 21  
View Looking East at the Underside of the West Bound Lanes of the  
Interstate 90 Bridge over East 9<sup>th</sup> Street (CUY-90-1628L)

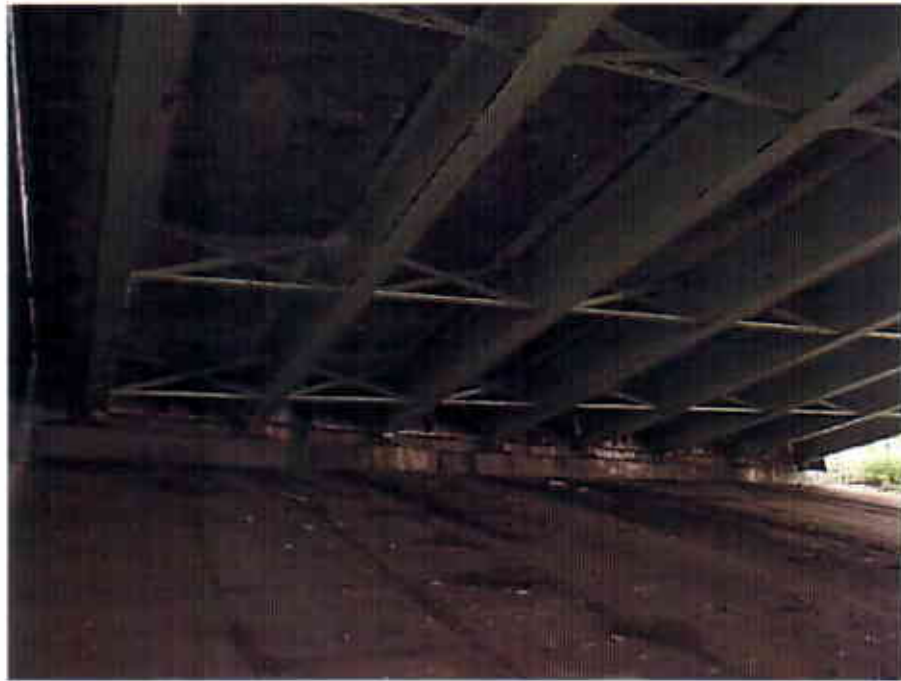
Photograph 22  
View Looking East at the Underside of the East Bound Lanes of the  
Interstate 90 Bridge over East 9<sup>th</sup> Street (CUY-90-1628R)

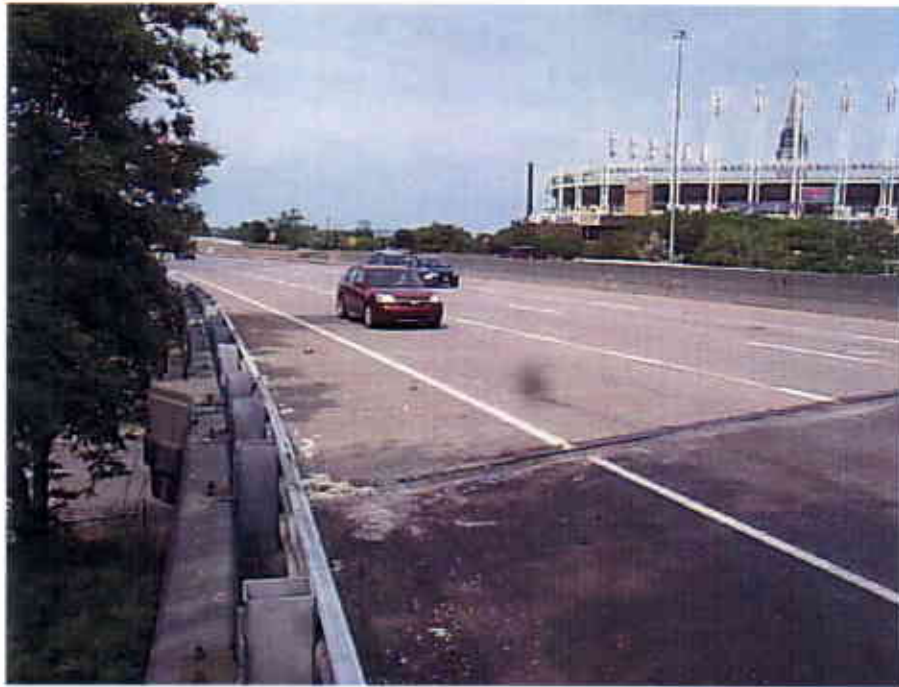
Photograph 23  
View Looking West at the Top of the East Bound Lanes of the  
Interstate 90 Bridge over East 9<sup>th</sup> Street (CUY-90-1628R)

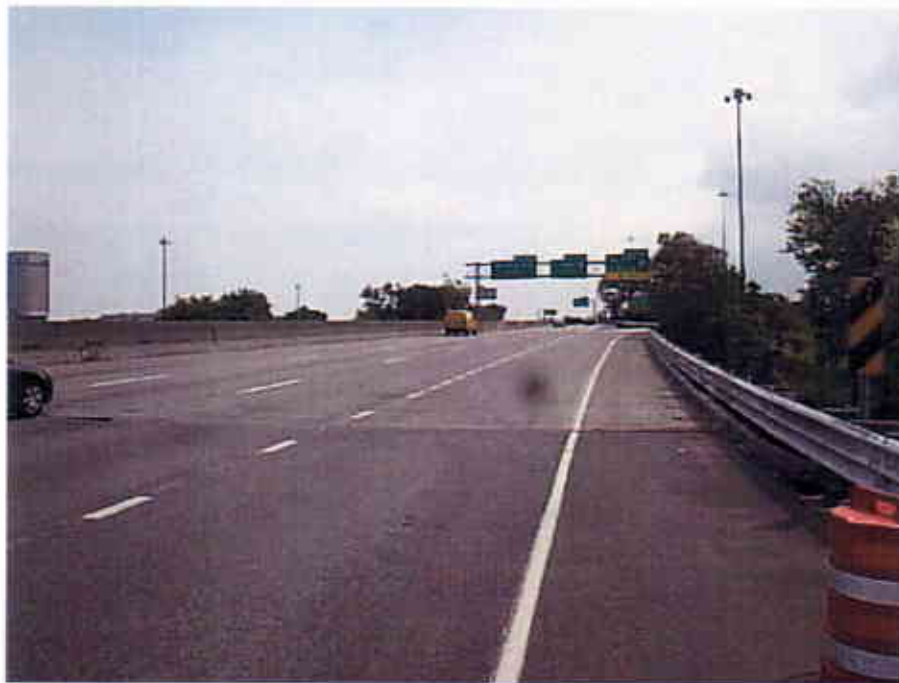
Photograph 24  
View Looking East at the Top of the East Bound Lanes of the  
Interstate 90 Bridge over East 9<sup>th</sup> Street (CUY-90-1628R)

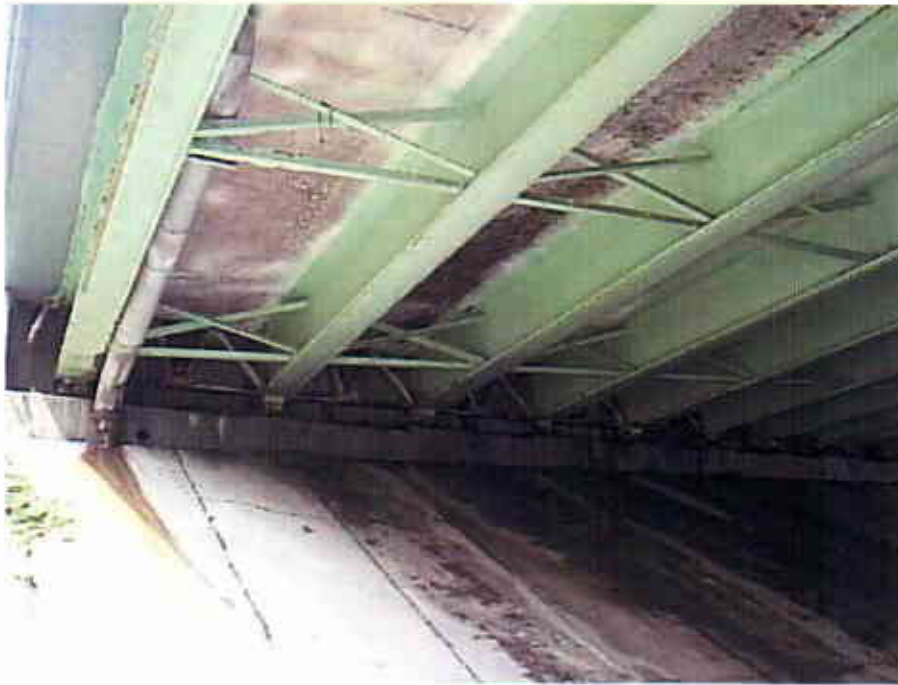
Photograph 25  
View Looking West at the Underside of the East Bound Lanes of the  
Interstate 90 Bridge over East 9<sup>th</sup> Street (CUY-90-1628R)

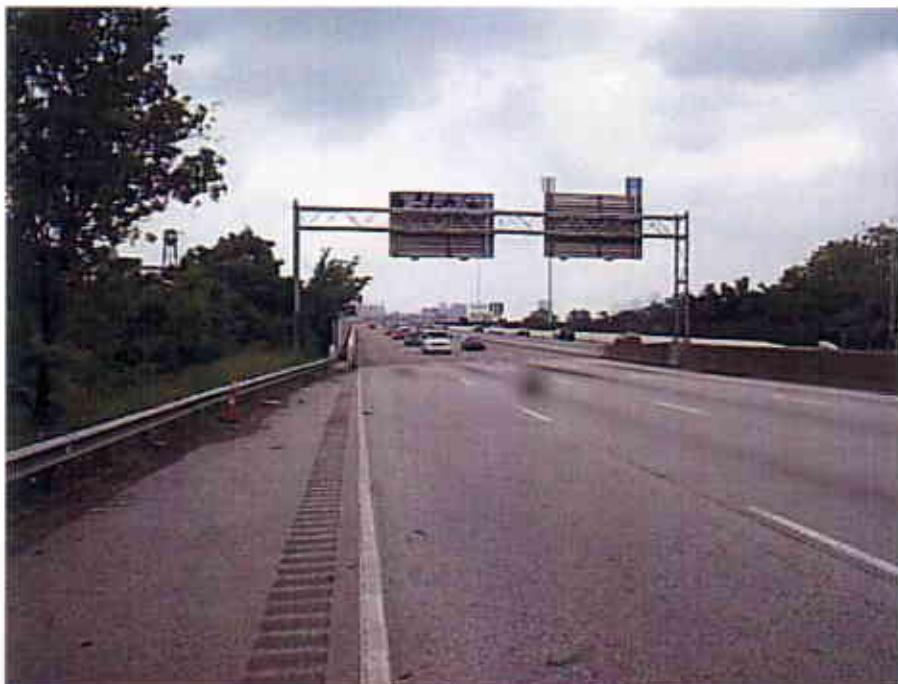
Photograph 26  
View Looking North at the Top of the West Bound Lanes of the  
Interstate 90 Innerbelt Bridge over the Cuyahoga River (CUY-90-15.24)

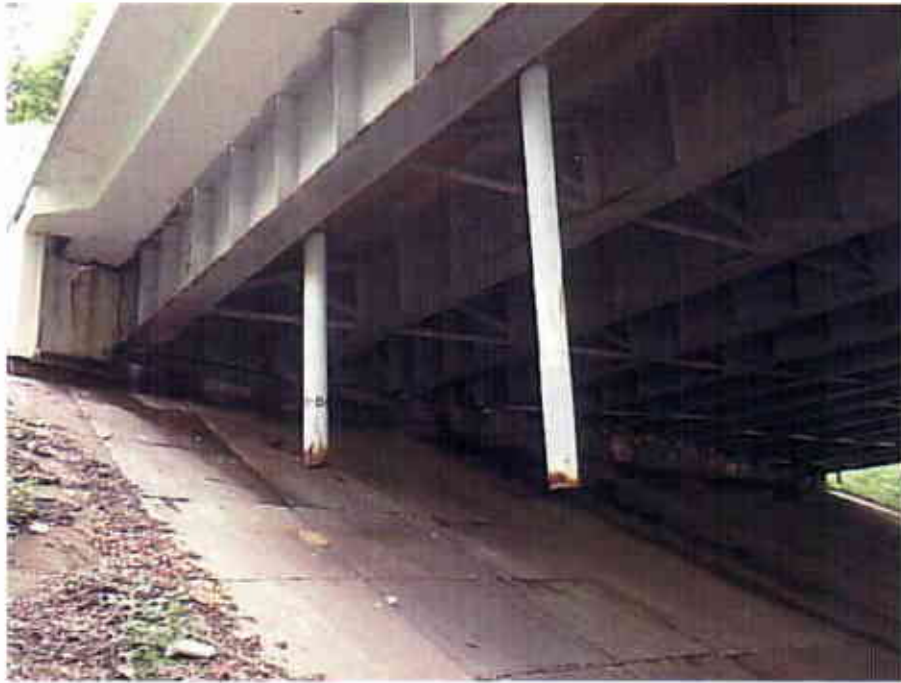
Photograph 27  
View Looking South at the Underside of the East and West Bound Lanes of the  
Interstate 90 Innerbelt Bridge over the Cuyahoga River (CUY-90-15.24)

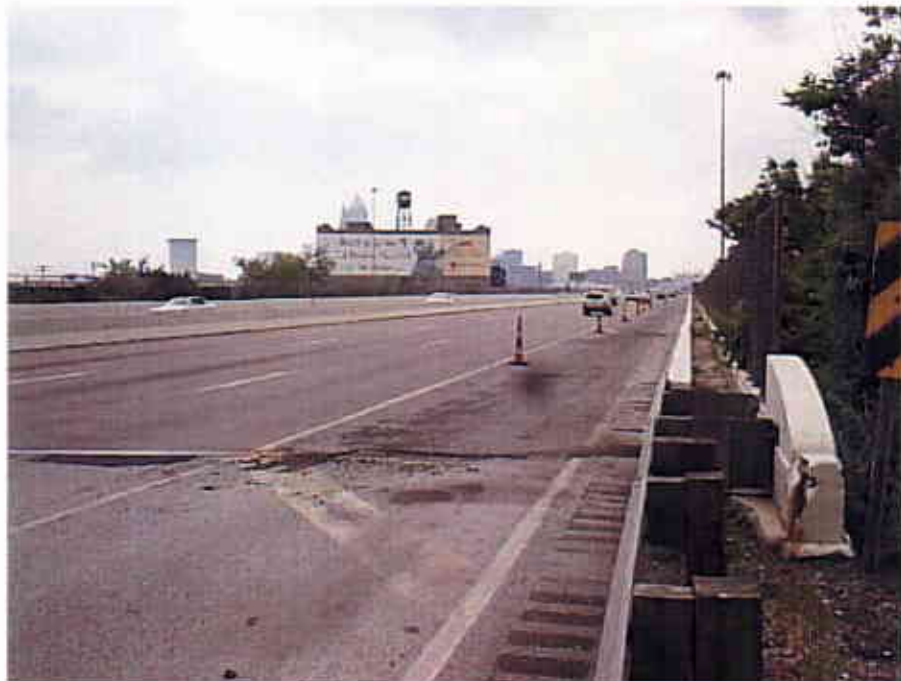
Photograph 28  
View Looking North at the Top of the East Bound Lanes of the  
Interstate 90 Innerbelt Bridge over the Cuyahoga River (CUY-90-15.24)

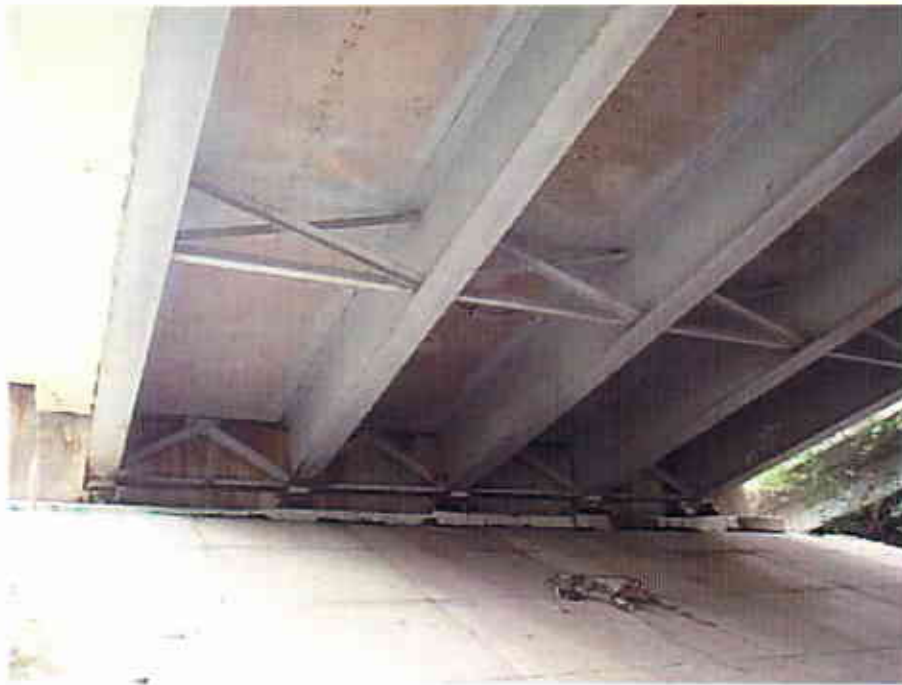
Photograph 29  
View Looking South at the Underside of the East Bound On Ramp Lane of the  
Interstate 90 Innerbelt Bridge over the Cuyahoga River (CUY-90-15.24)

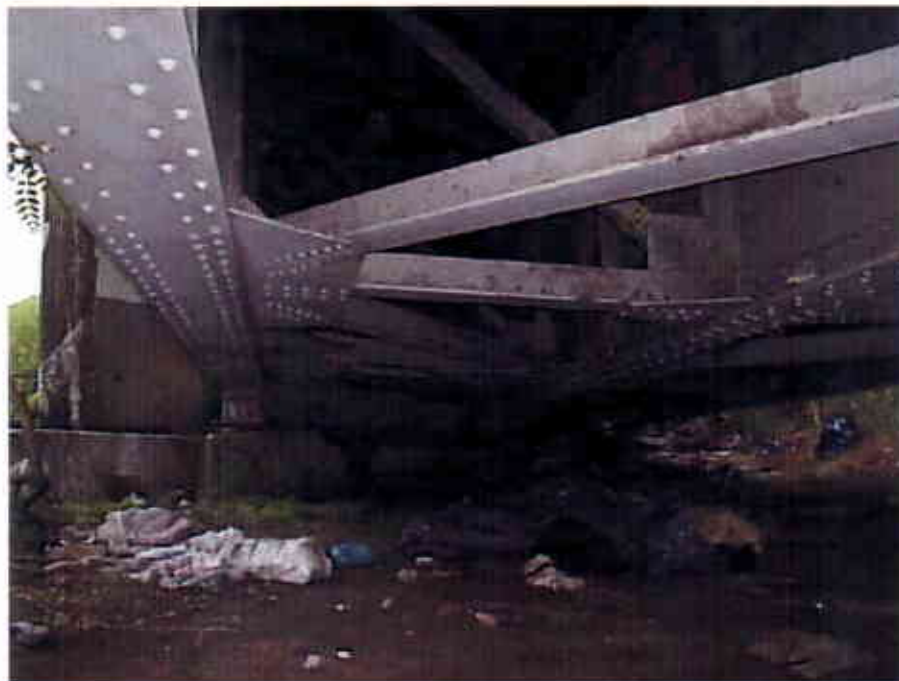
Photograph 30  
View Looking West at the Underside of the East Bound Off Ramp Lane of the  
Interstate 90 Innerbelt Bridge over the Cuyahoga River (CUY-90-15.24)

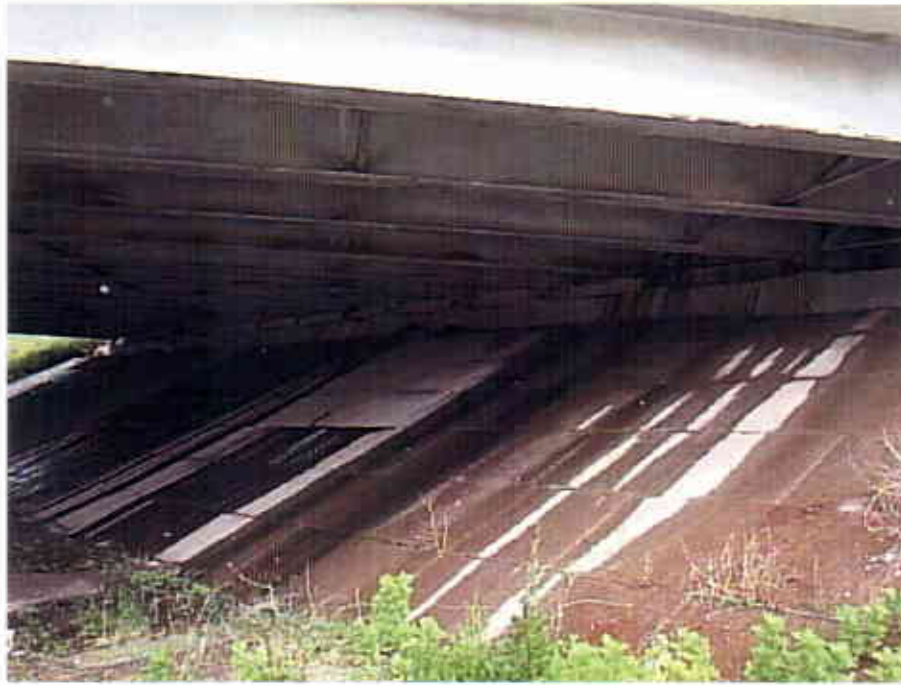
Photograph 31  
View Looking West at the Underside of the East and West Bound Lanes of the  
Interstate 90 Innerbelt Bridge over the Cuyahoga River (CUY-90-15.24)

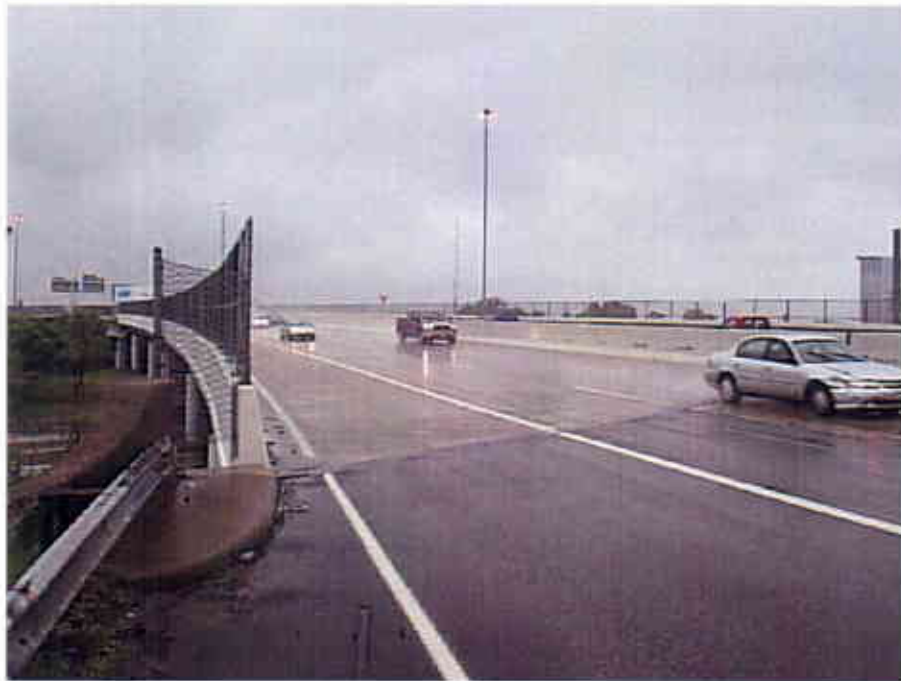
Photograph 32  
View Looking West at the Top of the East Bound Lanes of the  
Interstate 90 Innerbelt Bridge over the Cuyahoga River (CUY-90-15.24)

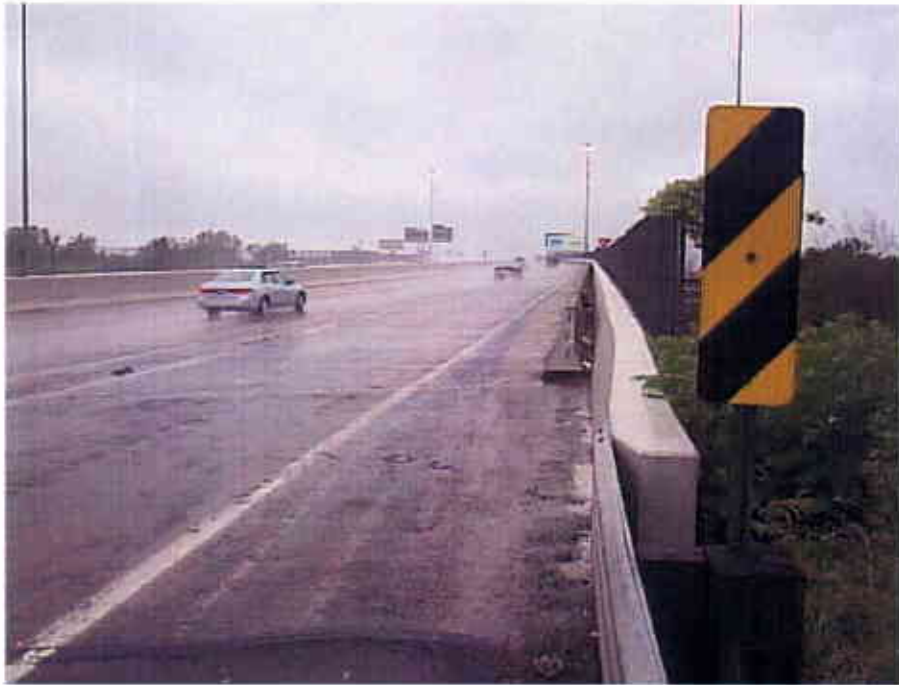
Photograph 33  
View Looking West at the Top of the West Bound Lanes of the  
Interstate 90 Innerbelt Bridge over the Cuyahoga River (CUY-90-15.24)

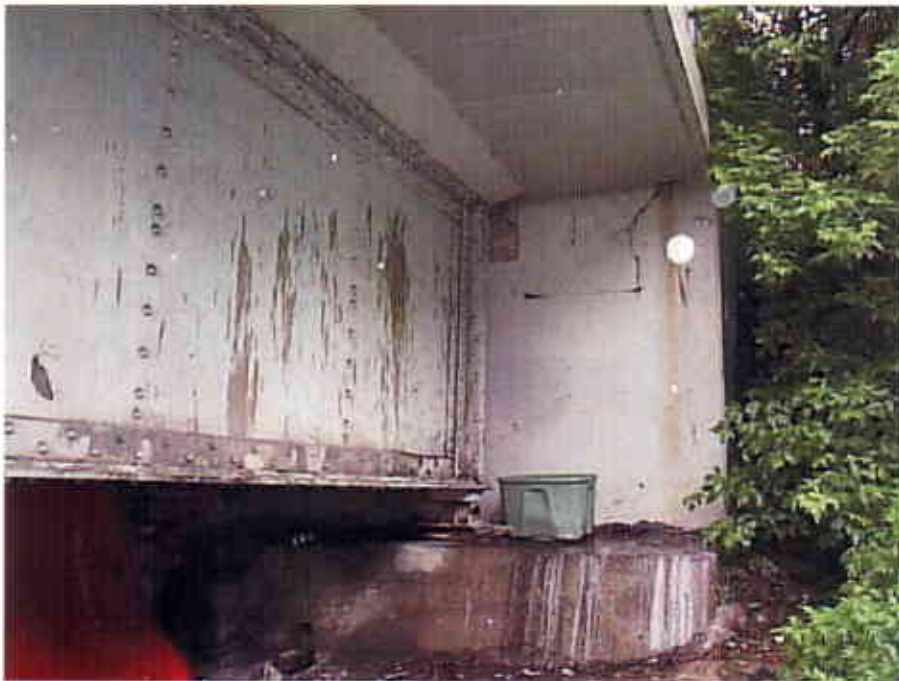
Photograph 34  
View Looking North at the Underside of the West Bound On Ramp Lane of the  
Interstate 90 Innerbelt Bridge over the Cuyahoga River (CUY-90-15.24)

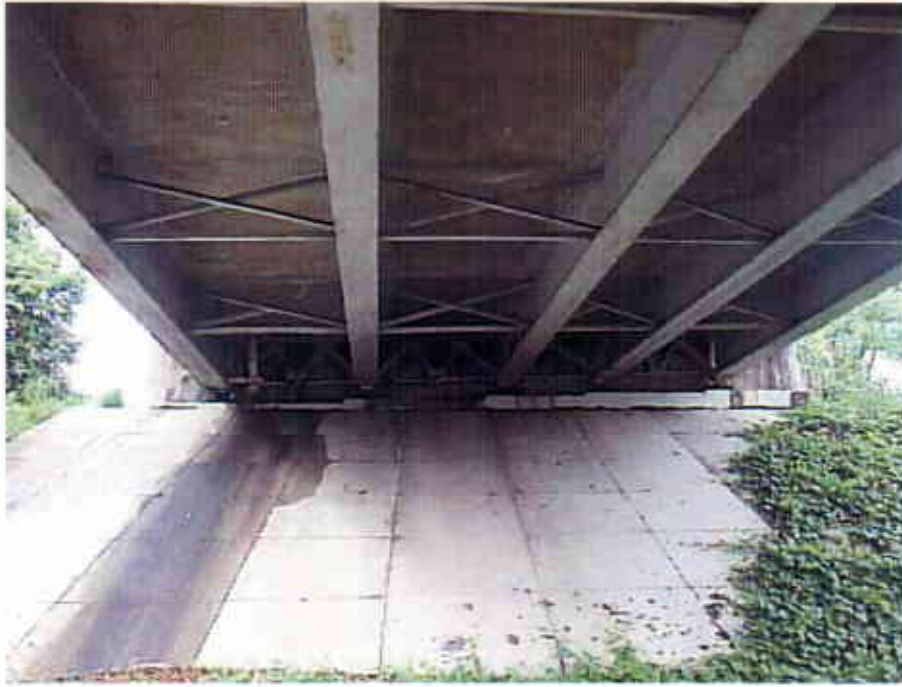
Photograph 35  
View Looking South at the Underside of the West Bound Off Ramp Lane of the  
Interstate 90 Innerbelt Bridge over the Cuyahoga River (CUY-90-15.24)
