**CUY-90-14.90**

**Innerbelt Bridge  
Construction Contract Group 1 (CCG1)**

# ***FINDINGS FROM AN ASBESTOS SURVEY***

## ***Eleven (11) Bridges Associated with the CUY-Innerbelt CCGI Design ODOT PID 77332***

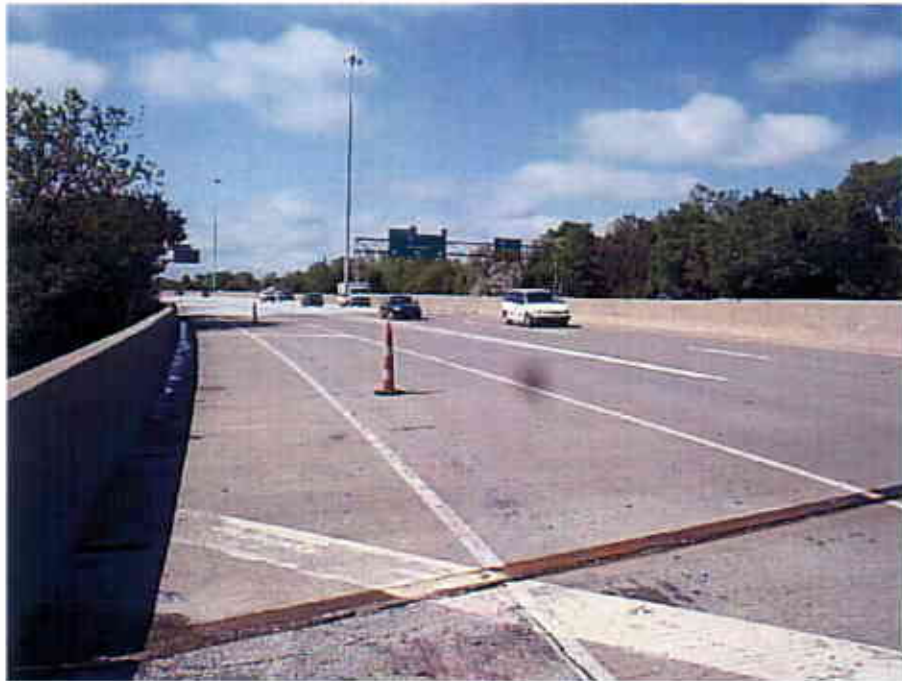
Photograph 36  
View Looking South at the Top of the East Bound Lanes of the  
Interstate 90 Bridge over Kenilworth Avenue (CUY-90-1506)

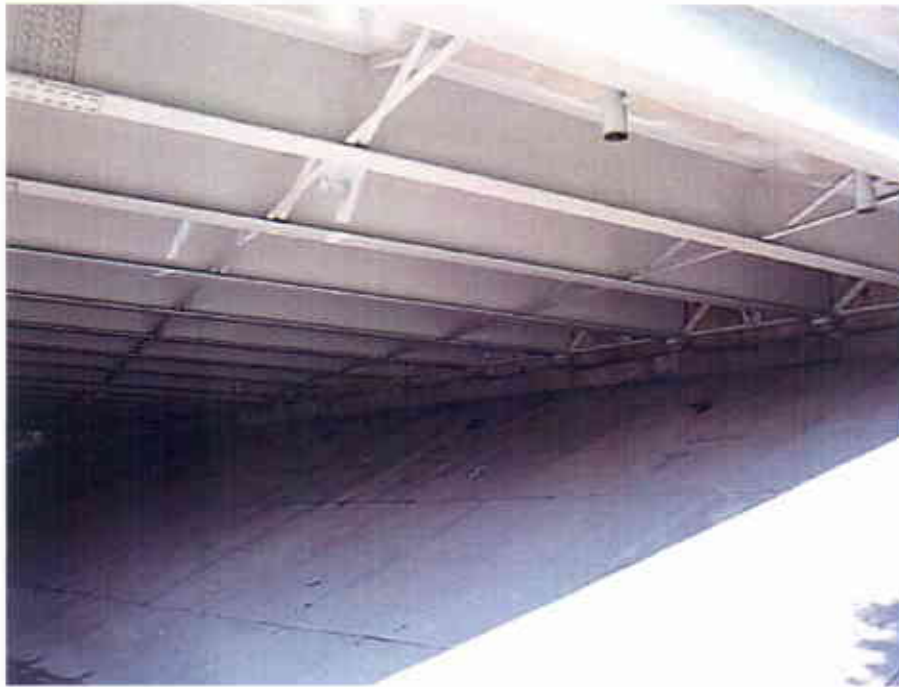
Photograph 37  
View Looking North at the Underside of the East and West Bound Lanes of the  
Interstate 90 Bridge over Kenilworth Avenue (CUY-90-1506)

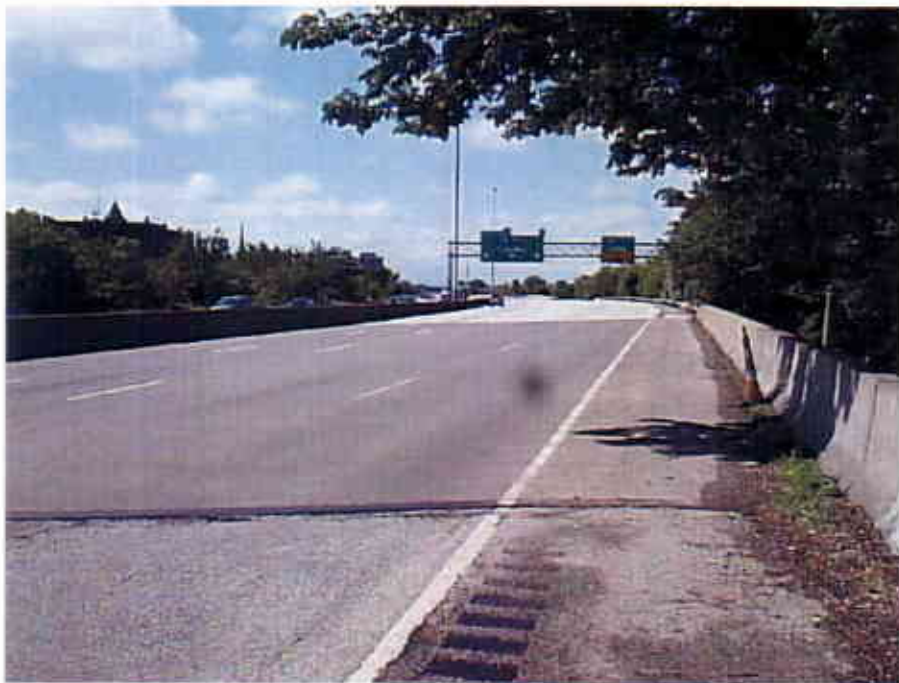
Photograph 38  
View Looking South at the Top of the West Bound Lanes of the  
Interstate 90 Bridge over Kenilworth Avenue (CUY-90-1506)

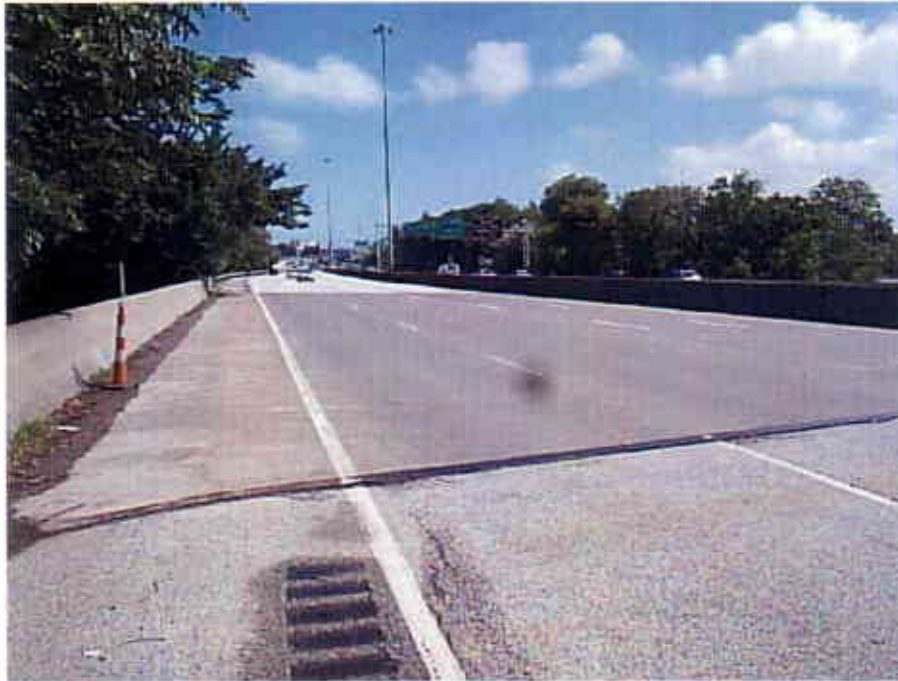
Photograph 39  
View Looking North at the Top of the West Bound Lanes of the  
Interstate 90 Bridge over Kenilworth Avenue (CUY-90-1506)

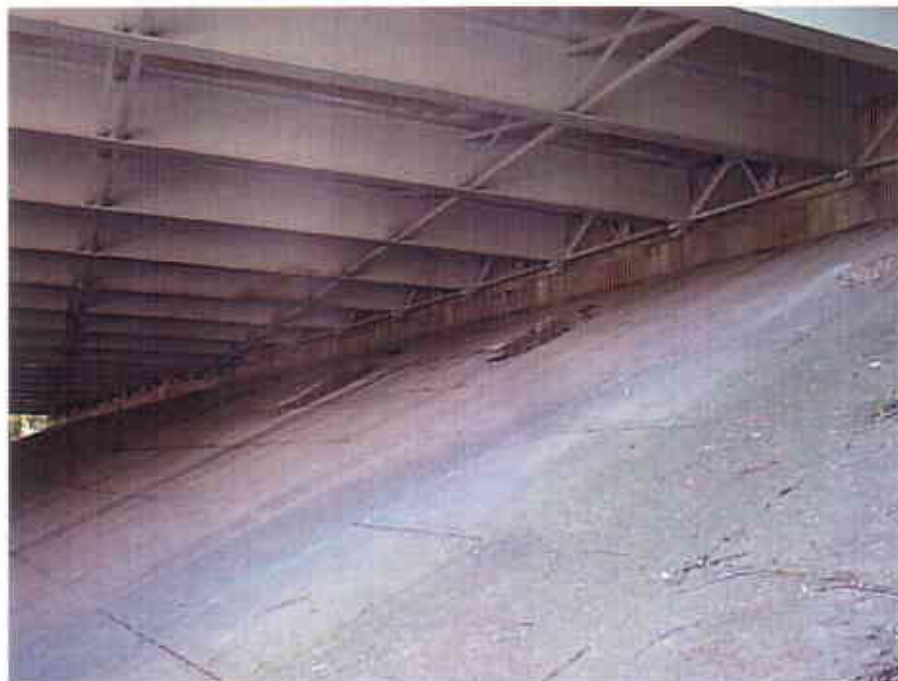
Photograph 40  
View Looking South at the Underside of the East and West Bound Lanes of the  
Interstate 90 Bridge over Kenilworth Avenue (CUY-90-1506)

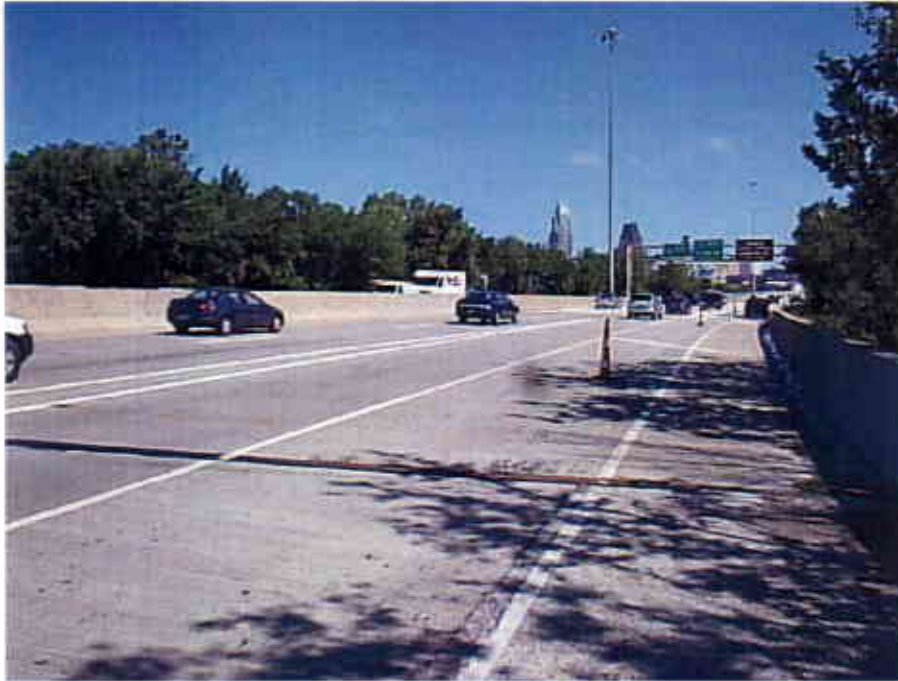
Photograph 41  
View Looking North at the Top of the East Bound Lanes of the  
Interstate 90 Bridge over Kenilworth Avenue (CUY-90-1506)

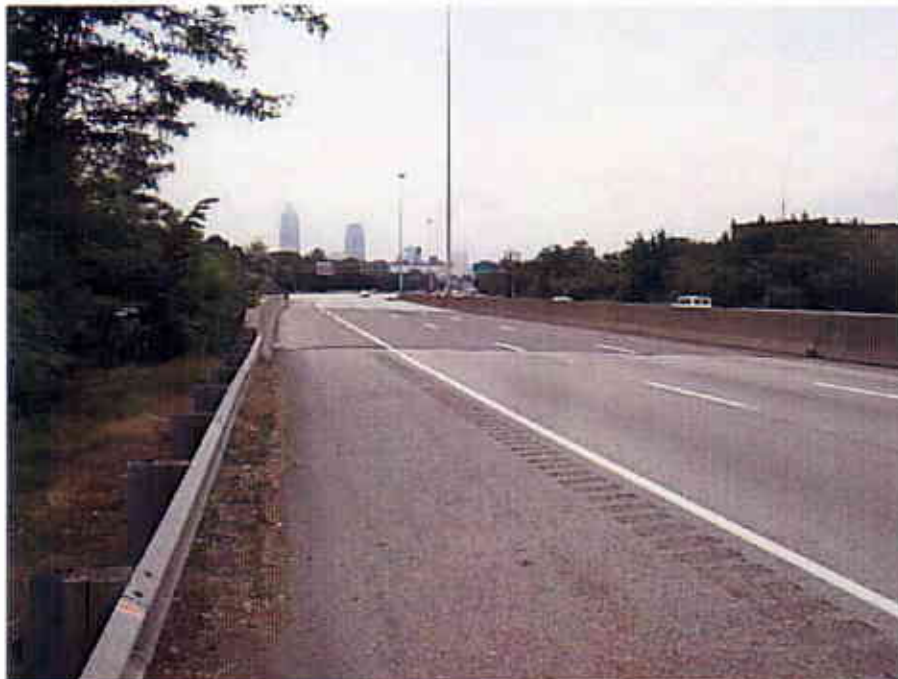
Photograph 42  
View Looking North at the Top of the West Bound Lanes of the  
Interstate 90 Bridge over Starkweather Avenue (CUY-90-1490L)

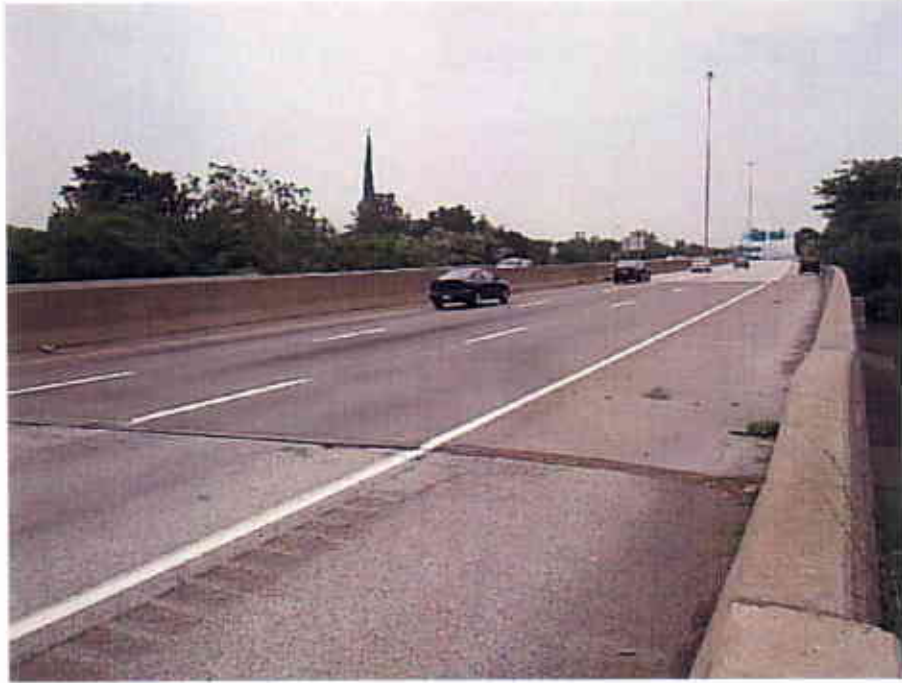
Photograph 43  
View Looking South at the Top of the West Bound Lanes of the  
Interstate 90 Bridge over Starkweather Avenue (CUY-90-1490L)

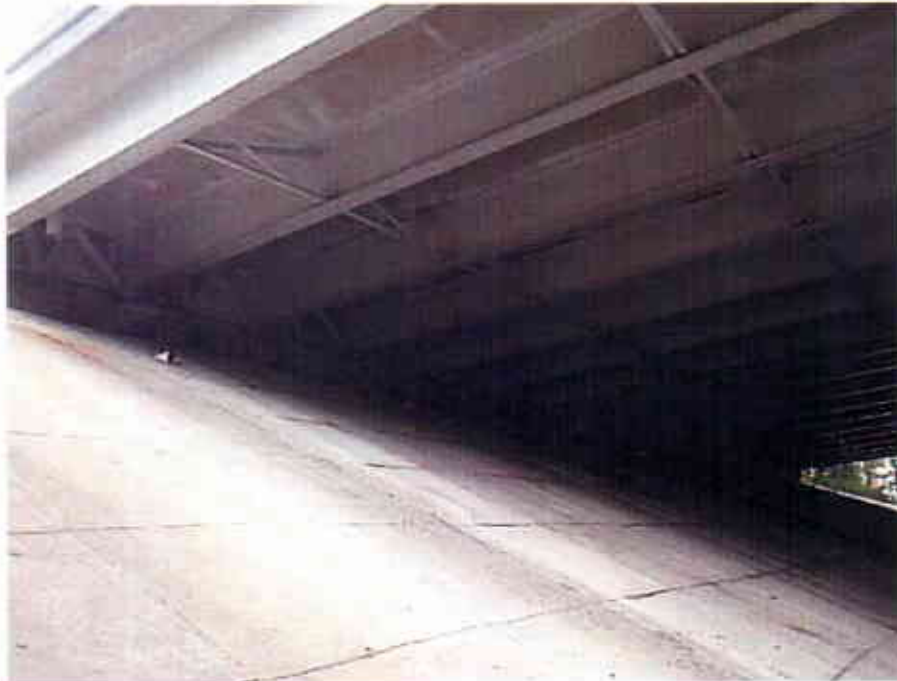
Photograph 44  
View Looking North at the Underside of the East and West Bound Lanes of the  
Interstate 90 Bridge over Starkweather Avenue (CUY-90-1490L)

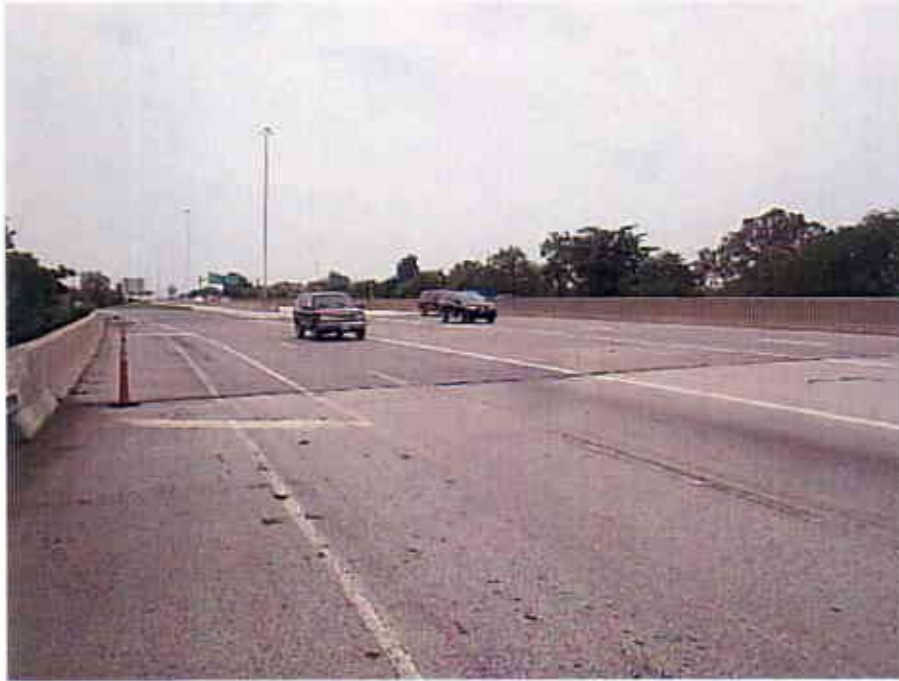
Photograph 45  
View Looking South at the Top of the East Bound Lanes of the  
Interstate 90 Bridge over Starkweather Avenue (CUY-90-1490R)

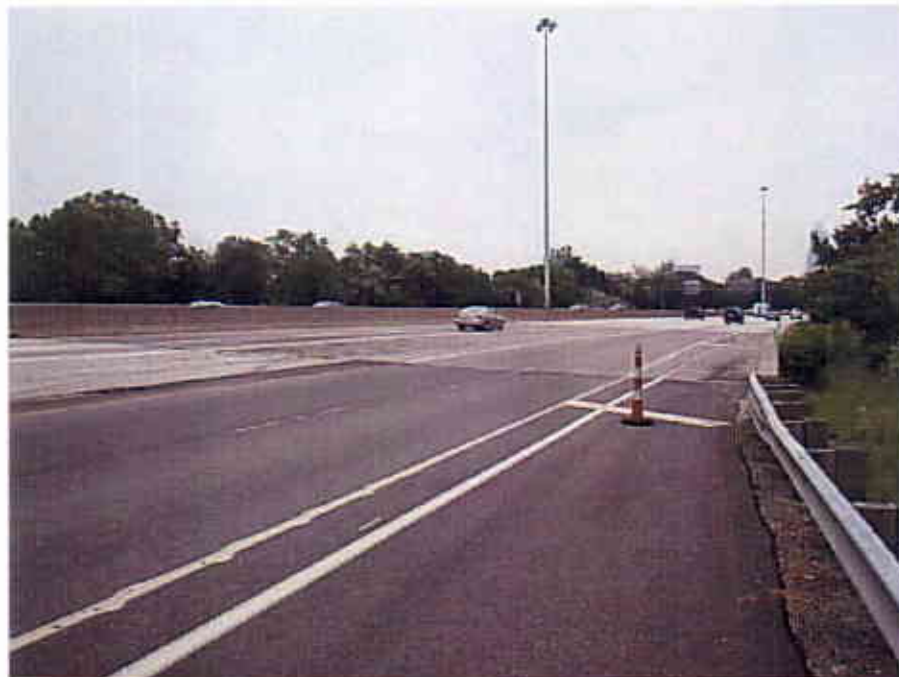
Photograph 46  
View Looking North at the Top of the East Bound Lanes of the  
Interstate 90 Bridge over Starkweather Avenue (CUY-90-1490R)

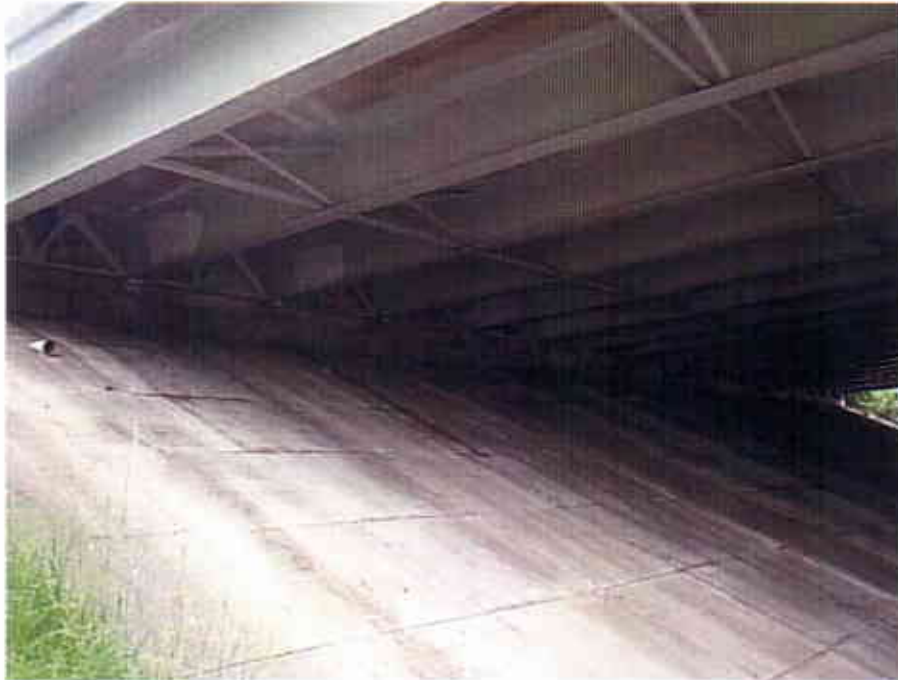
Photograph 47  
View Looking South at the Underside of the East and West Bound Lanes of the  
Interstate 90 Bridge over Starkweather Avenue (CUY-90-1490R)

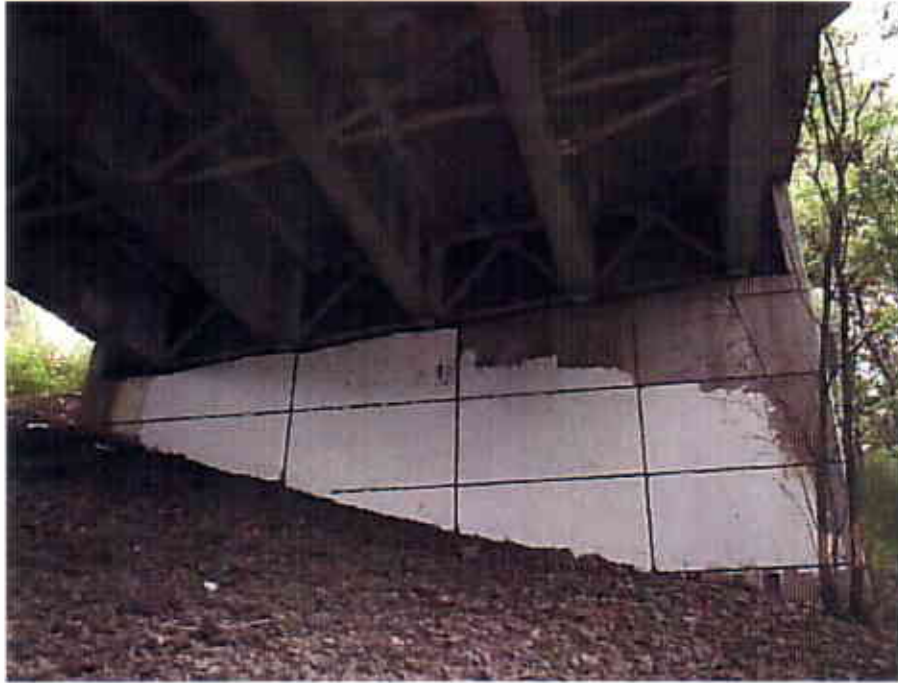
Photograph 49  
View Looking North at the Underside of the East Bound Lanes of the  
Interstate 90 Bridge Ramp WN under I-71 Mainline Bridge (CUY-90-1463R)

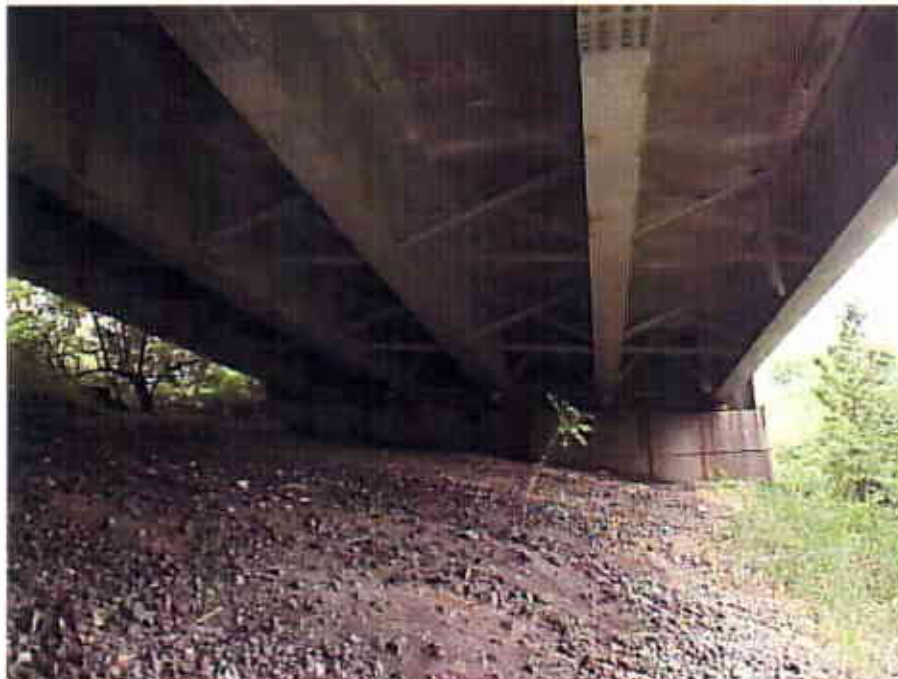
Photograph 50  
View Looking West at the Underside of the East Bound Lanes of the  
Interstate 90 Bridge Ramp WN under I-71 Mainline Bridge (CUY-90-1463R)
