**West Slope Stability Report
(Reference Document)**

**Innerbelt Bridge
Construction Contract Group 1 (CCG1)**

**SLOPE STABILITY
EVALUATION
REPORT**

Reference: CUY-90-14.92
Stability Evaluation of the Slope to the west of the Cuyahoga River

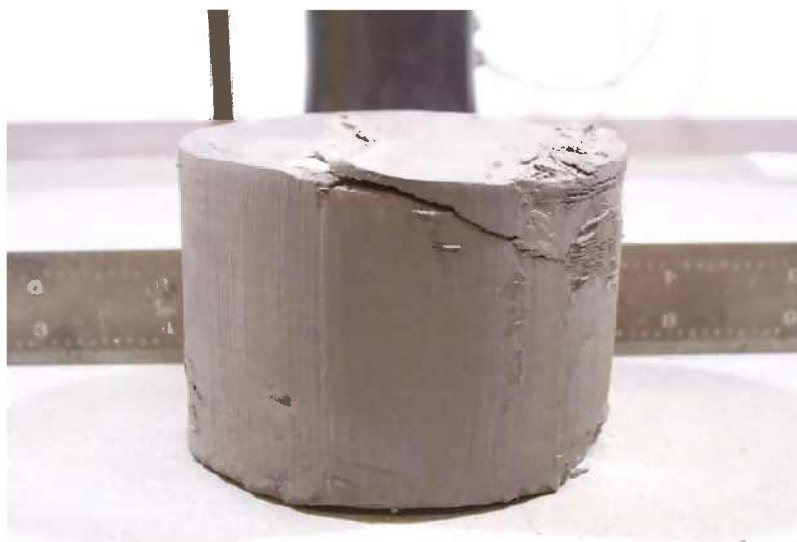
Client:	Geocomp Consulting
Project Name:	I-90 Central Viaduct
Project Location:	Cleveland, OH
GTX #:	6678
Test Date:	05/06/06
Tested By:	njh
Checked By:	jdt
Boring ID:	C-05-03
Sample ID:	S-30
Depth, ft:	118.5-120.3

Extruded sample showing in-situ shear plane. Side view.
Direct Simple Shear test, DSS-2 was trimmed from this piece.

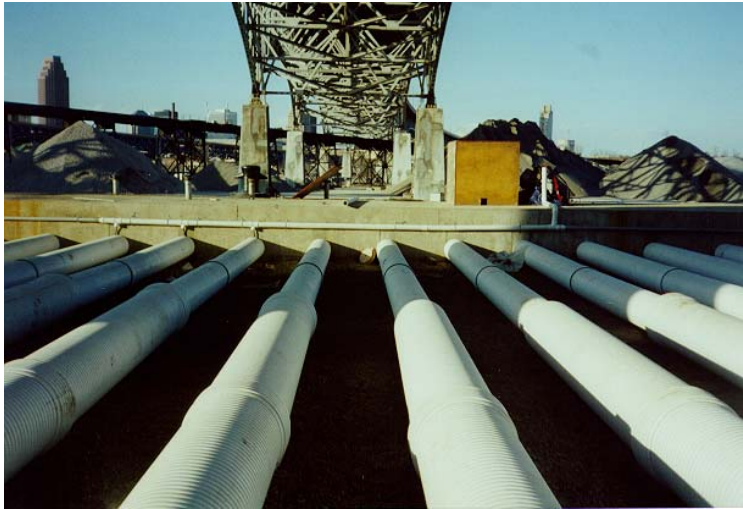
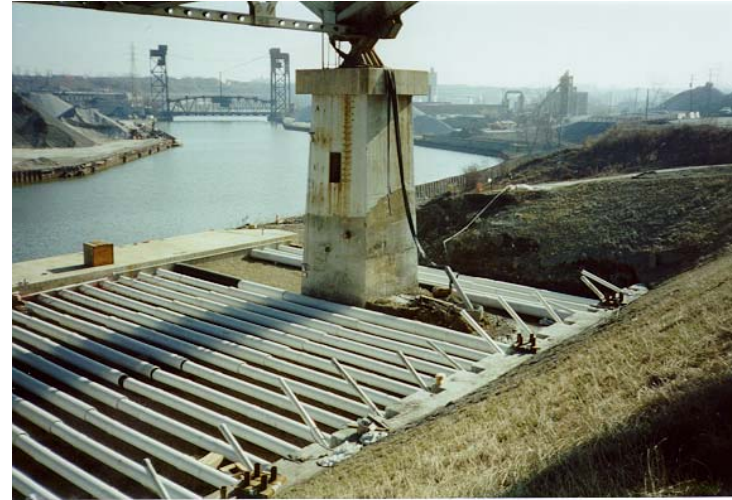
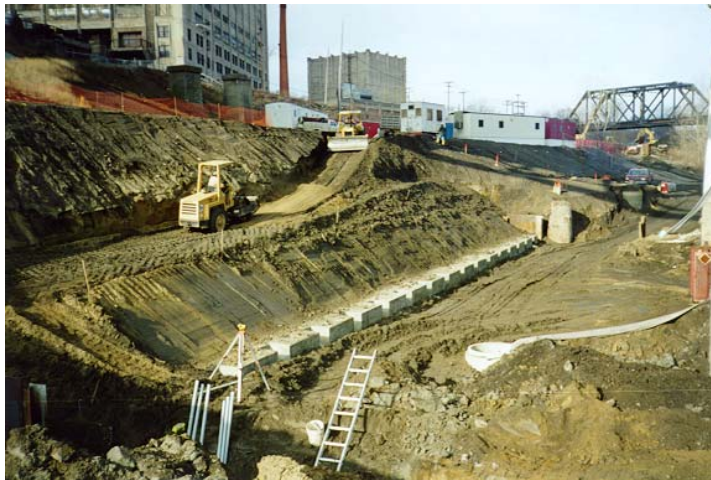
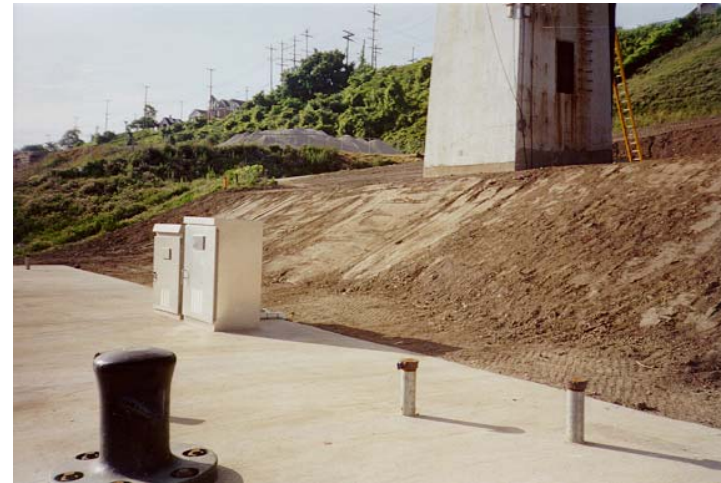
Figure 5.19 Photo showing the construction of the tie beams and the buildup of fill on top

Tie beam measurements are experiencing a steady state condition with no indication of any trend to vary with time except for slight stress changes which are most likely a result of changes in temperature. Note that there is a relatively high frictional resistance from the soil around and on top of the beams. The tie beams were insulated in a 24" diameter corrugated PVC, pipe which was filled with concrete after tensioning of the anchors. Due to the corrugated pipe and the concrete filling, the tie beams are acting as a composite 24" diameter corrugated section. The steel beam inside the section is not indicating any increase in stress in response to the movement of the caps. The force transmitted through the PVC composite sections has to overcome the friction of the surrounding soil. It appears that the drilled shaft cap and the pile cap are moving similar distances laterally, which allows the tie beams to remain in a constant state of stress. Pictures in Figure 5.19 show the construction of the tie beams and the placement of substantial embankment on top of the tie beams.

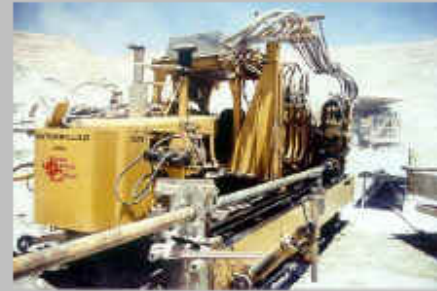
Custom Horizontal Drilling Machine, Designed and Built by Jensen Drilling Company

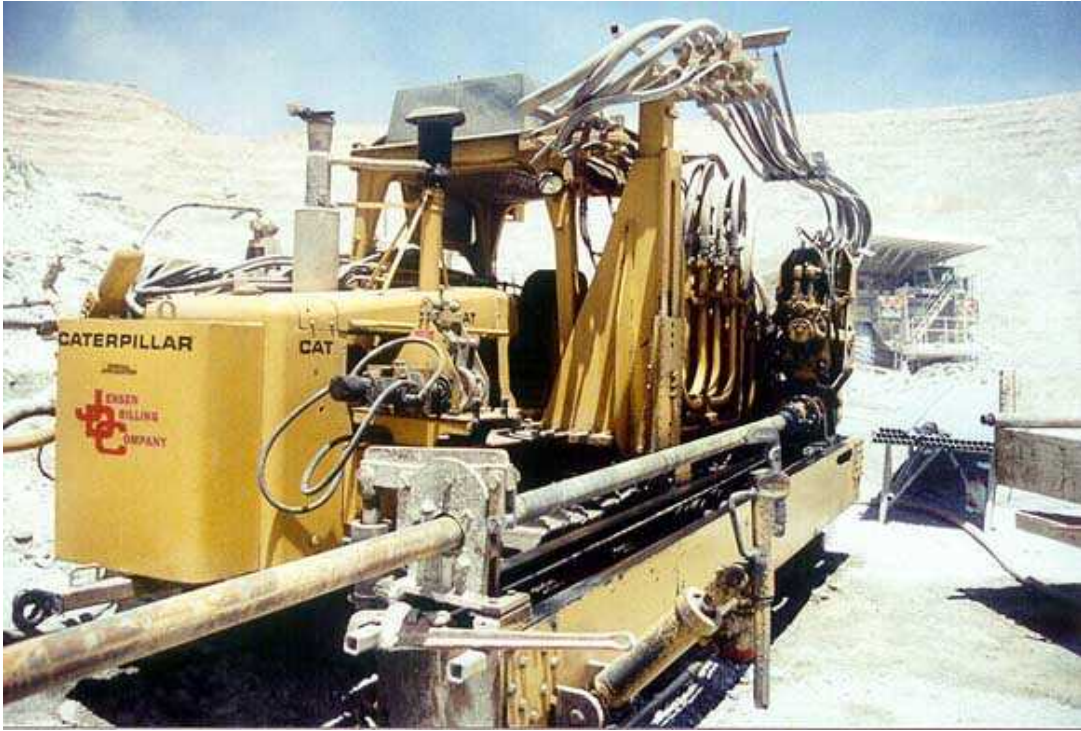
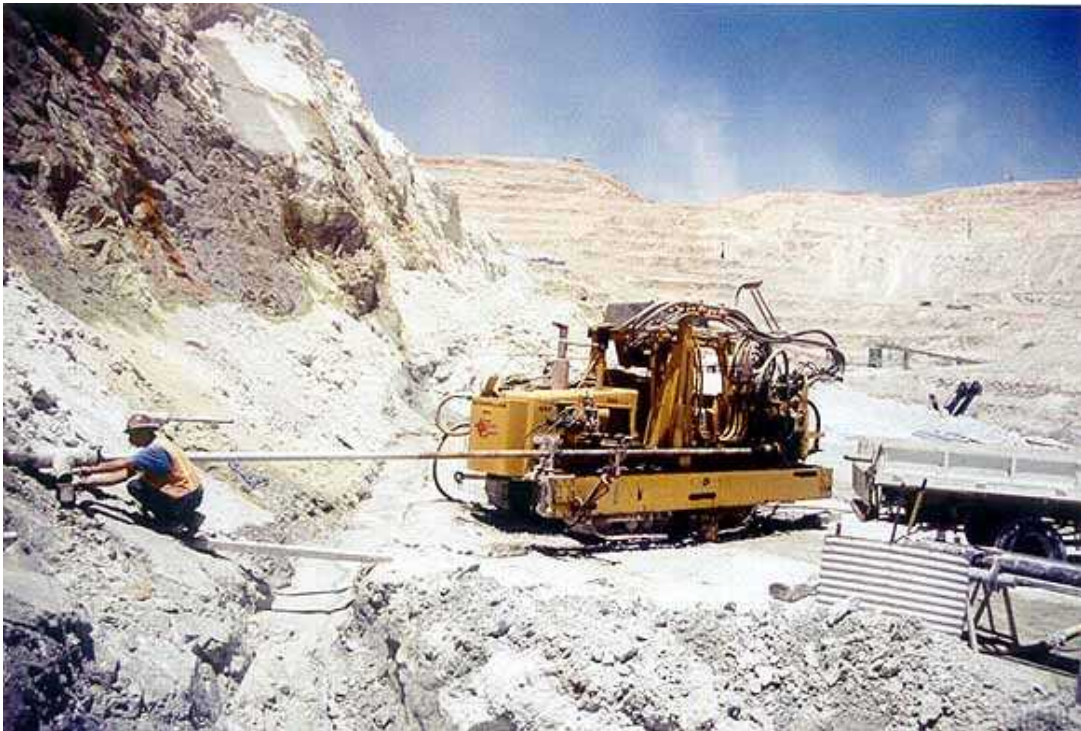
Figure 8.2: Pictures of horizontal drain installation equipment
