***ROCHE DE BOEUF BRIDGE COMMITTEE  
PHYSICAL CONDITION & PRESERVATION  
ALTERNATIVES REPORT***

**This Old Bridge, LLC  
Strongsville, Ohio**

**May 8, 2026**

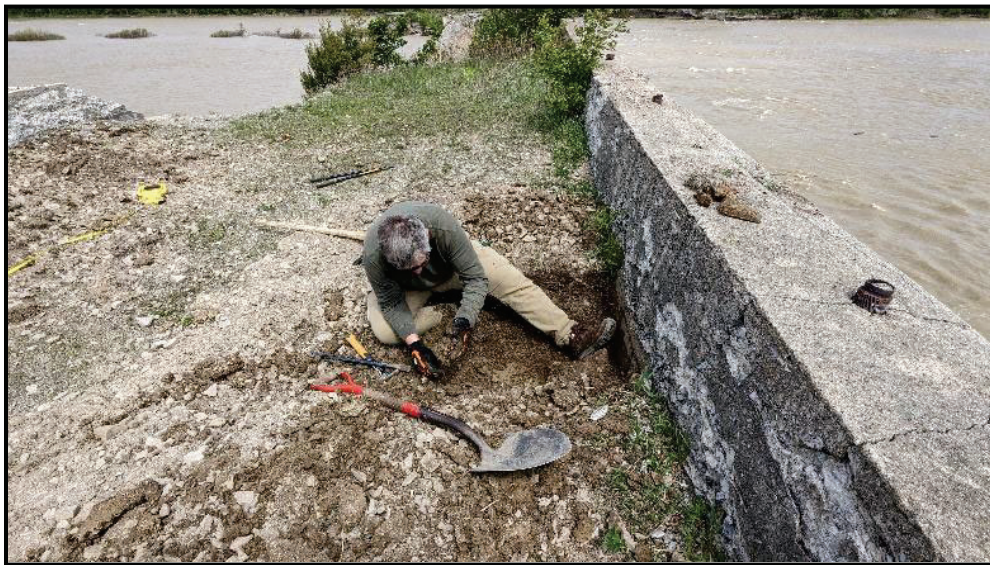
- May 3: Excavated fill to top of the Span 3 arch full width, and inspected the arch intrados for condition and workmanship. Performed a level survey verifying typical arch ring thickness and determined the heights of the spandrel walls and fill. Assisted TTL technician with Windsor probe test locations from the South Abutment to Span 3, Span 12 and the North Abutment.

Photo 1 – Excavation of Span 3 Arch Intrados, May 3, 2026.

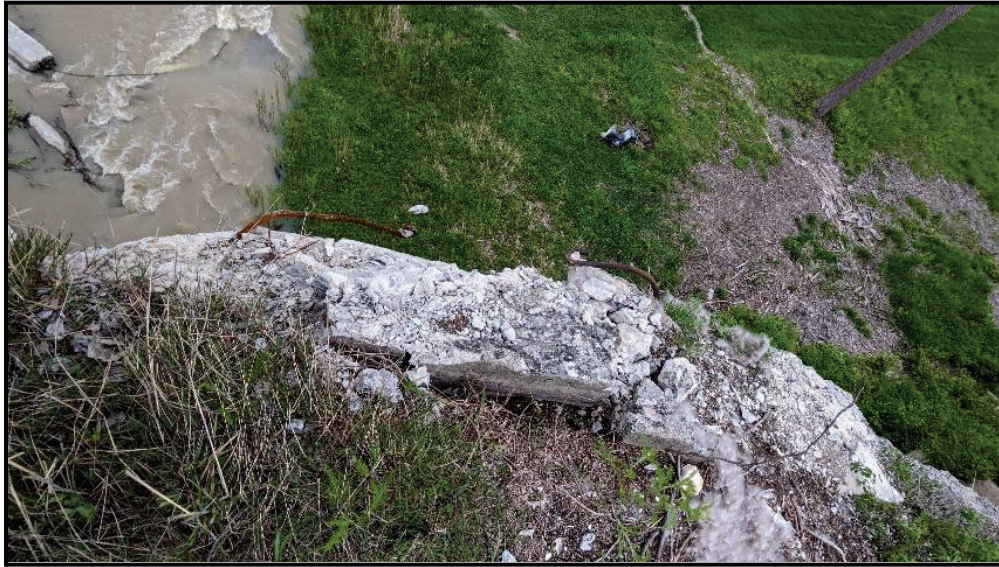
- Vertical reinforcement, commonly placed for flexural resistance of lateral forces of the earth fill, is present only along the exterior spandrel wall surface with 3-inch cover. These bars are spaced from 24 to 48 inches center-to-center (**Photos 2 & 3**).

**Photo 2 – Sparse Spandrel Wall Reinforcement, Span 2 East Spandrel Wall/**

The above observations add concern for the viability to retain the existing spandrel walls. If any spandrel walls are retained in order to maintain the property's standing within the National Register of Historic Places, consultation with the Ohio State Historic Preservation Office is recommended.
