ROCHE DE BOEUF BRIDGE COMMITTEE PHYSICAL CONDITION & PRESERVATION ALTERNATIVES REPORT

**This Old Bridge, LLC
Strongsville, Ohio**

**May 8, 2026
(Rev. May 30, 2026)**

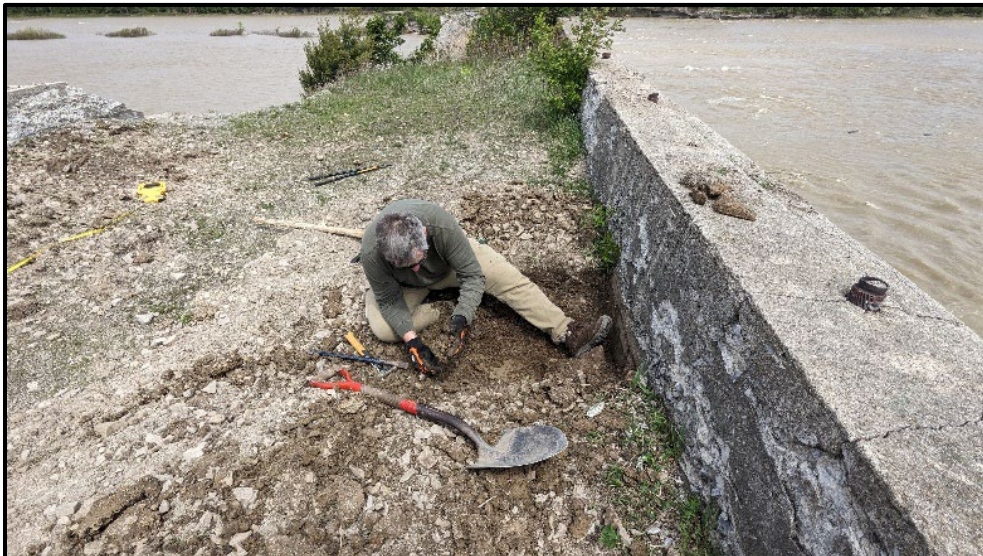
Photo 1 – Excavation of Span 3 Arch Intrados, May 3, 2026.

- May 3: Excavated fill to top of the Span 3 arch full width and inspected the arch intrados for condition and workmanship. Performed a level survey verifying typical arch ring thickness and determined the heights of the spandrel walls and fill. Assisted TTL technician with Windsor probe test locations from the South Abutment to Span 3, Span 12 and the North Abutment.

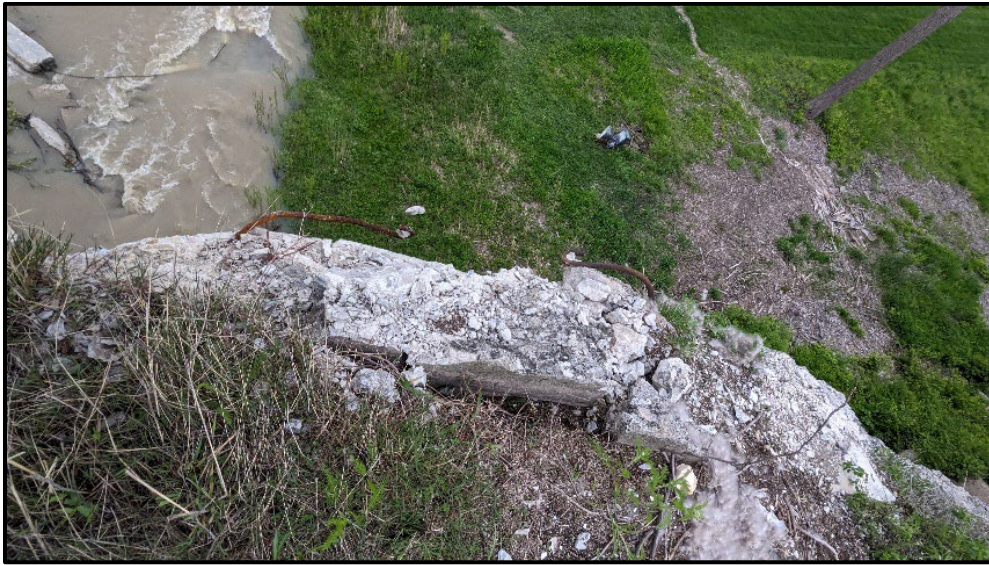
Photo 2 – Sparse Spandrel Wall Reinforcement, Span 2 East Spandrel Wall/

- Vertical reinforcement, commonly placed for flexural resistance of lateral forces of the earth fill, is present only along the exterior spandrel wall surface with 3-inch cover. These bars are spaced from 24 to 48 inches center-to-center (**Photos 2 & 3**).

- With no vertical reinforcement along the interior wall surface, little flexural strength is provided.
- Within the edge of the remaining exposed fill, it appears that Luten may have provided lateral reinforced tied encased in concrete between paired spandrel walls. If this is indeed the intent of these laterals, they have become ineffective.

The above observations add concern for the viability to retain the existing spandrel walls. If any spandrel walls are retained in order to maintain the property's standing within the National Register of Historic Places, consultation with the Ohio State Historic Preservation Office is recommended.

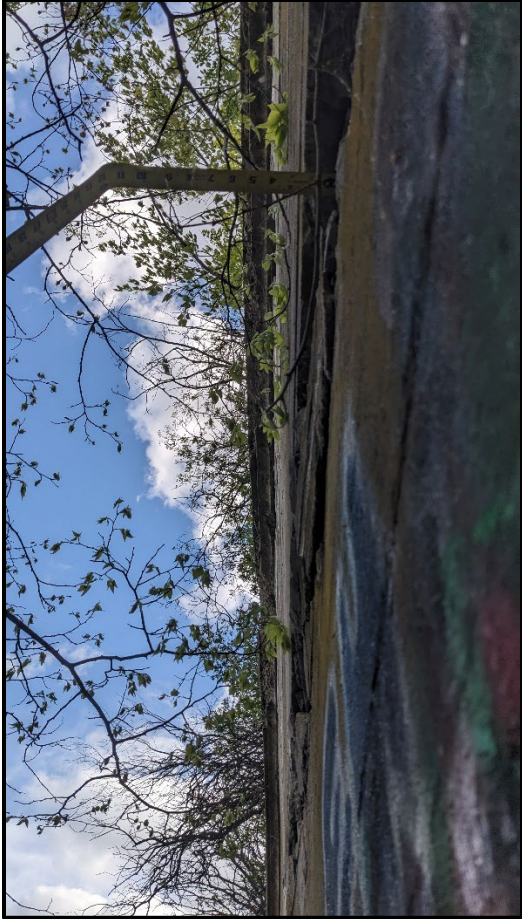
Photo 4 – East Spandrel Wall Movement 1.5 inches above Longitudinal Crack, Span 12.

- In the northern halves of the Span 12 spandrel walls, both walls exhibit longitudinal cracks above the arch barrel. The east spandrel wall has shifted outward approximately 1.5 inches (**Photo 3 & 4**).

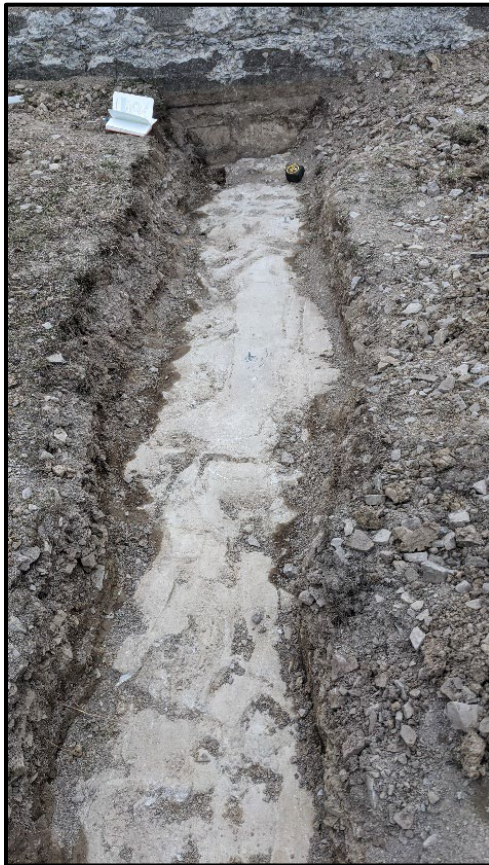
Photo 6 – Arch Extrados Exposed, Span 3.

The excavated extrados of the Span 3 arch is in good condition with no deficiencies (**Photos 6 & 7**). The surface observed was at the center of the arch where laborers placed the last portions of fresh concrete in 1907 and trowel-finished the surface to a smooth but uneven surface. The level survey performed confirmed that the arch is a minimum 24 inches thick per Daniel Lutens's writings. The arch intrados below this section exhibits longitudinal efflorescence which has been described as being non-corrosive calcium hydroxide (quick lime) leaching from the cement paste (**Photo 8**).

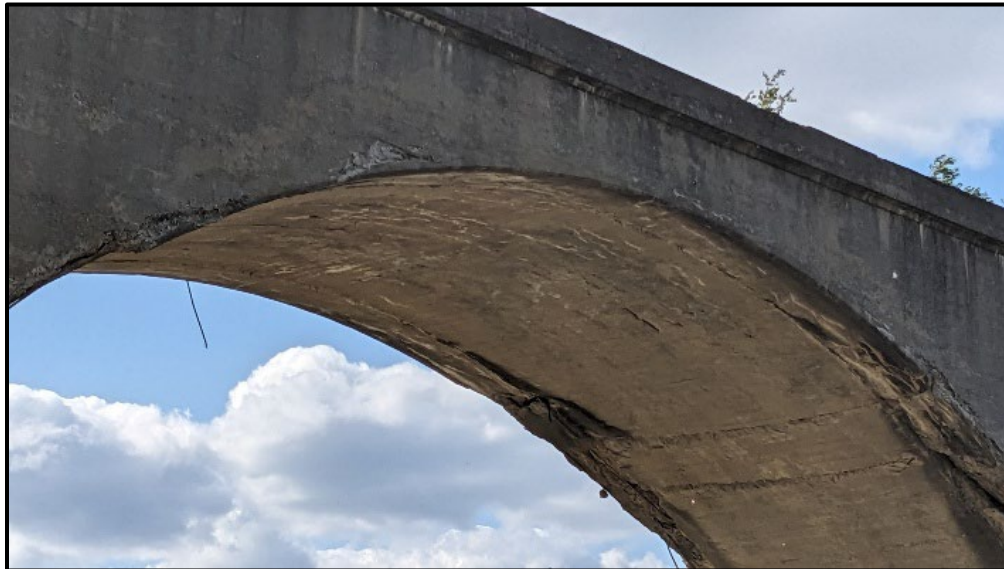
Photo 8 – Longitudinal Cracking with Calcium Hydroxide Efflorescence and Construction Joint Infiltration, Span 3.

Throughout all 12 spans, observation of water staining and spalling of the arch intrados and bottom of spandrel walls suggest that rain water passing through the fill above generally follows the path of least resistance, which likely is the vertical arch barrel-spandrel wall construction joint and through the hidden longitudinal cracks in the spandrel wall above the arch barrels (**See Photo 8**). Thus, it is anticipated that when uncovered, the tops of all arch barrels will show little, if any, deterioration.

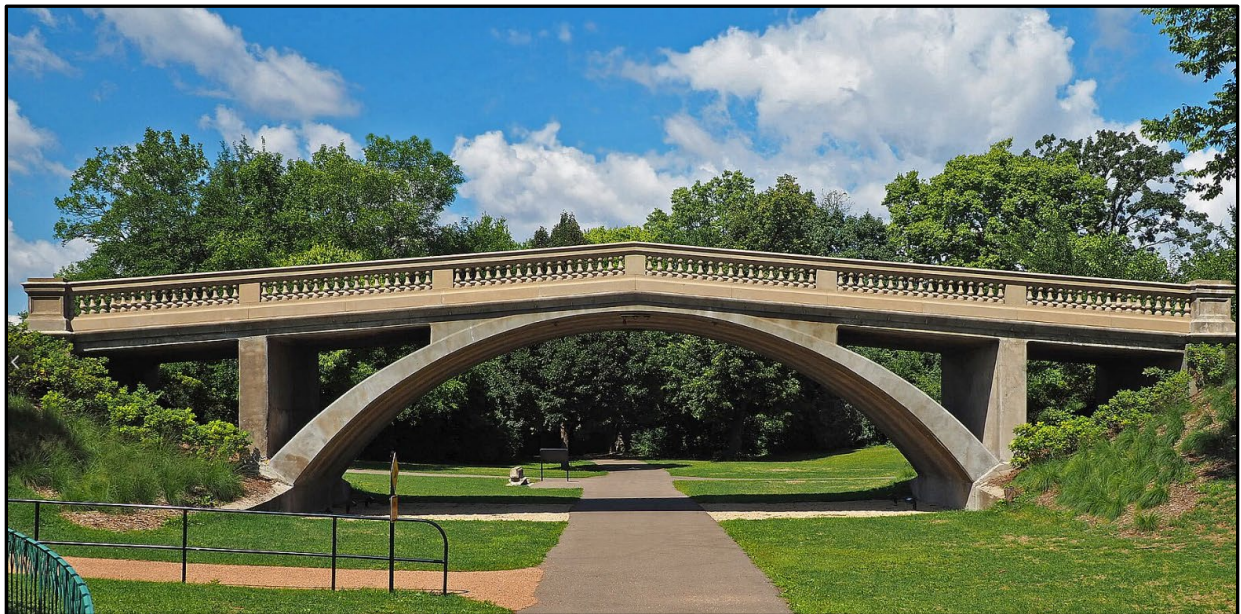
Photo 1 – Restored Interurban Bridge, Como Park, June 2024.

The Interurban Bridge is a three-span reinforced concrete bridge featuring a Milan arch main span (Photo 1). By the 2000s the bridge was in serious condition and closed to pedestrian traffic both on and below. Lacking rehabilitation funds, the initial preservation plan for the structure was to remove deteriorated concrete and to maintain the structure as an abandoned artifact. Eventually rehabilitation funds were secured, and the structure was fully rehabilitated by 2020.

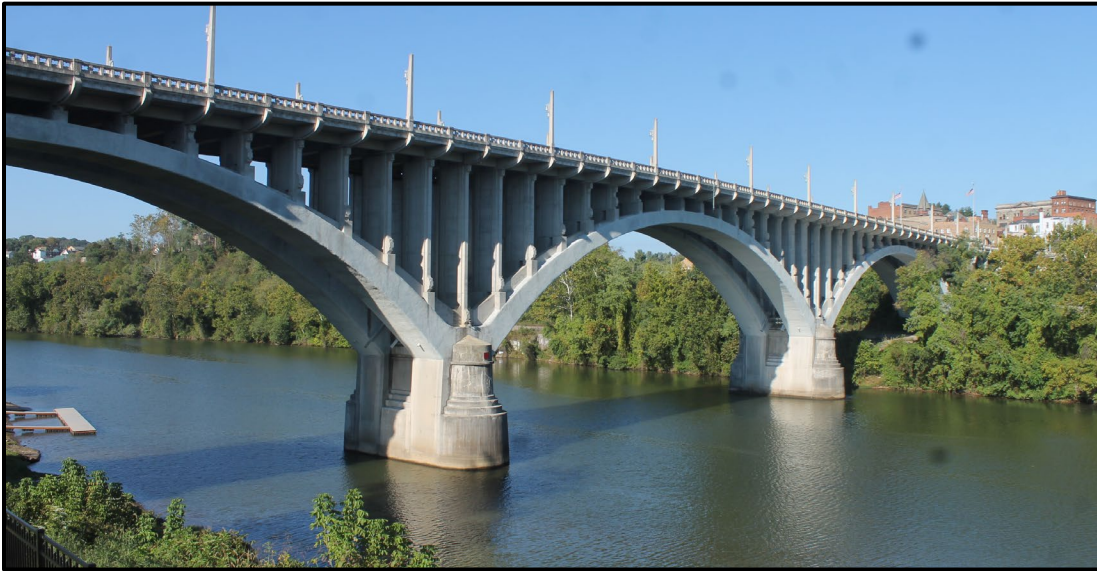
Photo 9 – Restored Jefferson Street Bridge, October 2016.

Opened in 1921, the Jefferson Street Bridge over the Monongahela River in Fairmont, West Virginia, has been a notable landmark in its region.³ Following advanced deterioration, a major rehabilitation was performed to save the bridge in the late 1990s. This project included demolition of all concrete down to the tops of the arch ribs with near exact replication of these components (**Photo 9**). The arch ribs were “bulked up” with a concrete surface layer encapsulating a titanium mesh for cathodic protection.⁴ This bridge has remained on the National Register of Historic Places.
