Re: September 26, 2013 Readings
CUY-90-15.24 Slope Monitoring
PID 76117
EDP Project No. 062943.00

The September monthly instrument readings for the I-90 west slope are presented in this report.

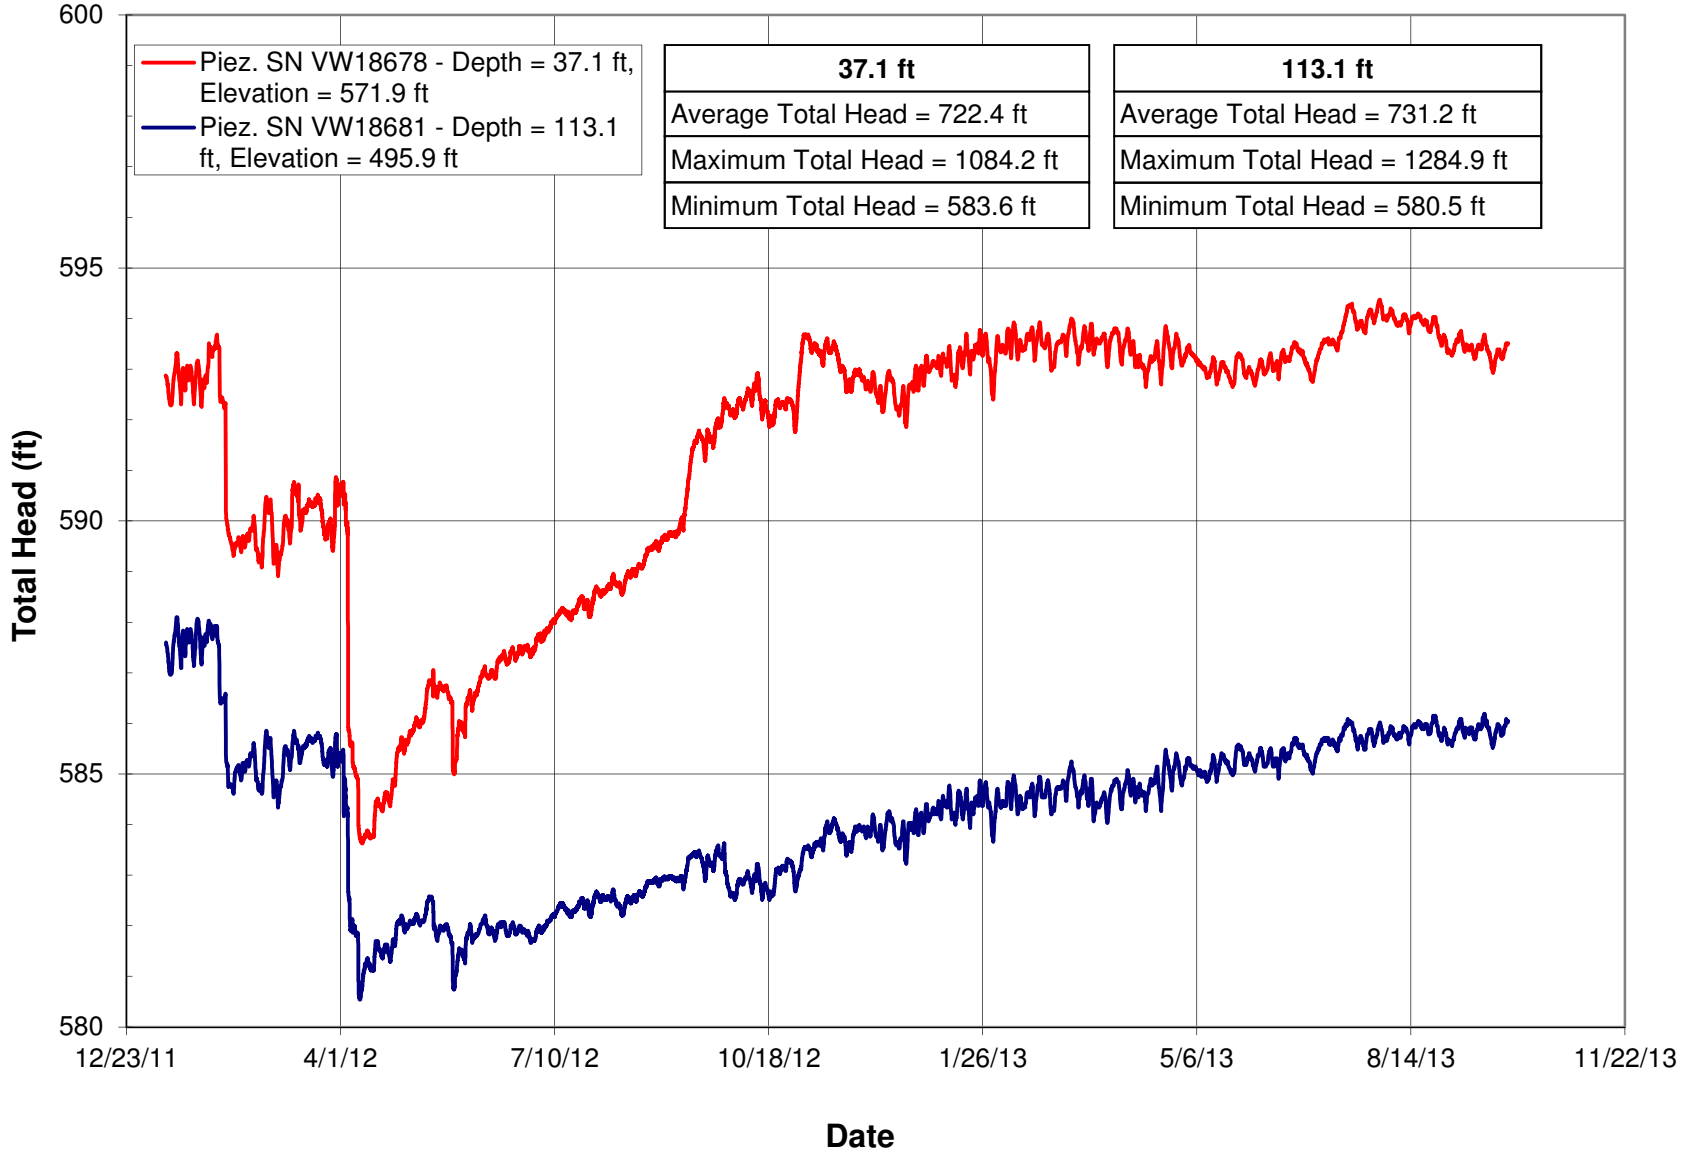
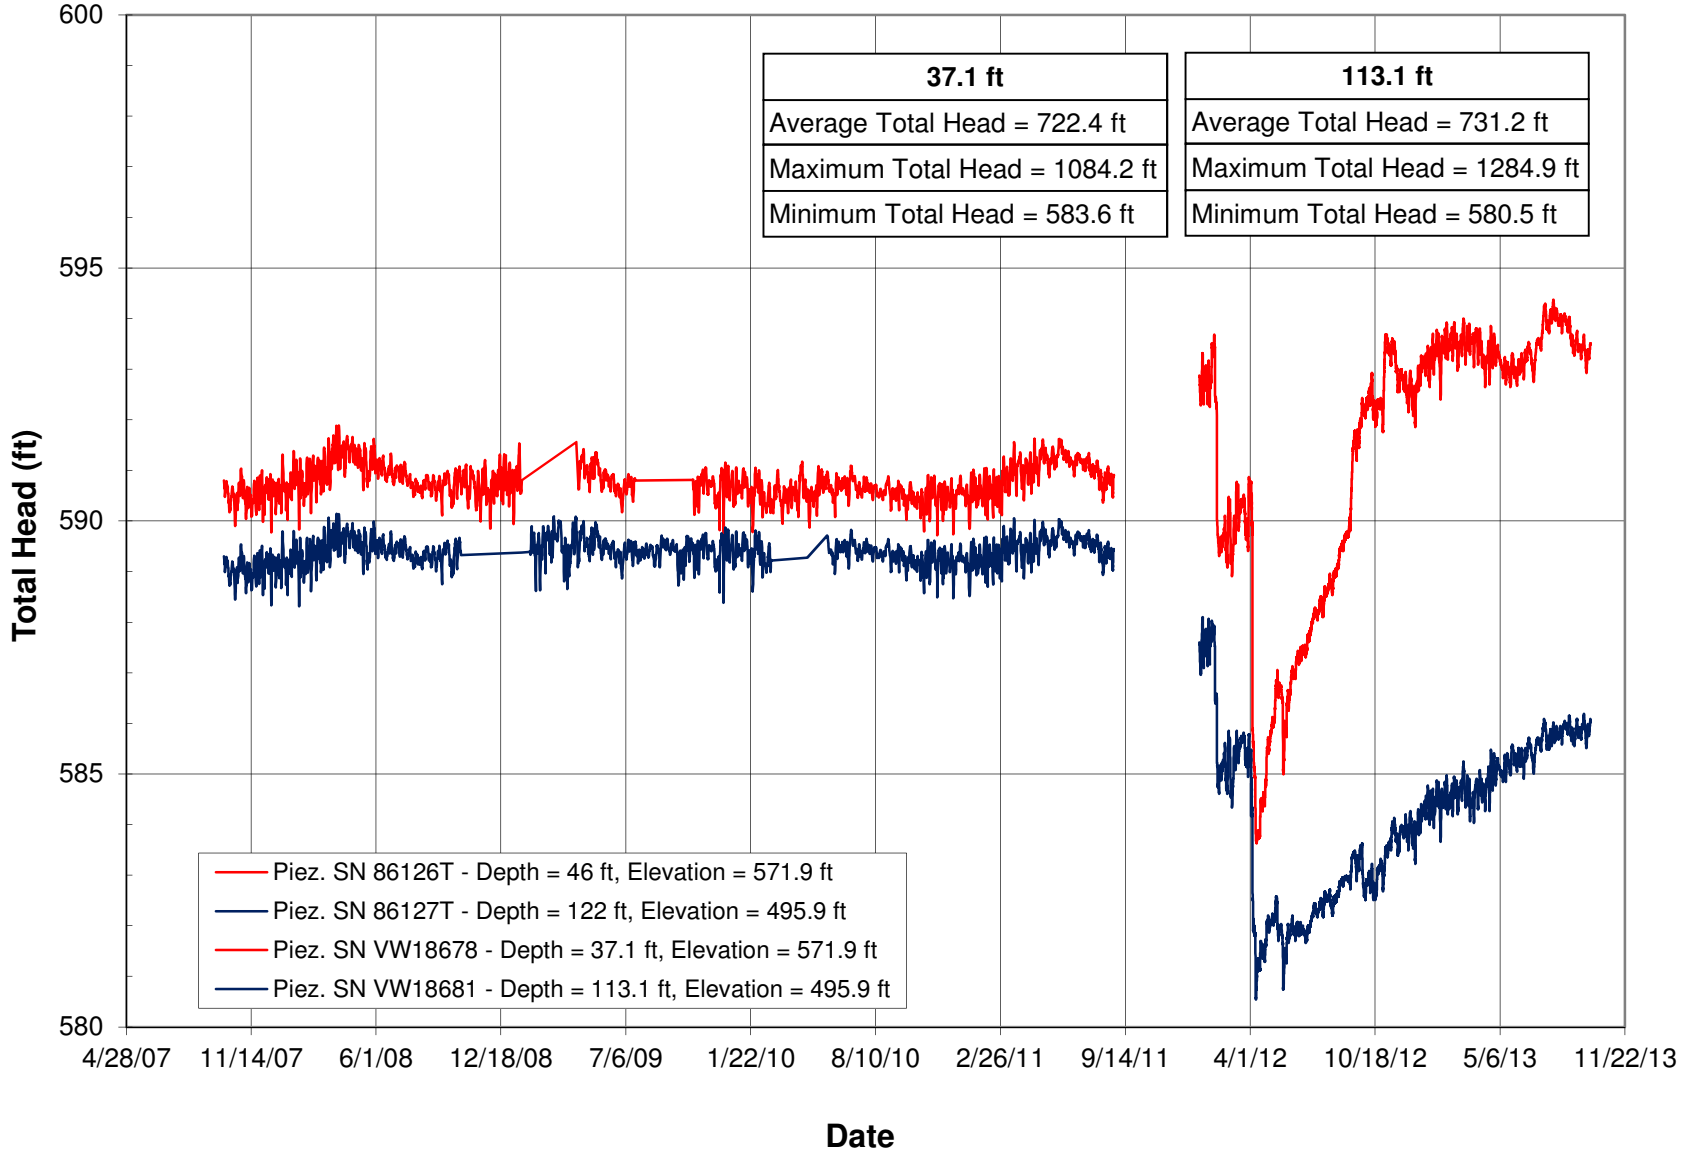
B-05-02 VW Piezometer Readings

Piezometer Readings at B-05-02
Total head in the shallow piezometer at B-05-02 decreased about 0.5 foot this month. There was virtually no change in total head in the deep piezometer for the month. Total head in the deep piezometer had been increasing, but at least for this month, it appears to have reached equilibrium. As in the past, we have included graphs showing pore pressures since the original piezometers were installed in 2007, and since readings started on the replacement piezometers in January 2012.

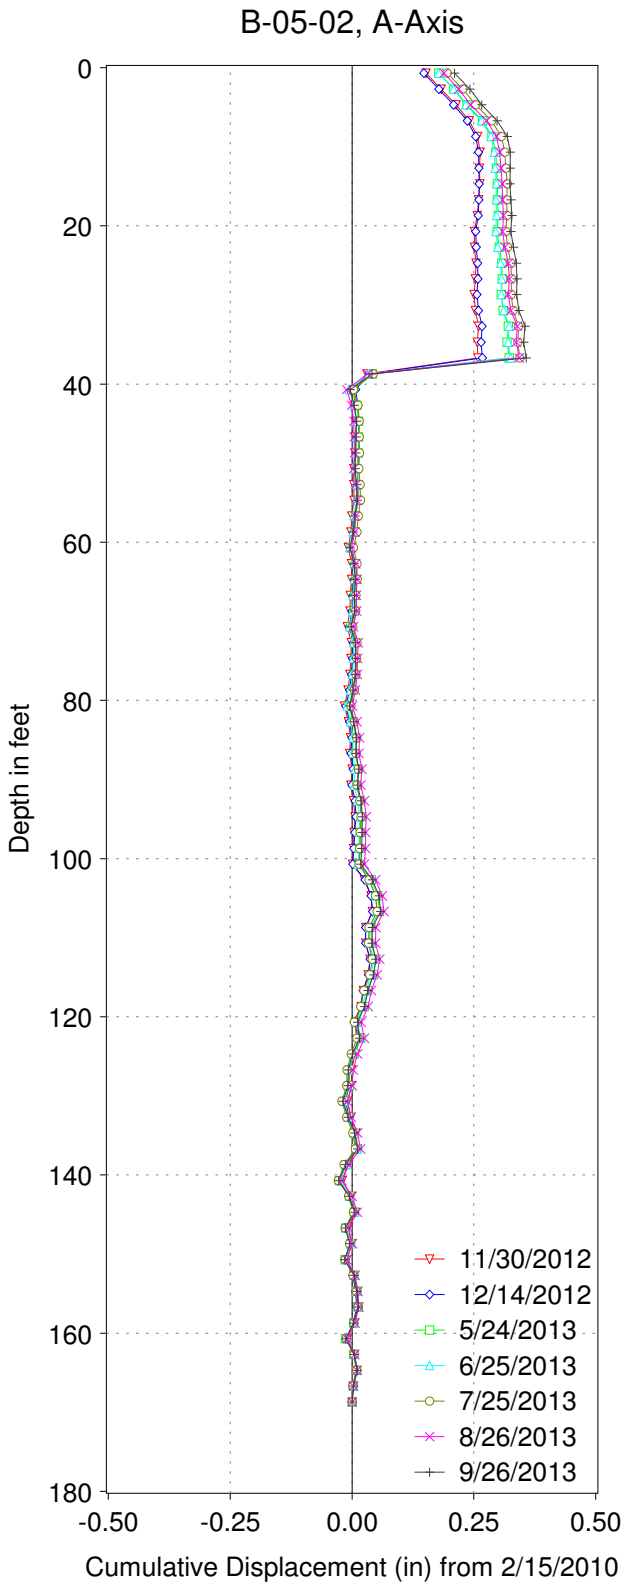
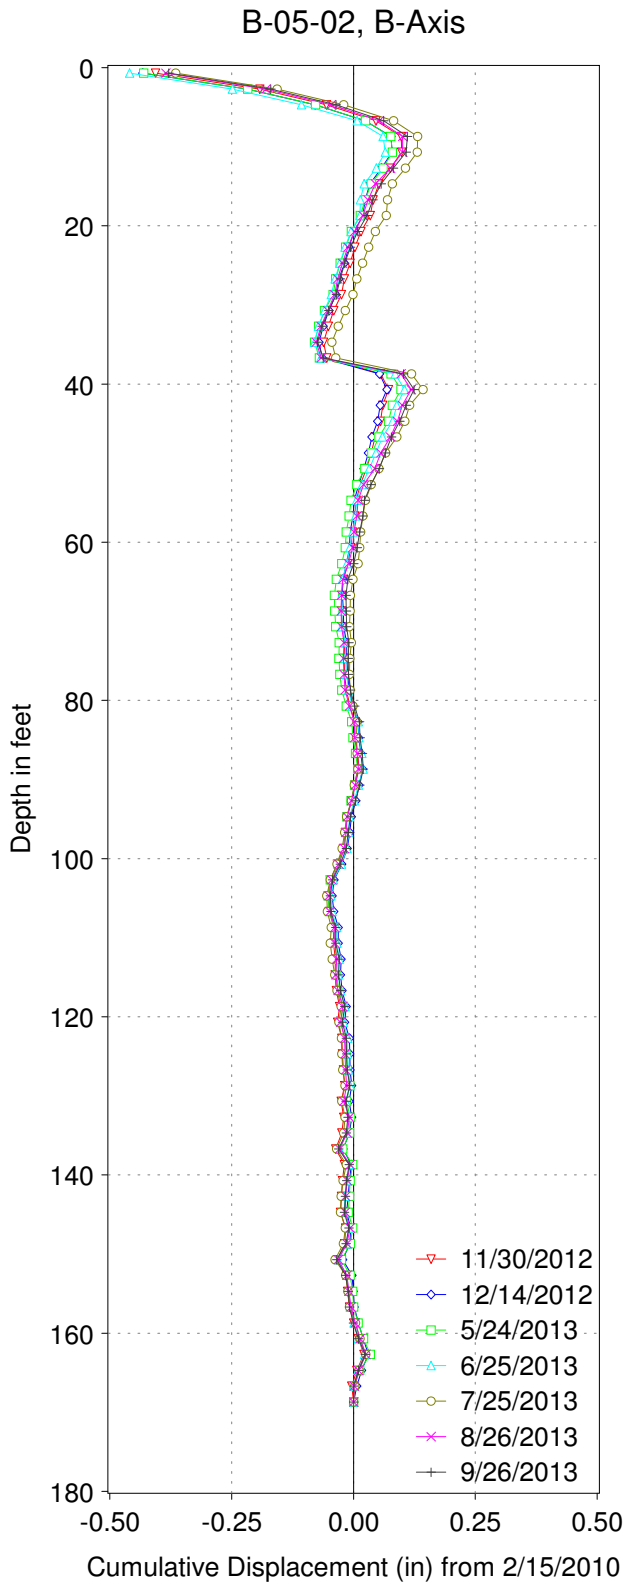
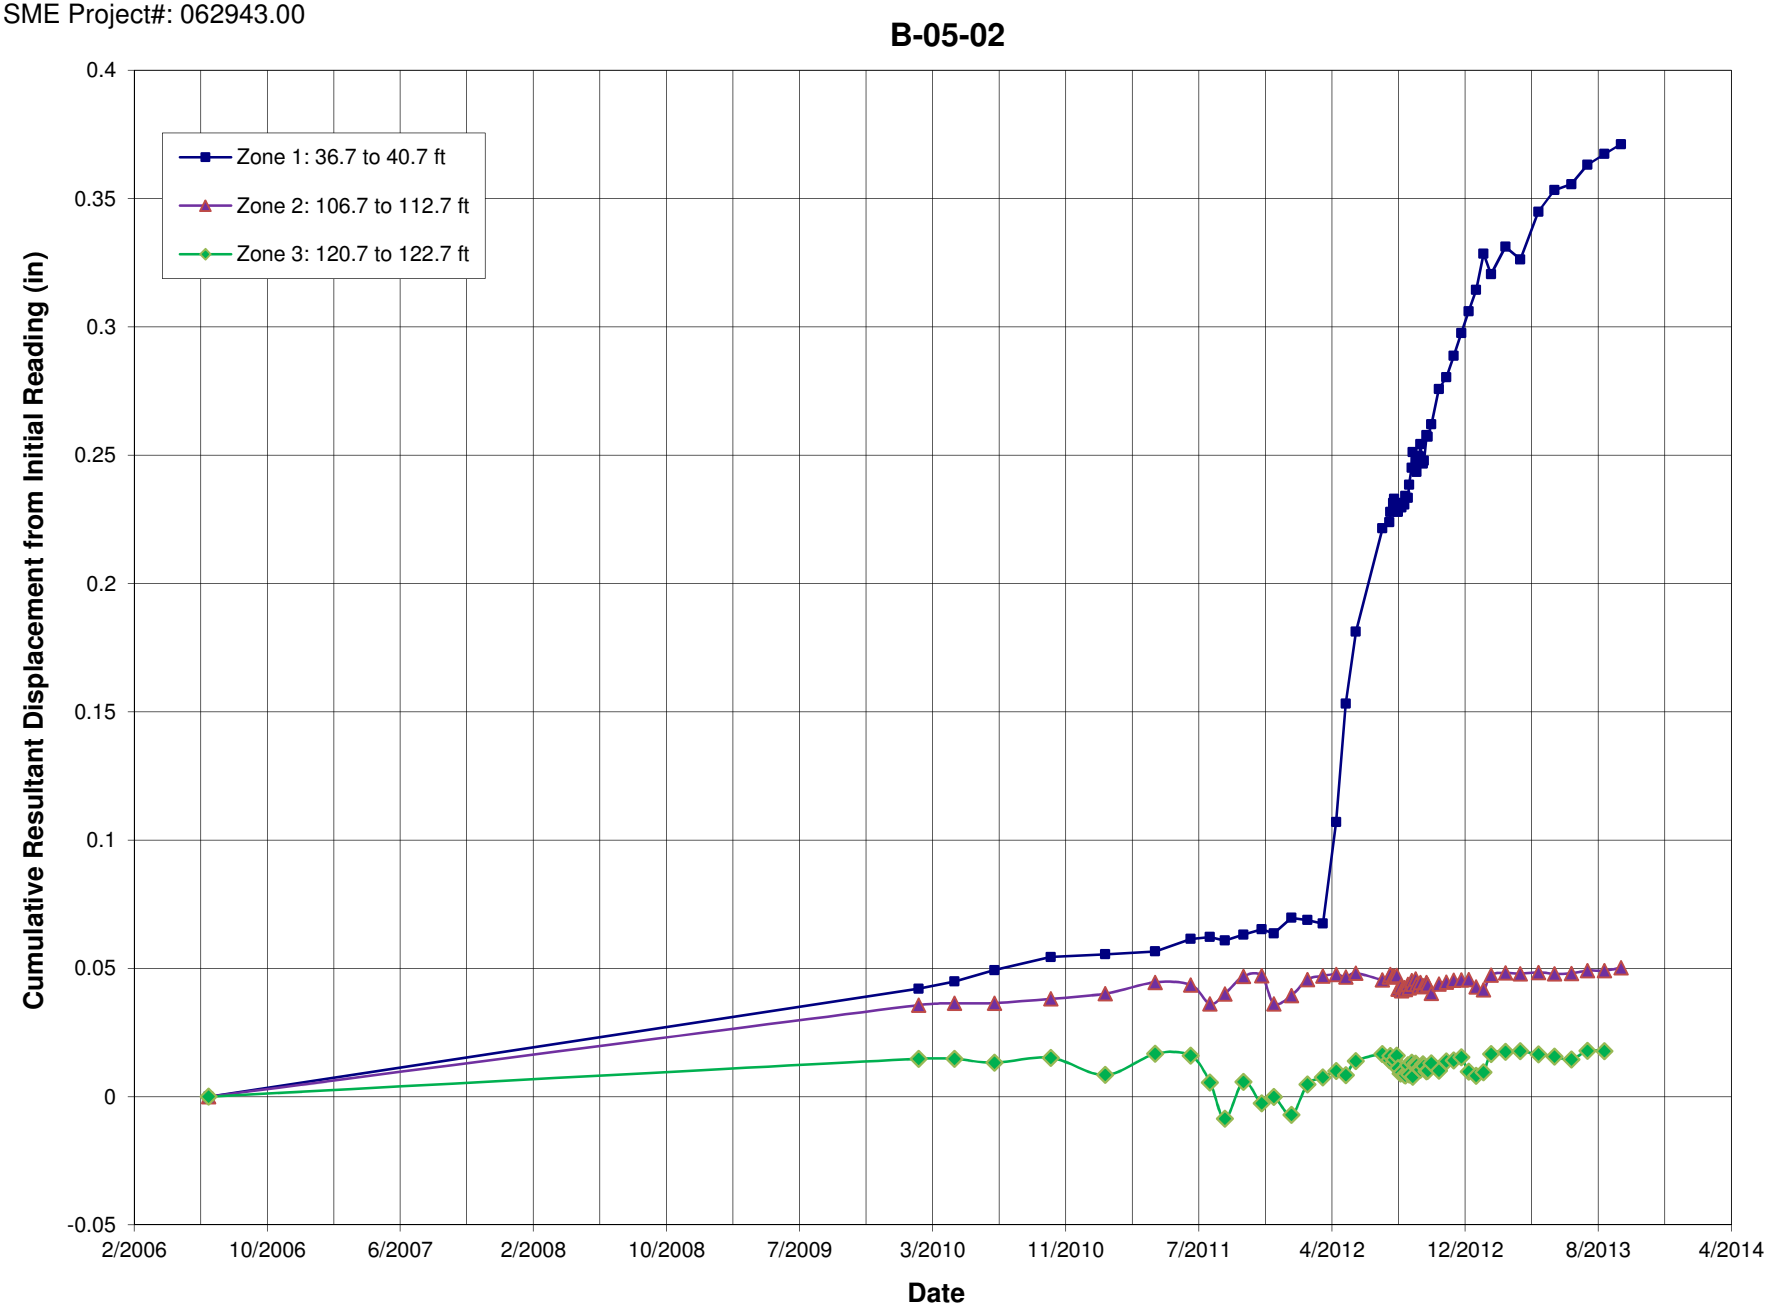
CUY-90-14.92
PID 76117
SME Project#: 062943.00
Reading Date: 9/26/2013

Inclinometer Readings at I-010 and B-05-02
A-axis displacement at 36 to 38 feet continued to increase this month at B-05-02. From the zone plot it appears that the rate of increase is continuing to slow in this shallow zone. Zone plots for the two deeper zones indicate no change.

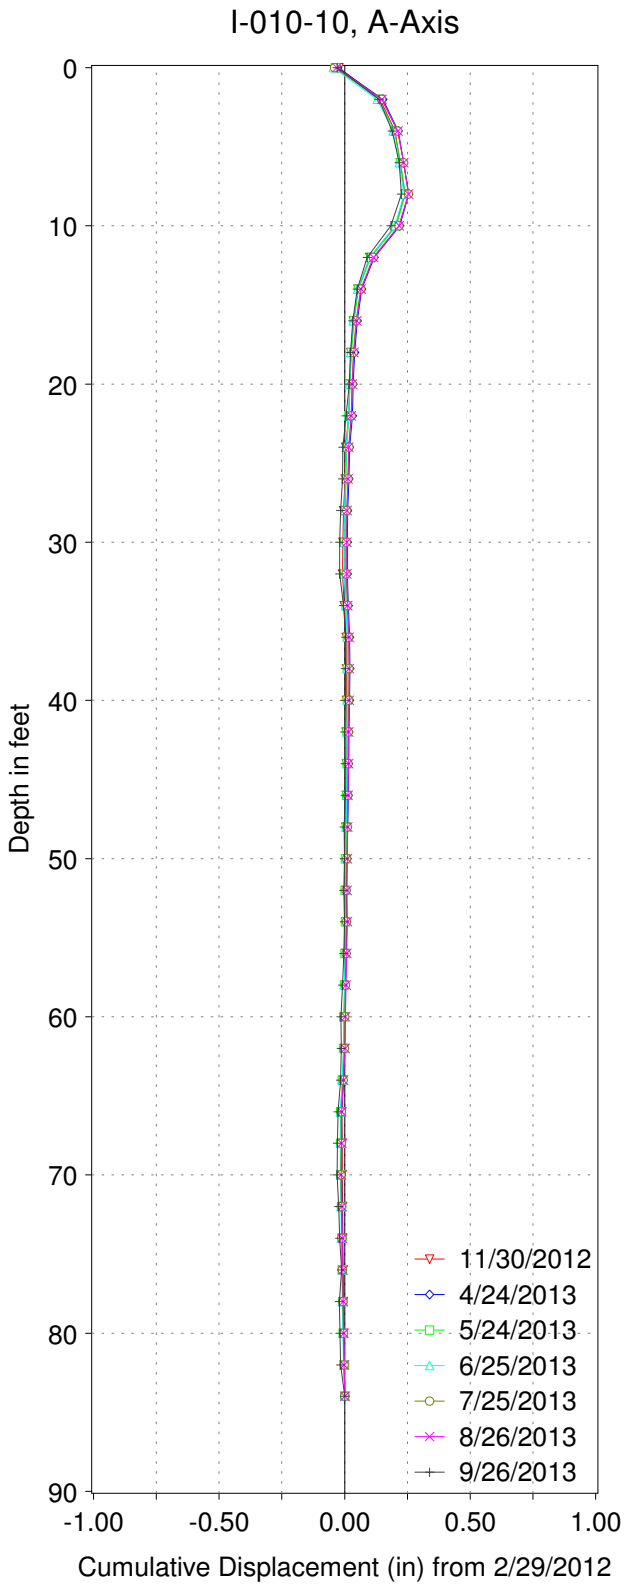
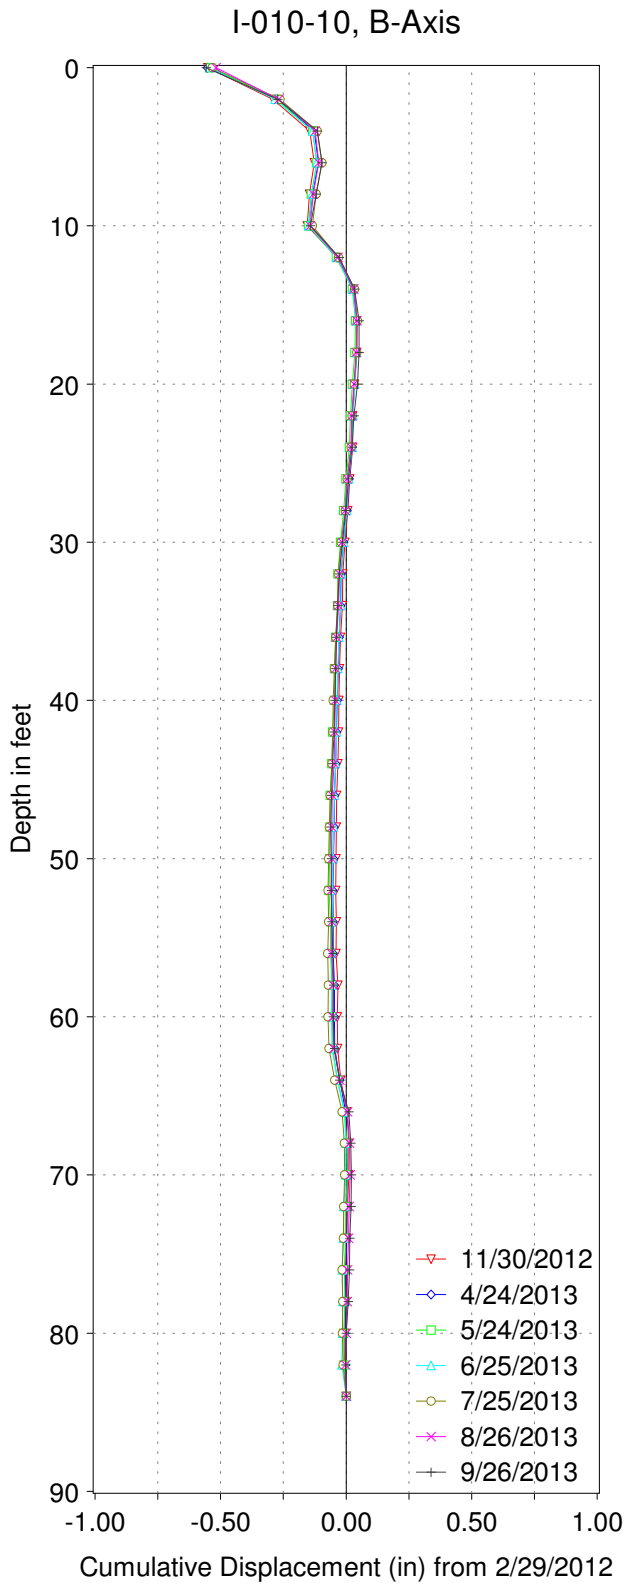
CUY-90-15.24
PID 76117
SME Project# 062943.00
Reading Date: 9/26/2013

Inclinometer readings at I-010 show no change again this month.
