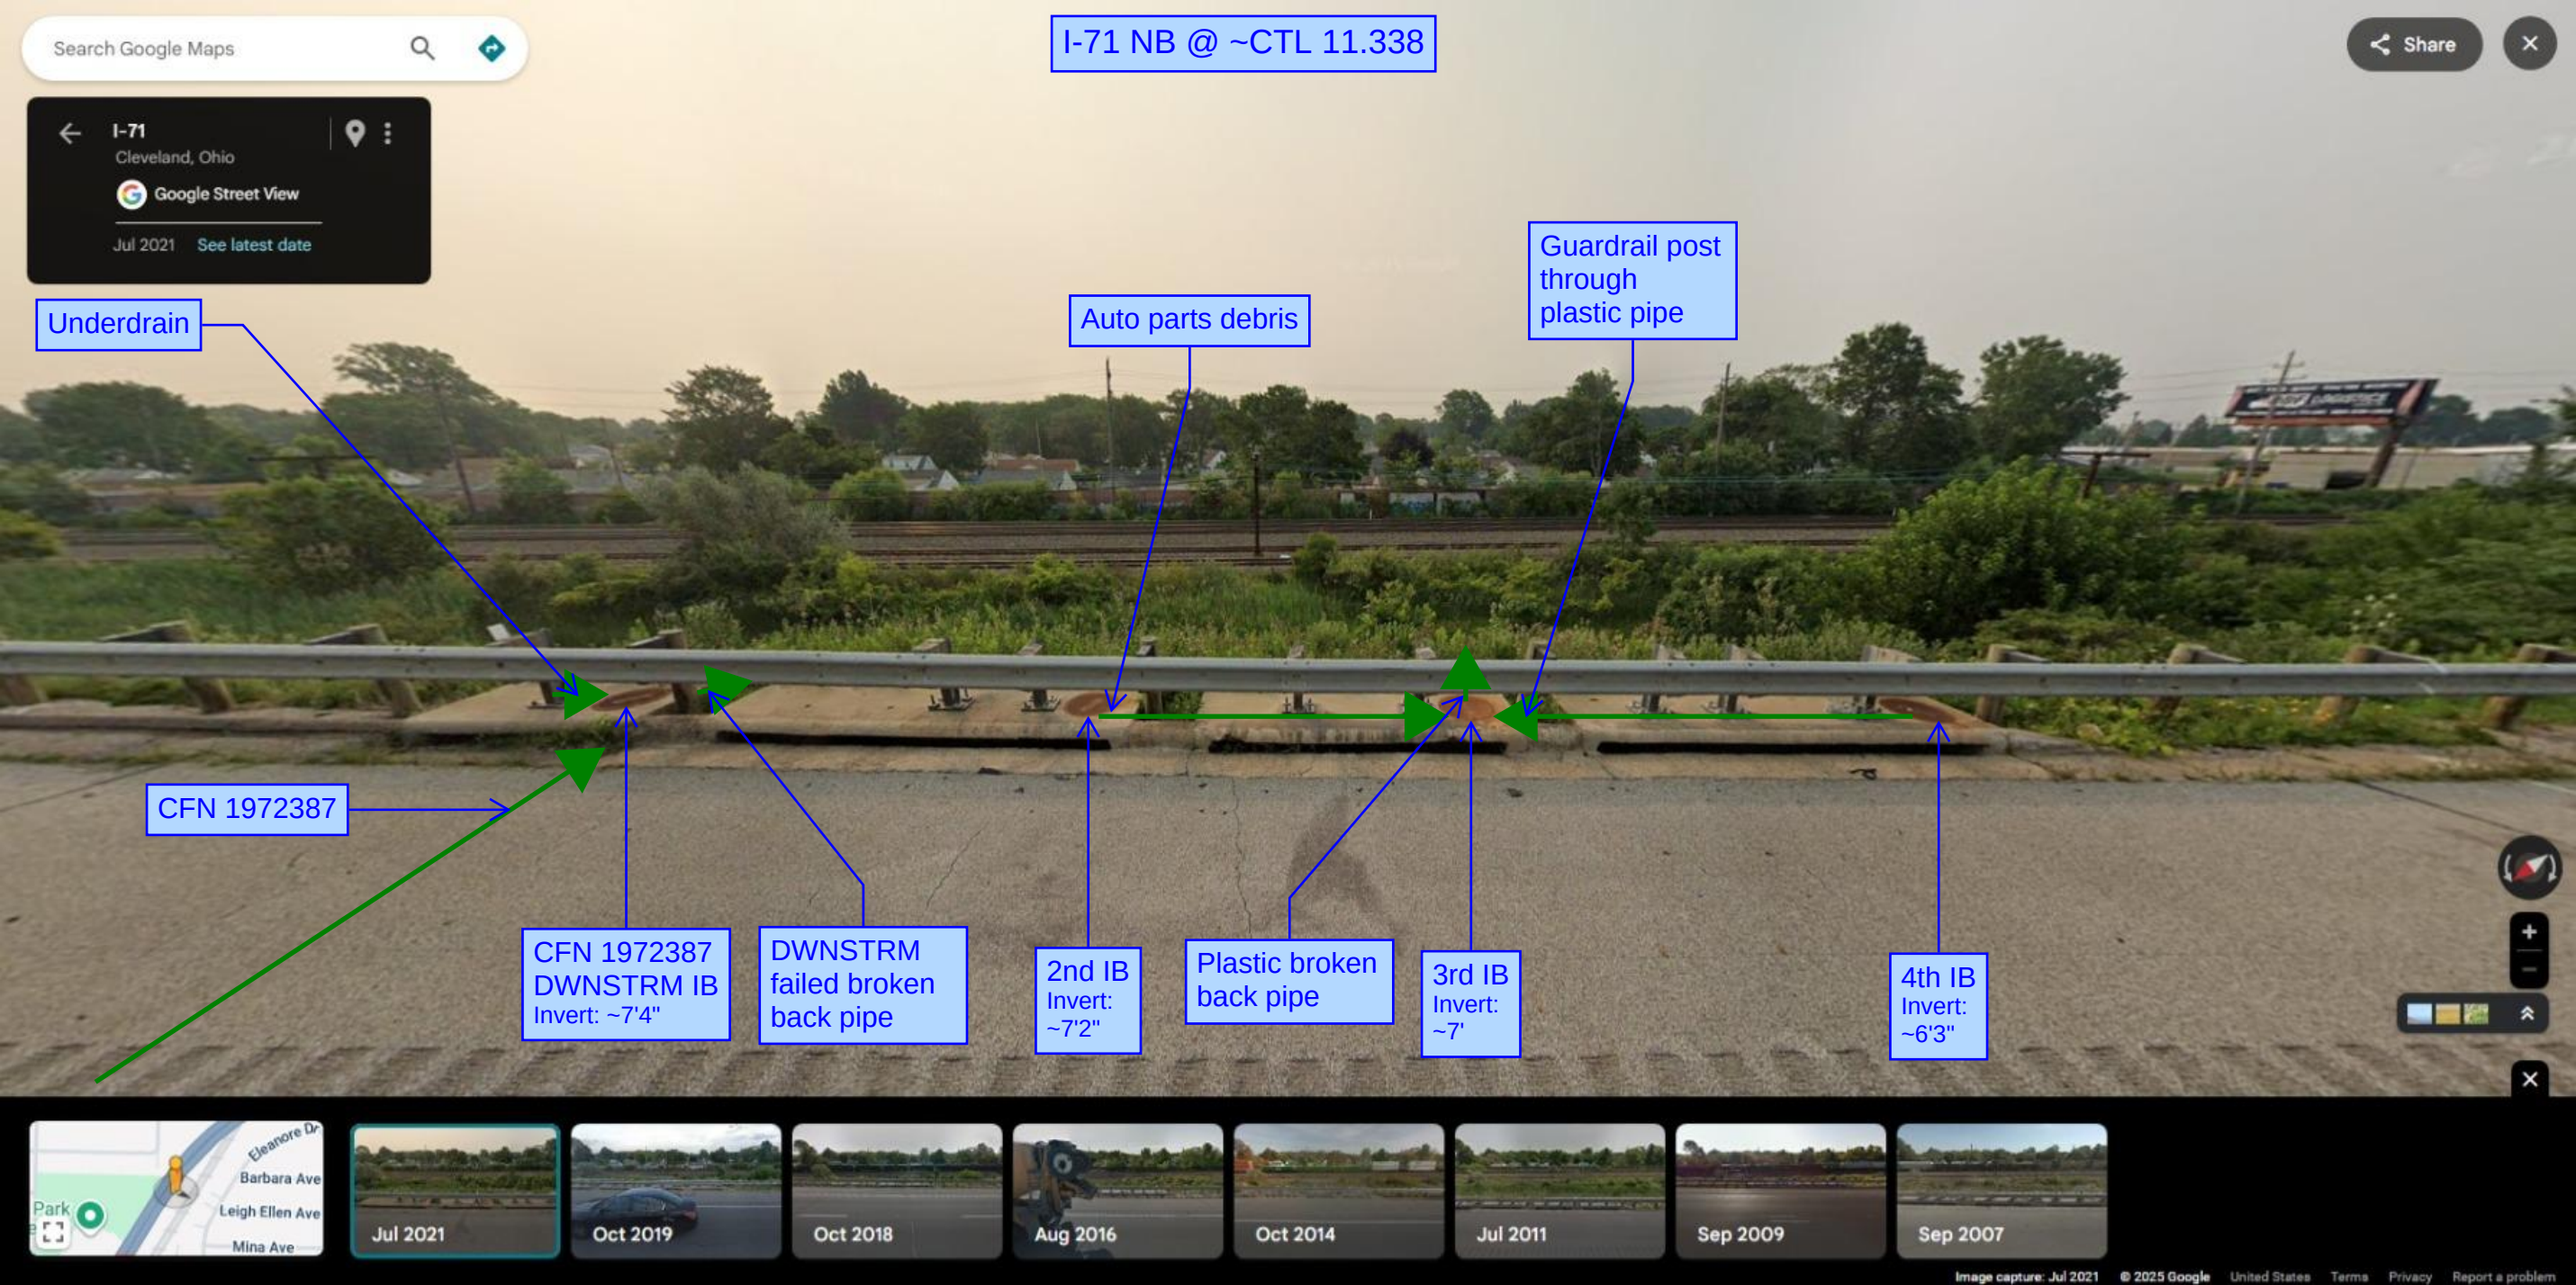
Search Google Maps
I-71
Cleveland, Ohio
Google Street View
Jul 2021
See latest date
I-71 NB @ ~CTL 11.338
Share
Underdrain
Auto parts debris
Guardrail post through plastic pipe
CFN 1972387
CFN 1972387 DWNSTRM IB Invert: ~7'4"
DWNSTRM failed broken back pipe
2nd IB Invert: ~7'2"
Plastic broken back pipe
3rd IB Invert: ~7'
4th IB Invert: ~6'3"
Eleanore Dr
Barbara Ave
Leigh Ellen Ave
Mina Ave
Park
Jul 2021
Oct 2019
Oct 2018
Aug 2016
Oct 2014
Jul 2011
Sep 2009
Sep 2007
Image capture: Jul 2021
© 2025 Google
United States
Terms
Privacy
Report a problem
