Lawhon & Associates, Inc.
ENVIRONMENTAL ENGINEERING AND CONSULTING SERVICES

Subject: Asbestos Inspection of the MAH C0151 679 South Avenue Bridge over Interstate Route 680 (SFN 5003350 / PID 121474) in Youngstown, Ohio 44502.
L&A Project No: 24-0045 Task M

APPENDIX B
BULK SAMPLE DIAGRAM

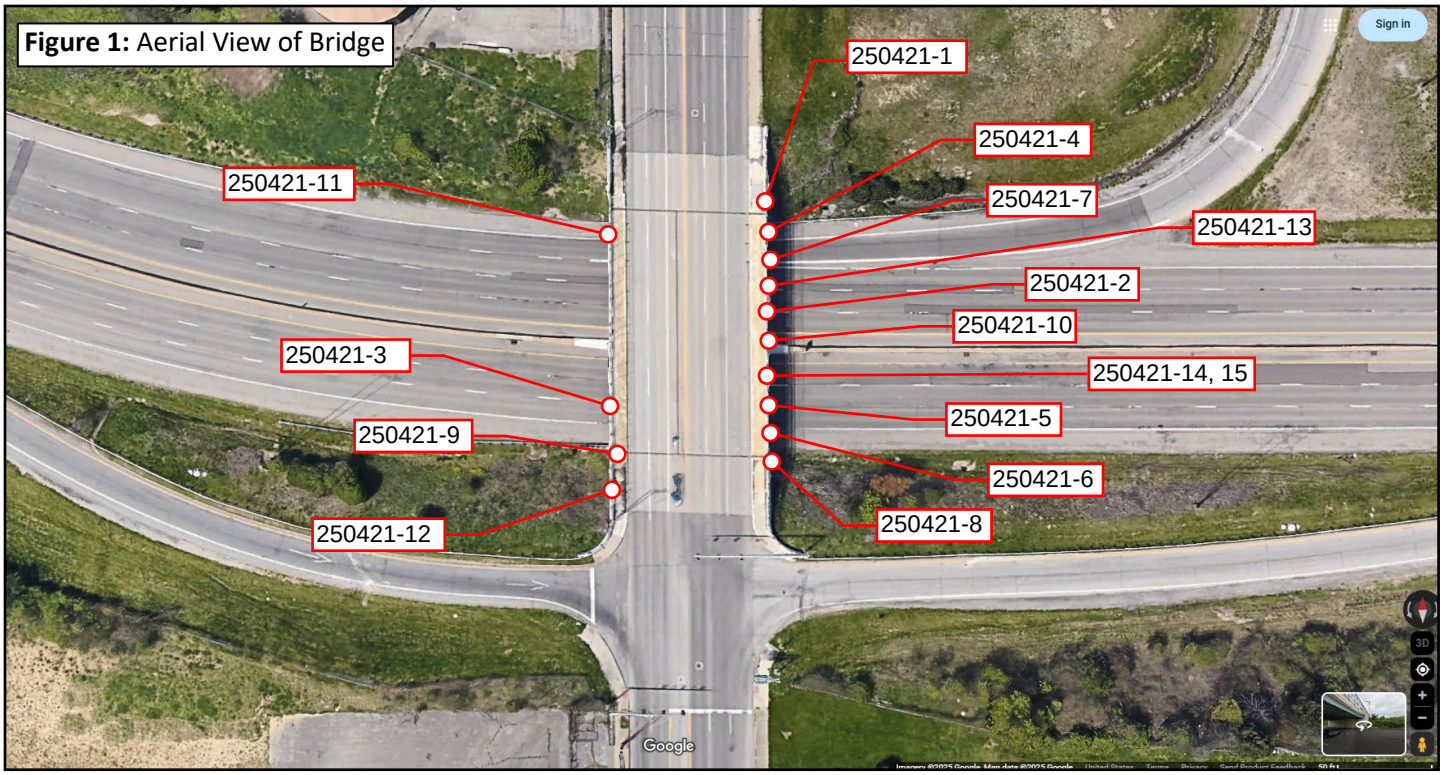
Figure 1: Aerial View of Bridge

Figure 2: View of Parapet Expansion Joint

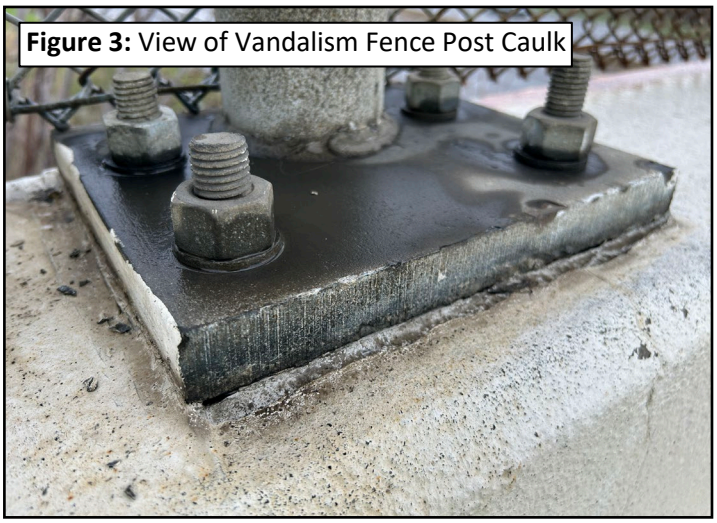
Figure 3: View of Vandalism Fence Post Caulk

Figure 4: View of Preformed Expansion Joint

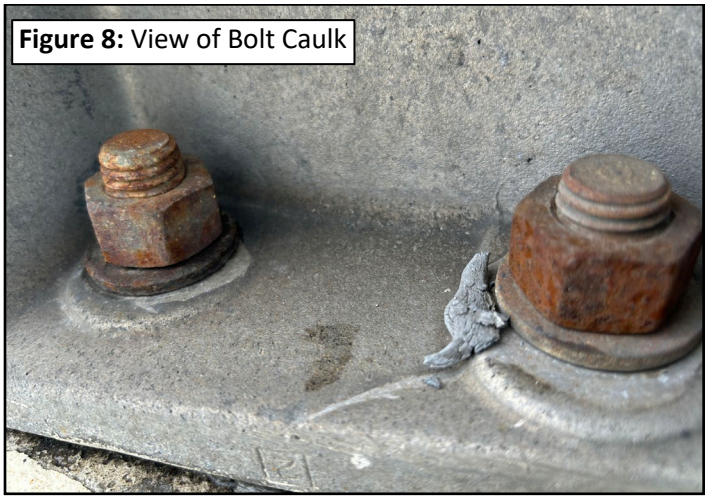
Figure 8: View of Bolt Caulk

250421-13	*Rail Pad / Bolt Caulk – North End, East Side*	*0.4% Chrysotile*
250421-14	*Rail Pad / Bolt Caulk – Middle, East Side*	*0.7% Chrysotile*
250421-15	*Rail Pad / Bolt Caulk – South End, West Side*	*0.5% Chrysotile*

Under the current EPA/NESHAP regulations, materials that contain greater than 1% asbestos are considered to be an asbestos-containing material (ACM). None of the materials sampled were found to be asbestos-containing material as defined by U.S EPA/NESHAP regulations. However, three samples of the rail pad / bolt caulking were reported as containing less than 1% asbestos. This material is not regulated under U.S EPA/NESHAP regulations, however, it is regulated under OSHA. There is approximately 40 square feet of this material on the East and West sides of the bridge. A Photo depicting this material can be seen in Figures 7 and 8 in Appendix B of the Bulk Sample Diagram..
