Lawhon & Associates, Inc.
ENVIRONMENTAL ENGINEERING AND CONSULTING SERVICES

Subject: Asbestos Inspection of the MAH C0018 173 Mahoning Avenue Bridge over Interstate Route 680 (SFN 5006864 / PID 121474) in Youngstown, Ohio 44509.
L&A Project No: 24-0045 Task M

Bulk Sample Diagram

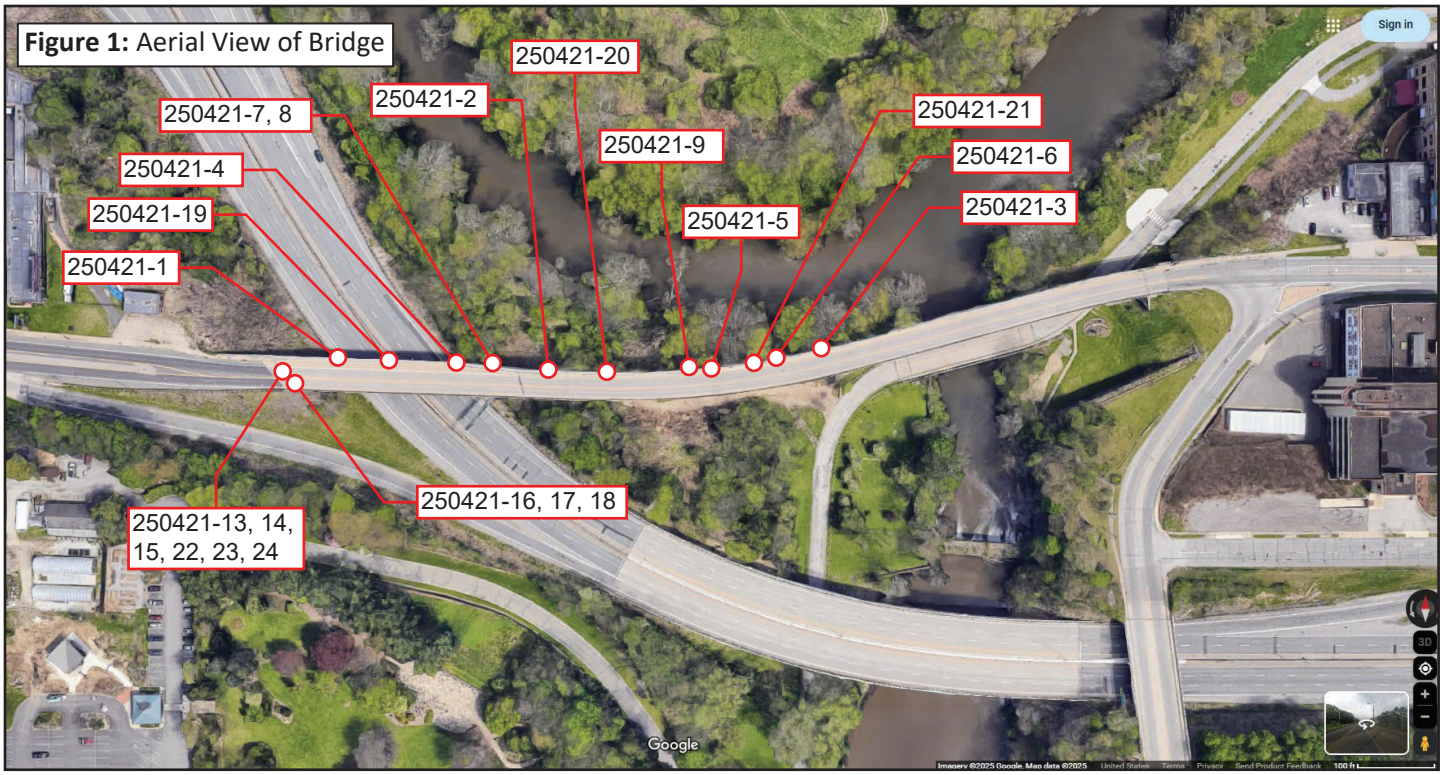
Figure 1: Aerial View of Bridge

Figure 2: View of Parapet Expansion Joint

Figure 3: View of Preformed Expansion Joint

Figure 4: View of Bearing Pad

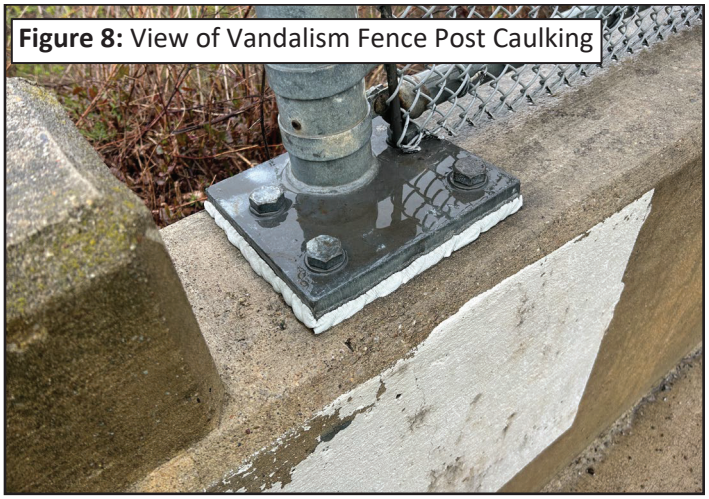
Figure 8: View of Vandalism Fence Post Caulking
