2026 Routine Element Level Inspection Report

HAM-00075-00.220R

SFN 3108805, PID 109780

November 13, 2026

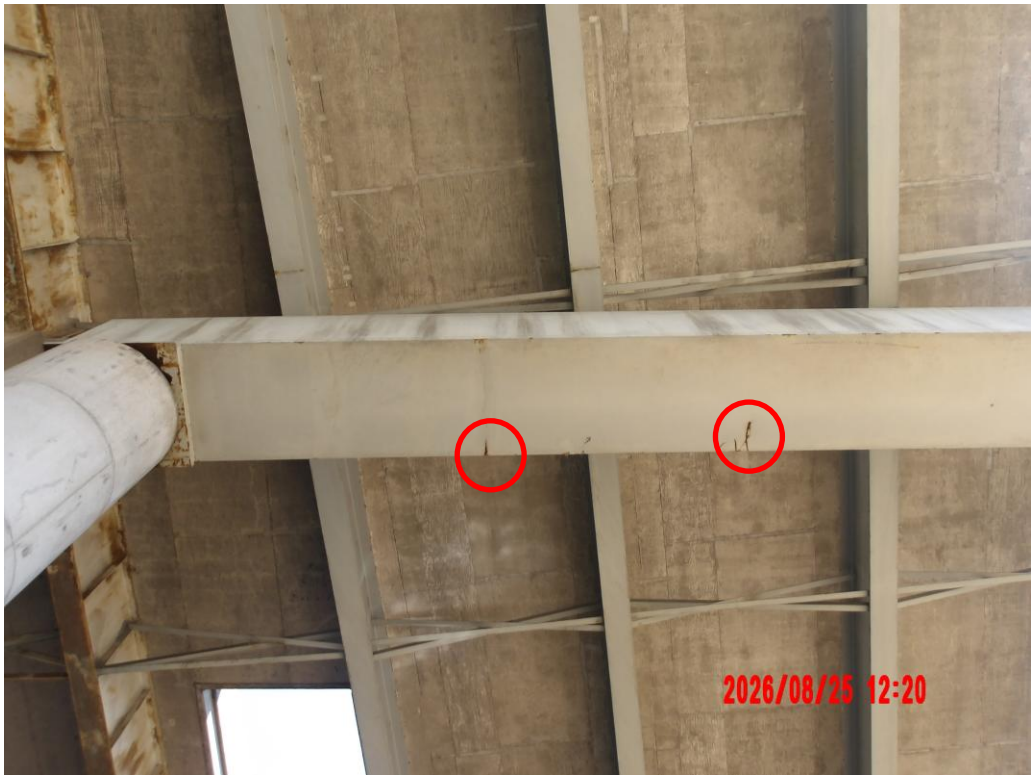
The pier cap exterior is in GOOD CONDITION (7). There are areas of surface corrosion scattered throughout the pier cap exterior, particularly on the top flange at the east end and along the edges of both flanges. There are minor scrapes with surface corrosion in the bottom flange (**Figure 23**). The bottom flange bearing plates at both columns exhibit minor surface corrosion.

FIGURE 23—SCRAPES WITH MINOR SURFACE CORROSION (PIER CAP 25J)

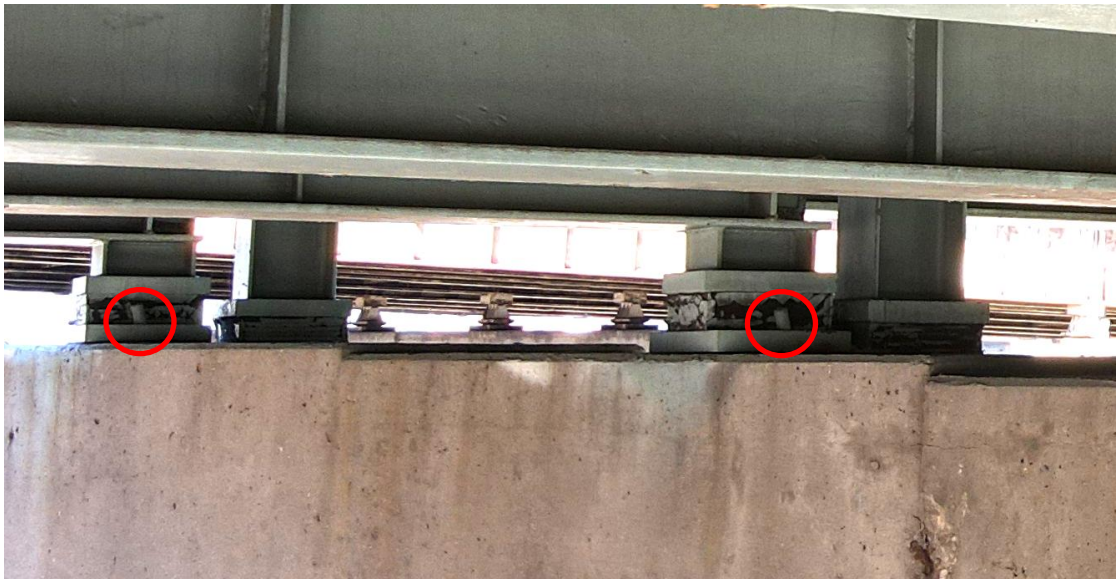
The new elastomeric bearings installed at Piers 15C, 18C, 23C and 26C are in good condition with minor isolated surface corrosion and laminating corrosion on the steel bearing plates (**Figure 33**). The restraining rods of the Span 18C bearings at Pier 18C are bent slightly (**Figure 34**).

FIGURE 34—SLIGHTLY BENT RESTRAINING RODS ON BEARINGS (PIER 18C)
