UNDERWATER BRIDGE INSPECTION REPORT

STRUCTURE NO. TUS-77-2217 SB
I-77 OVER SUGAR CREEK
TUSCARAWAS COUNTY, OH
DISTRICT 11

July 2017

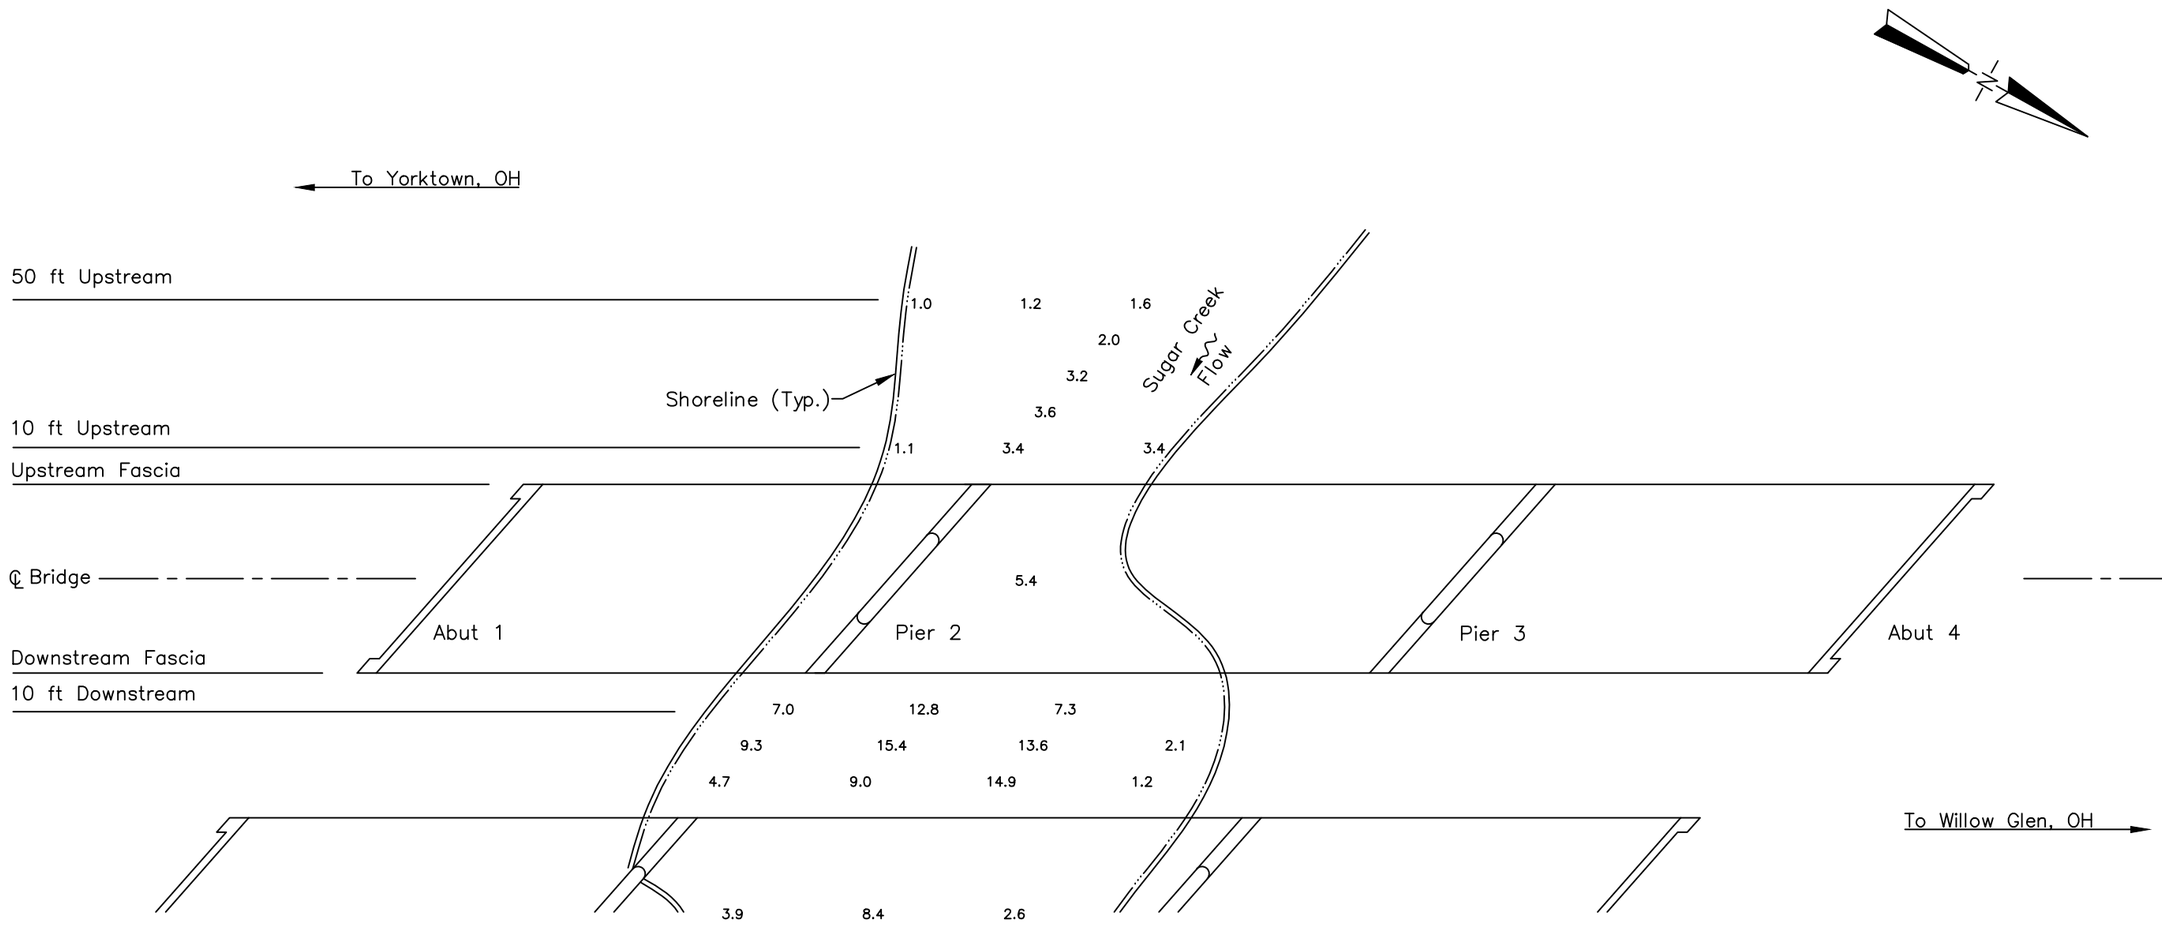
SOUNDING PLAN

Overall, the inspected substructure units of Structure No. TUS-77-2217 SB were in good condition. A comparison of the soundings recorded during the previous inspection on September 23, 2012 and the soundings taken during this inspection revealed no significant change in the channel bottom profile in the vicinity of the structure. Although no channel deficiencies were observed, the channel bottom should continue to be monitored during future underwater inspections to verify that localized scour or overall channel degradation is not occurring and that the pier footings remain adequately embedded in the channel bottom.

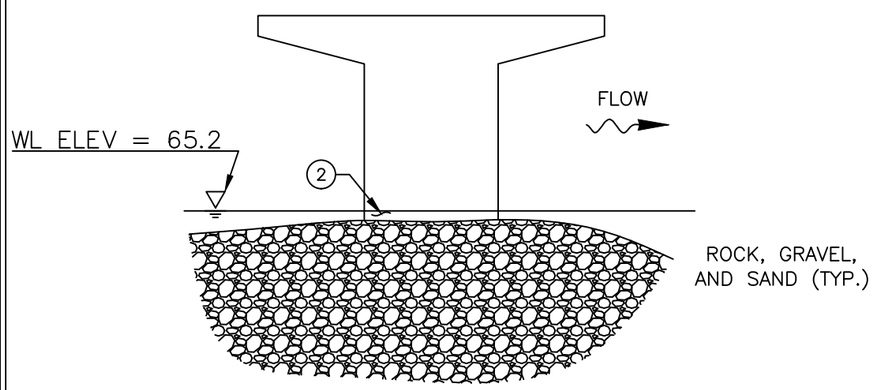
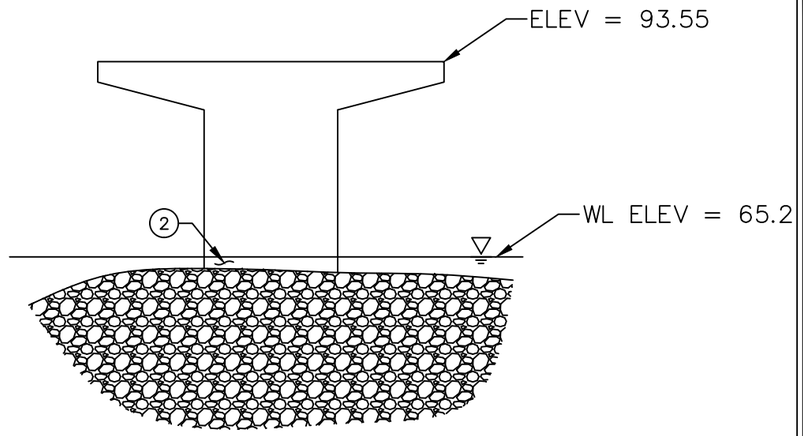
I-77 OVER SUGAR CREEK
BRIDGE NO. TUS-77-2217 SB
PIER 2
TUSCARAWAS COUNTY, OHIO

The channel bottom material around Pier 2 consisted of rip-rap with approximately 2 in. probe rod penetration. The submerged portions of the pier exhibited light scaling up to 1/8 in deep and light marine growth. Refer to Figure 4 in Exhibit 1 for detailed inspection notes of Pier 2. Refer to Photographs 9 through 11 in Exhibit 2 for views of Pier 2 and typical concrete condition at the waterline.

1. The channel bottom material consisted of rip–rap with approximately 2 in. probe rod penetration.
2. The submerged portions of the pier had light scaling up to 1/8 in. diameter.

- Monitor scaling on Piers 2.
