UNDERWATER BRIDGE INSPECTION REPORT

STRUCTURE NO. SFN1001388
(CAR-183-0790)
SR-183 OVER BIG SANDY CREEK
CARROLL COUNTY, OH
DISTRICT 11

July 2022

Project: ODOT D11 Underwater Bridge Inspections - 2022.

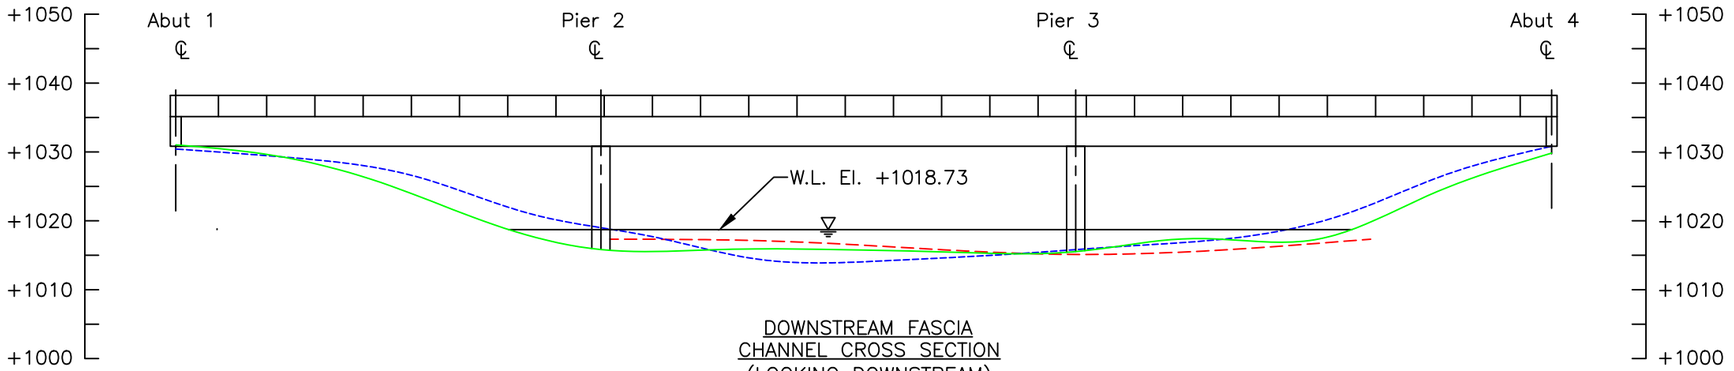
DOWNSTREAM FASCIA
CHANNEL CROSS SECTION
(LOOKING DOWNSTREAM)

1. The channel bottom material consisted of riprap up to 2 in. diameter with sand and silt in−fill.
2. Typical light marine growth algae and silt up to 1/8 in. deep was observed on the submerged portions of the pier.

3. The submerged portions of the pier exhibited light scaling up to 1/4 in. deep from the channel bottom to 2 ft above the waterline.
4. A spall measuring 1 ft horizontal by 3 ft vertical by 3 in. deep with three exposed reinforcing bars and light surface corrosion was observed on the pier cap of the south face of the pier.

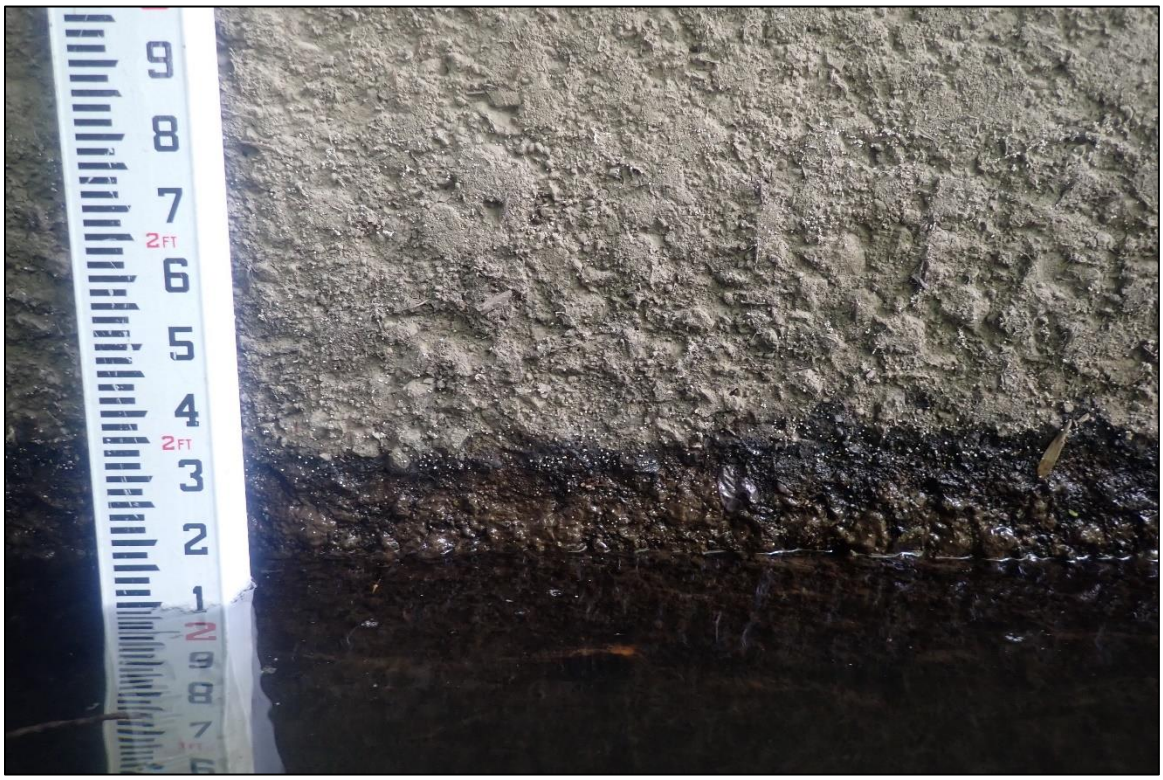
Photograph No. 17: View of the Typical Concrete Condition at the Waterline on the North Face of Pier 2, Looking Southeast.
