UNDERWATER BRIDGE INSPECTION REPORT

STRUCTURE NO. SFN3410000
(HAS-799-3.91)
OH-799 OVER CLENDENING LAKE
HARRISON COUNTY, OH
DISTRICT 11

August 2022

COLLINS ENGINEERS INC.

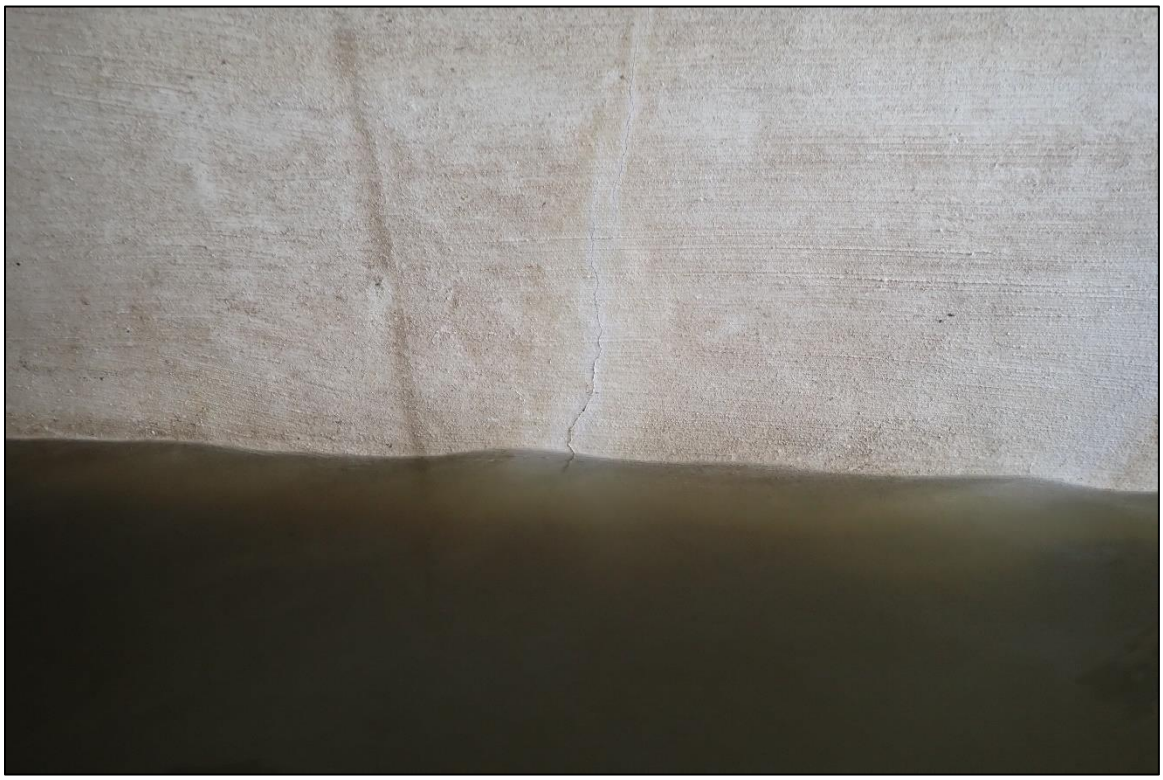
Photograph No. 11: View of the Vertical Crack on the North Face of Abutment 1, Looking South.

The cracks at Abutments 1 and 2 are not structural concerns at this time. However, the cracks do provide a means for water infiltration and freeze-thaw damage. It is therefore recommended that these cracks be monitored during future underwater inspections. If further crack propagation or increased crack widths are observed, it may be necessary to repair the cracks by injection or patching with a repair material suitable for underwater applications
