UNDERWATER BRIDGE INSPECTION REPORT

STRUCTURE NO. SFN4102428
(JEF-150-1294)
SR-150 OVER SHORT CREEK
JEFFERSON COUNTY, OH
DISTRICT 11

August 2022

COLLINS ENGINEERS INC.

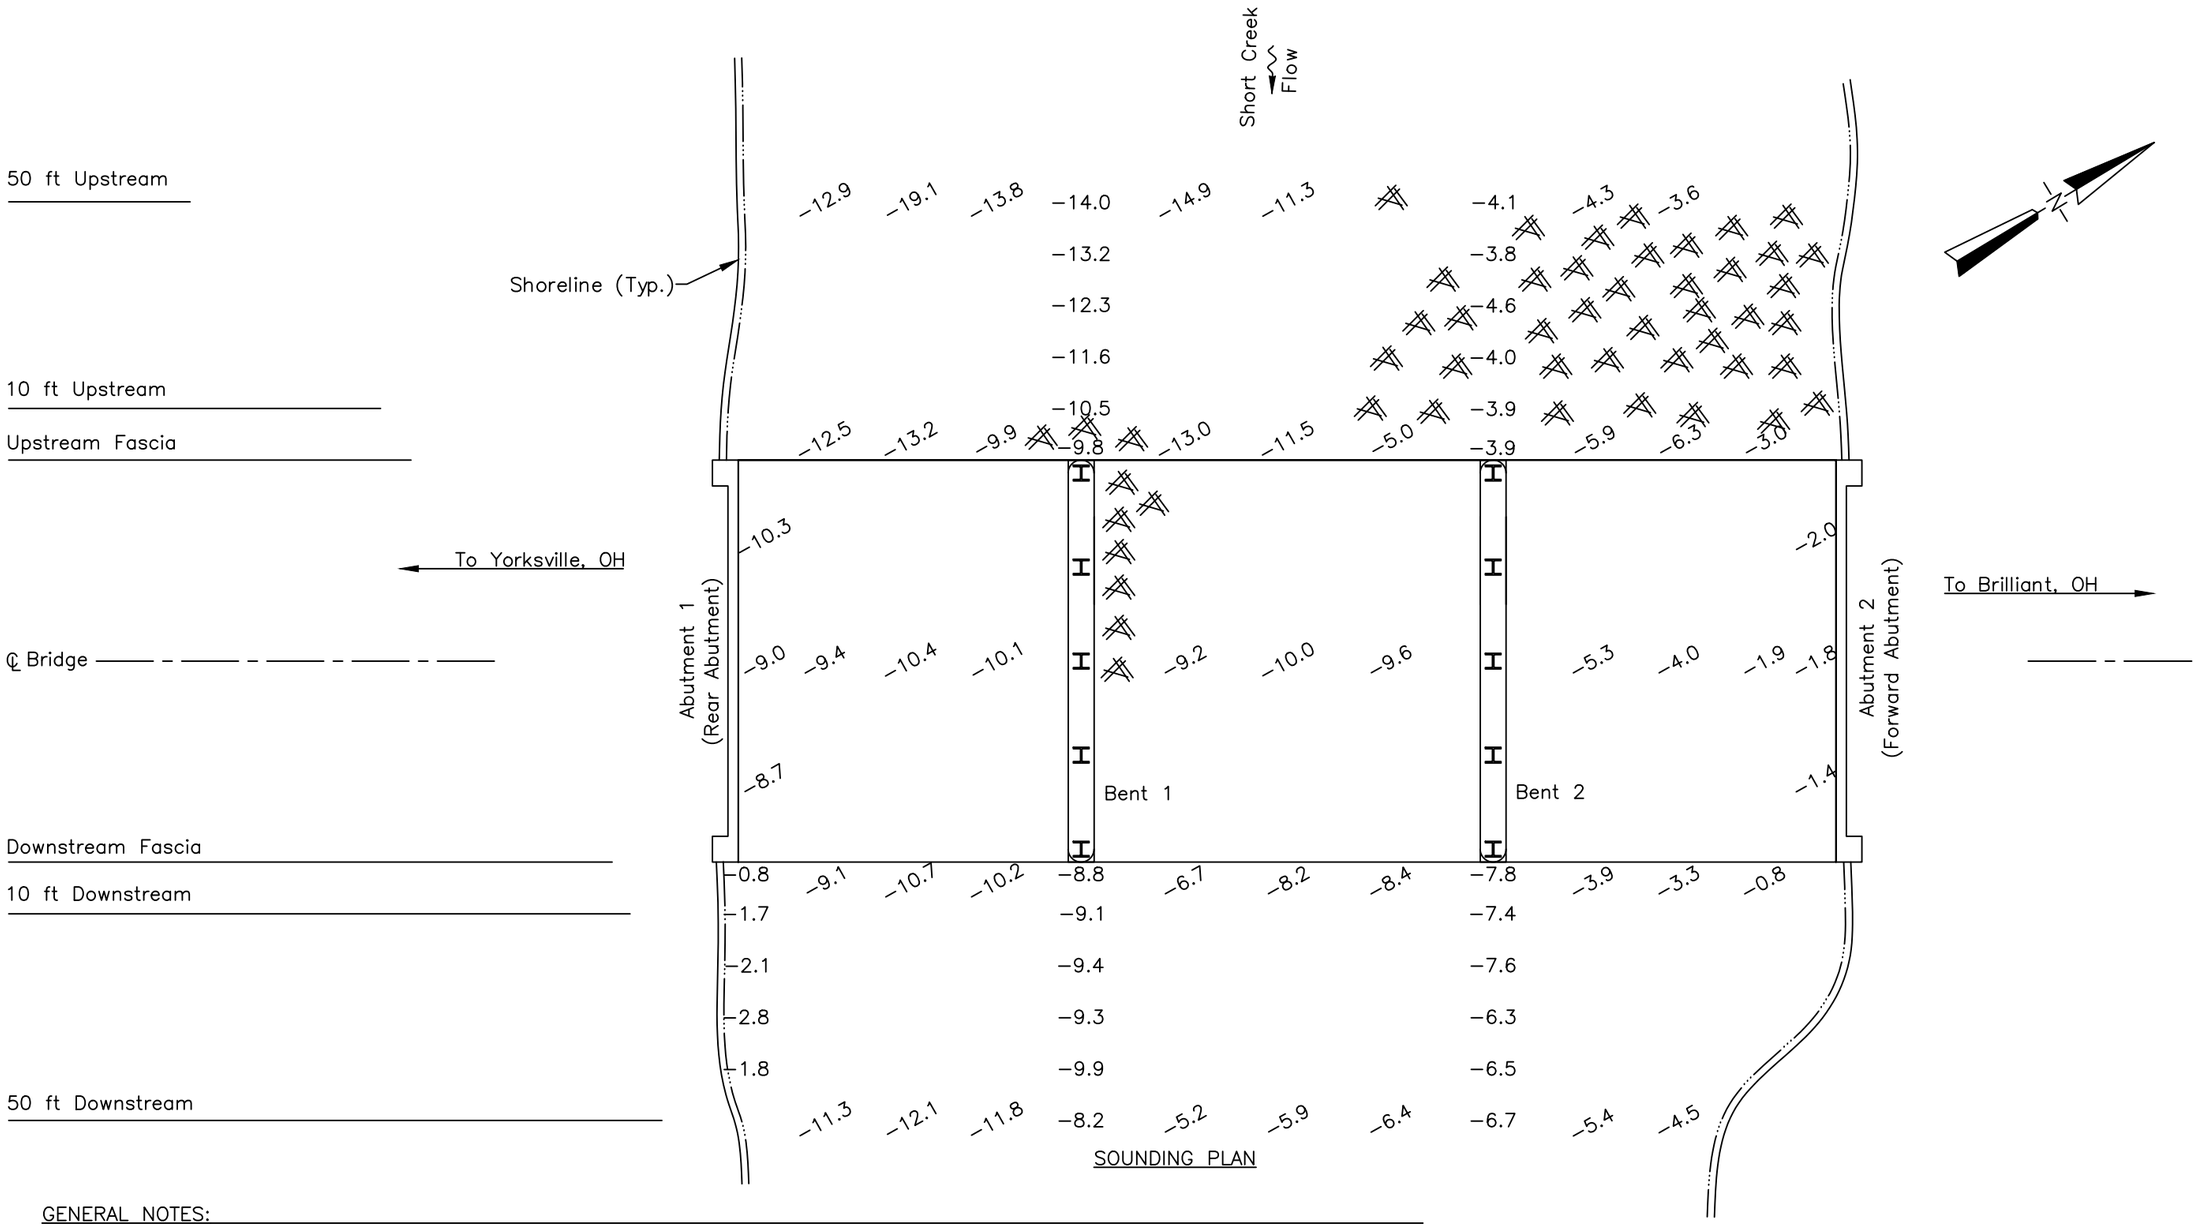
SOUNDING PLAN

- Heavy timber debris accumulation consisting of logs up to 12 in. diameter was observed from the upstream nose of Bent 1 to the north face of Bent 2 extending from the channel bottom to approximately 1 ft above the waterline.

The timber debris accumulation at Bents 1 and 2 did not significantly affect the channel flow, and as a result, does not require removal at this time. If the debris accumulation increases in size or density, it may be necessary to remove the debris to reduce excessive lateral loads on the piles, limit further debris accumulation, and reduce the likelihood of channel bottom degradation resulting from obstructed flow.

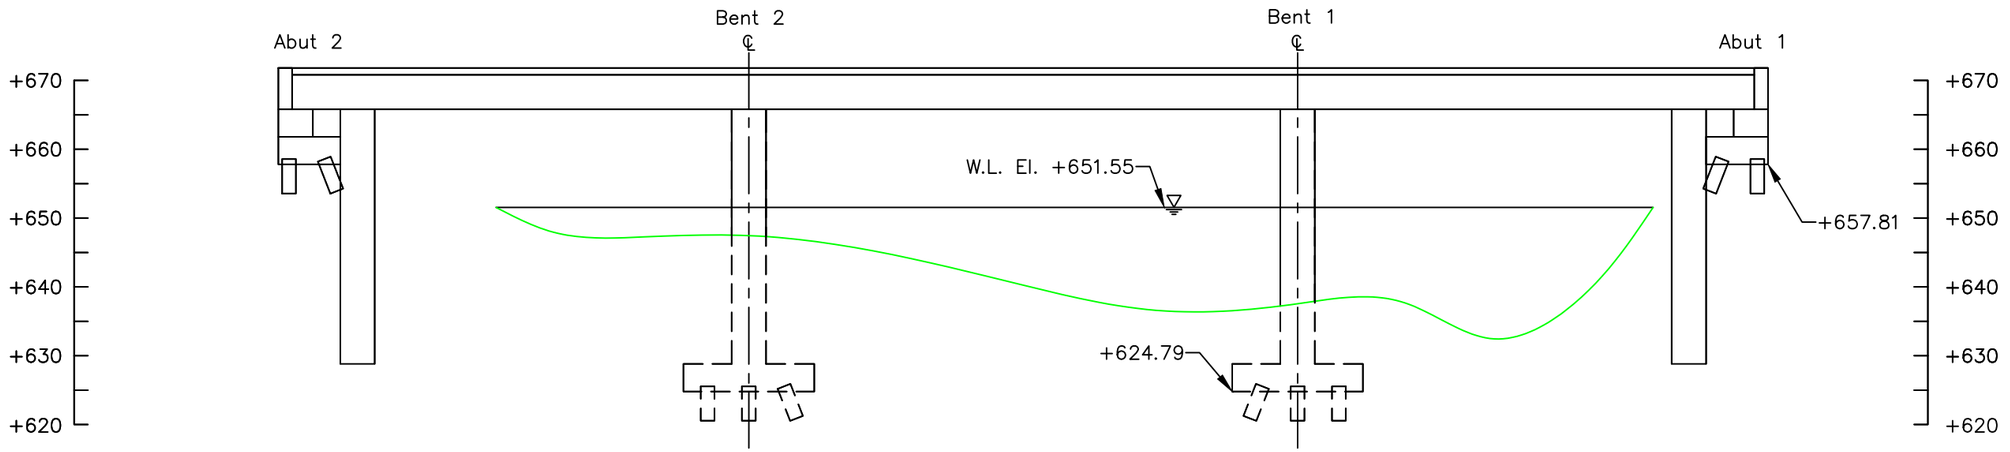
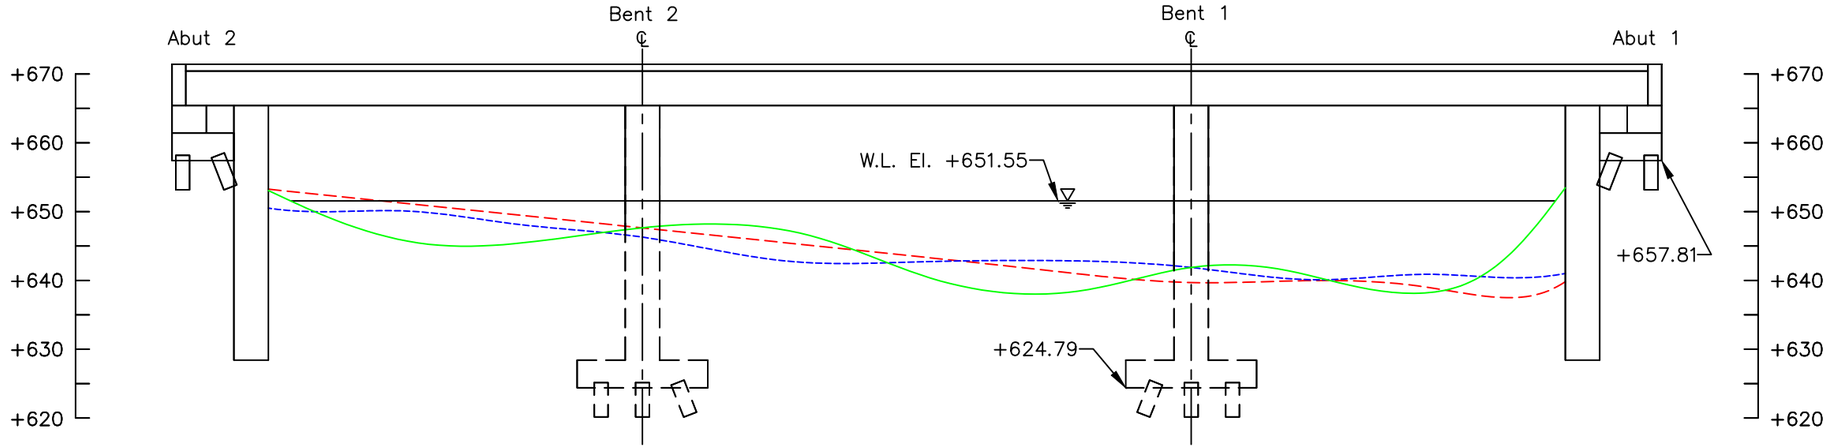
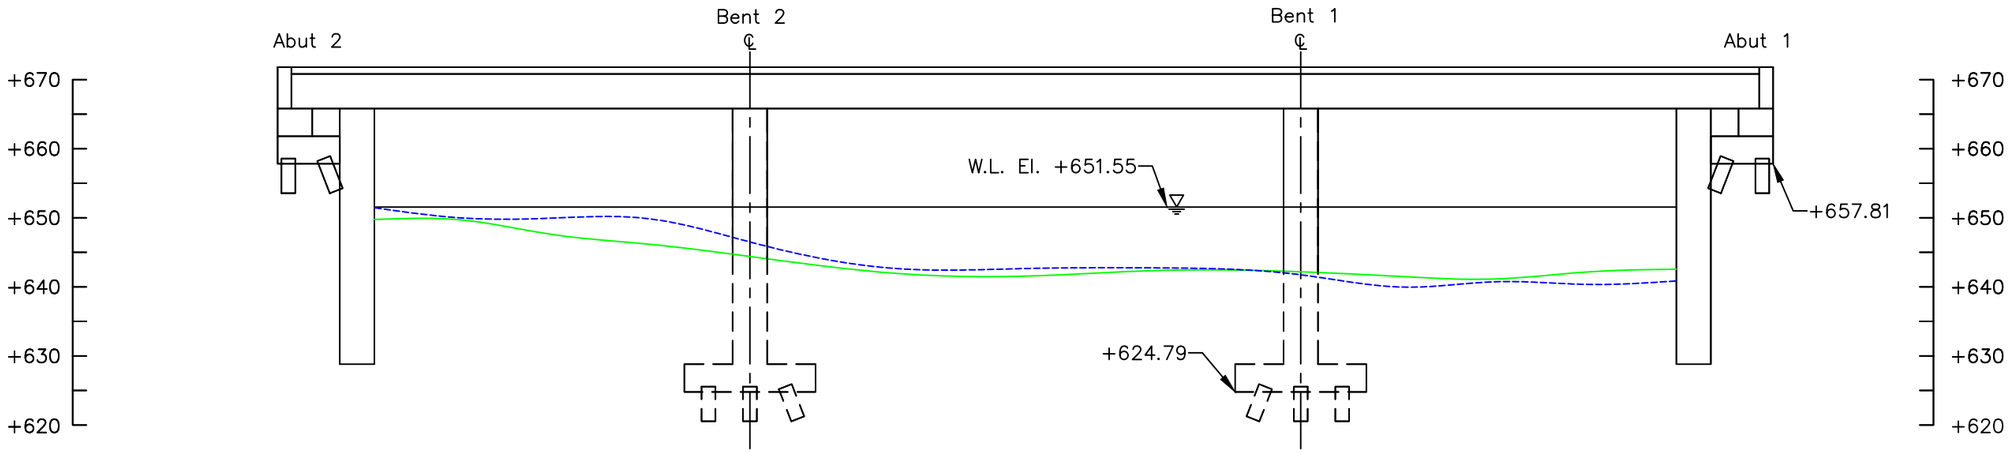
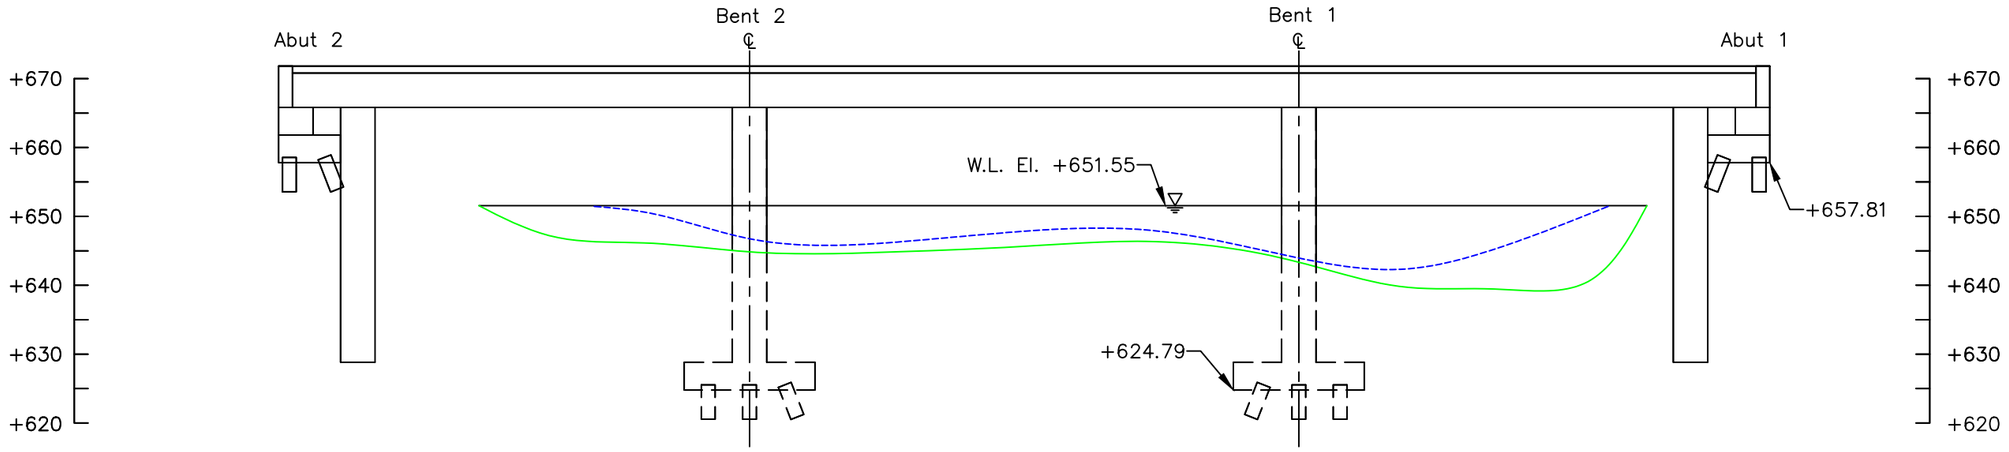
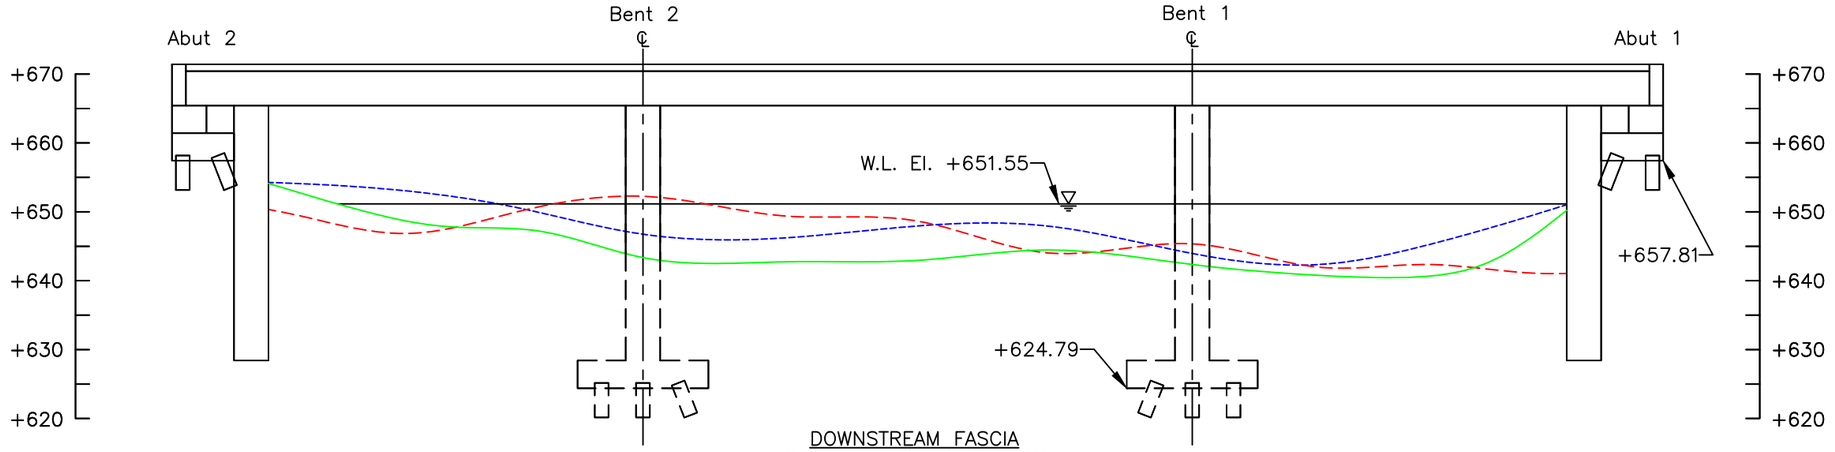
Overall, the inspected substructure units of Structure No. SFN4102428 were in satisfactory condition. A comparison of the soundings recorded during the previous inspection on August 5, 2017 and the soundings taken during this inspection revealed no significant change in the channel bottom profile in the vicinity of the structure. Although no channel deficiencies were observed, the channel bottom should continue to be monitored during future underwater inspections to verify that localized scour or overall channel degradation is not occurring.

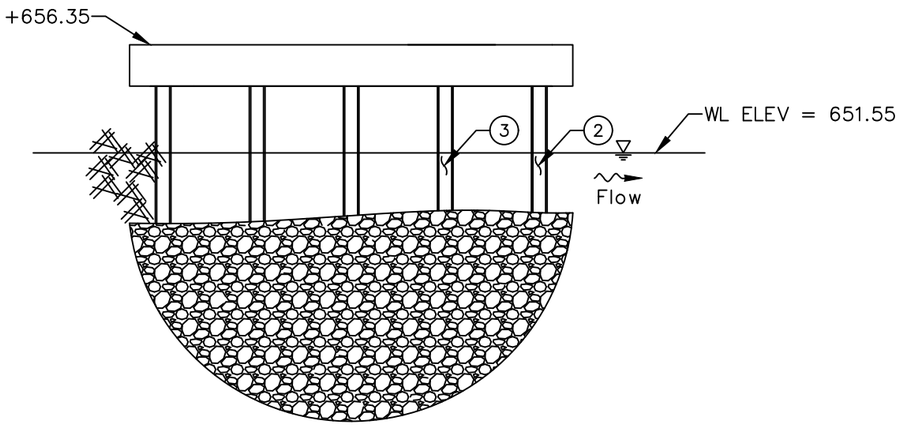
SOUTH ELEVATION
(LOOKING NORTH)

1. The channel bottom material consisted of soft silt with approximately 36 in. probe rod penetration.
2. Typical light marine growth algae and silt up to 1/8 in. deep was observed on the submerged portions of the bent.
3. The submerged portions of the piles exhibited light corrosion with no measurable loss of section extending from the channel bottom to the waterline.
4. Heavy timber debris accumulation consisting of logs up to 12 in. diameter was observed from the upstream nose of Bent 1 to the north face of Bent 2 extending from the channel bottom to approximately 1 ft above the waterline.
5. 8 abandoned steel H piles were observed 3 1/2 ft below the waterline at 8 ft north of the bent.

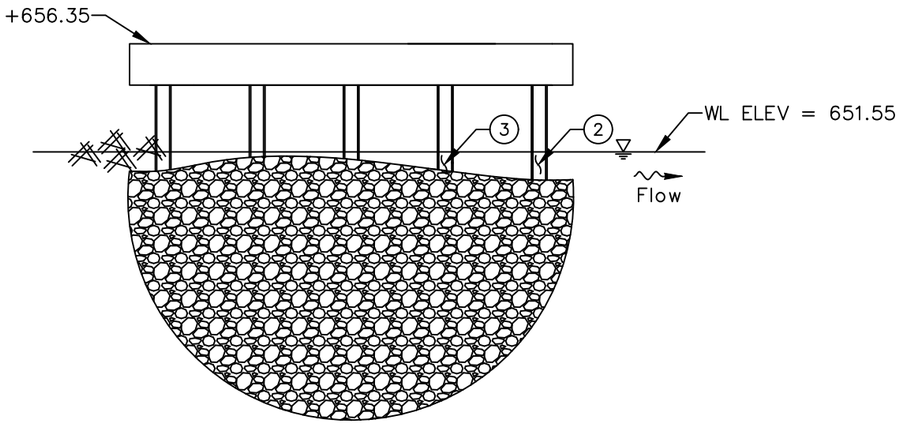
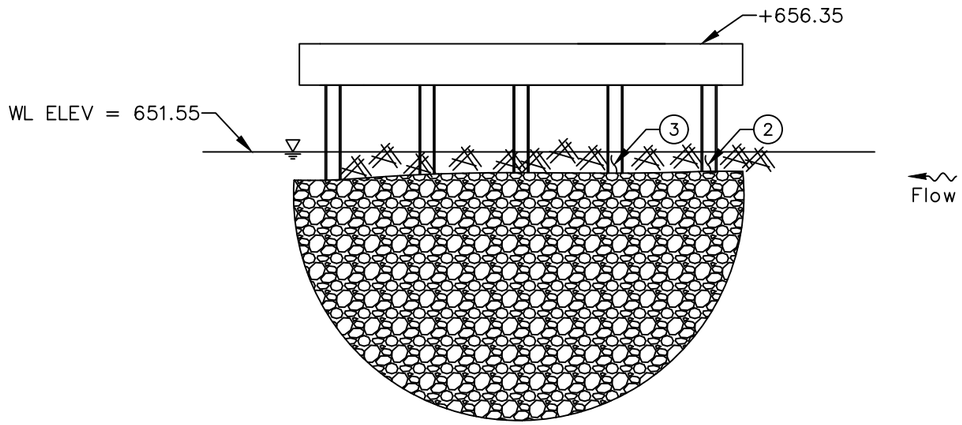
SR-150 OVER SHORT CREEK
BRIDGE NO. SFN4102428
BENT 2
JEFFERSON COUNTY, OHIO

1. The channel bottom material consisted of soft silt with approximately 36 in. probe rod penetration.
2. Typical light marine growth algae and silt up to 1/8 in. deep was observed on the submerged portions of the bent.
3. The submerged portions of the piles exhibited light corrosion with no measurable loss of section extending from the channel bottom to the waterline.
4. Heavy timber debris accumulation consisting of logs up to 12 in. diameter was observed from the upstream nose of Bent 1 to the north face Bent 2 extending from the channel bottom to approximately 1 ft above the waterline.
5. 8 abandoned steel H piles were observed 2 1/2 ft below the waterline at 8 ft south of the bent.

The corrosion on the piles of Bents 1 and 2 is not a structural concern at this time, and as a result, no repairs are recommended. It is recommended that the extent and severity of the corrosion be closely monitored during future inspections. Should the extent or severity of the corrosion progress, it may be necessary to repair the piles by cleaning the piles and installing wraps or encasements. It is also recommended that during future inspections the remaining thickness of the steel piles be measured with the use of an ultrasonic thickness measuring device.
