UNDERWATER BRIDGE INSPECTION REPORT

STRUCTURE NO. SFN0700371
(BEL-149-0005L)
SR-149 OVER MCMAHON CREEK
BELMONT COUNTY, OH
DISTRICT 11

May 2025

COLLINS ENGINEERS INC.

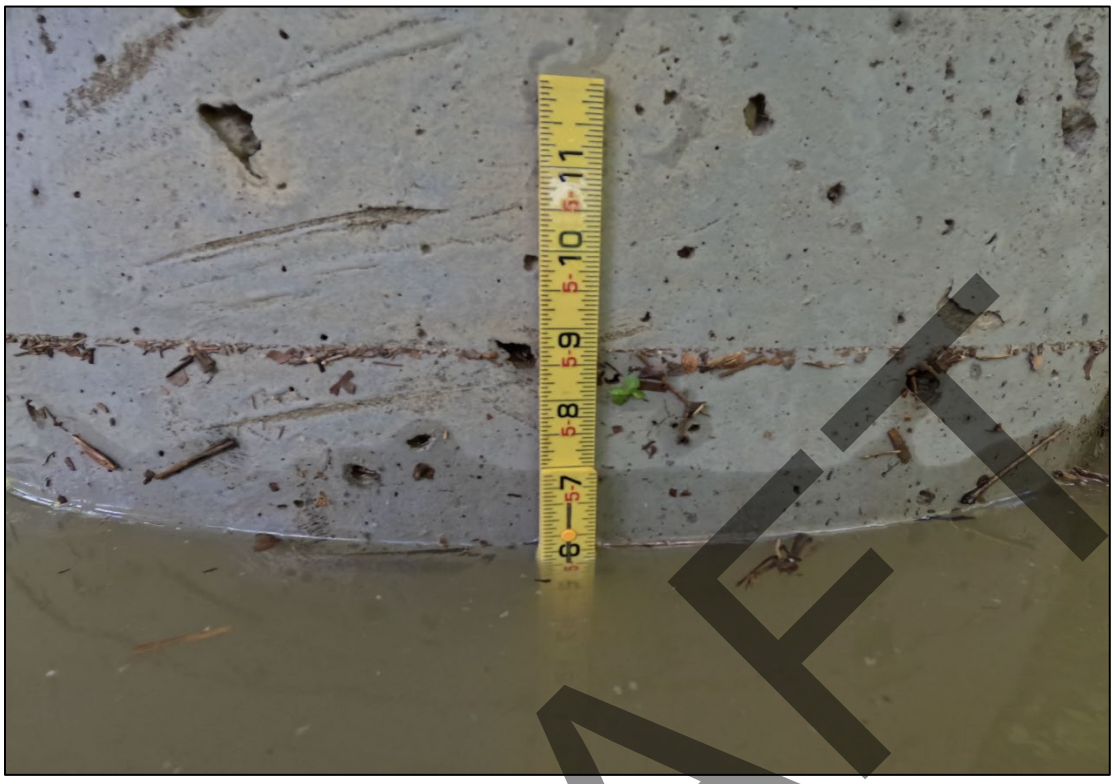
Photograph No. 17: View of the Typical Concrete Condition at the Waterline, Looking North.
