UNDERWATER BRIDGE INSPECTION REPORT

STRUCTURE NO. SFN3401685
(HAS-250-0934)
SR 250 OVER TAPPAN LAKE RESERVOIR
HARRISON COUNTY, OH
DISTRICT 11

August 2022

COLLINS ENGINEERS INC.

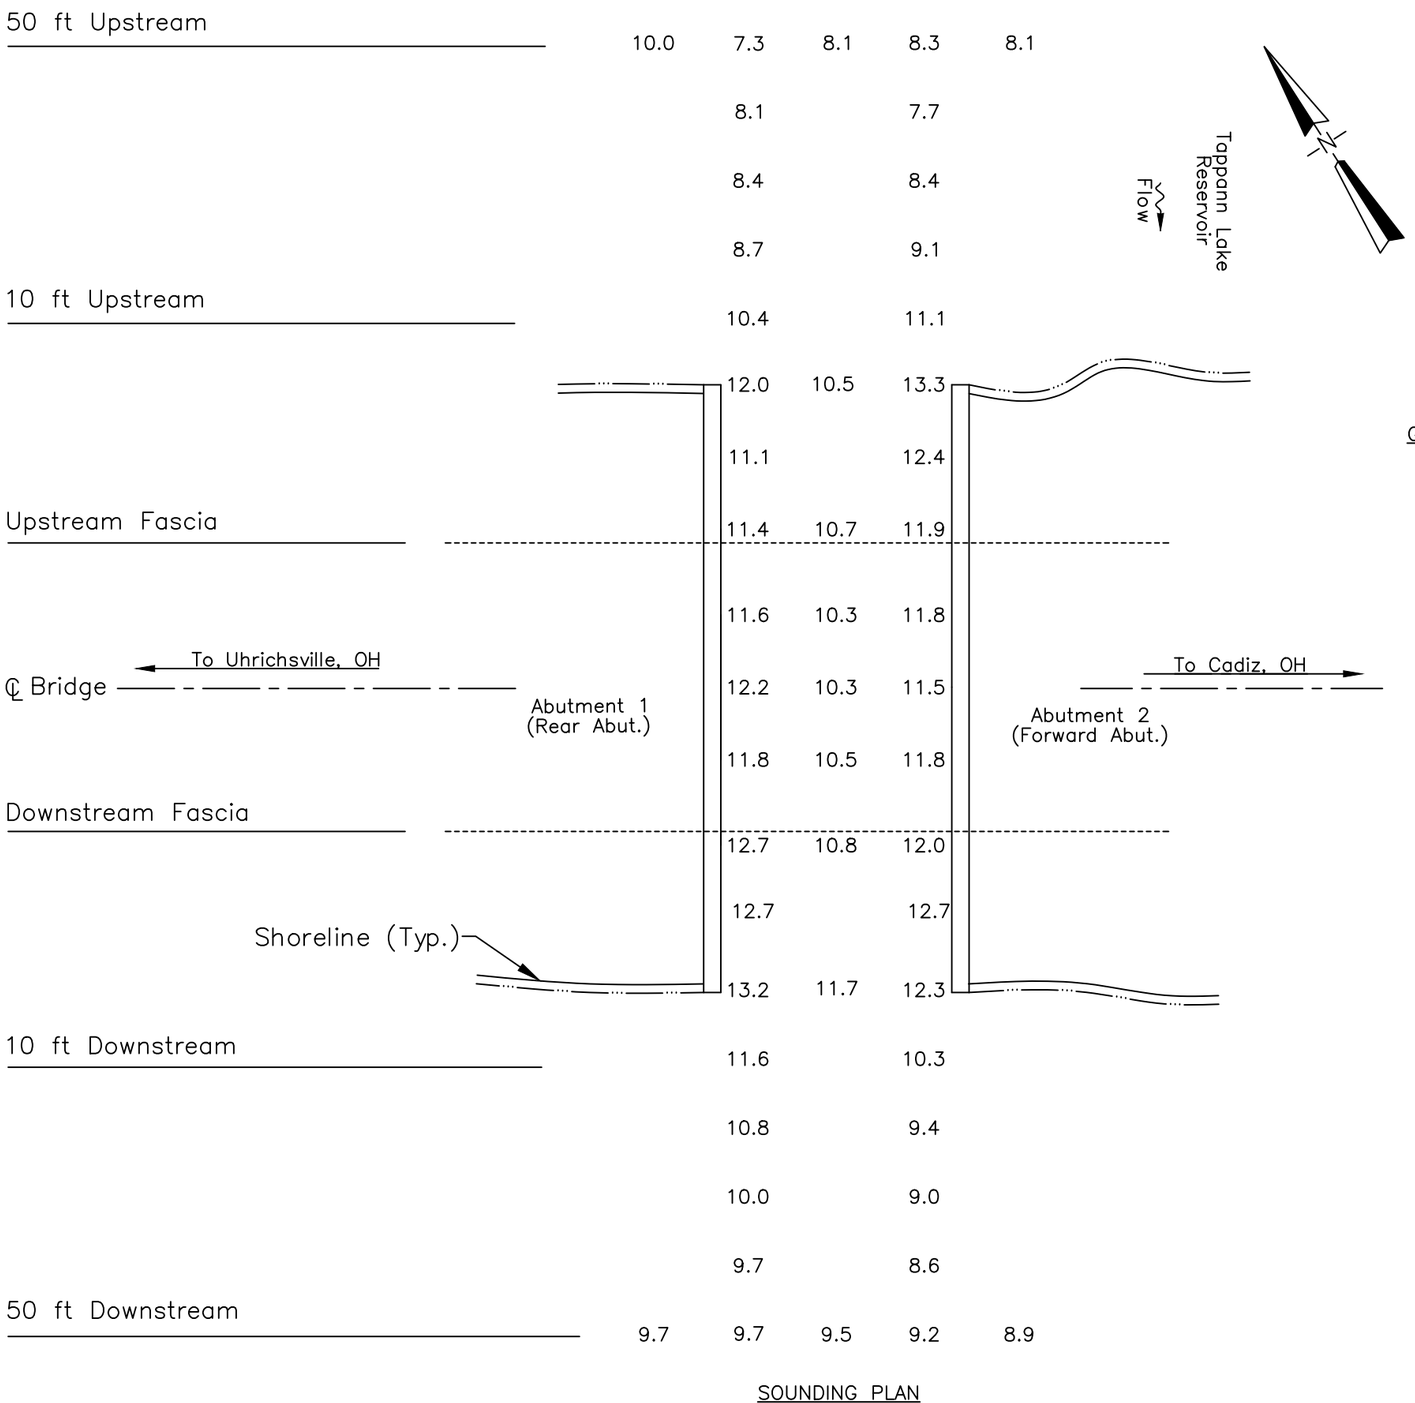
SOUNDING PLAN

Overall, the inspected substructure units of Structure No. SFN3401685 were in good condition. A comparison of the soundings recorded during the previous inspection on August 2, 2017 and the soundings taken during this inspection revealed no significant change in the channel bottom profile in the vicinity of the structure. Although no channel deficiencies were observed, the channel bottom should continue to be monitored during future underwater inspections to verify that localized scour or overall channel degradation is not occurring and that the abutment footings remain adequately embedded in the channel bottom.

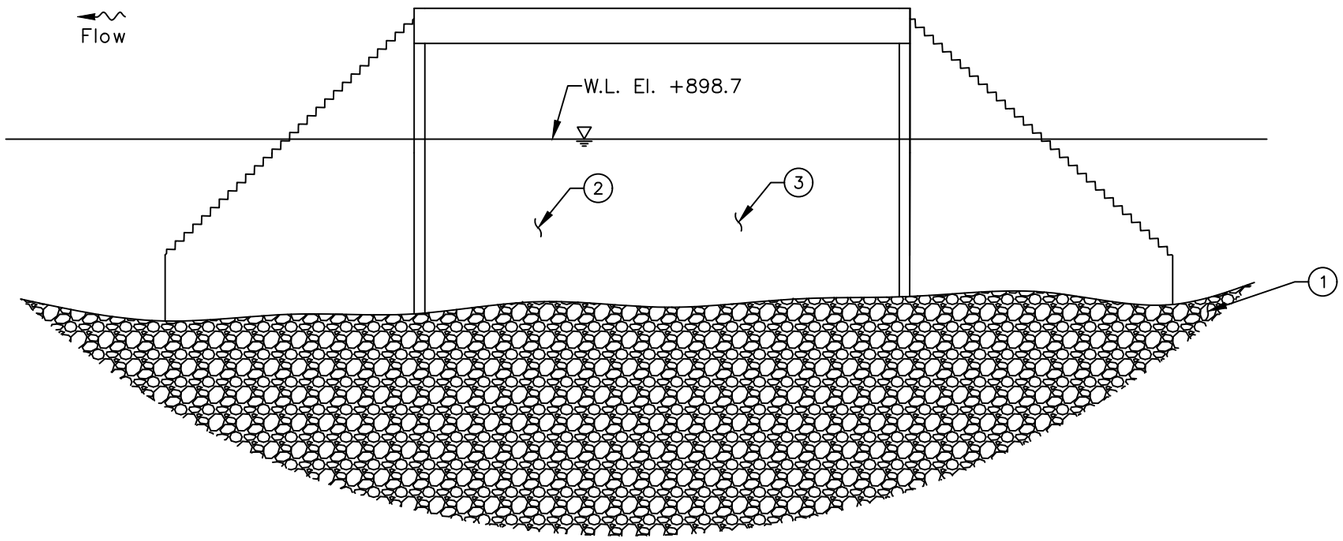
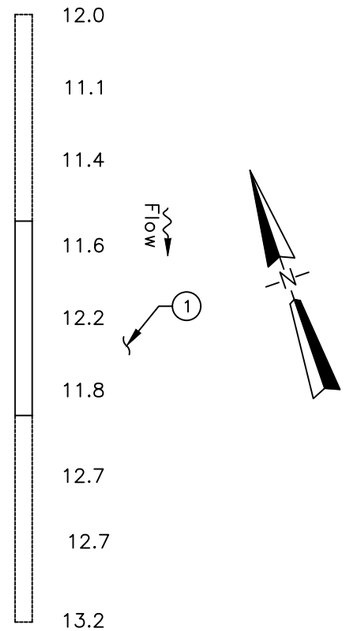
SR 250 OVER TAPPAN LAKE RESERVOIR
BRIDGE NO. SFN3401685
ABUTMENT 1
HARRISON COUNTY, OHIO

1. The channel bottom material consisted of 2 ft diameter riprap and silt with up to a 3 in. probe rod penetration.
2. Light scaling up to 1/16 in. deep with isolated areas of up to 1/4 in. deep was observed on the submerged portion of the abutment.
3. Typical light marine growth algae and silt up to 1/4 in. deep was observed on the submerged portions of the abutment.

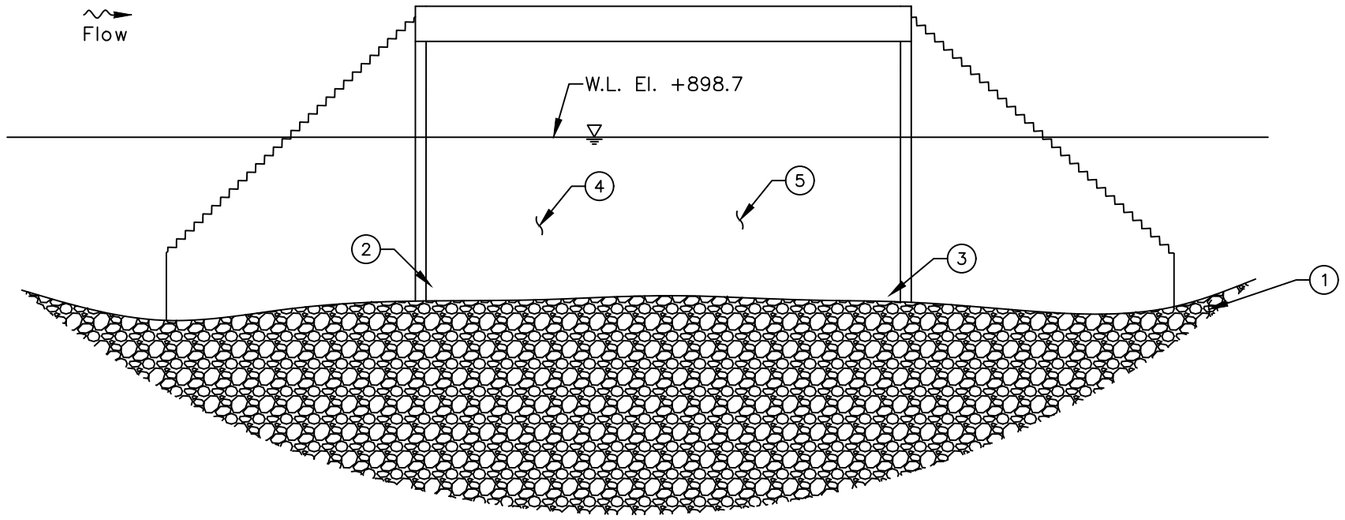
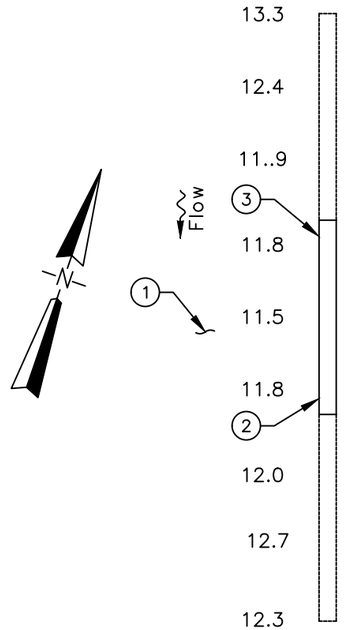
SR 250 OVER TAPPAN LAKE RESERVOIR
BRIDGE NO. SFN3401685
ABUTMENT 2
HARRISON COUNTY, OHIO

1. The channel bottom material consisted of 2 ft diameter riprap and silt with up to a 3 in. probe rod penetration.
2. A construction joint up to 1 in. wide was observed near the south fascia at the channel bottom.
3. A construction joint up to 1/2 in. wide was observed near the north fascia at the channel bottom.
4. Light scaling up to 1/16 in. deep with isolated areas of up to 1/4 in. deep was observed in the submerged portion of the abutment.
5. Typical light marine growth algae and silt up to 1/4 in. deep was observed on the submerged portions of the abutment.
